# Engineered Riffles on Portage Creek, MI

Design, Post Construction Monitoring, and Lessons  
Learned

Janeen McDermott, PE

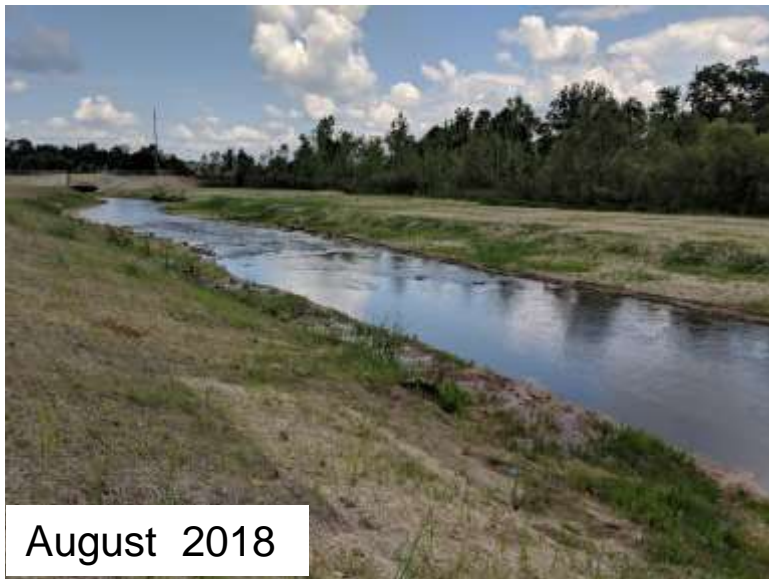
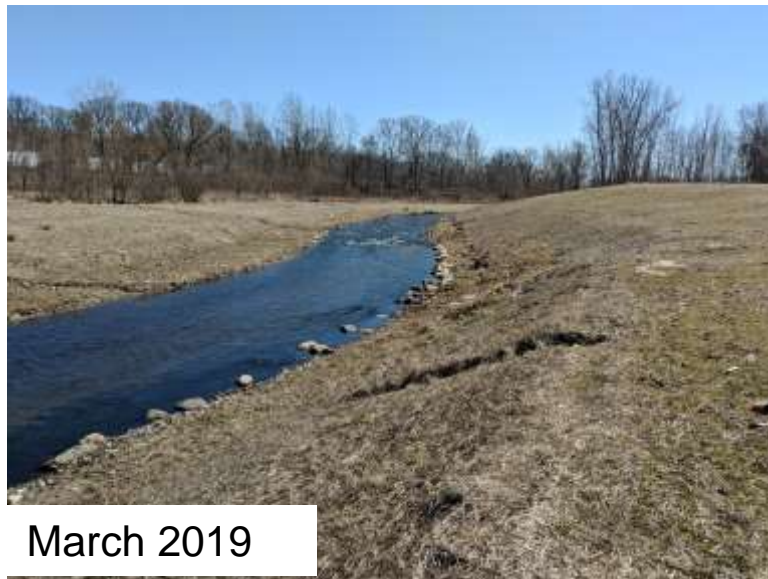
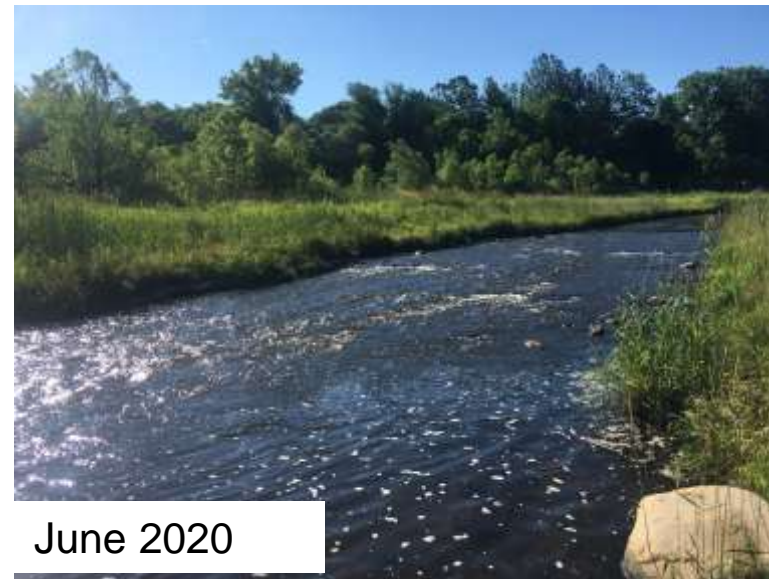
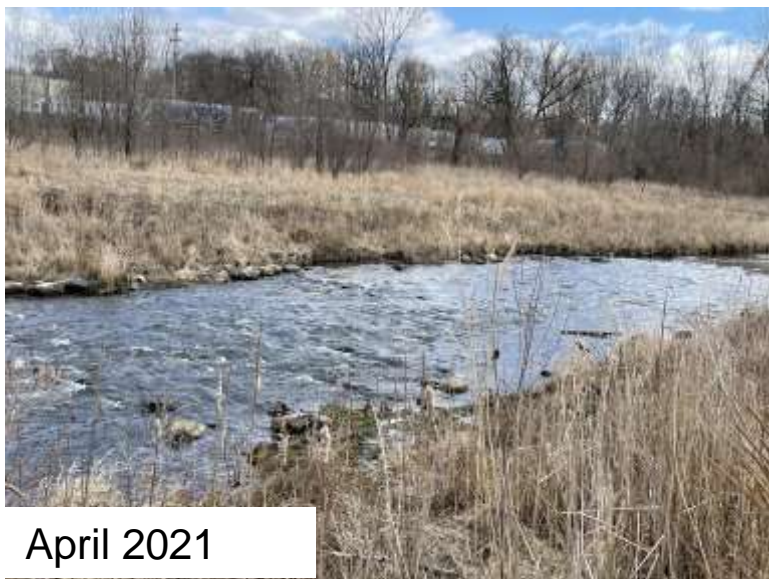
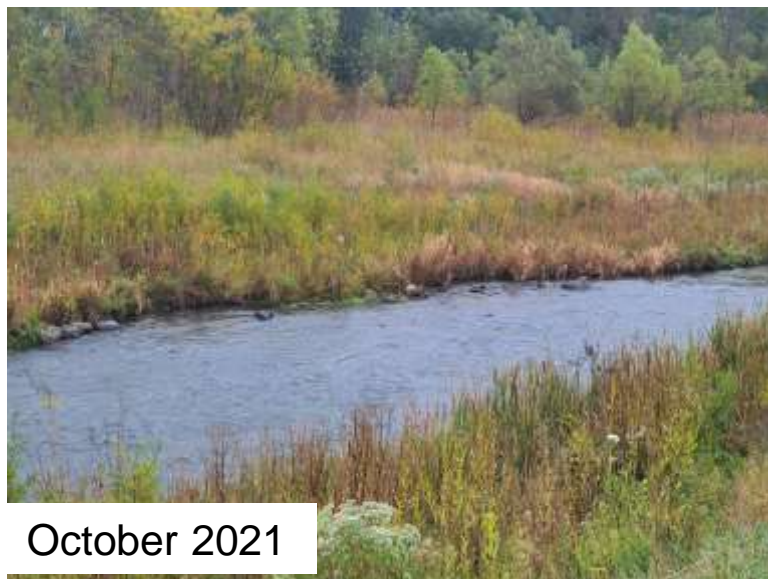
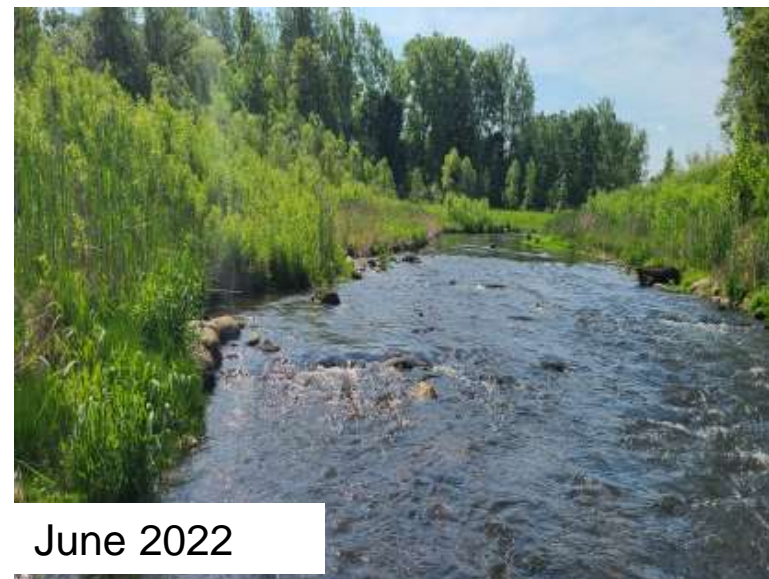
# Riffle #1

- Riffles 1, 2, and 3 have noted the most pronounced bank erosion between the embedded rock vanes.
- Riffle 4 has largely remained the same throughout the monitoring period.
- Bank erosion has been a slow process with small increases from year to year.
- Embedded rock vanes appear to be working to direct flow back toward the main channel.
- Aquatic habitat diversity with pool riffle system, undercut banks, and large wood structures has improved water quality and habitat as shown by fish survey data.

- When flow was introduced to channel some erosion of channel banks occurred – where not repaired those initial bank erosions have progressed in successive years.
  - Stabilize stream banks at riffles prior to introducing flow and/or be sure to re-establish designed banks at time of final restoration
- Details matter!

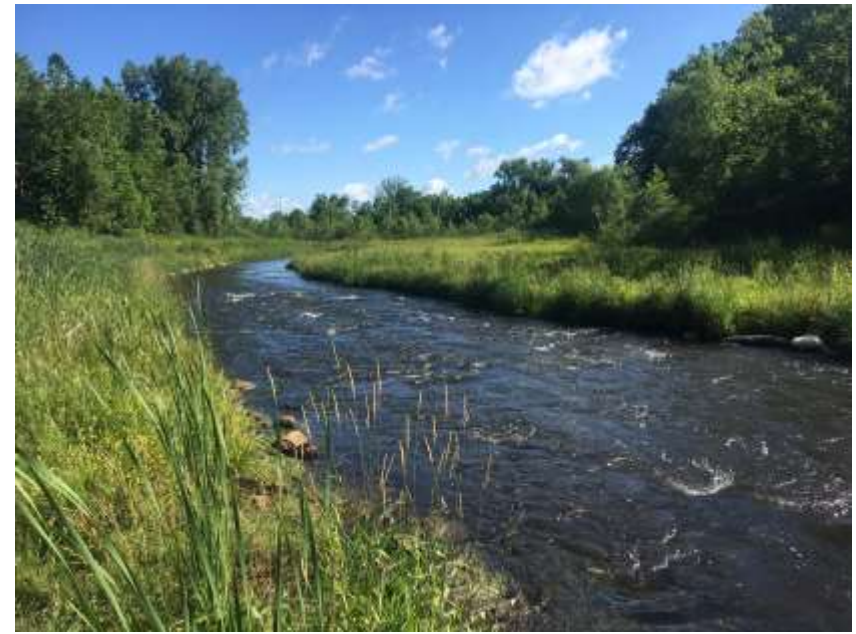
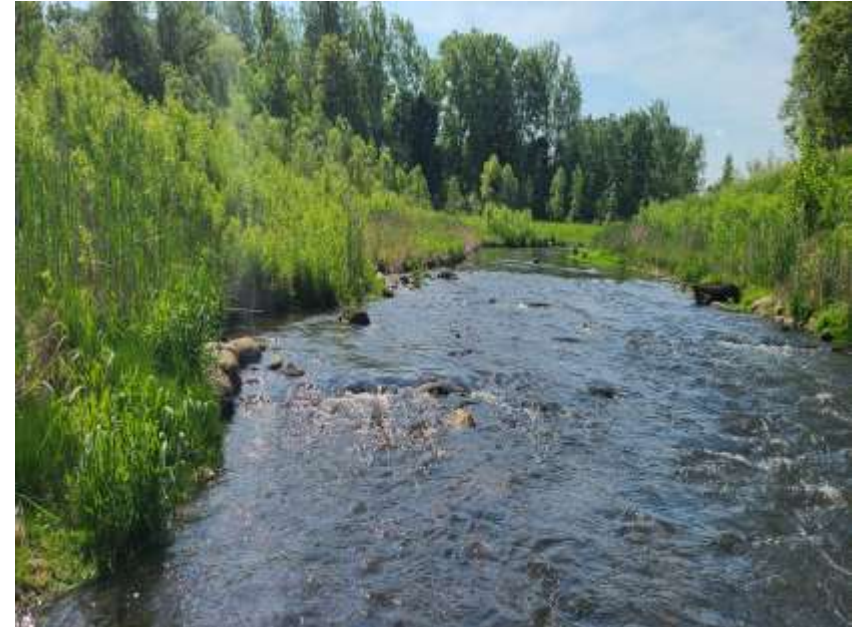
- Be aware of large boulders placed along stream banks that could incidentally direct flow toward bank or contribute to bank scour.
- Incorporate a third rock vane at upstream portion of riffle to further stabilize riffle.
- Restoration practices have shown success with habitat improvement and should be continued.
