WATERSHED-SCALE RESTORATION IN A HIGHLY URBANIZED SETTING

Tinkers Creek Stream Restoration Project

Prepared for: National Stream Restoration Conference 2023

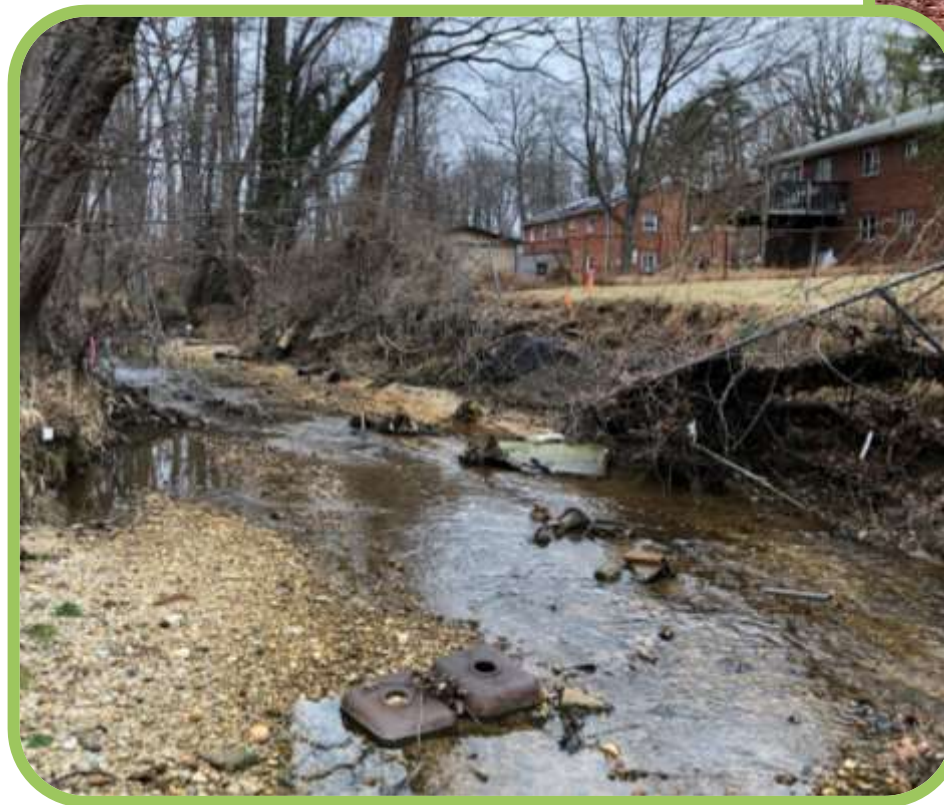
Above: Severe bank incision on Paynes Branch.

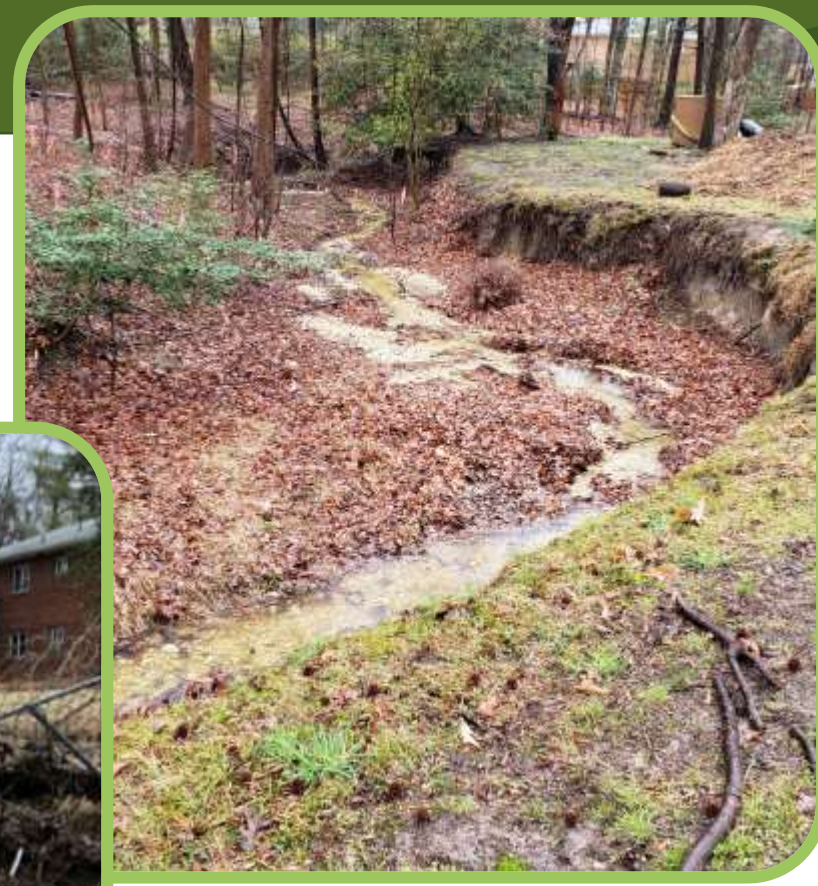
Left: Heavily eroded stream threatens adjacent fencing and residences.

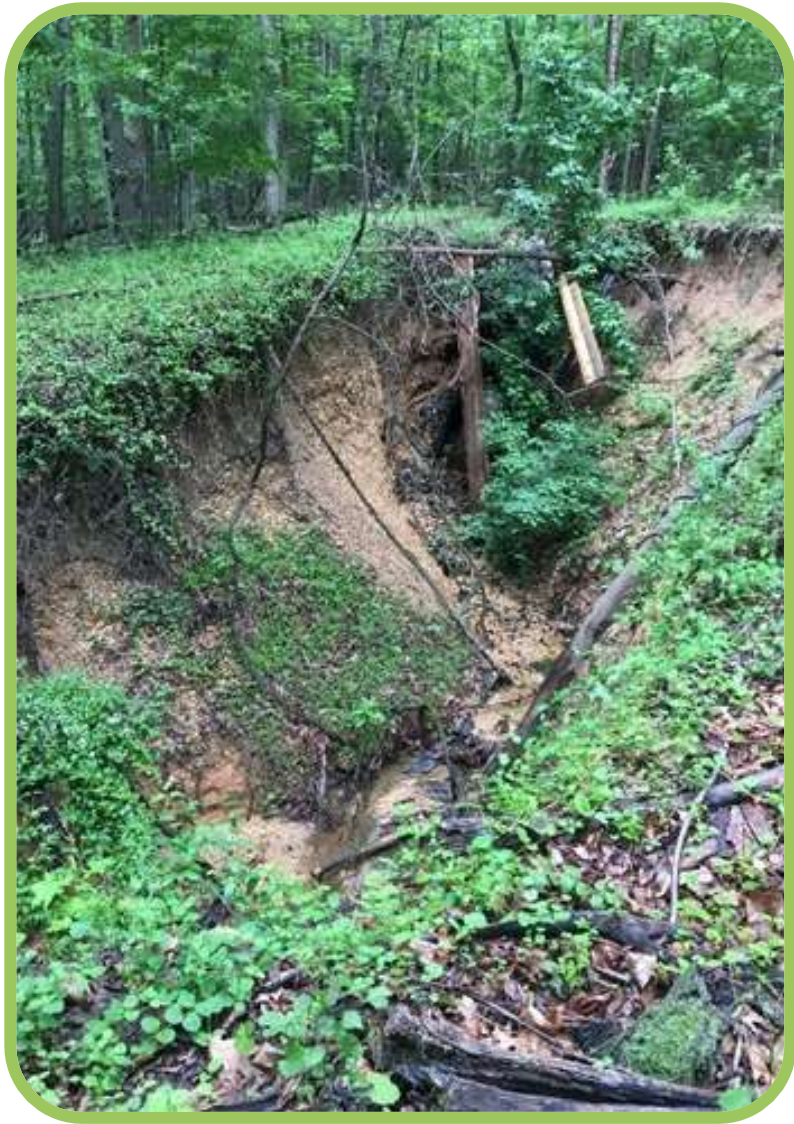
Left: Chasm resultant of failed level spreader structure.
Above & Right: Photos of the restored SW infrastructure and repaired slope.

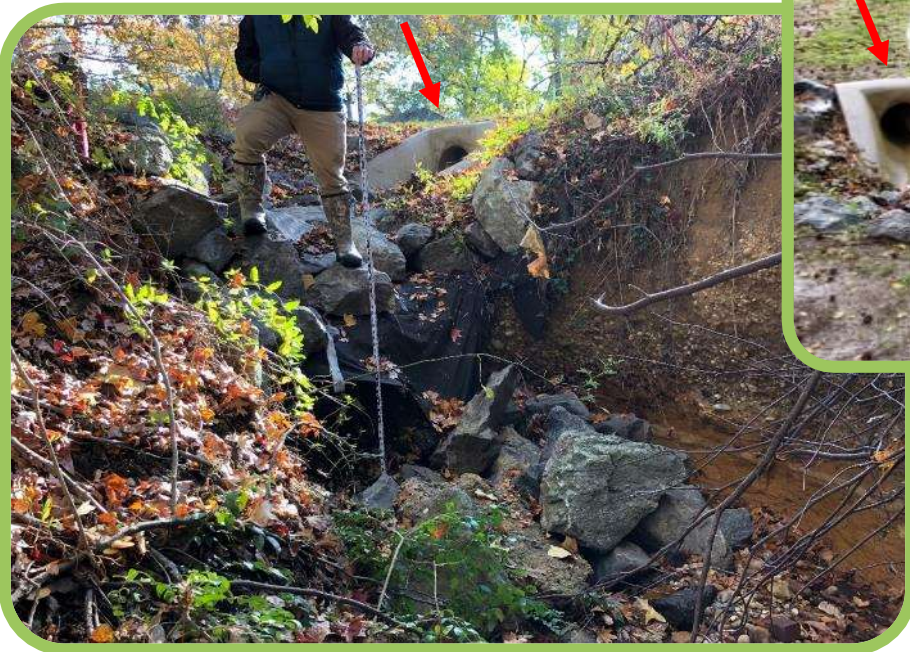
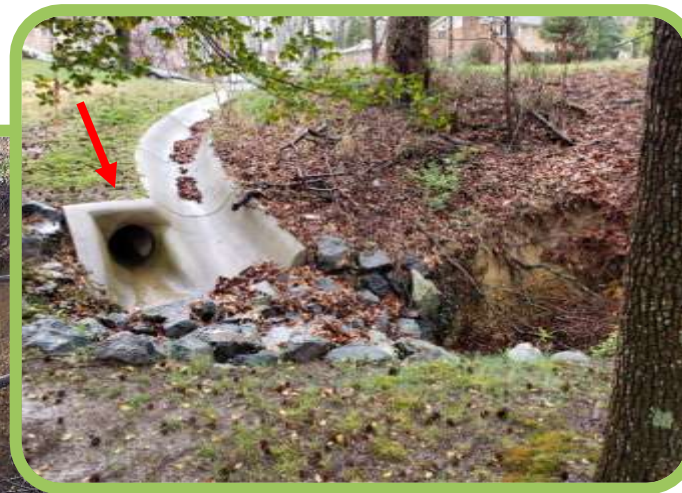
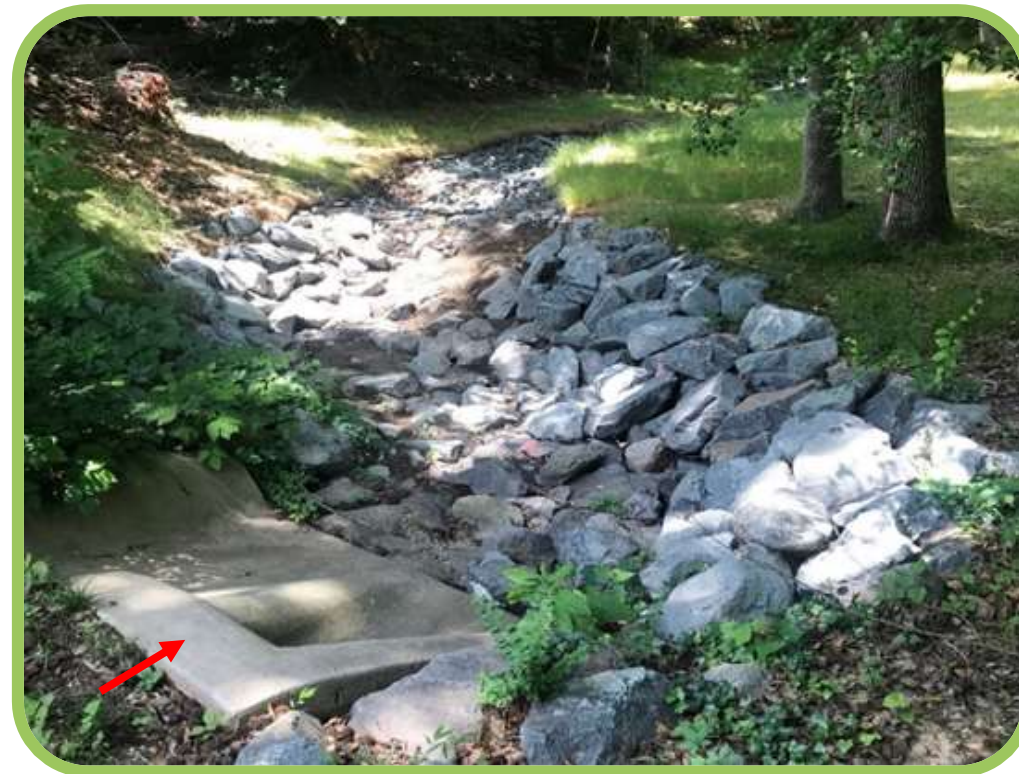
Photos of the plunge pool system before and after restoration. The headcut resulted from large amounts of runoff from the surrounding impervious drainage area entering the channel at high velocity. The original channel was not appropriately protected for increased impervious area impacts. Restoration stabilized the failed existing plunge pool and downstream channel using grading, stream realignment, and rock grade control structures, thereby decreasing the velocity of incoming water, increasing the channel's stormwater capacity, and allowing limited floodplain access.

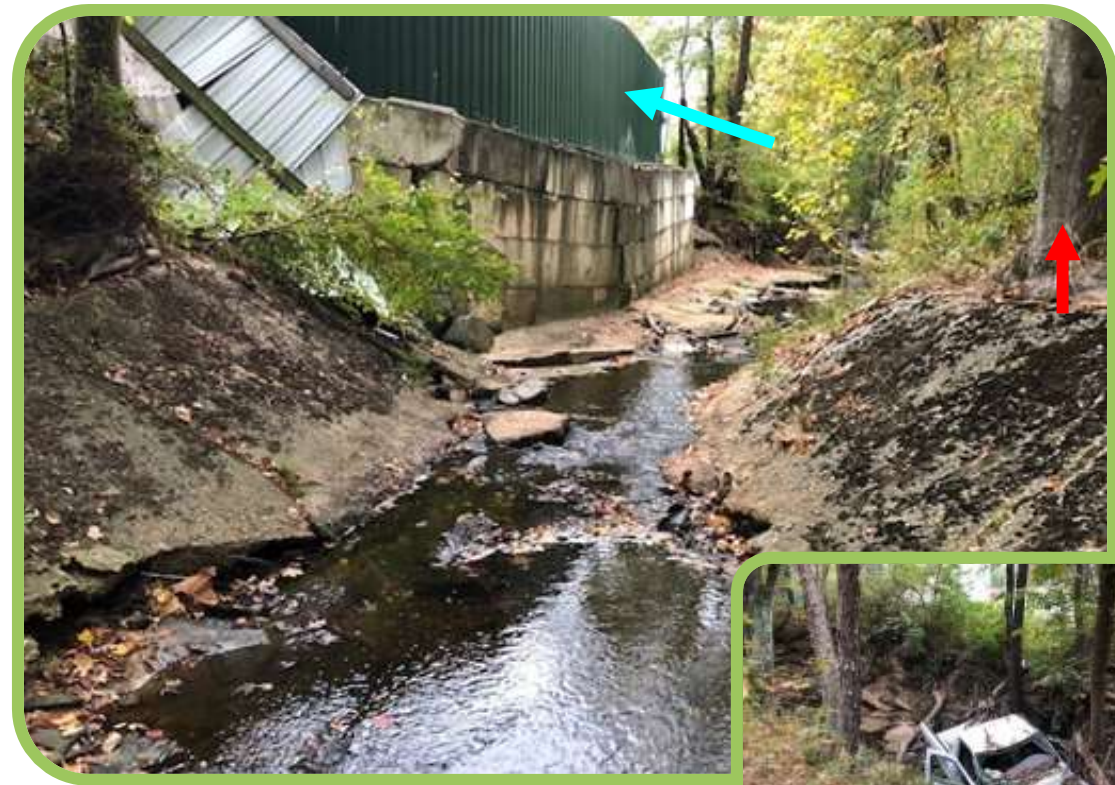
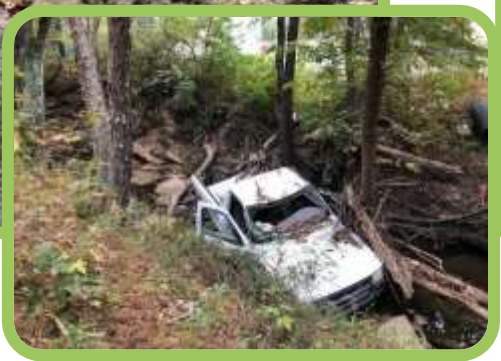
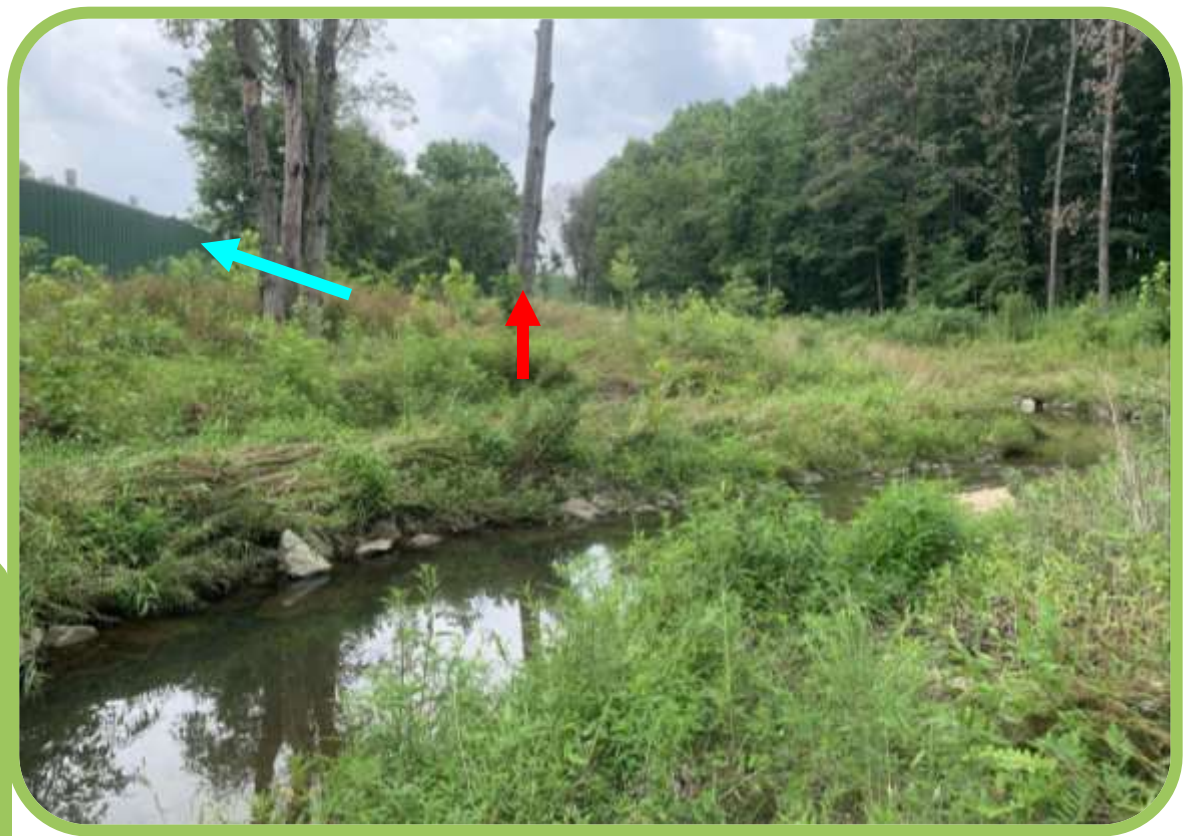
The same view of a landowner's retaining wall immediately before and 3-years after construction.
