**Effects of floods on the  
high energy cobble-boulder  
bedded, urbanized Ellis Creek,  
British Columbia, Canada**

**Presented by:  
Leif Burge, Senior Associate/Water Team Lead**

*National Stream Restoration Conference  
August 2, 2022*

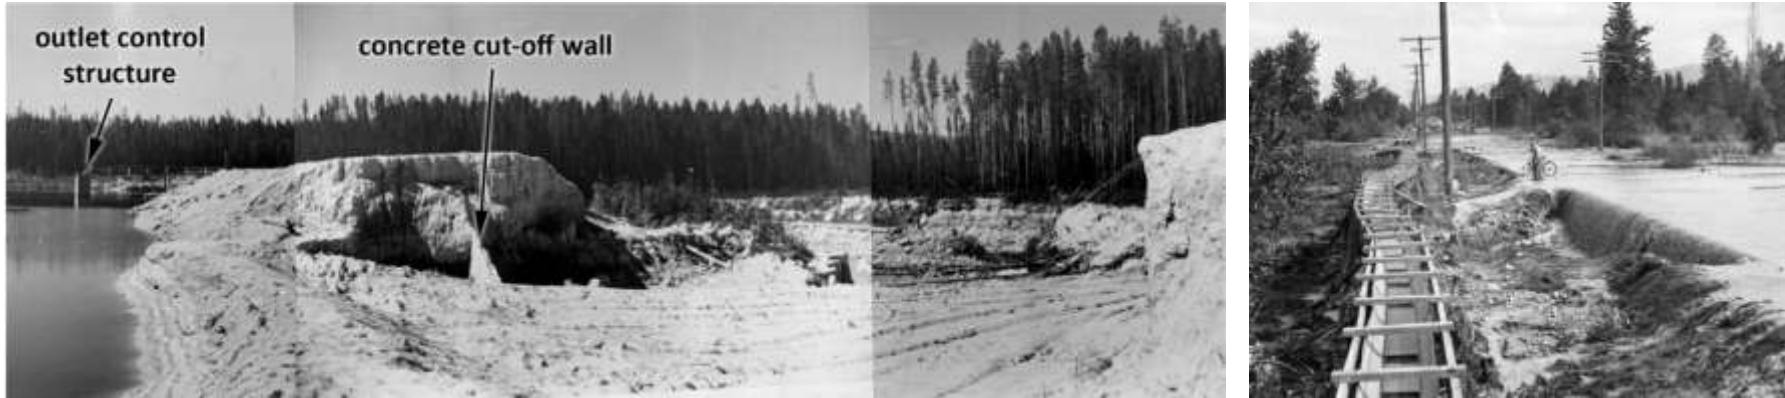
May 1941 – 36 m breach of EC No. 4 Dam

Road damage downstream

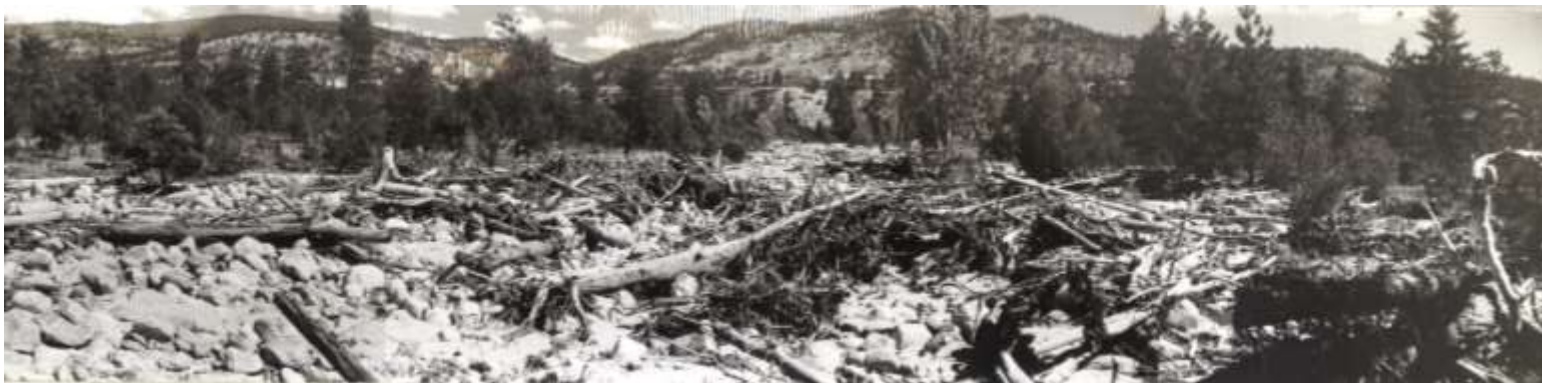
May 1942 – Flood damage from of breach of EC No. 4 Deposition of Cobbles, Boulders and LWD

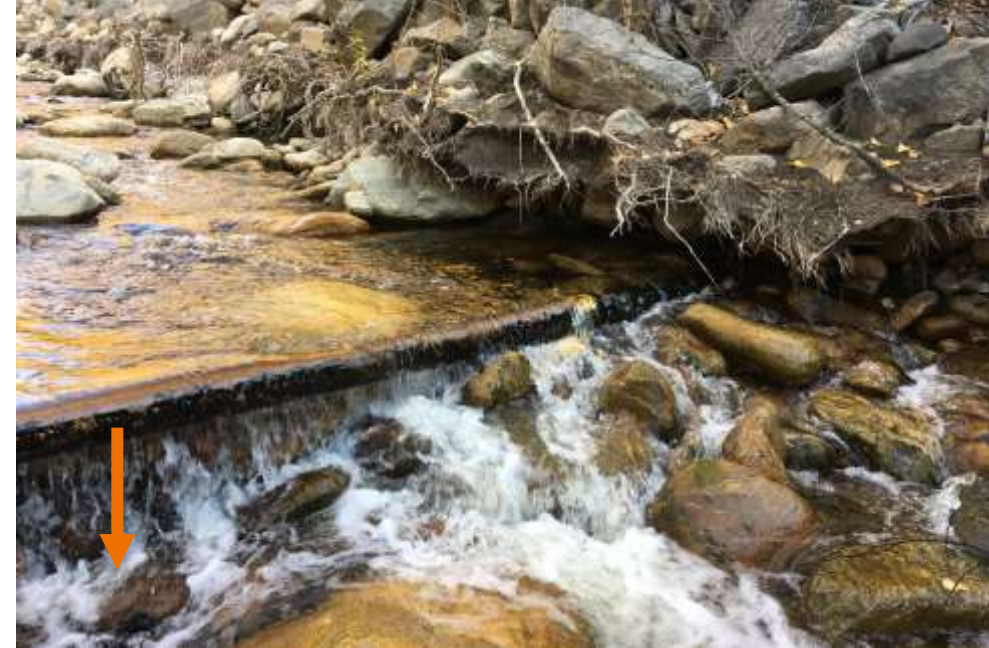
- Narrow channels
- Dencutting seen at toe or banks
- Undercut banks
- Nick points on channel bed
- Exposed utilities
- Increase in bridge openings

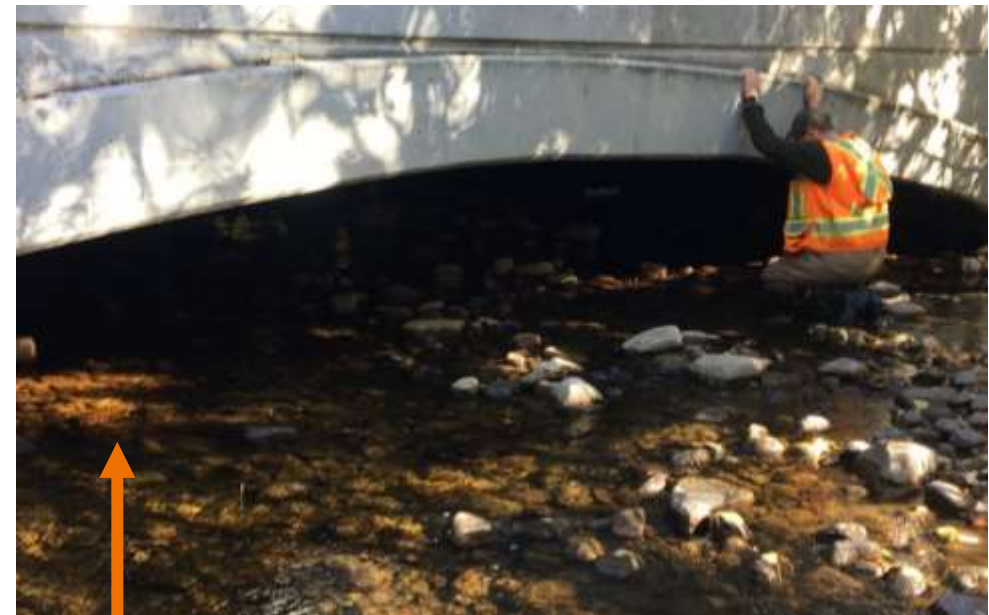
- Wide channel
- Large bars
- Absence of channel banks
- Banks lower than bankfull
- Recently deposited sediment
- Decreases in bridge openings

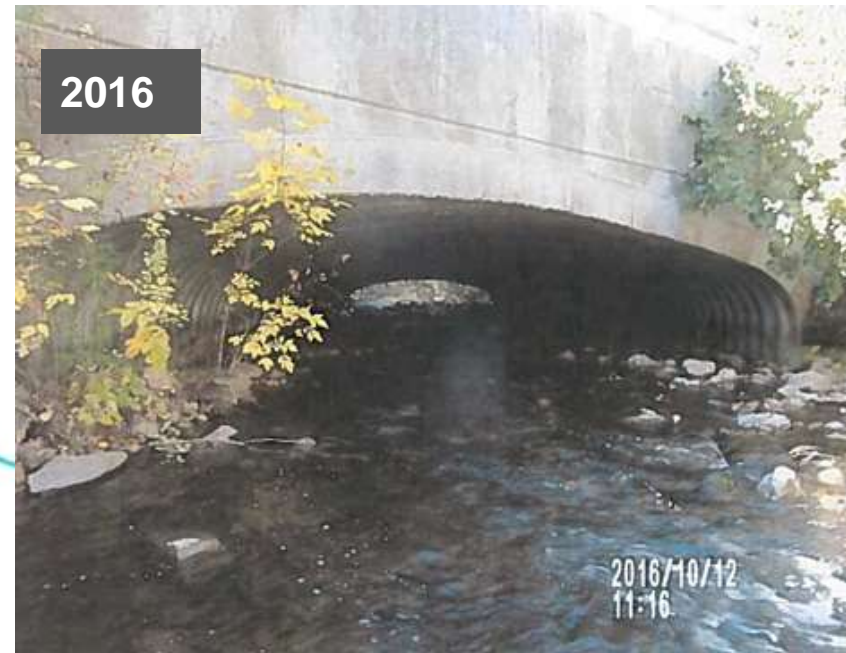
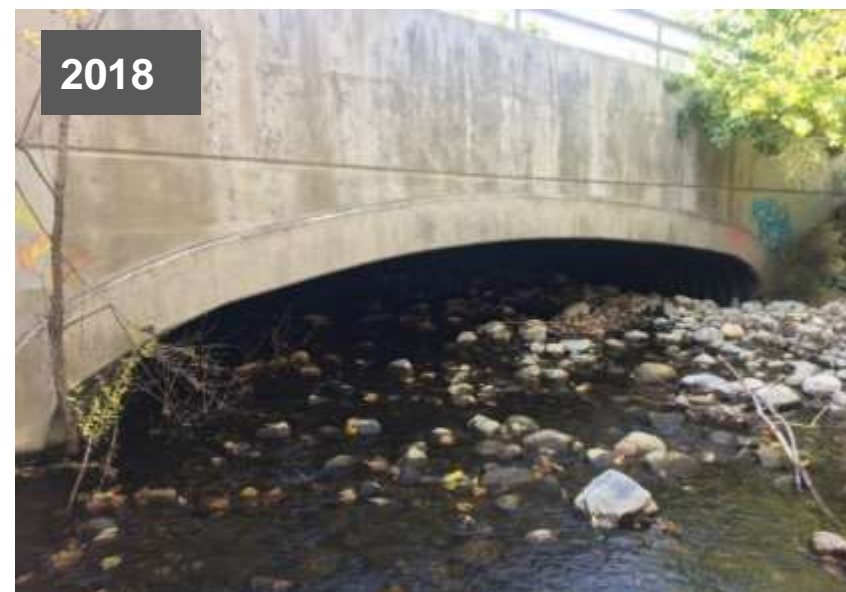
## Reach 1-3 Key Findings

- Very high flood risk
- Aggraded channel
- Low channel slope
- Channelization

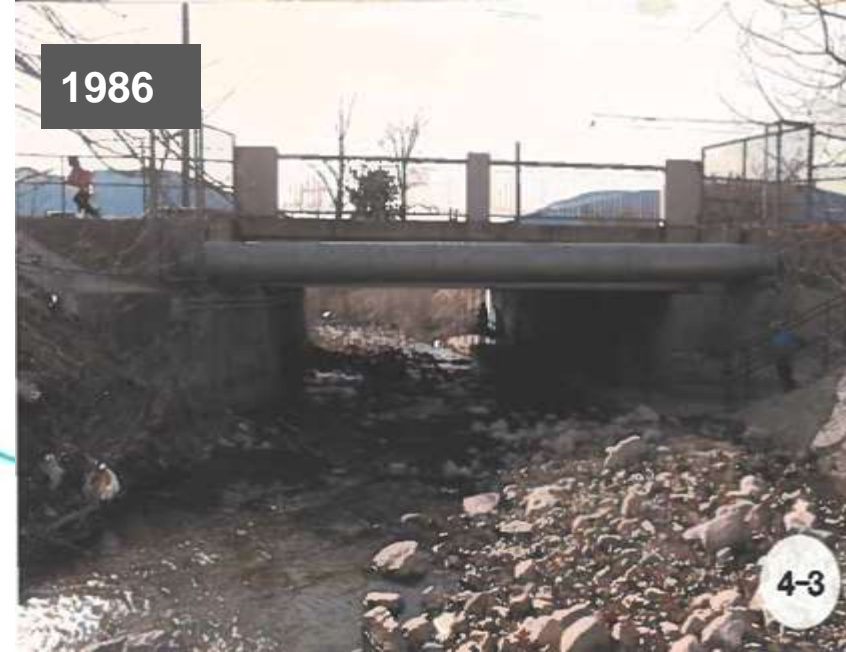
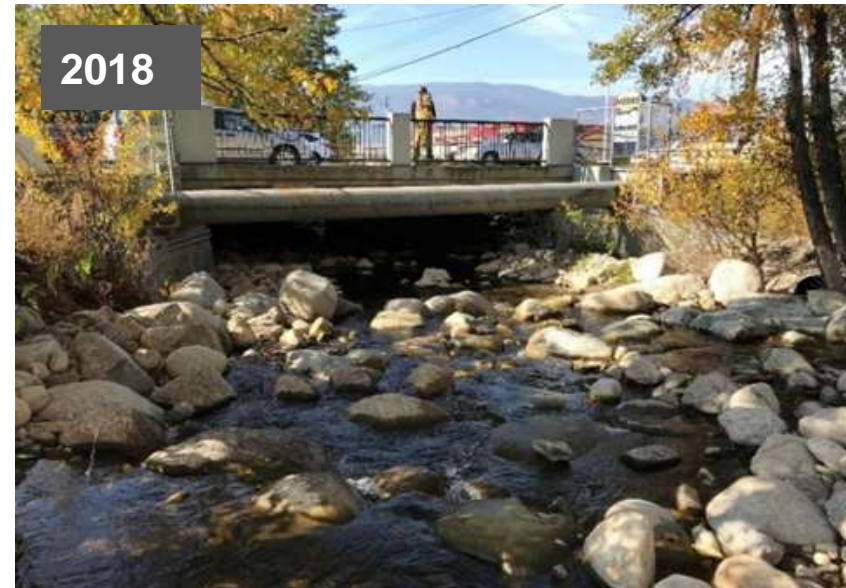
## Reach 4-5 Key Findings

- High to very high flood risk
- Aggraded channel
- Low channel depth

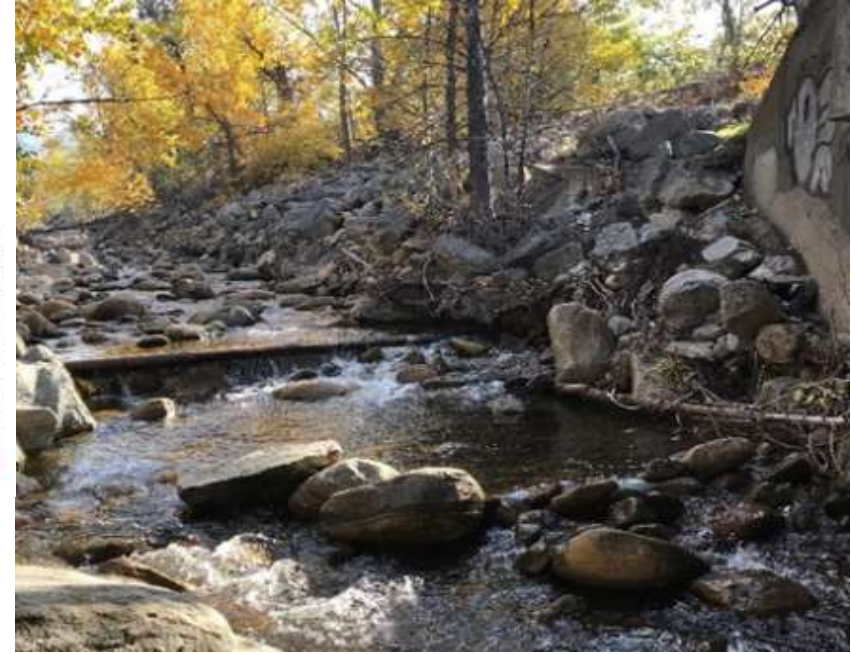
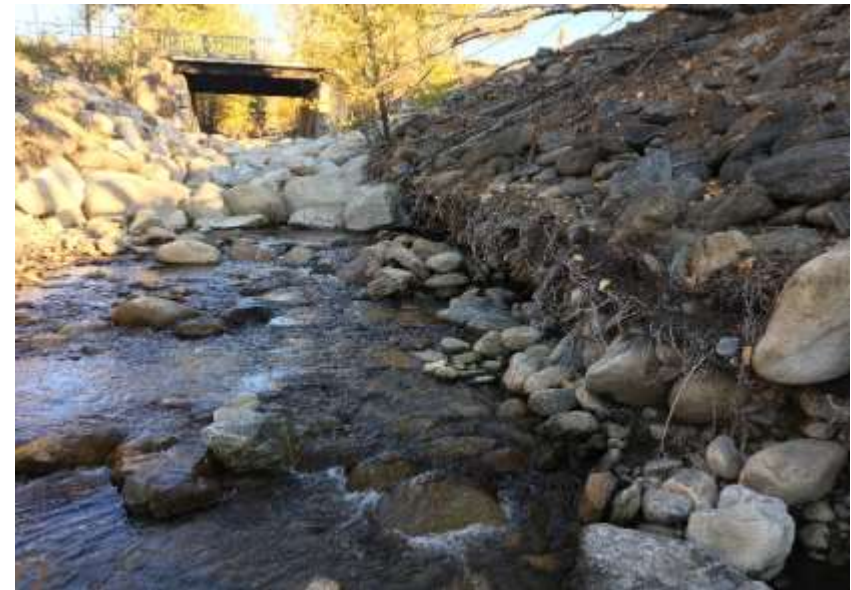
## Reach 6-11 Key Findings

- Deeply incised channel
- Steep bed
- Narrow channel
- Bed degrading

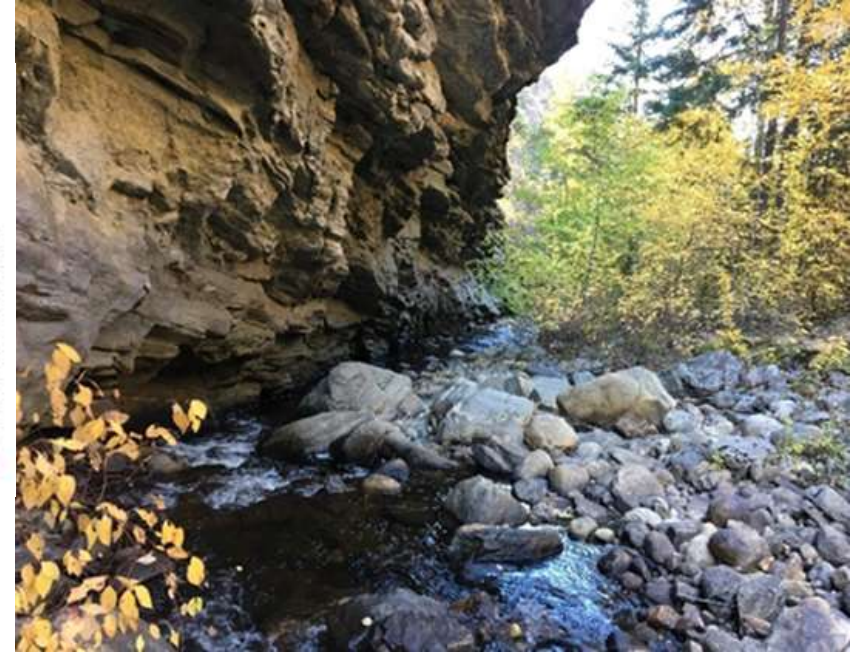
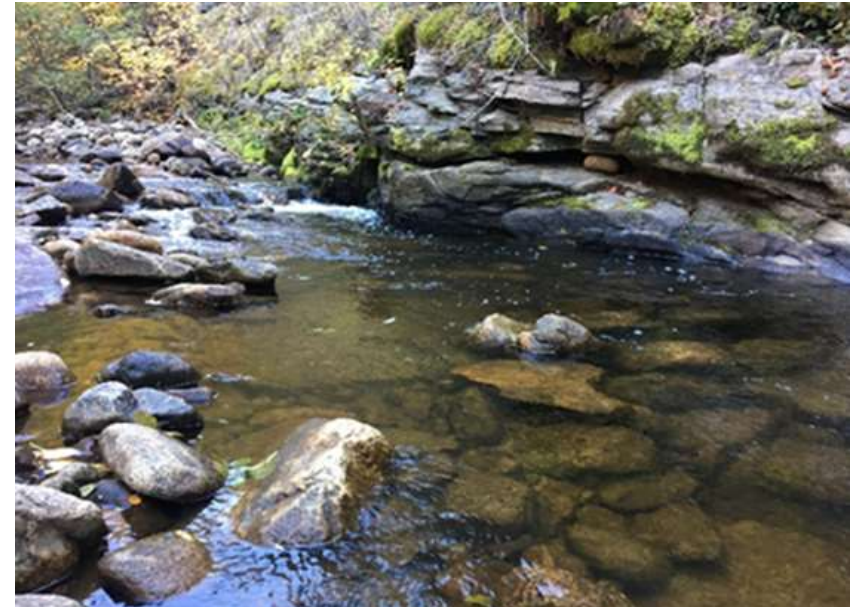
## Reach 12-13 Key Findings

- Natural channel
- Not incised
- Steep
- Step-pools
- Boulder banks
