Payne Branch Dam Removal & Middle Fork of the New River Restoration

Designed by: Brushy Fork Environmental Consulting, Inc.

Constructed by: Northstate Environmental, Inc.

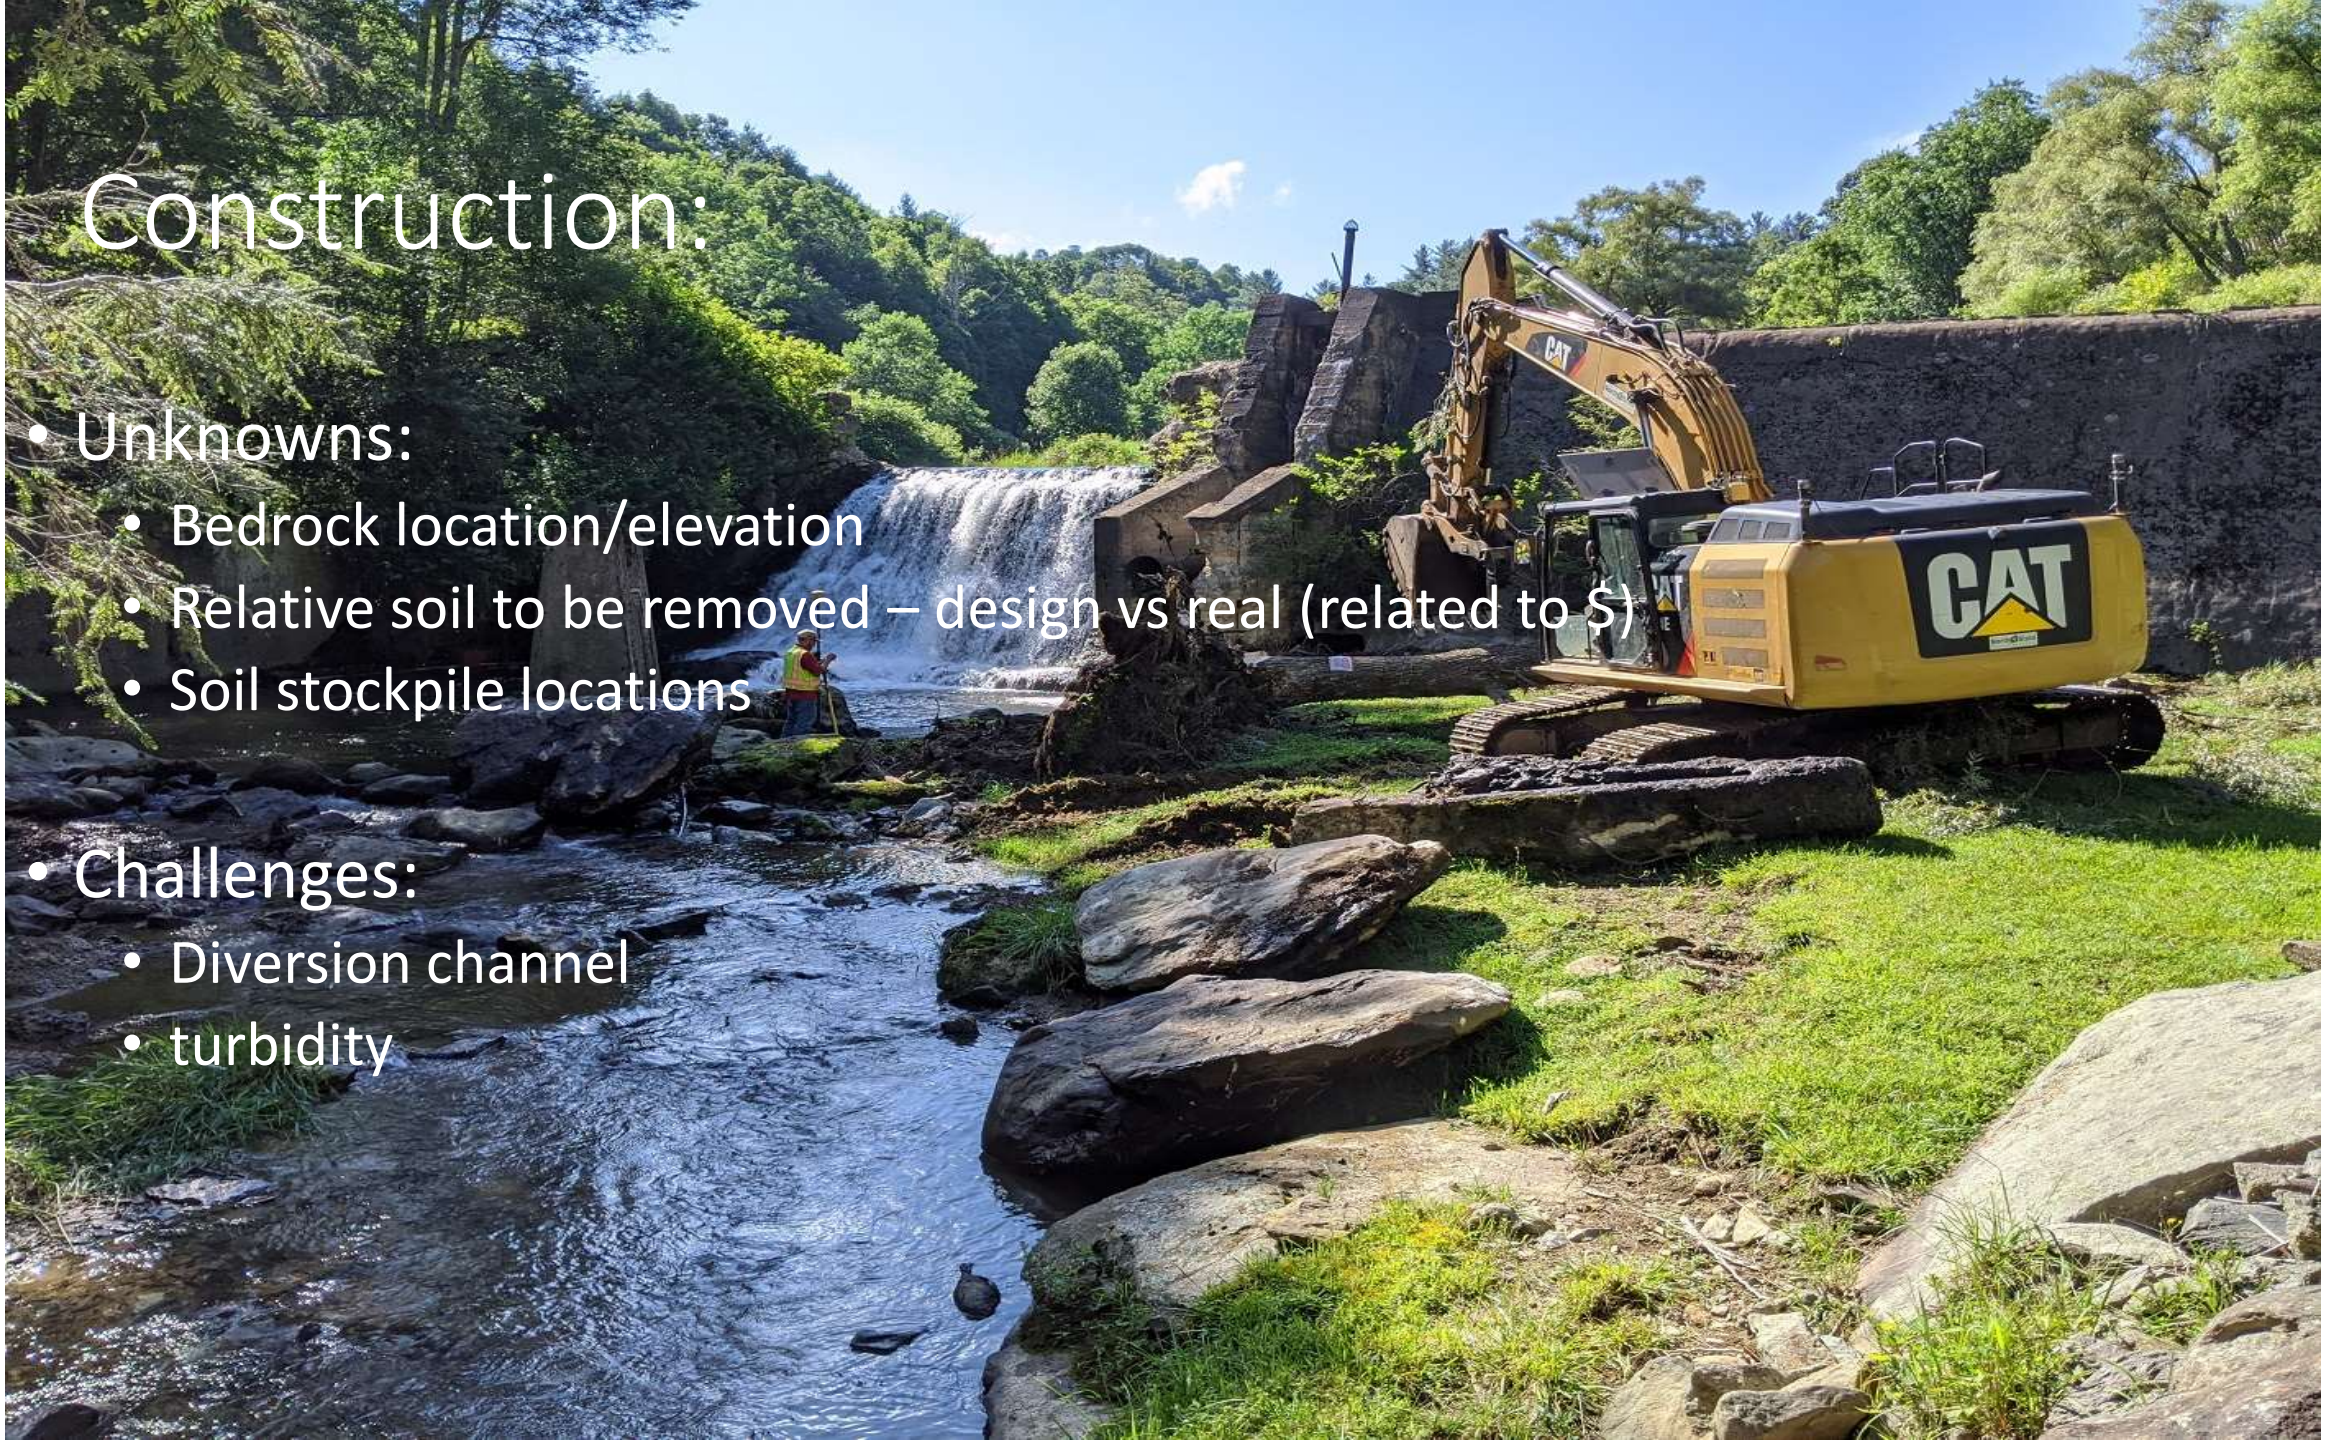
Diversion notch

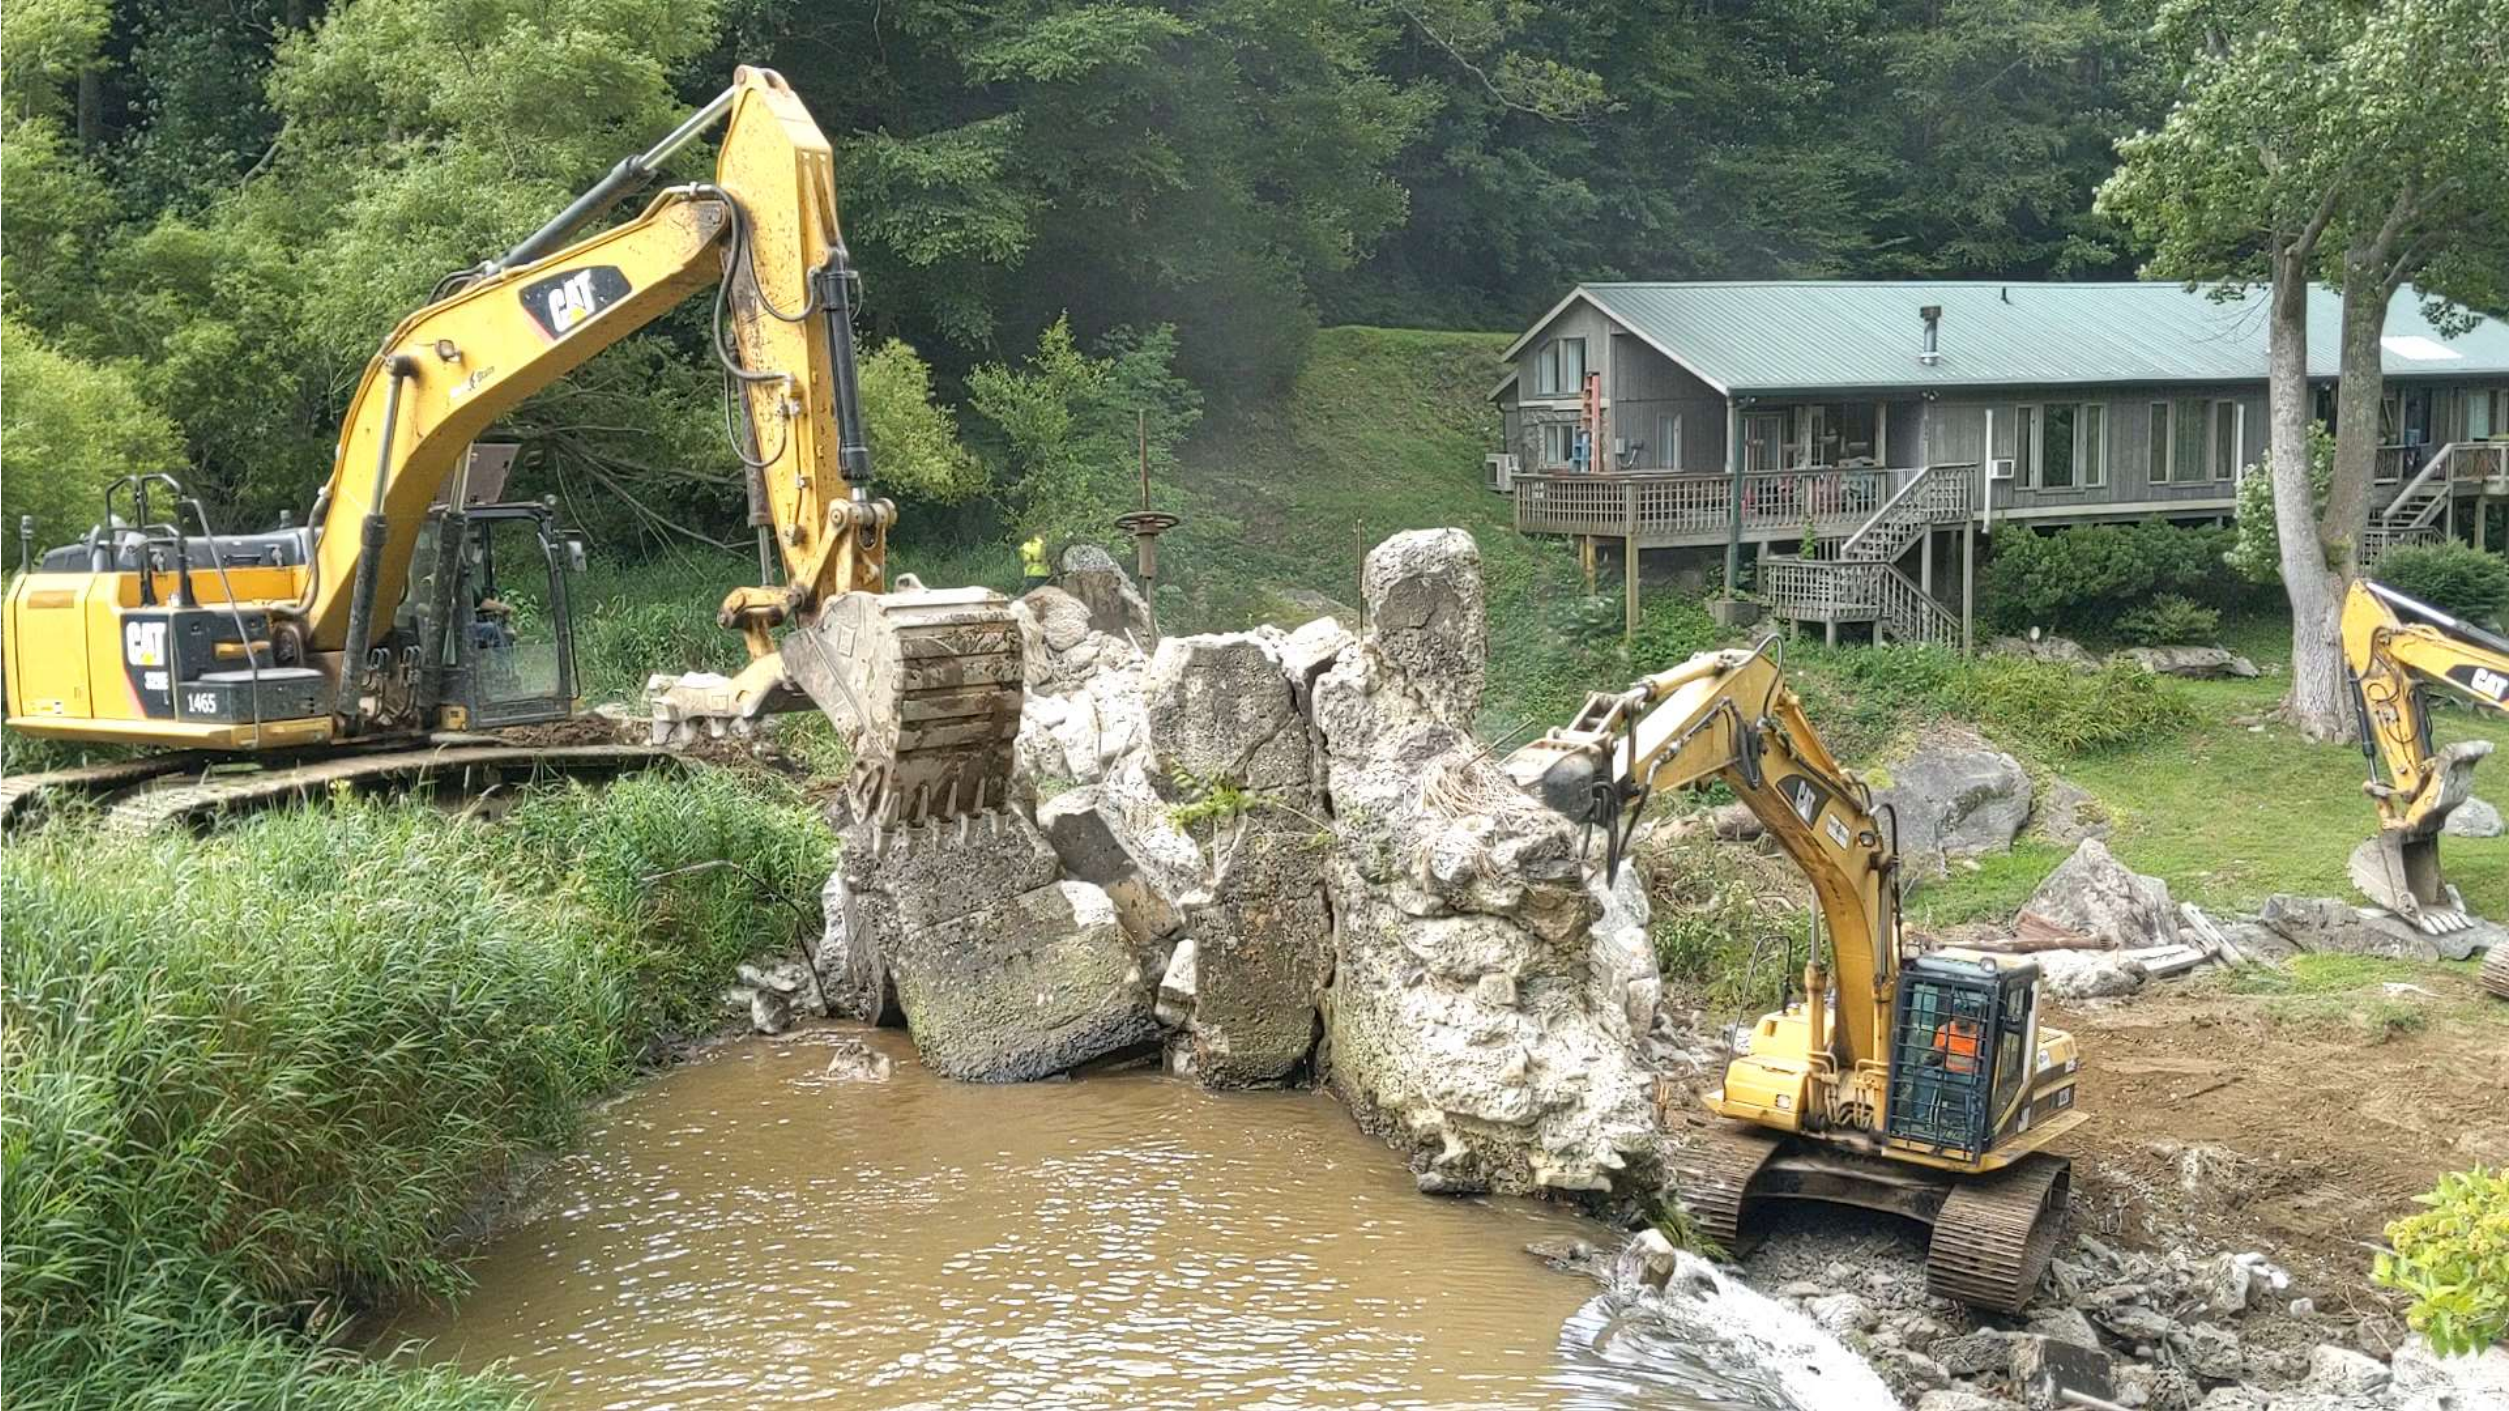
Diversion channel excavation and soil removal
