Innovative Grade Controls for Restoring an Incised Urban Channel at Millbrook Exchange Park, Raleigh, NC

Barbara A. Doll^{1,2}, Jonathan Page³, Kevin Boyer⁴, Heather Dutra⁴, Dan Line¹, Cameron Jernigan⁵, Jack Kurki-Fox¹

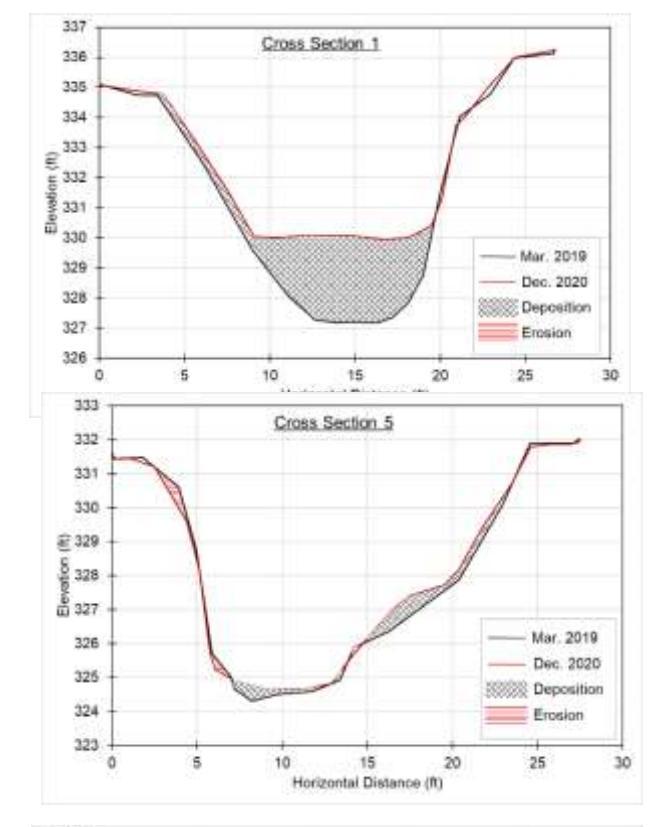
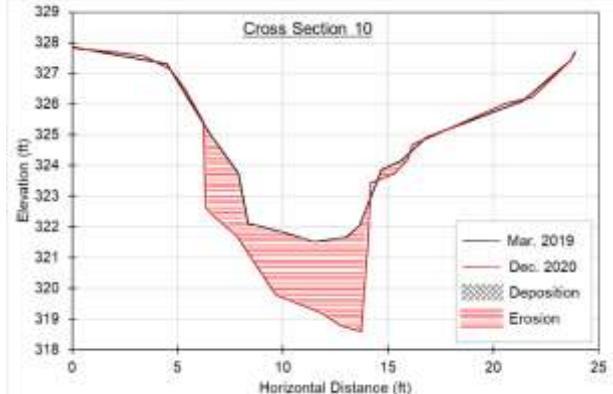
Cross Section 1

3/22/2018

4/23/2019

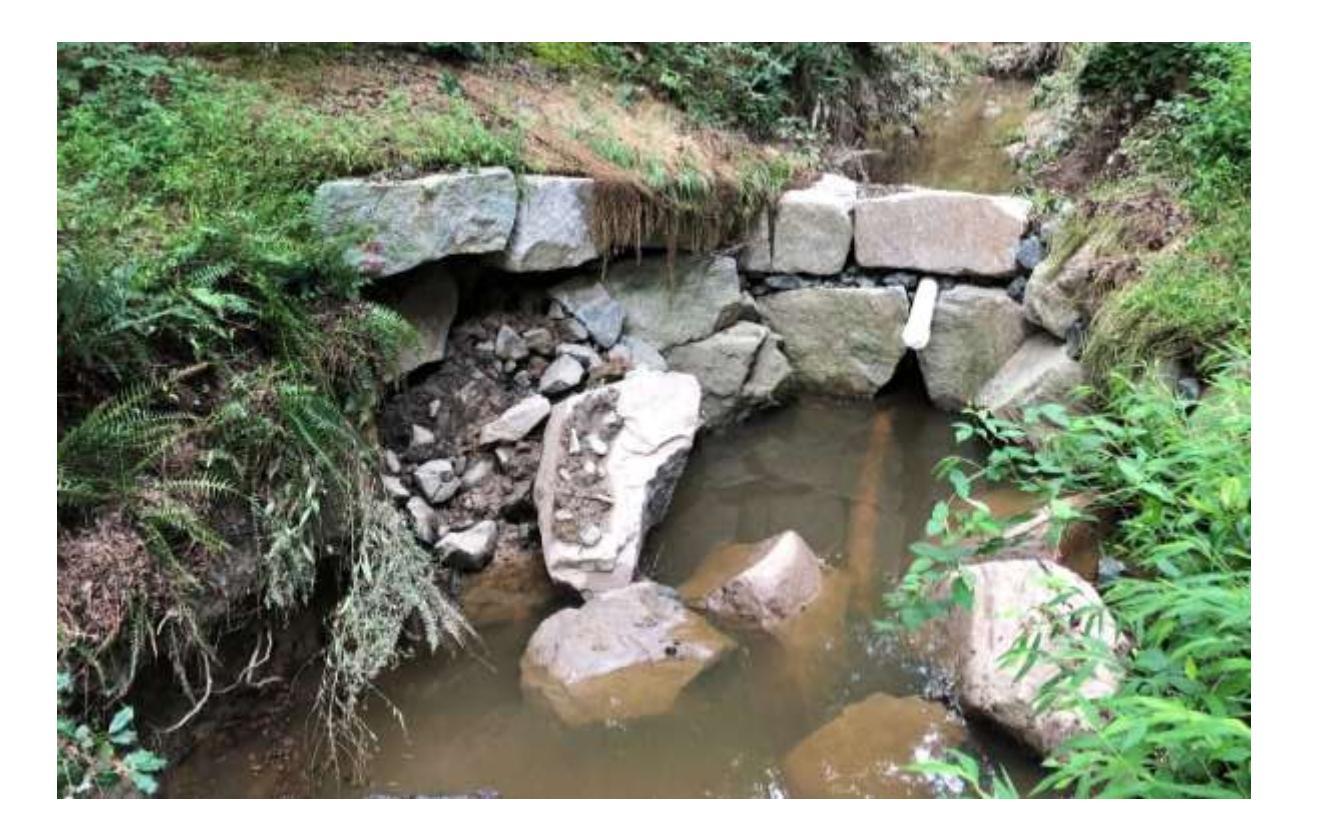
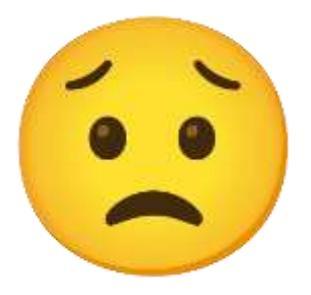
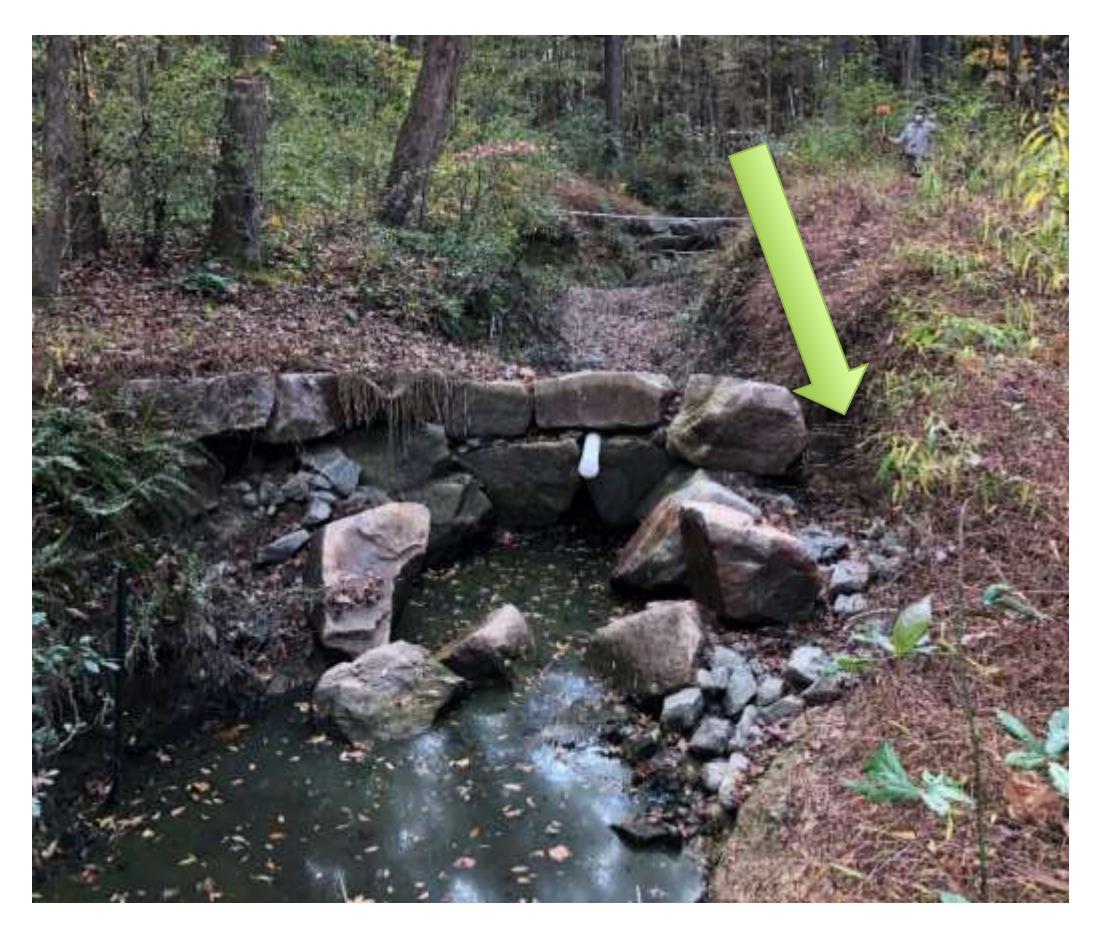
- Channel Not aggrading as Fast as Anticipated
- Structure Arms Undermined

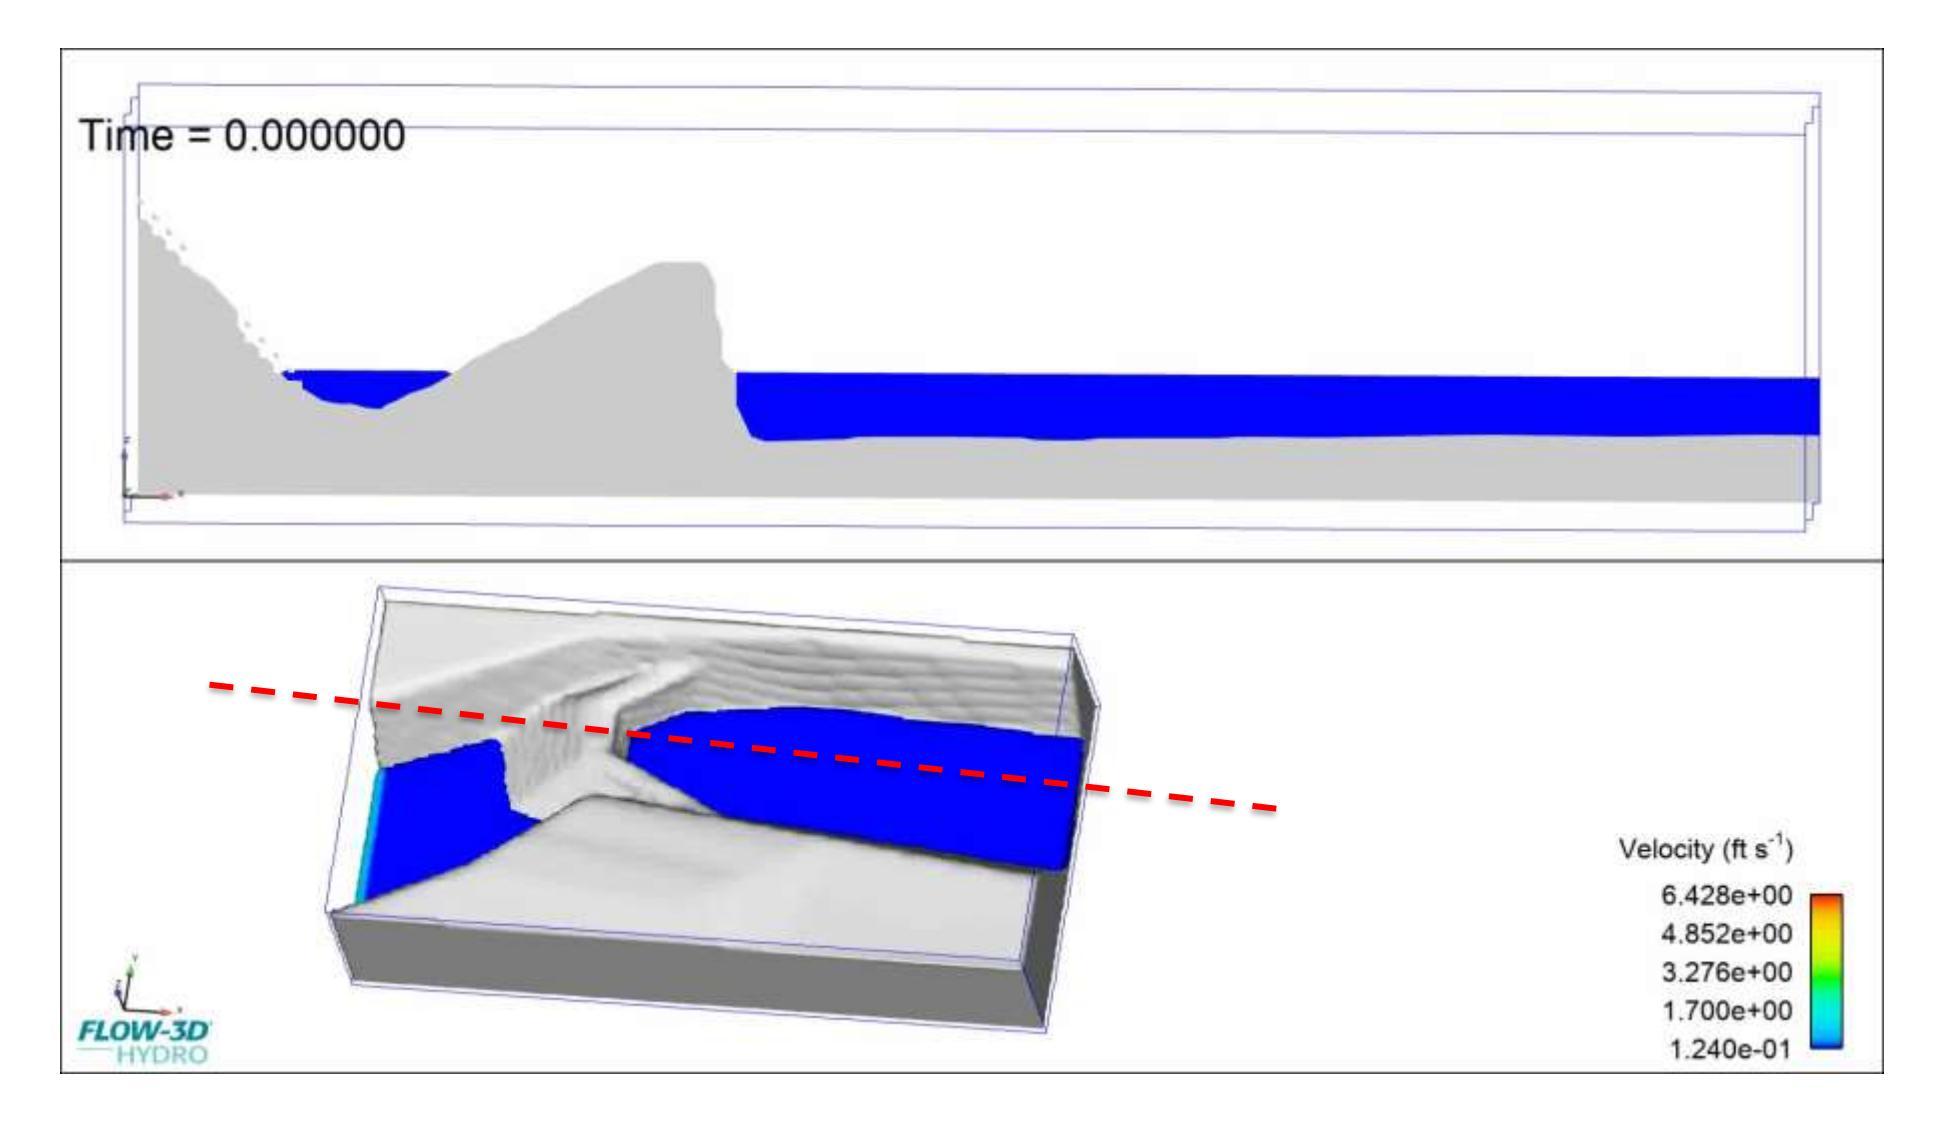
Flow Recirculation (2-yr)

Not an actual event hydrograph but provides illustration of recirculating hydraulics

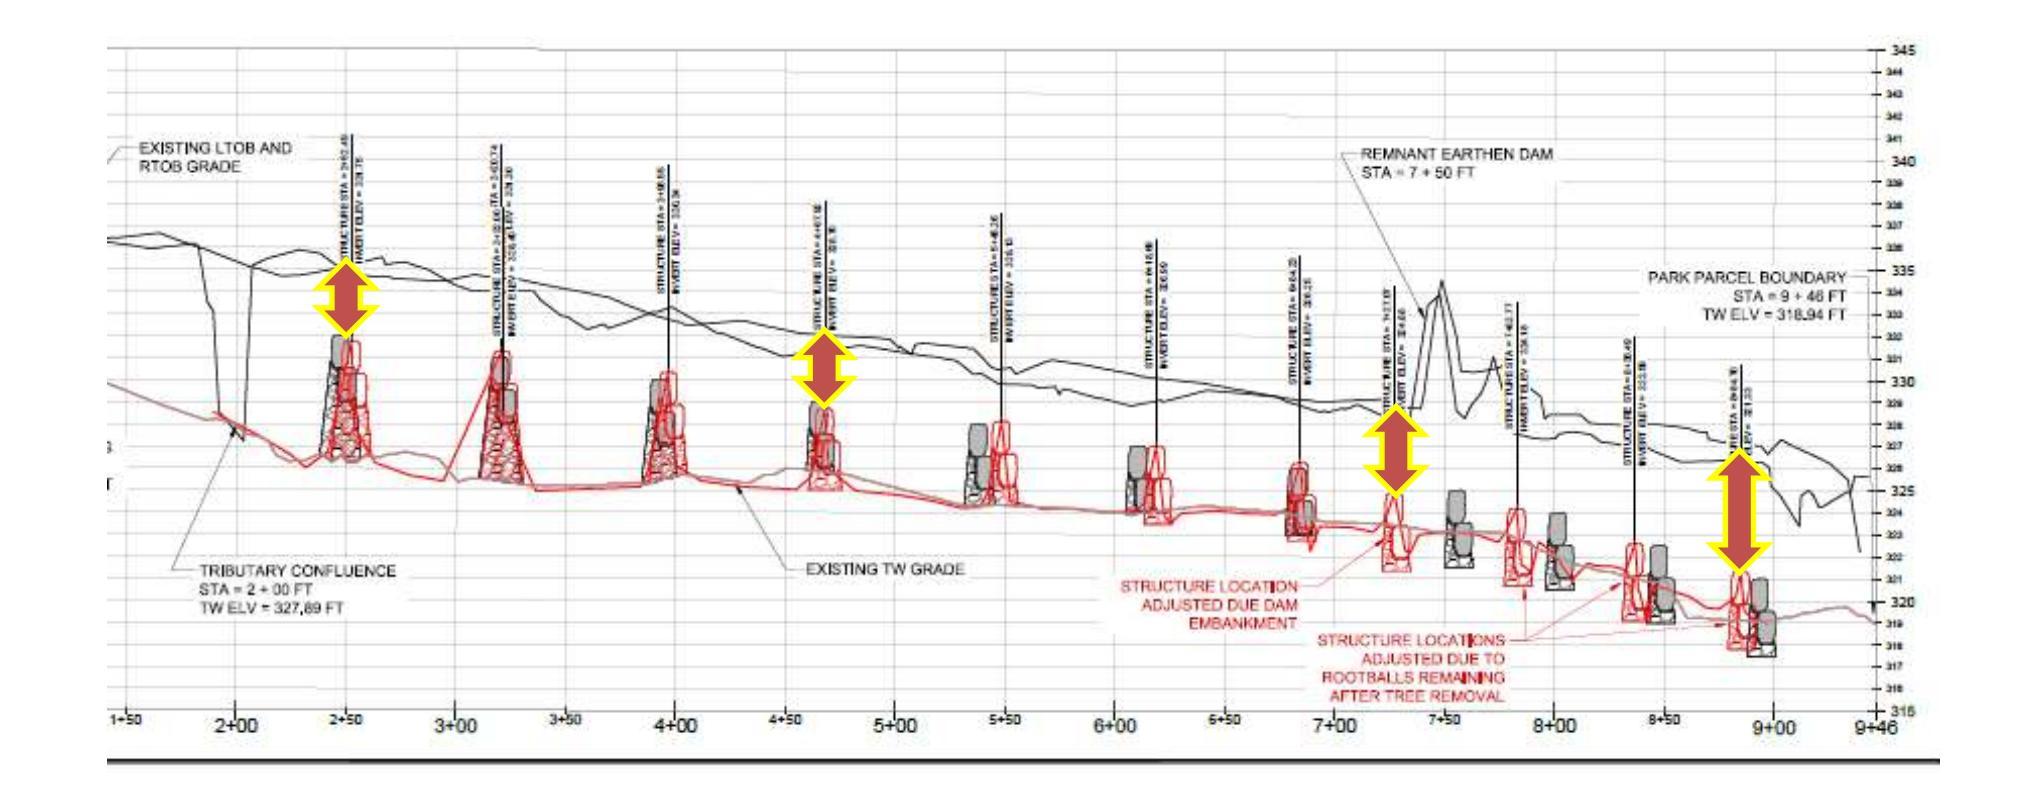
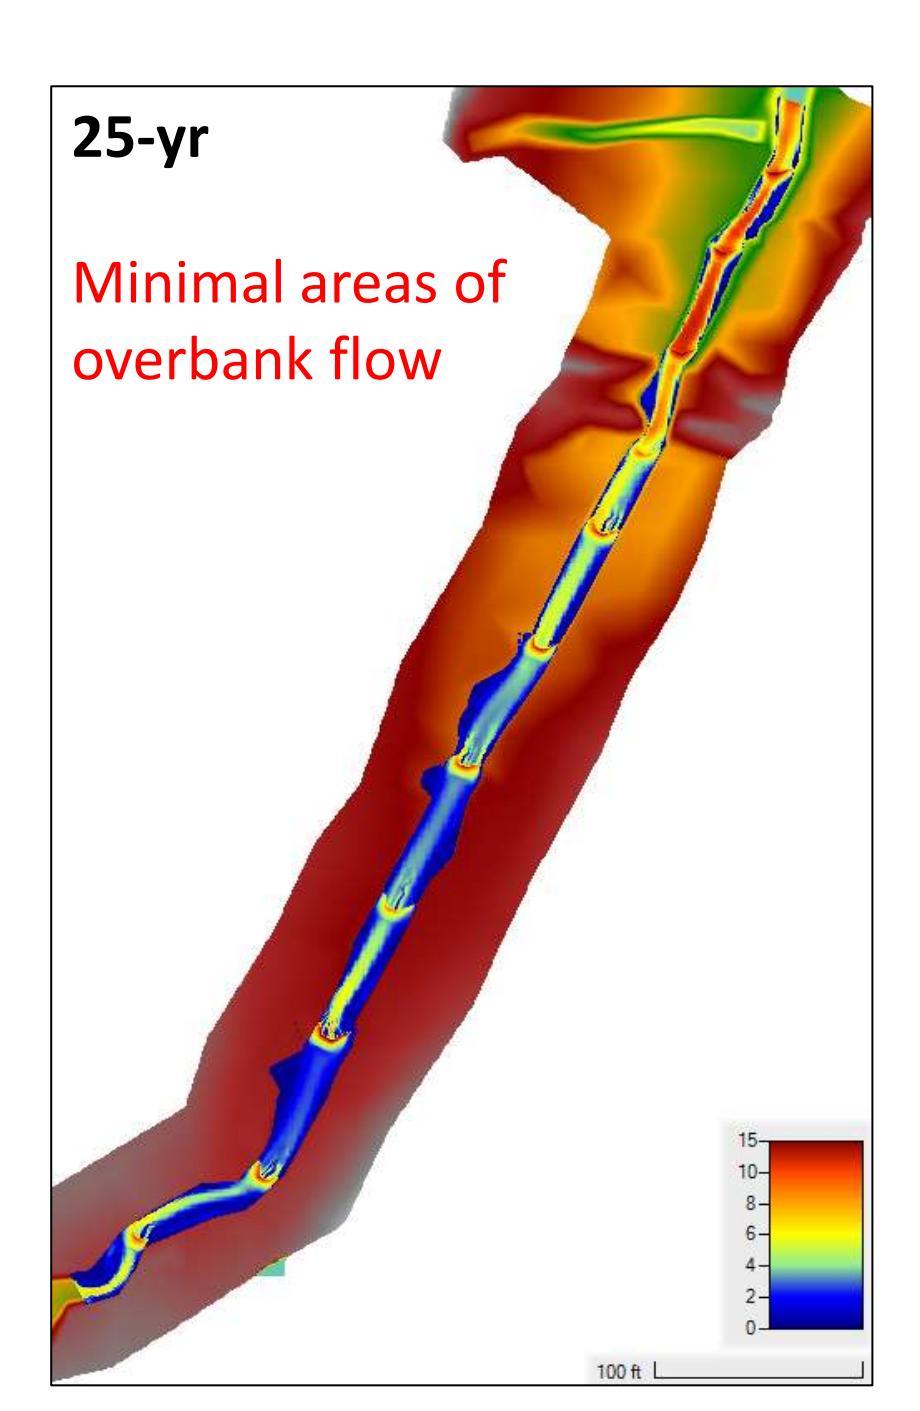
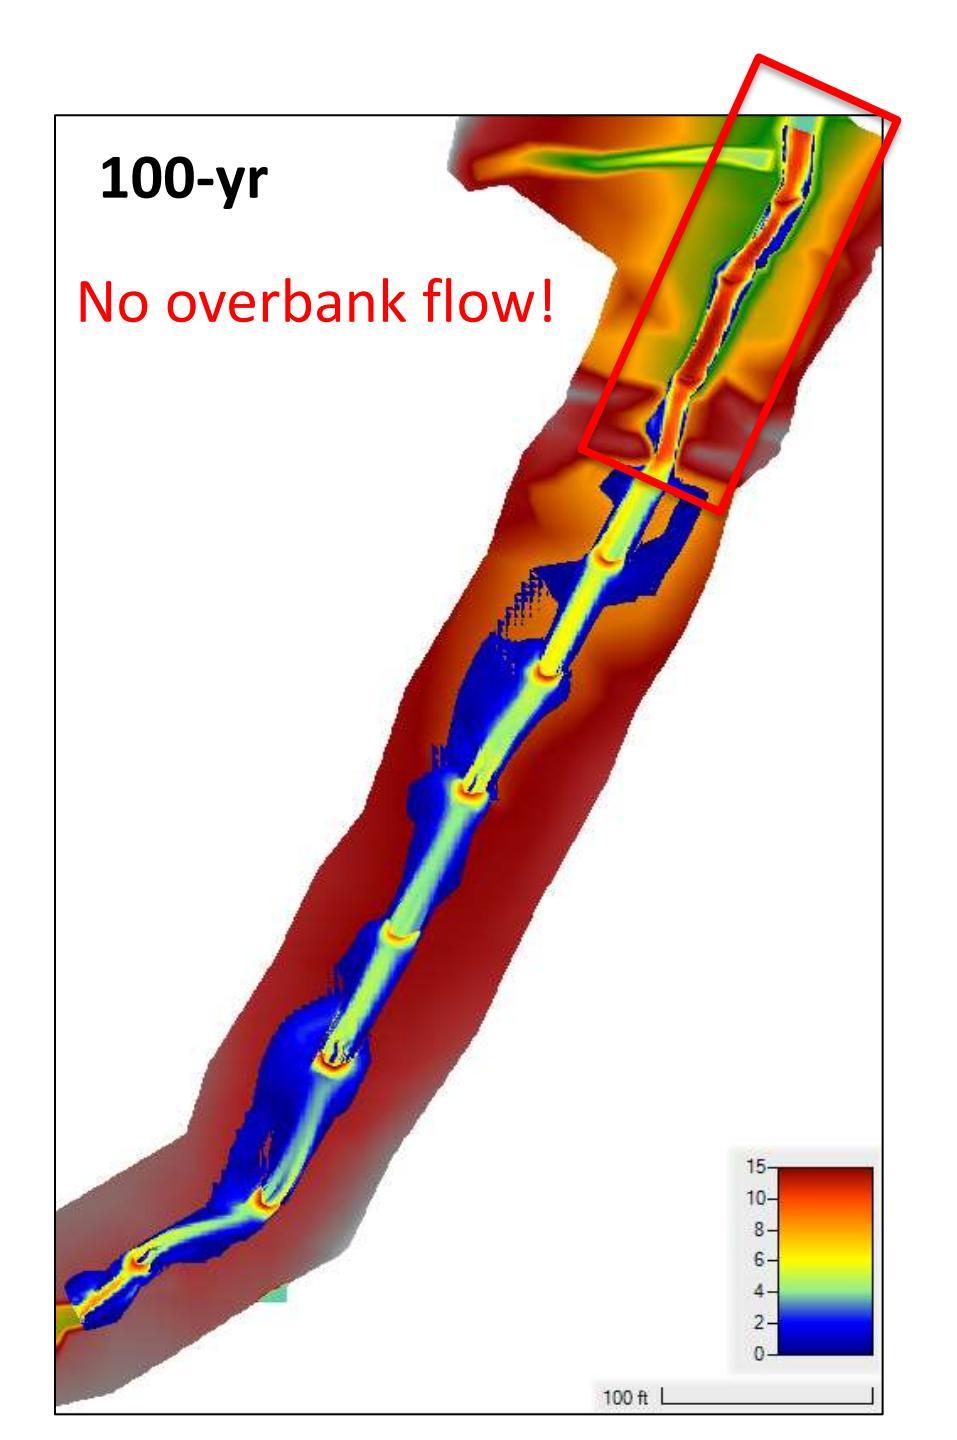
- Grade control structures did not adequately connect the channel to the floodplain
- Q > 25-yr flow still confined to channel
- Very high velocity and shear

- Use 2D and 3D models to evaluate shear and velocity of grade control designs
 - Model results seem to explain observed erosion/deposition
- Improve floodplain connection
 - Minimize velocity and recirculation
- Consider an alternate design approach
 - Priority 2/3 stream restoration with steppool channel
 - RSC
 - Stage 0 Channel
- Use Experienced Contractor!!!!
