Headwater Stream Restoration Goals and Practices

National Stream Restoration Conference Lindsay Nicoll

August 1, 2022

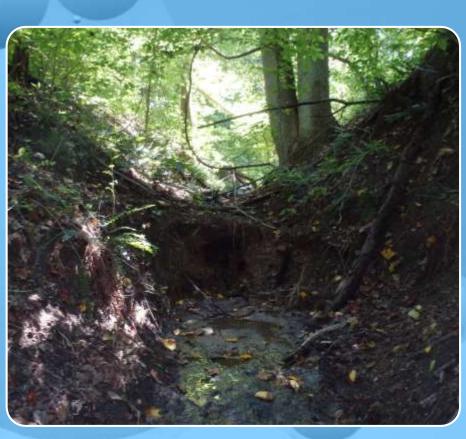
Headcut erosion may contribute significantly to total erosion and suspended sediment concentrations within study area

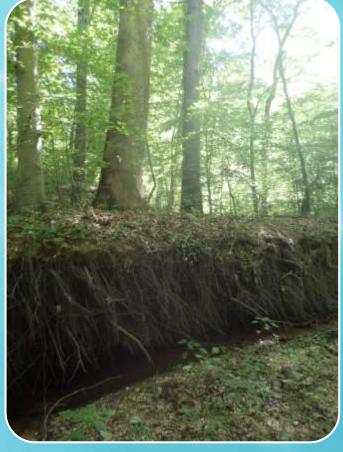
Substrate is homogenous, independent of hydrologic breaks, and with limited bedform diversity.

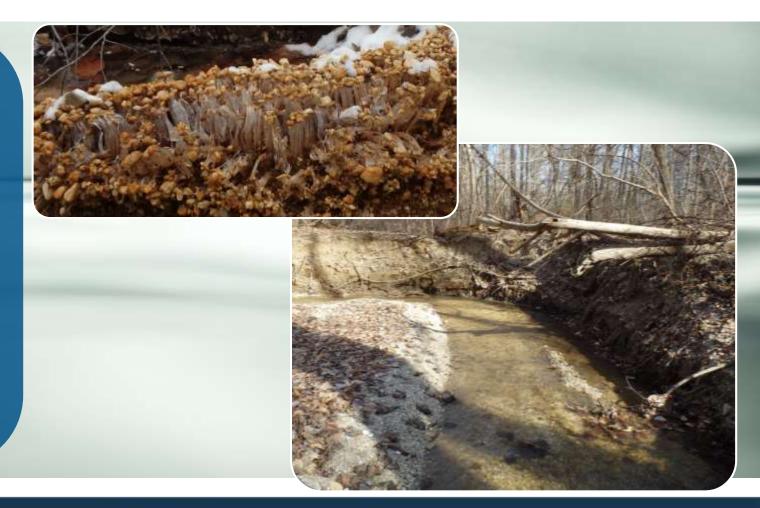
Tributary A

• 1.1% Slope

- 161-acre Drainage Area
- Perennial

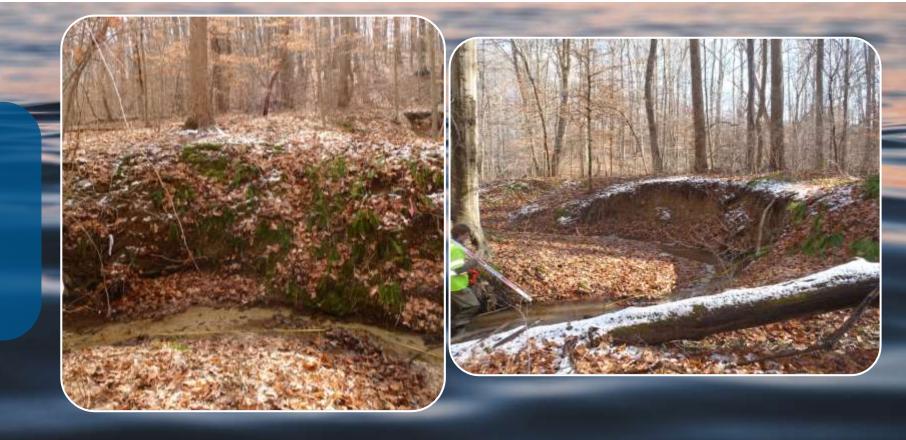
Tributary A

- "Healing" hydrograph
- Difficult Access
- Wetlands

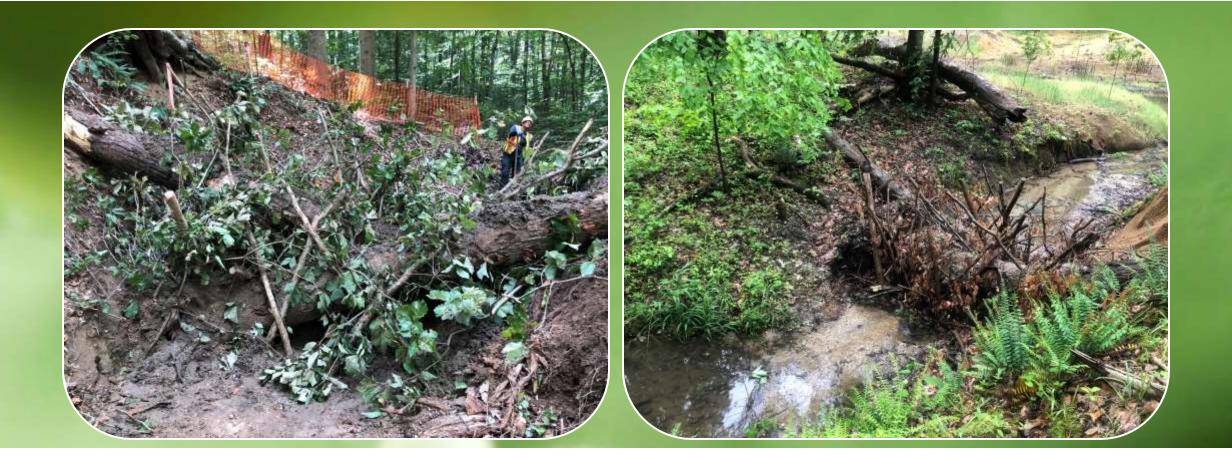
Tributary B

- 6.3% Slope
- 40-acre Drainage Area
- Intermittent

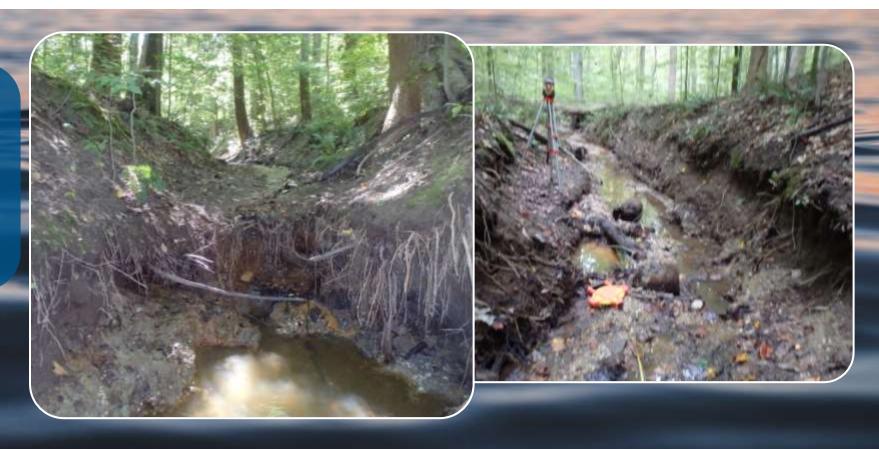
Tributary B

- Prominent Headcut
- Difficult Access Upstream
- No Wetlands
- Few high value or large trees

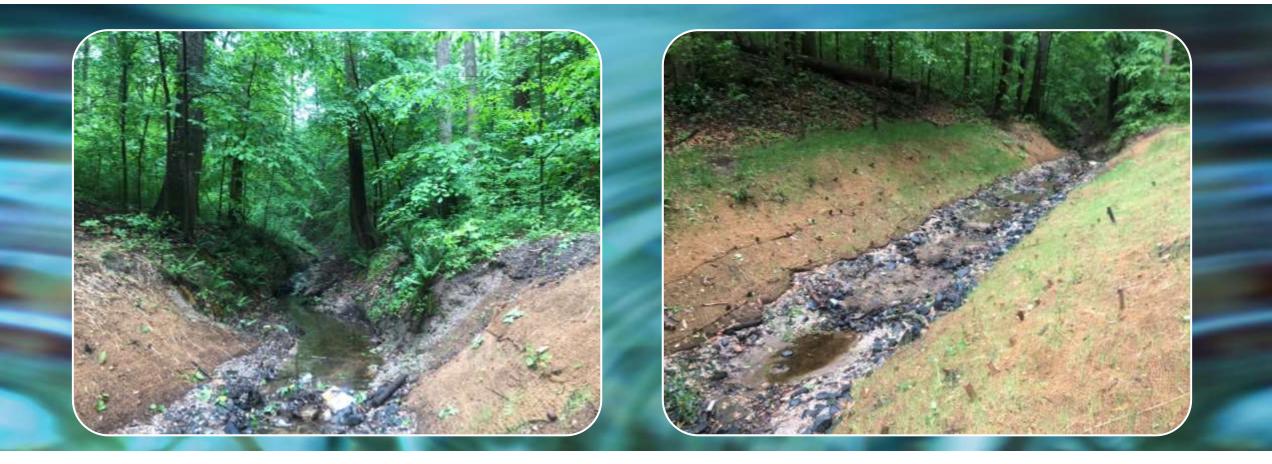
Tributary C

- 12% Slope
- 2-acre Drainage Area
- Ephemeral

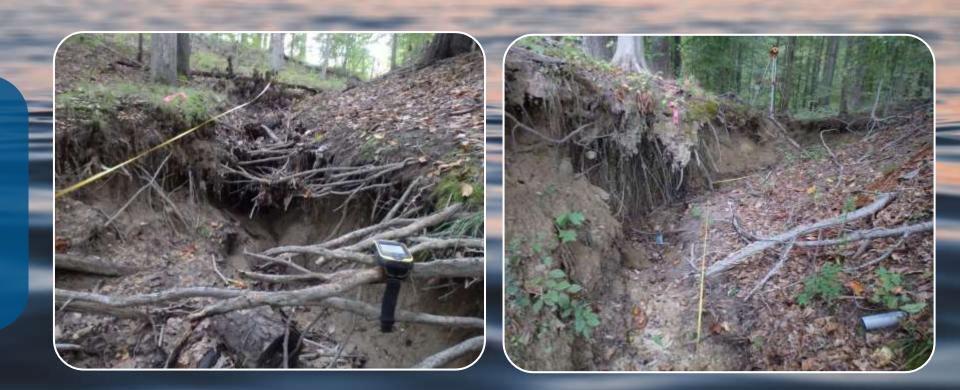
Tributary C

- Active incision
- Roadway Runoff
- No Wetlands
- Few high value or large trees
