Geospatial and Field-Based Methods for Predicting and Quantifying Streambank Erosion

Layla El-Khoury¹, Dr. Barbara Doll^{1,2}, Dr. Jack Kurki-Fox¹ and Dr. Melanie Carter³ (1) North Carolina State University, Department of Biological and Agricultural Engineering, (2) NC Sea Grant, (3) Virginia Tech Conservation Management Institute

Research Goal: Improve methods for identifying, predicting and quantifying streambank erosion to better target restoration efforts

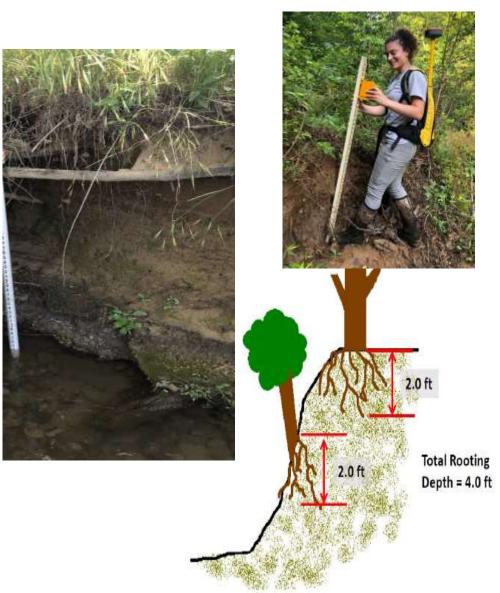
Bank Erosion Hazard Index (BEHI)

- Bank height to bankfull height ratio
- Root depth to bank height ratio
- Weighted root density
- Bank angle
- Surface protection
- Material adjustment
- Stratification adjustment

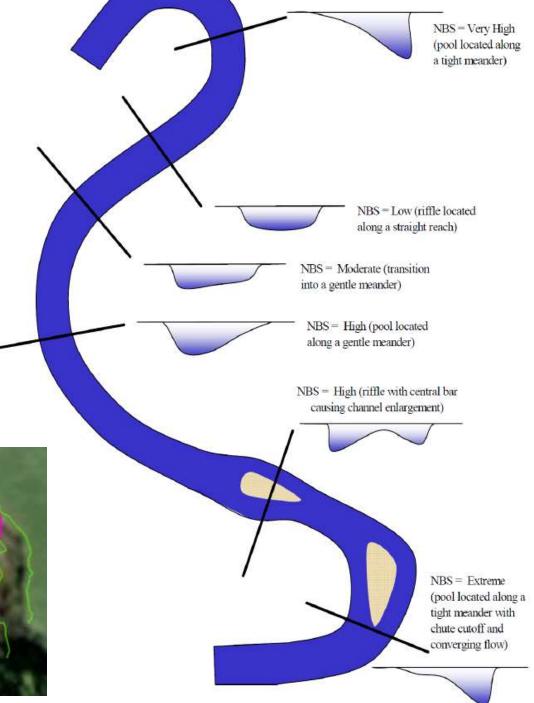
Near Bank Stress (NBS)

- Method 1: Visual
- Method 2: ratio of radius of curvature to bankfull width

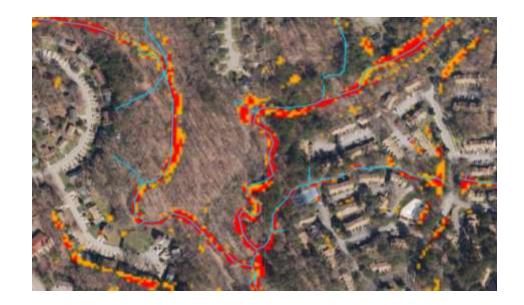
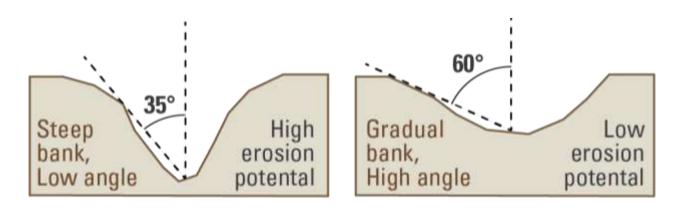
USGS Positive Openness

- Raster dataset developed from 2013 & 2015 lidar data
- Identifies locations of concave surfaces
 - Relief angles are less than 90°

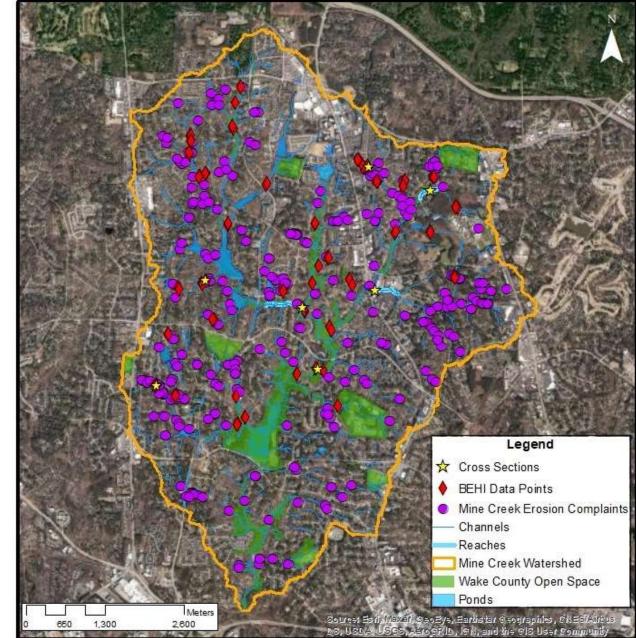
Mine Creek Study Sites, Raleigh, NC

- Mine Creek
 Watershed, North
 Raleigh, NC
 - 10 sq mi
 - 43 miles of streams
 - 32% impervious
- Drains to Shelley Lake
- Most erosion complaints

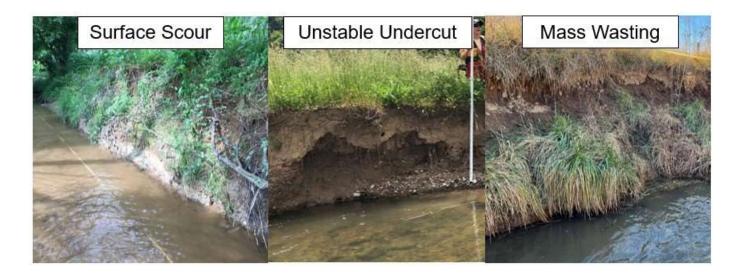
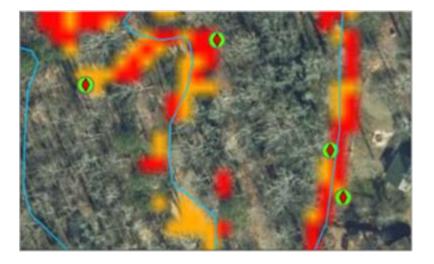
Erosion Categories & ArcGIS Analysis

- Buffers at each data collection point
- Zonal Statistics as a Table to obtain PO

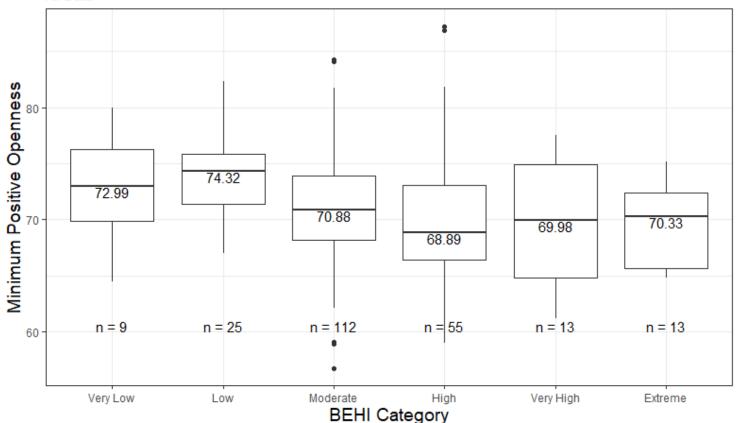
Positive Openness vs BEHI Category

Mine Creek Watershed, NC

All Data

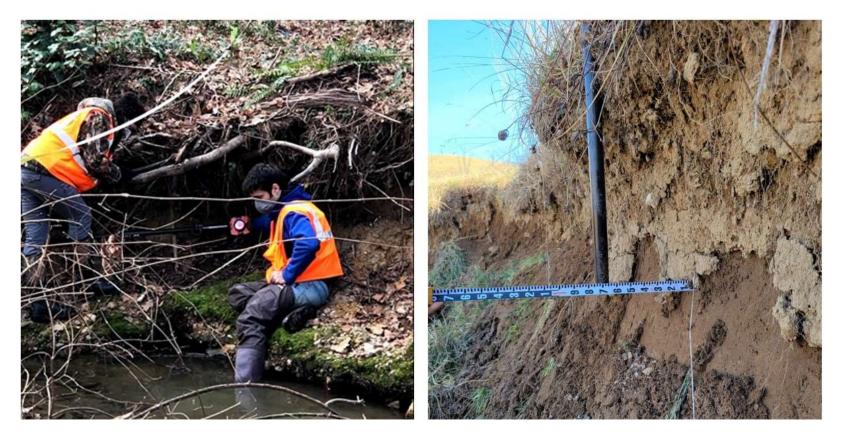
Surveying Undercut Banks

Prism directly against bank

Measure offset & correct after

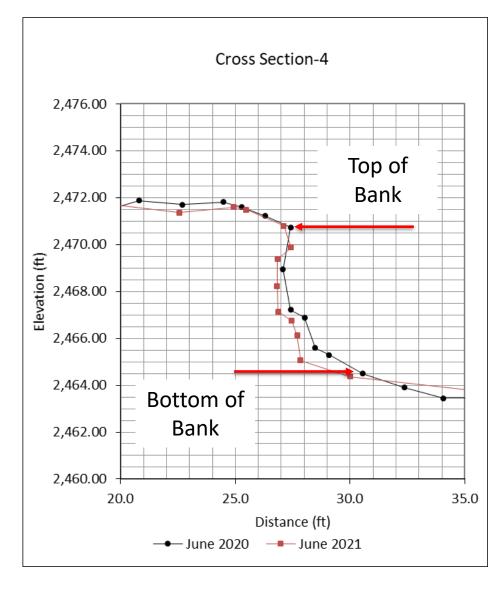
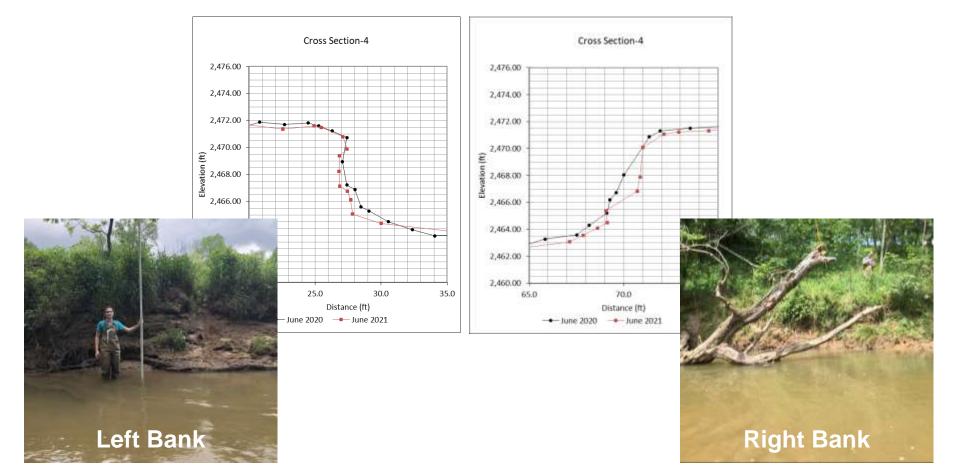
Bank Retreat Analysis – Excel

- Right Bank Retreat = year 1 – year 2
- Left Bank Retreat = year 2 – year 1
- Erosion: negative
- Deposition: positive

Elk Creek – XS 4

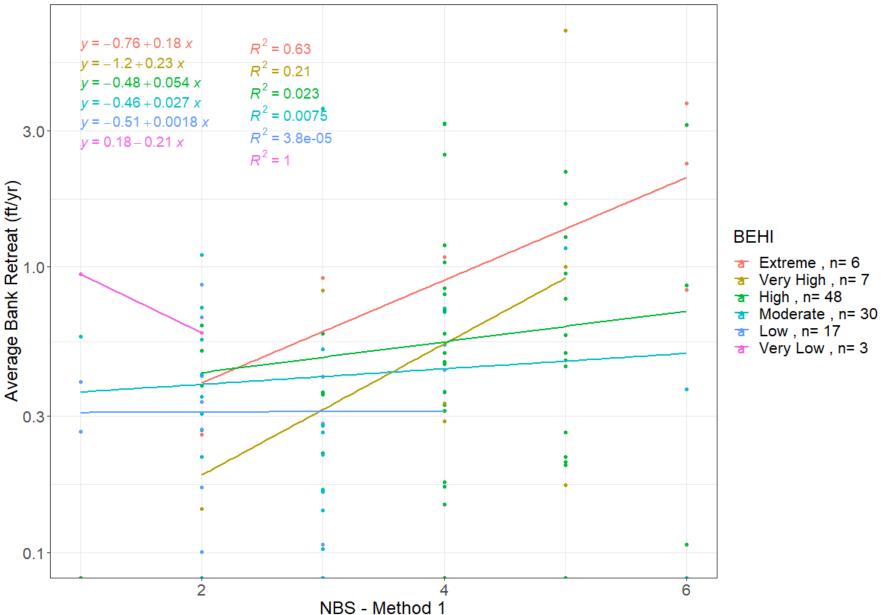
BEHI Erosion Curve

Blue Ridge and Valley & Ridge VA Regions

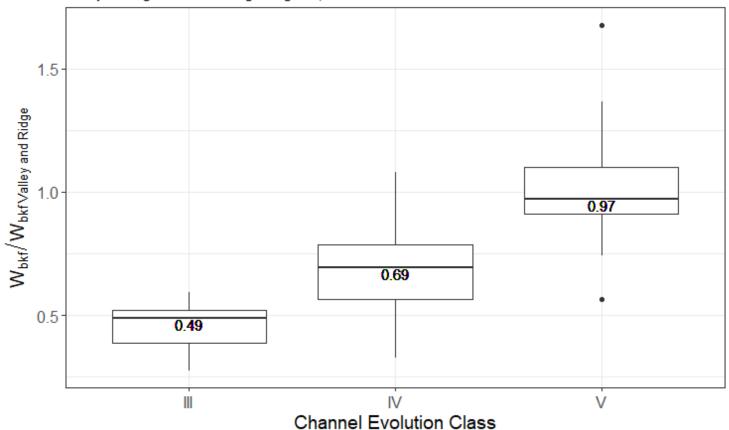
Channel Evolution Class Surrogate

Comparing bankfull width ratios across channel evolution classes

Valley & Ridge and Blue Ridge Regions, VA

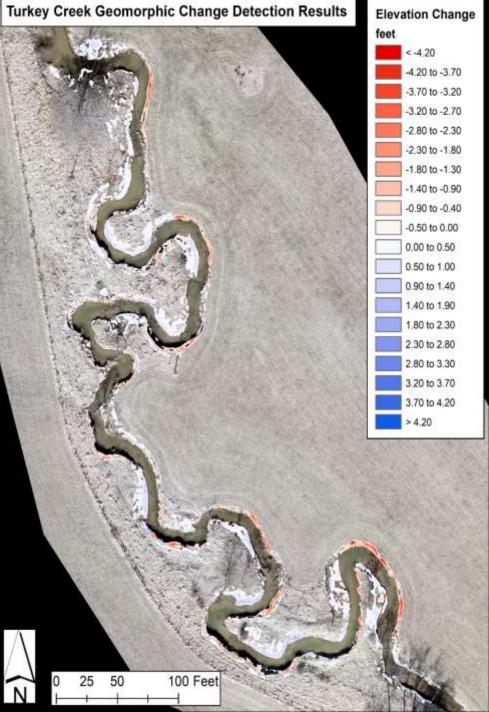
LiDAR Analysis

- Surveys completed:
 - March 2021
 - February 2022
- Error rates ranged from 25 to 44%

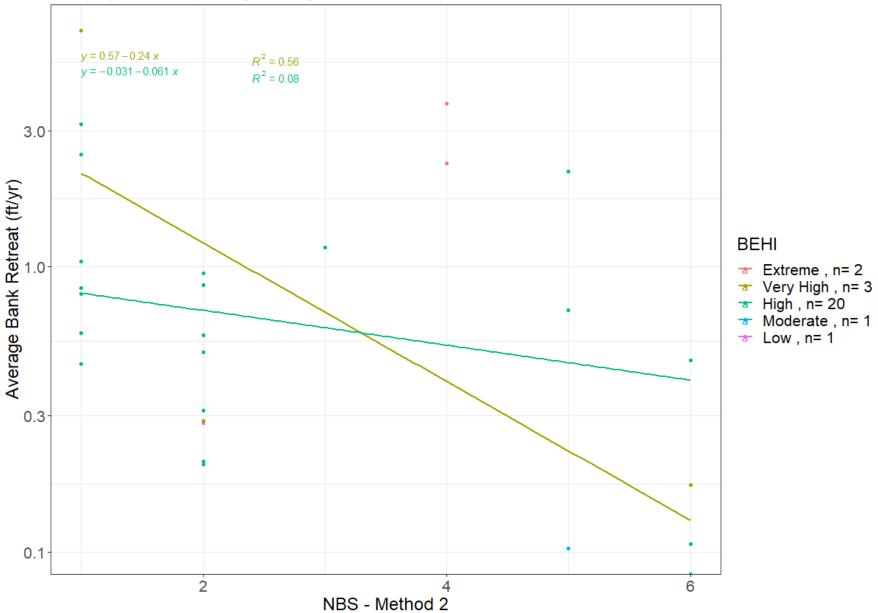
BEHI Erosion Curve

Blue Ridge and Valley & Ridge VA Regions
