Floodplain Restoration along Big Spring Run in Lancaster County, Pennsylvania

PROJECT IMPLEMENTATION PERSPECTIVES

2023 National Stream Restoration Conference
August 22, 2023

Presented by Ben Uhler (LandStudies)
and Bryce Workman (Flyway Excavating)

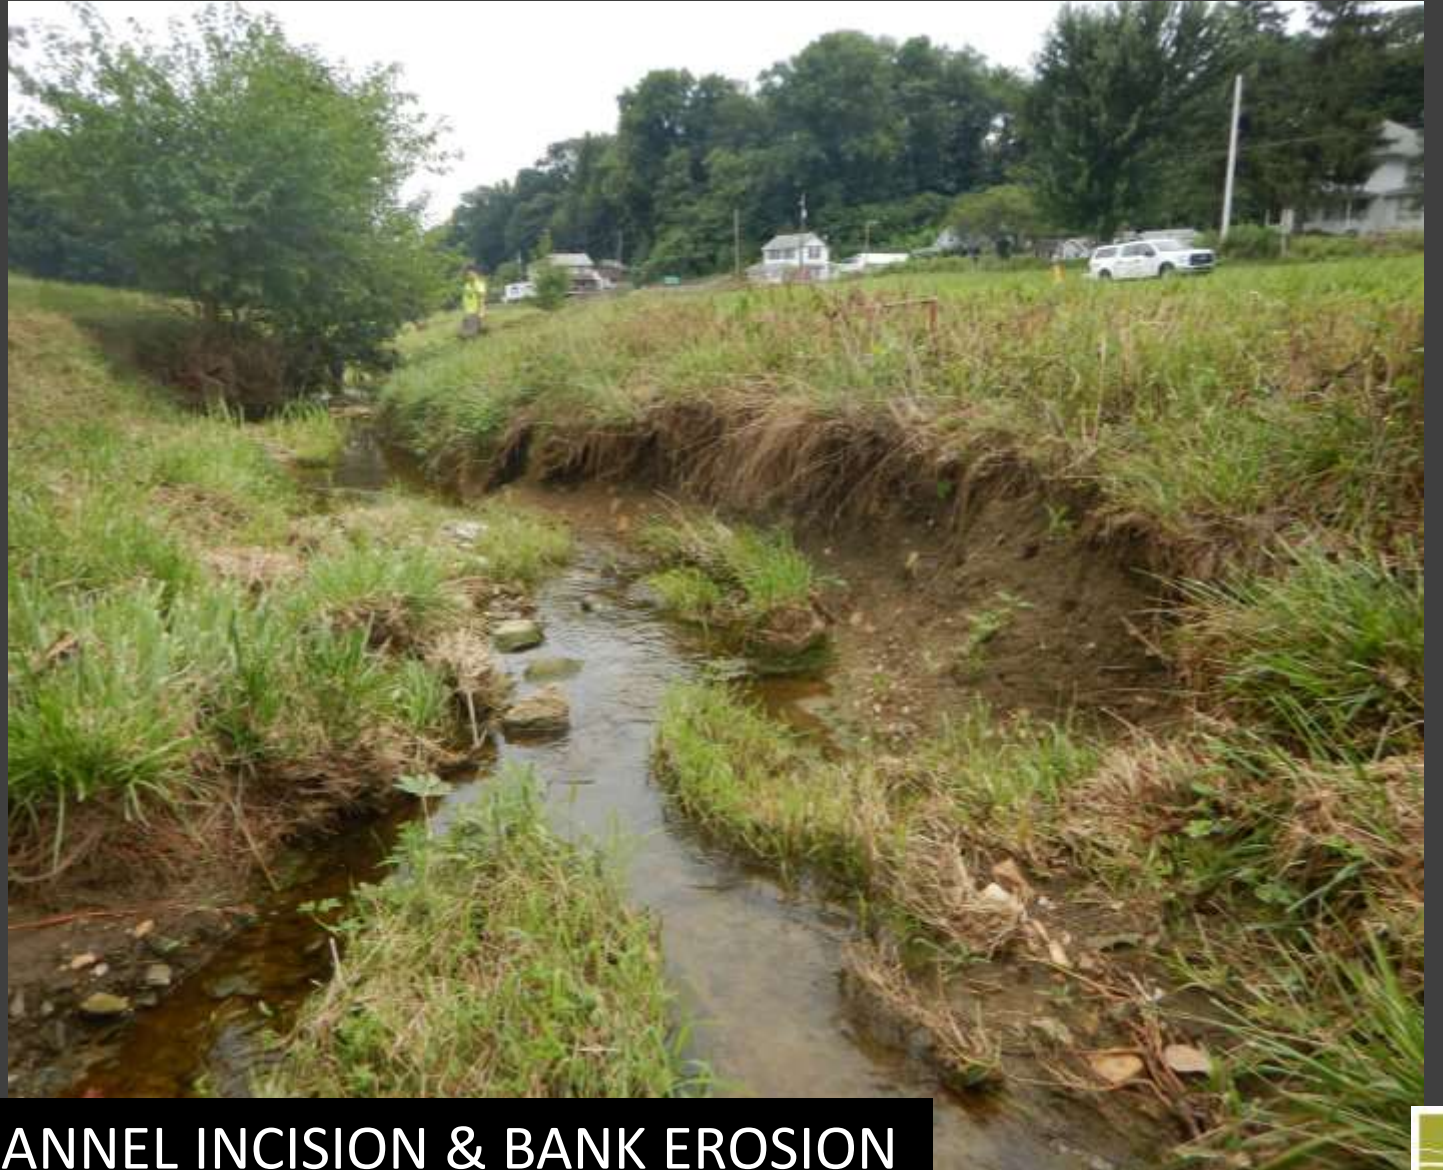
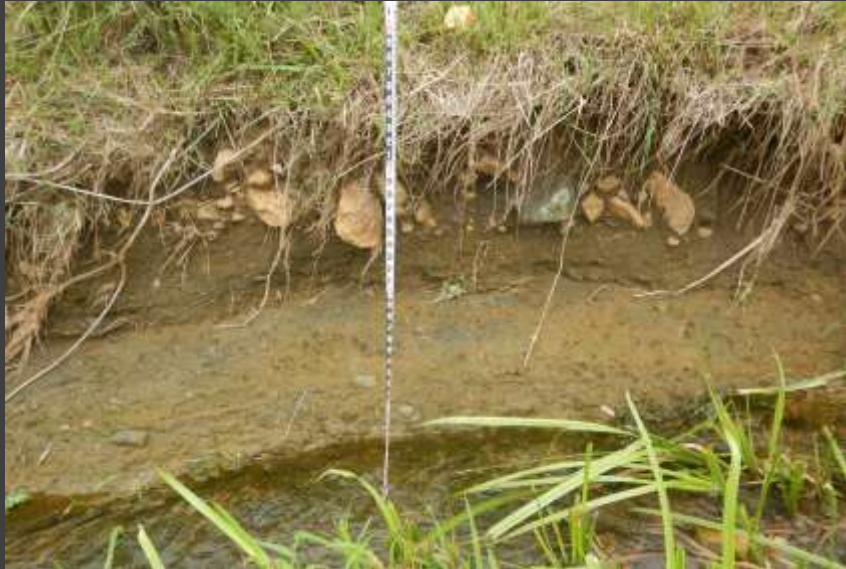
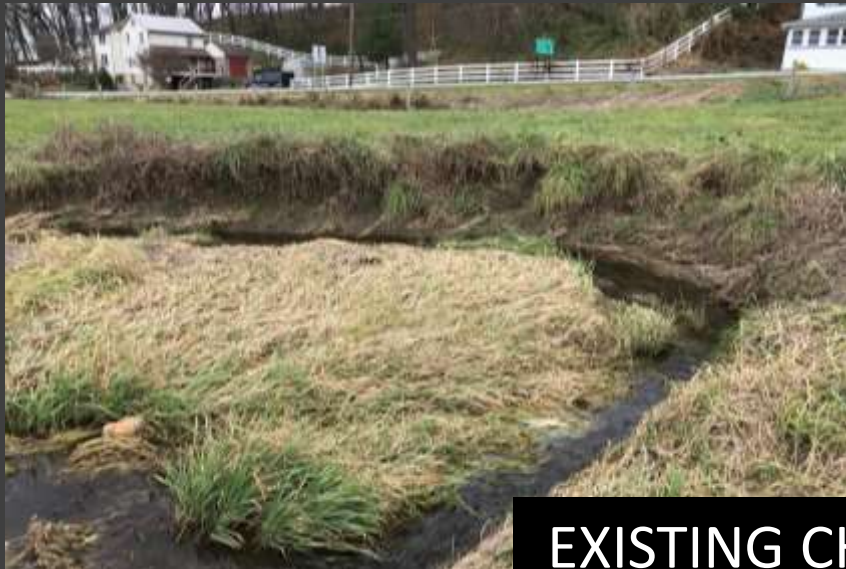
EXISTING CHANNEL INCISION & BANK EROSION

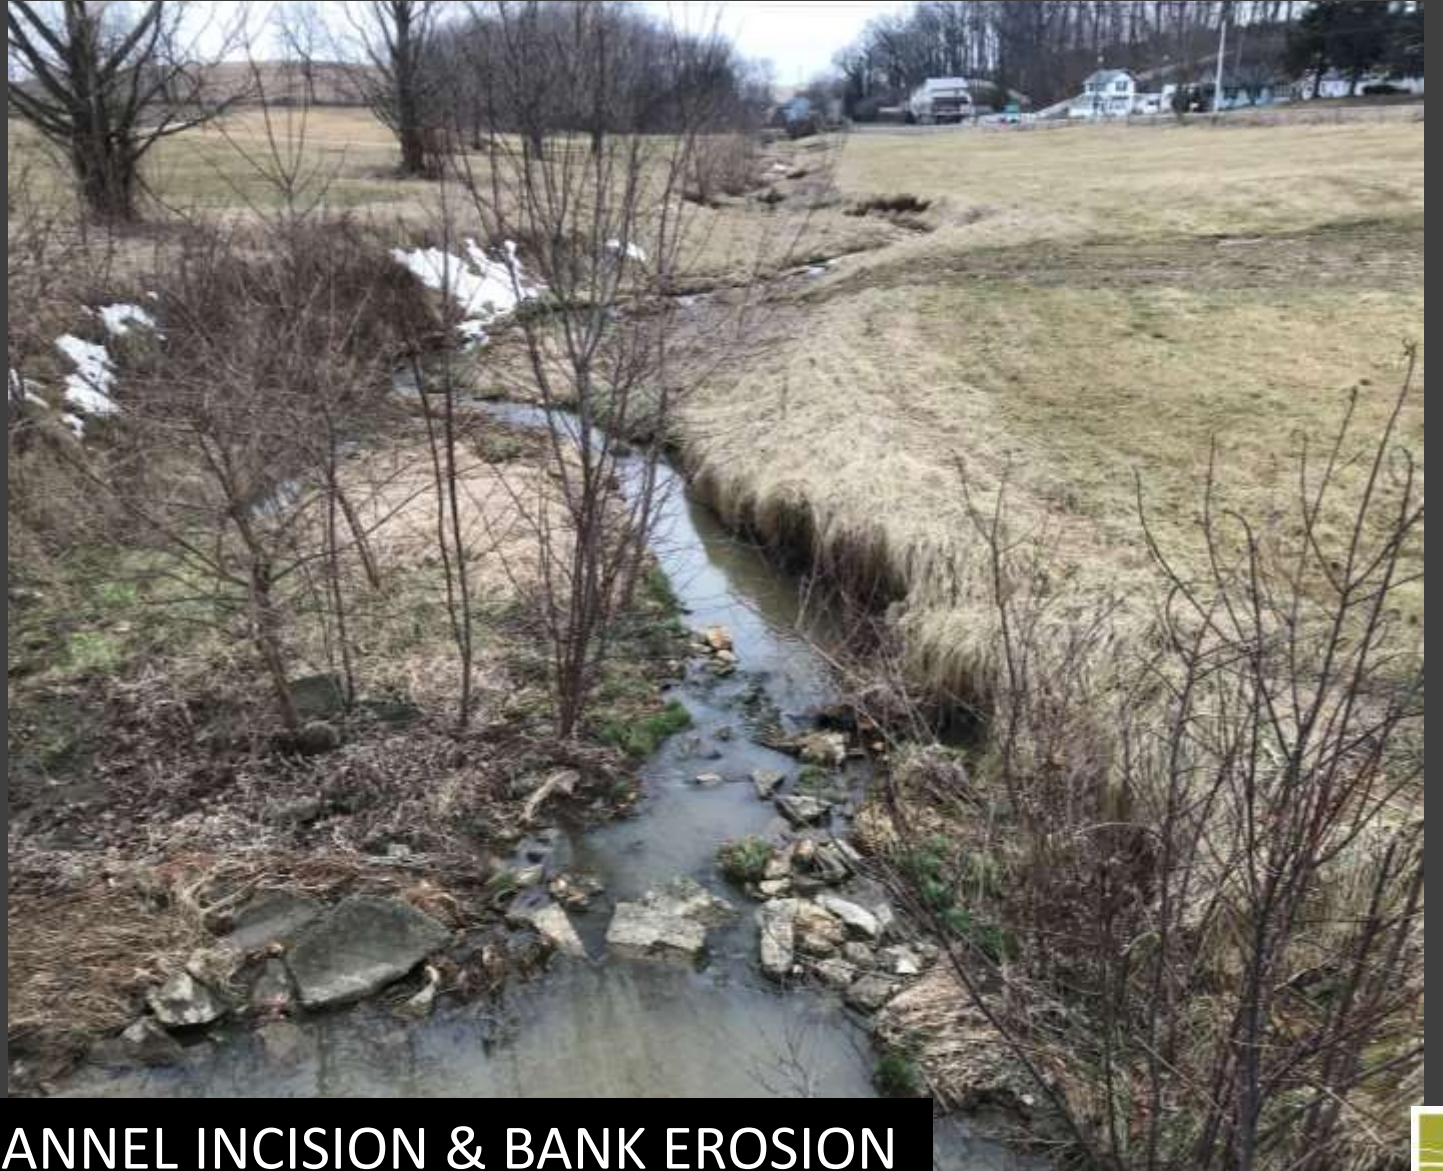
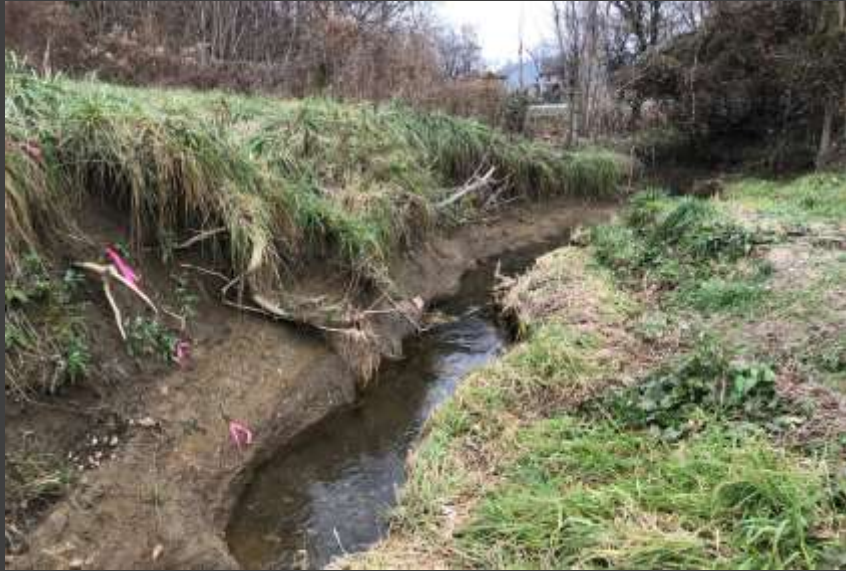
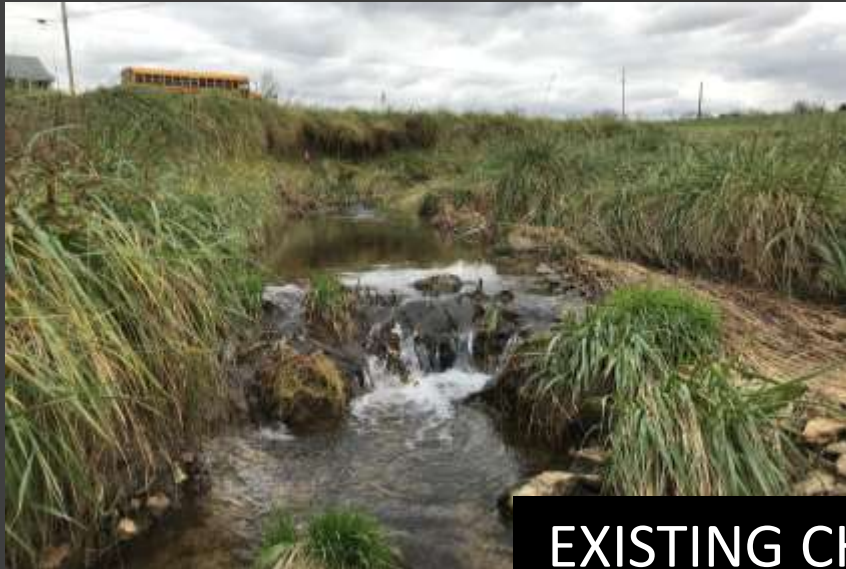
EXISTING CHANNEL INCISION & BANK EROSION

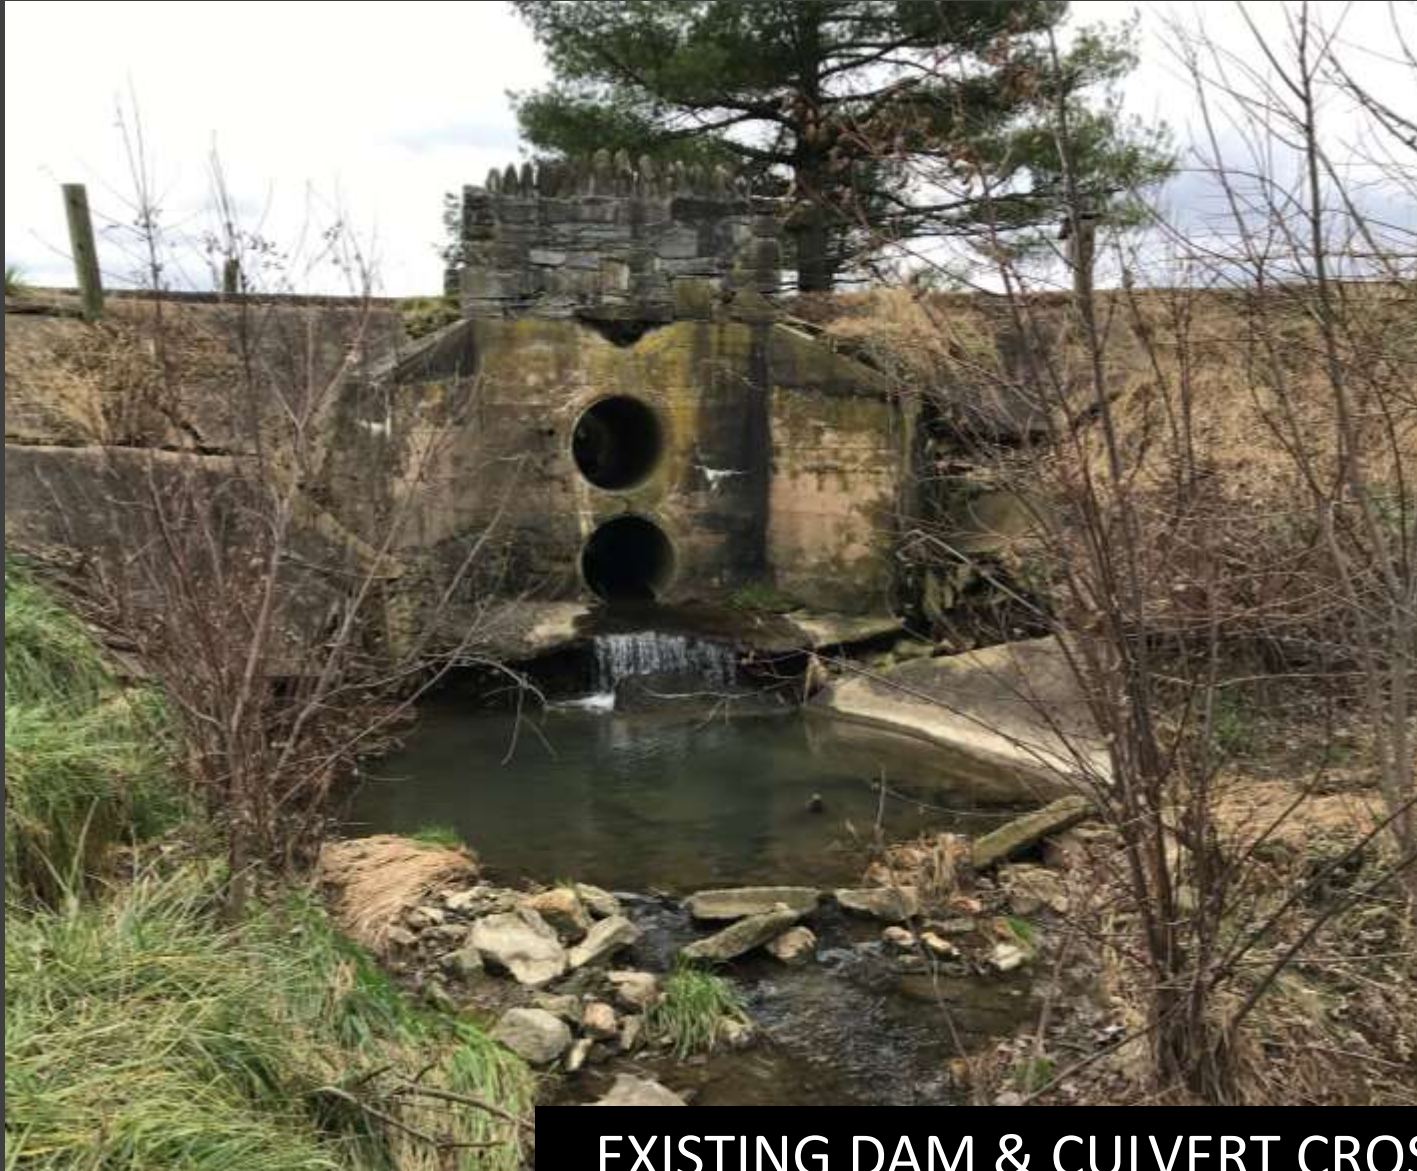
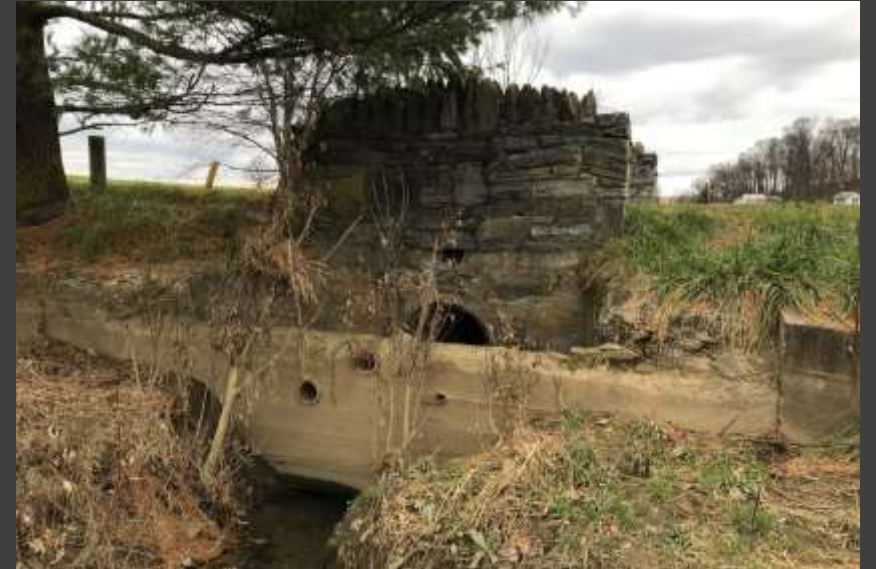
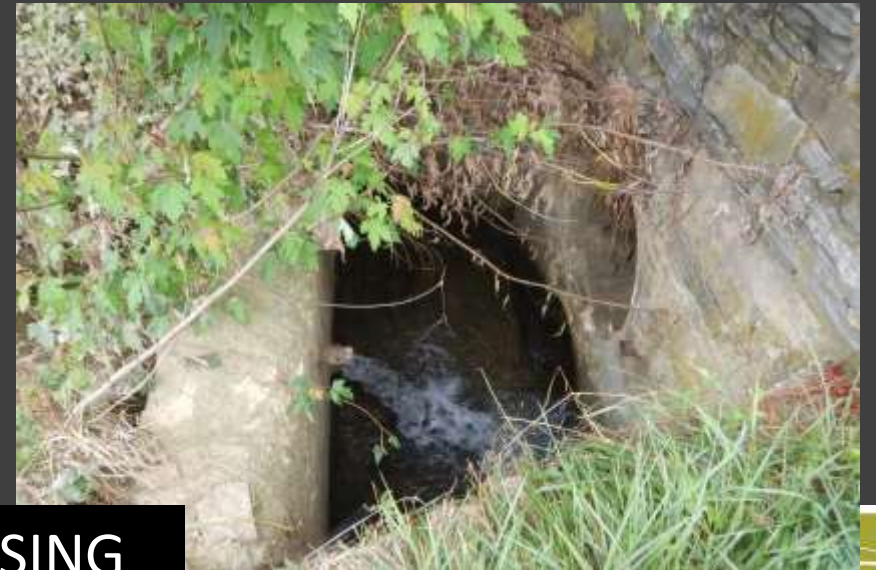
EXISTING DAM & CULVERT CROSSING

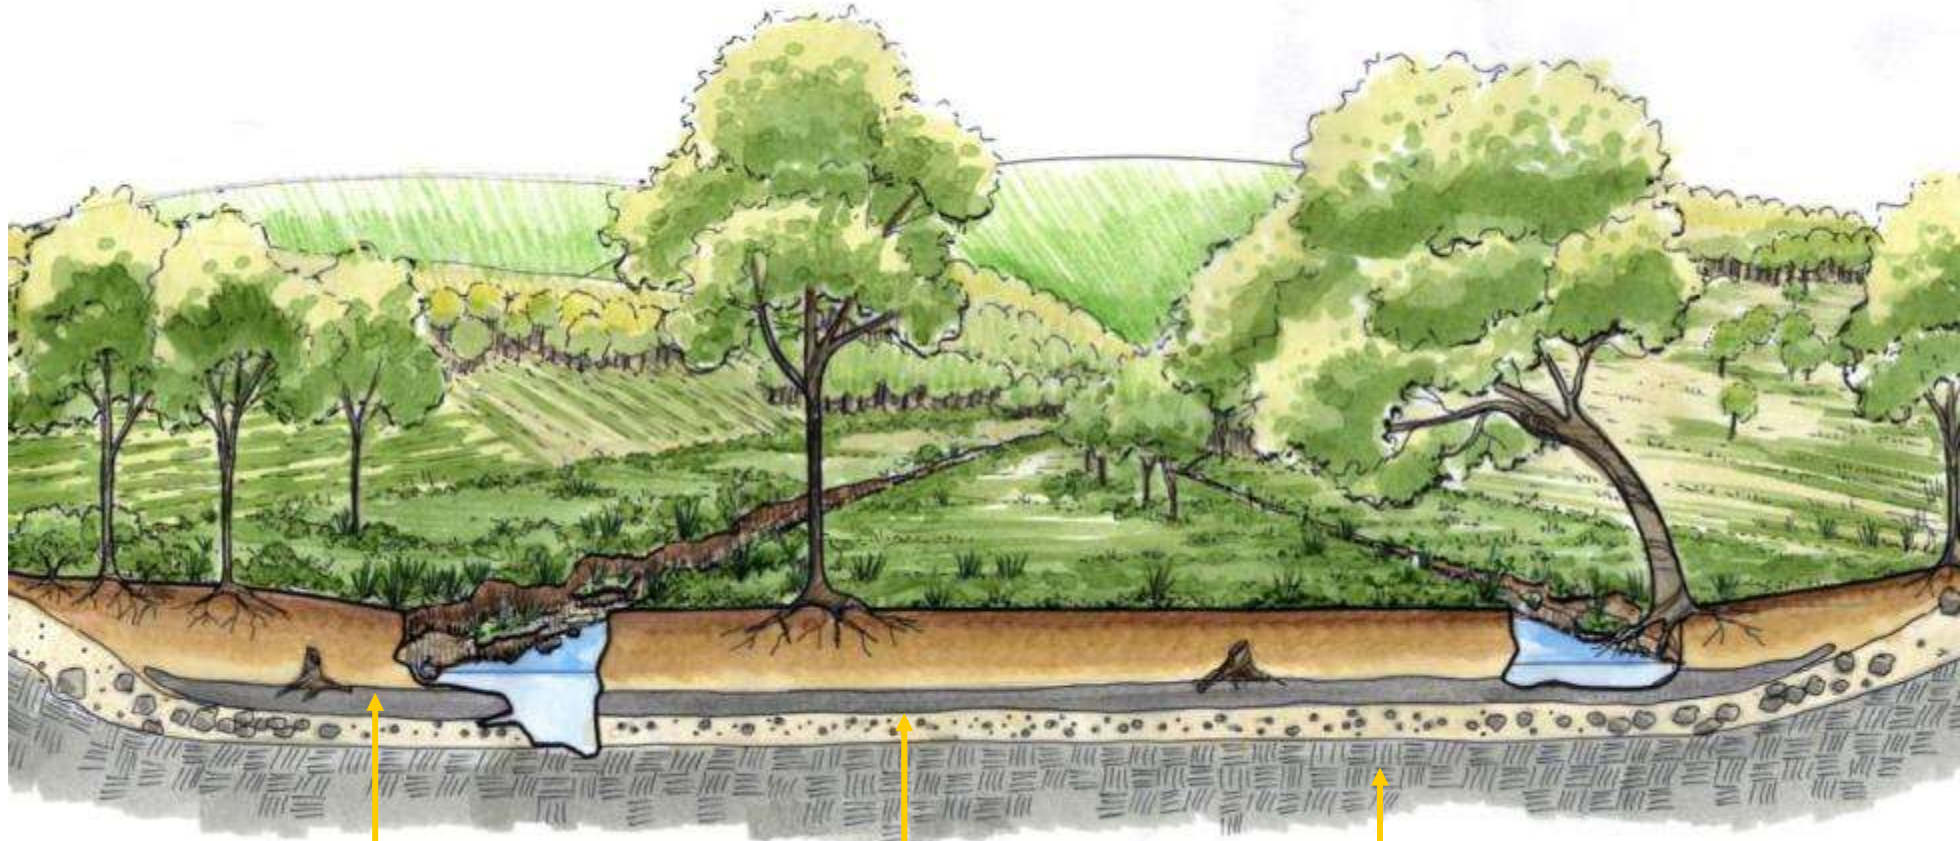
Existing Conditions

Historical
Floodplain Soils

Cobble/Gravel Bed

Bedrock

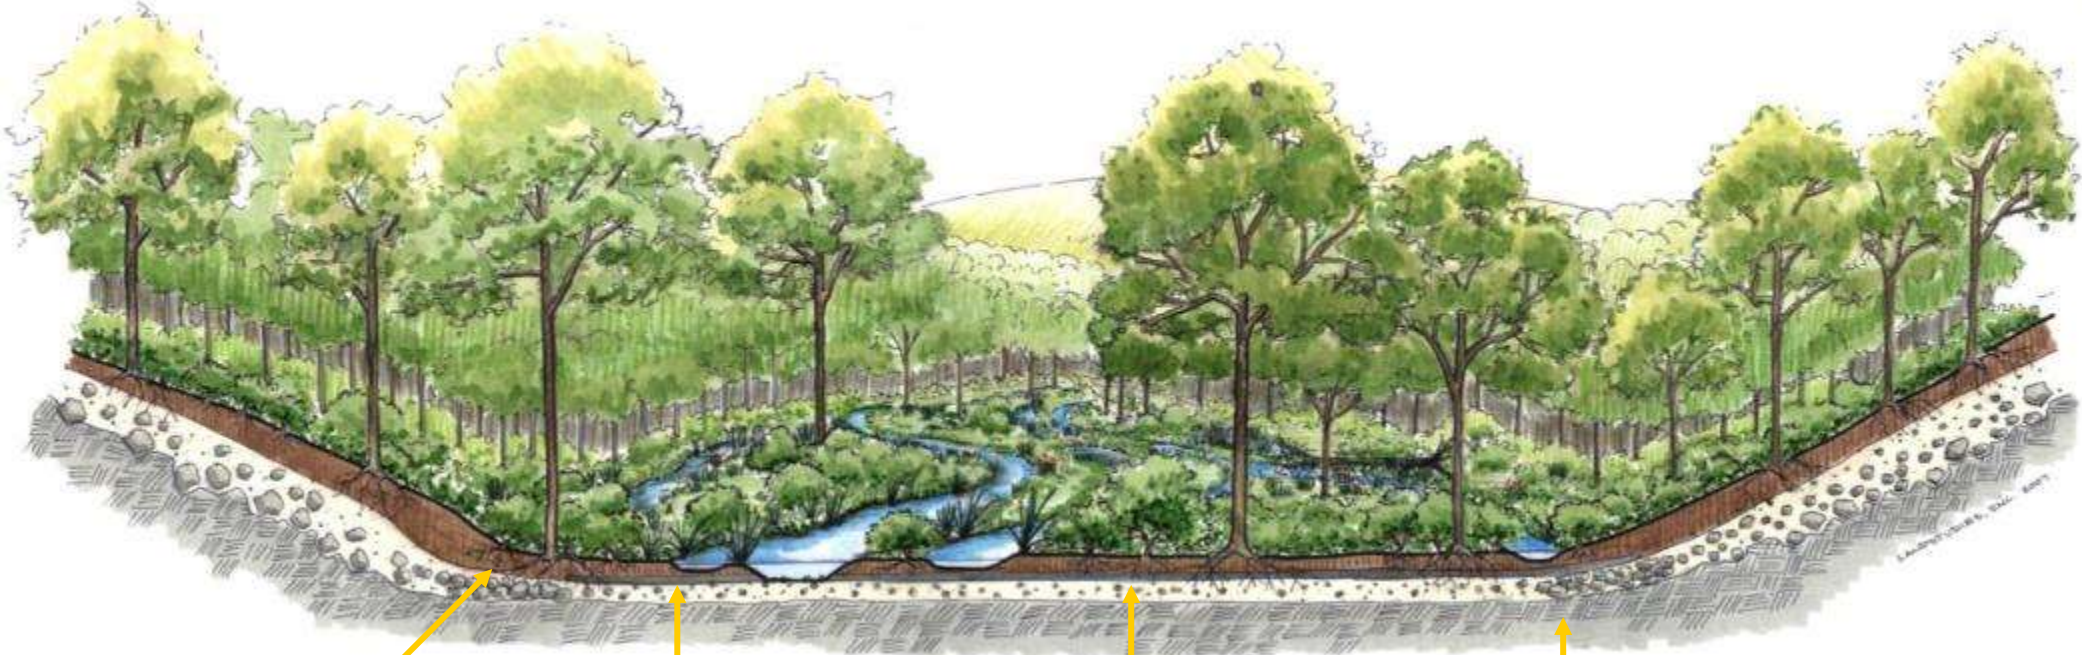
Floodplain Restoration

Roots extend to groundwater

Floodplain Soils – Shallow, Peaty, Organic, & Porous

Cobble/Gravel Bed (Groundwater)

Bedrock
