Streambank erosion downstream of a flood control dam: Processes, rates, and management

Kari A. Bigham, PE, PhD

Carl and Melinda Helwig Department of Biological & Agricultural Engineering

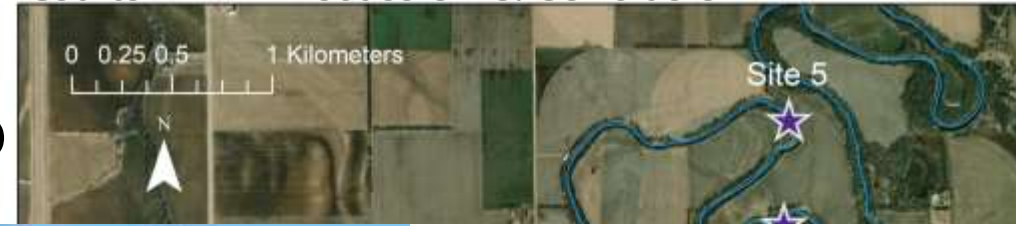
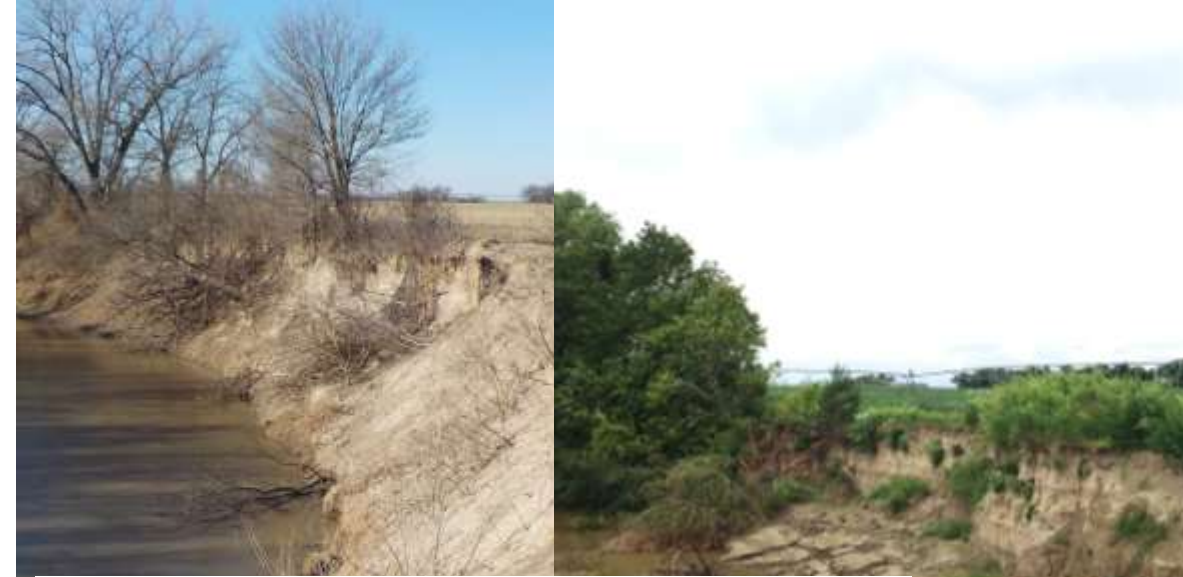
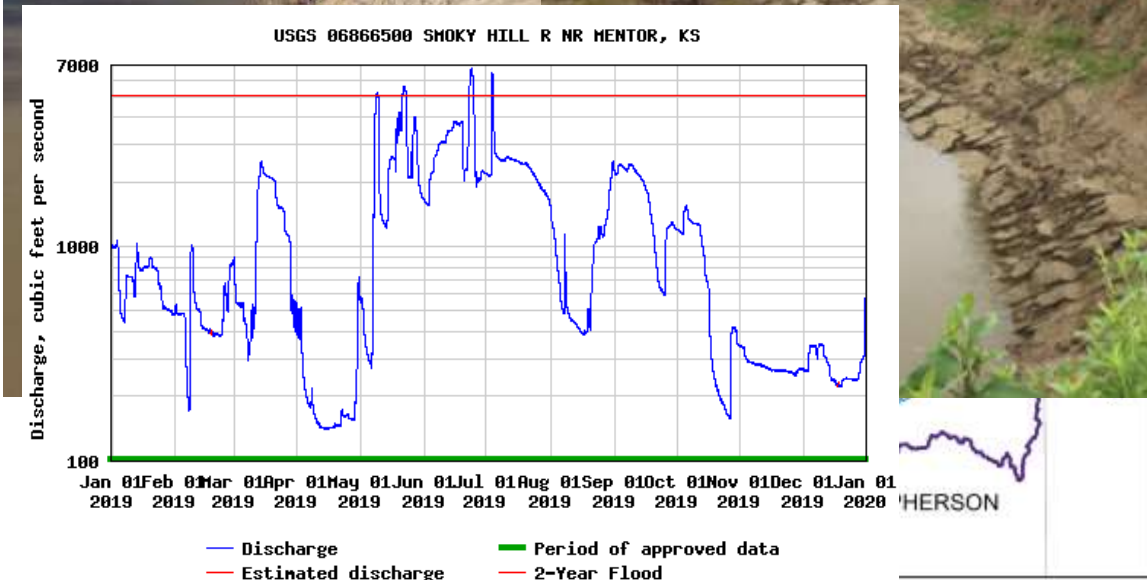
- Began monitoring woody revetment design in 2016 downstream of Kanopolis Dam on the Smoky Hill River
- In 2019, they failed – why?
 - Insufficient anchoring?
 - Lack of early-stage protection?
 - Construction disturbance?
 - **What about dam operation?**

Why did these projects fail?

- Insufficient anchoring? ✓
 - Lack of early cover? ✓
 - Construction disturbance? ✓
 - Dam operation? ✓
- **We failed to get to know the system first.**
 - Flow & sediment regime
 - Channel evolution phase
 - Channel form and process
 - Field work + modeling

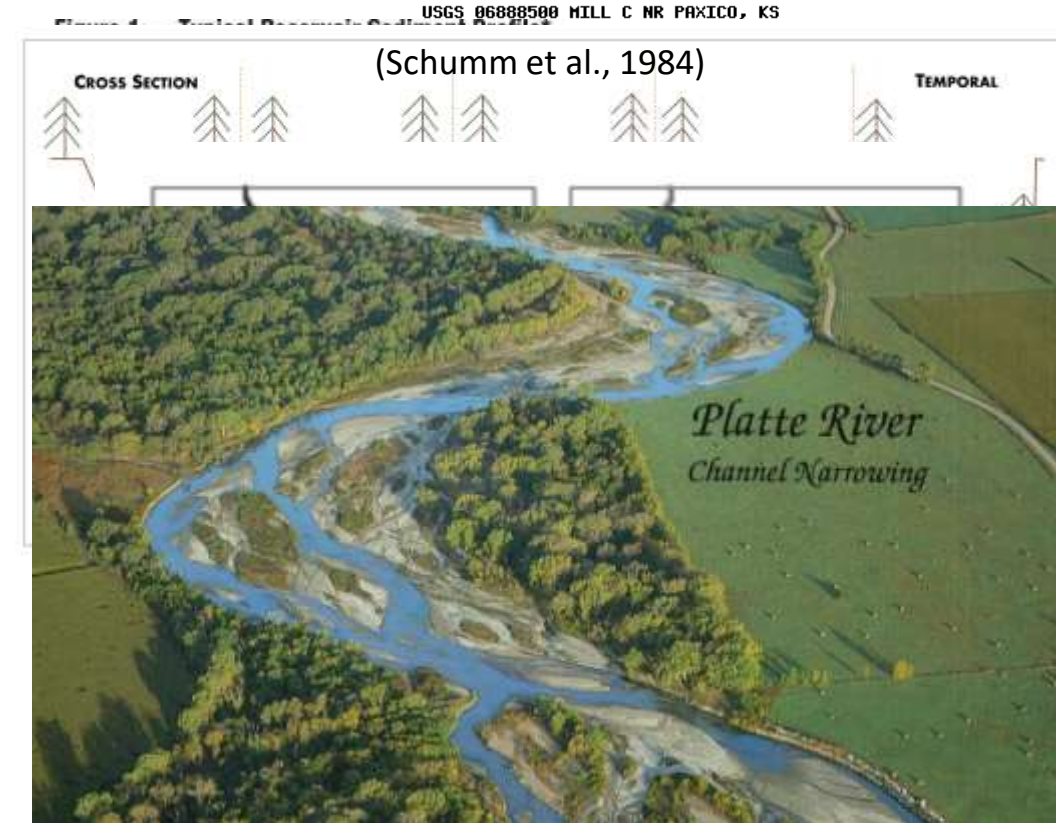
axis of Figure 5.

From Rosgen (1996), from Lane, Proceedings, 1955.
Published with the permission of American Society of Civil Engineers.

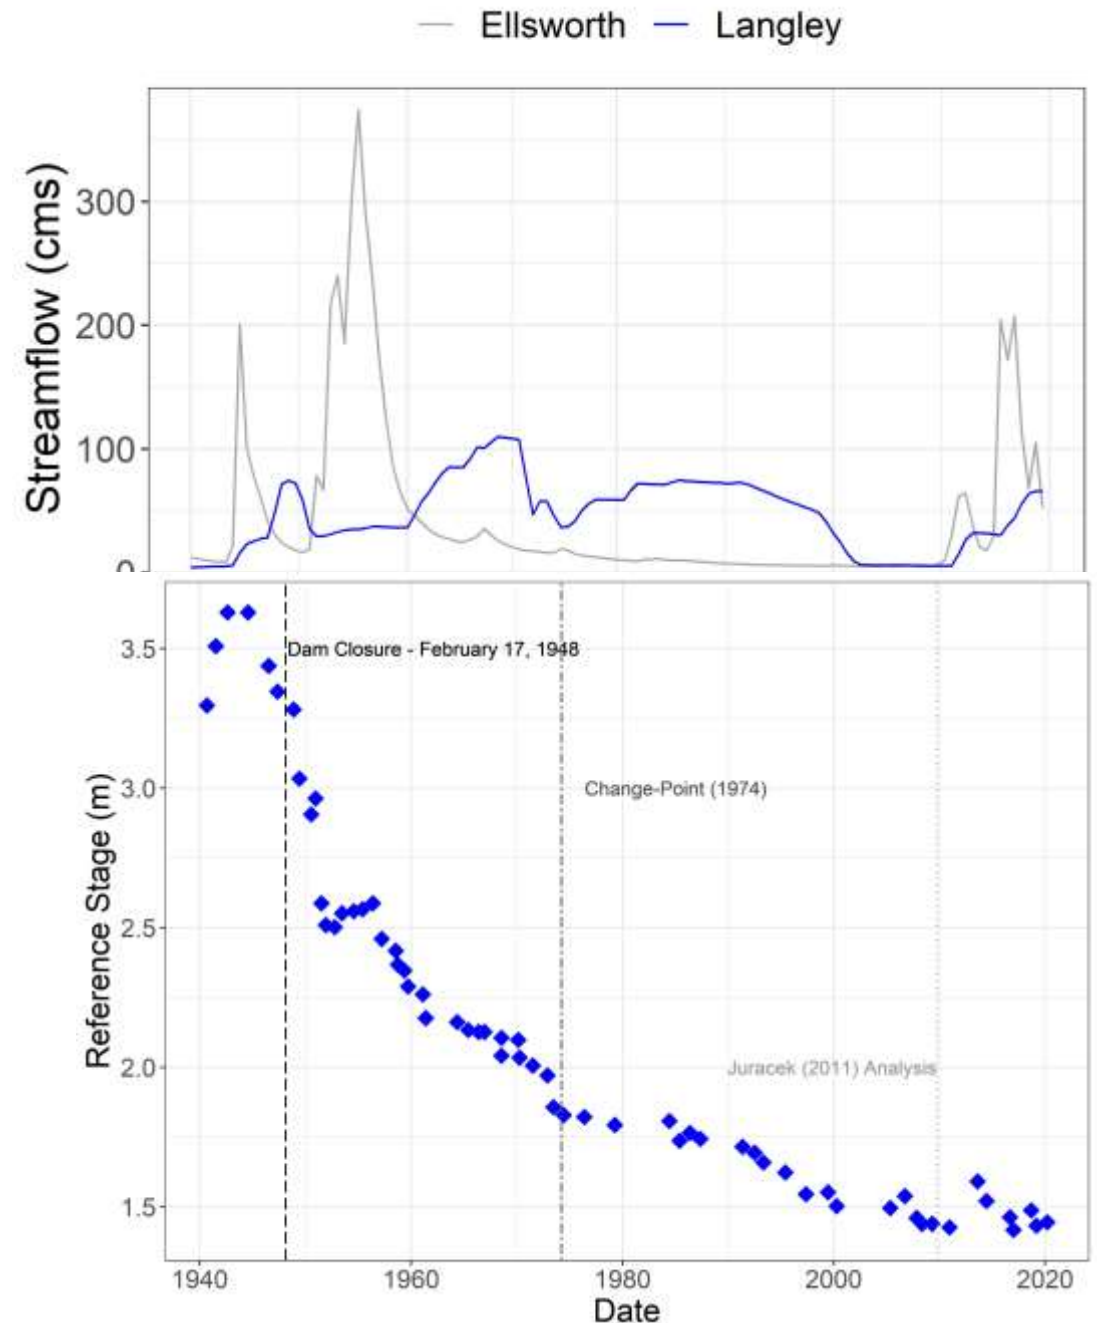
Flow & Bed Stability

- Dampened peak flows by 72%
- Increased moderate flows (5-90% DEP)
- Bankfull discharge decreased by 50%; annual return interval remains the same
- Resulted in up to 60 years of bed instability up to 10 river km downstream

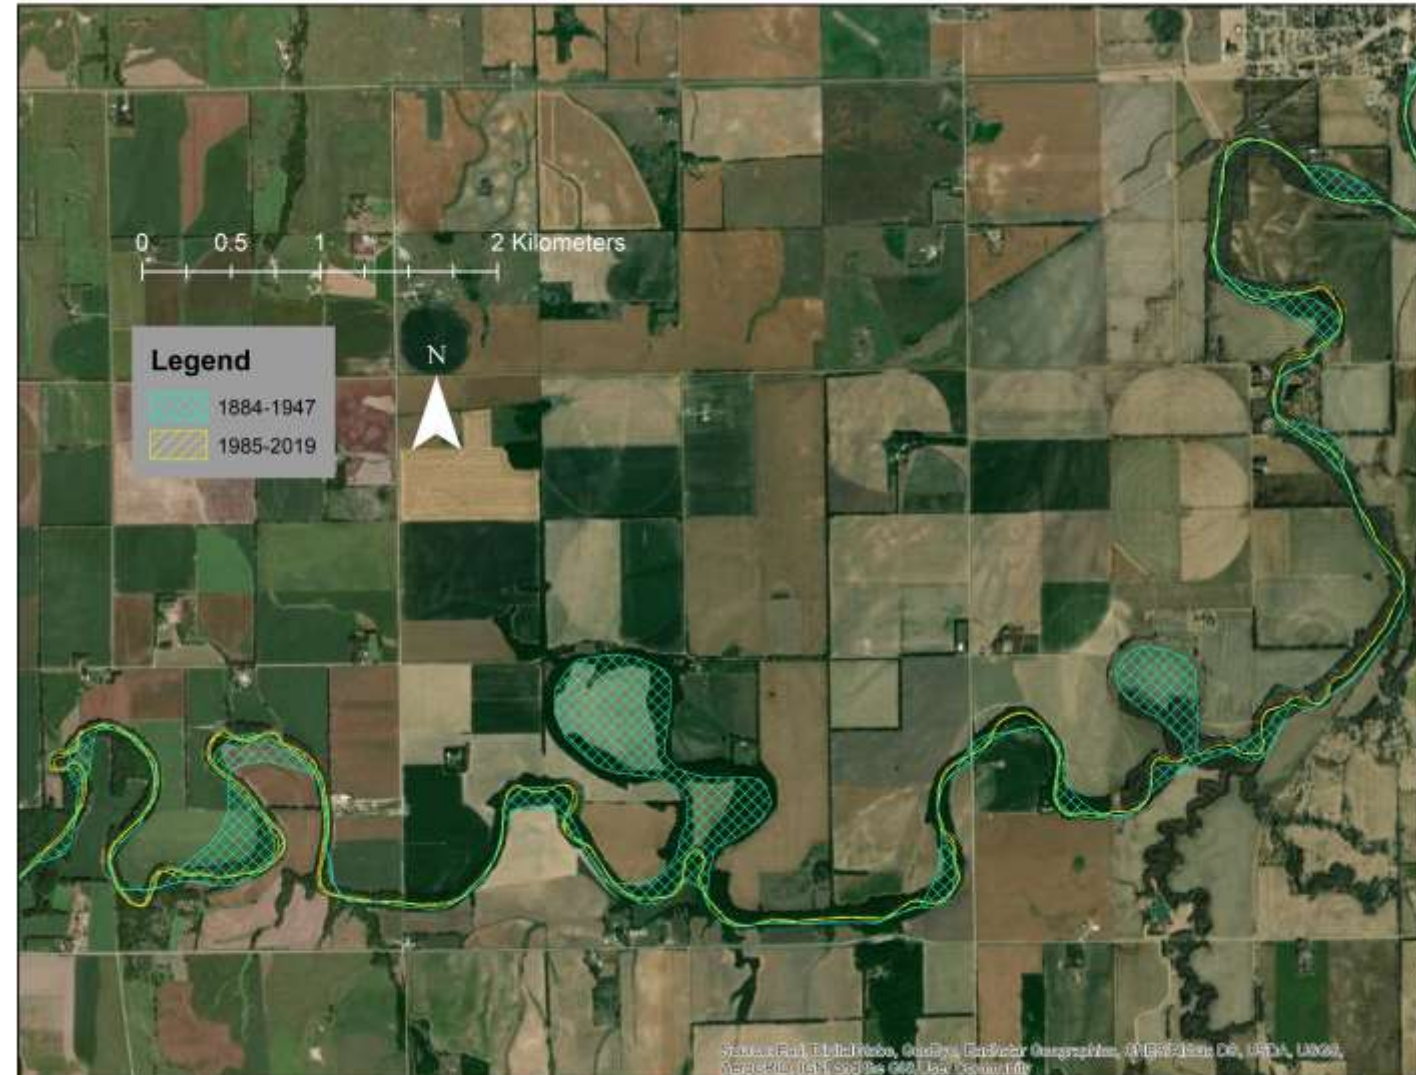
Channel Planform

- Channel migration rates decreased by 66%
- Sinuosity increased by 5%

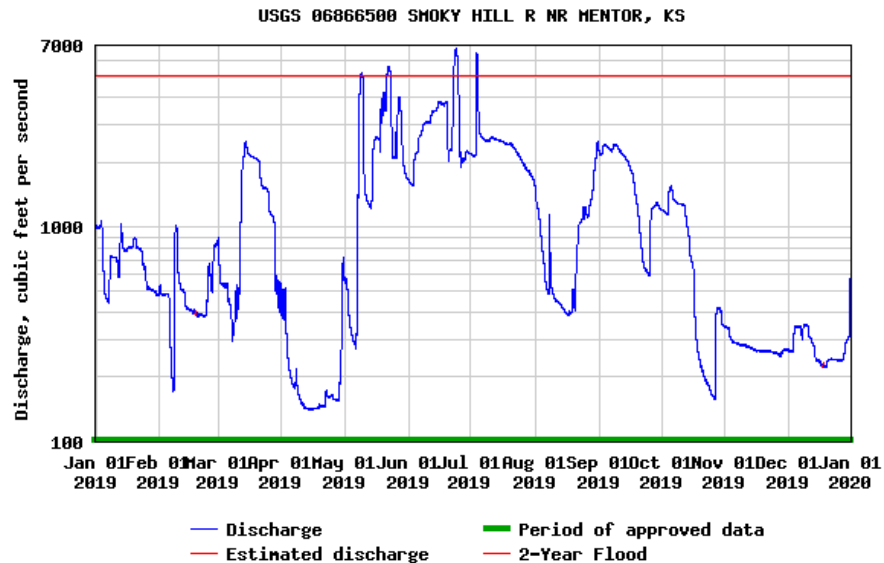
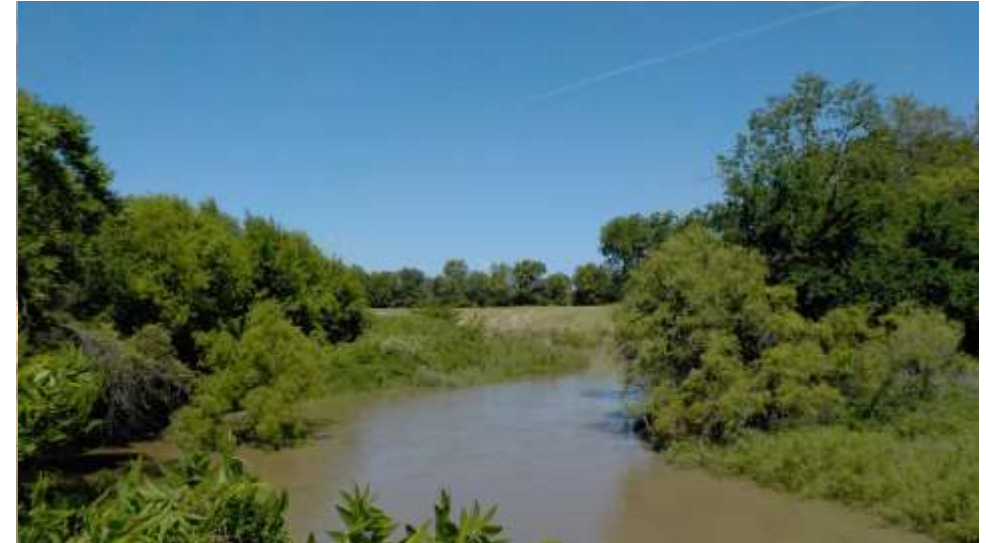
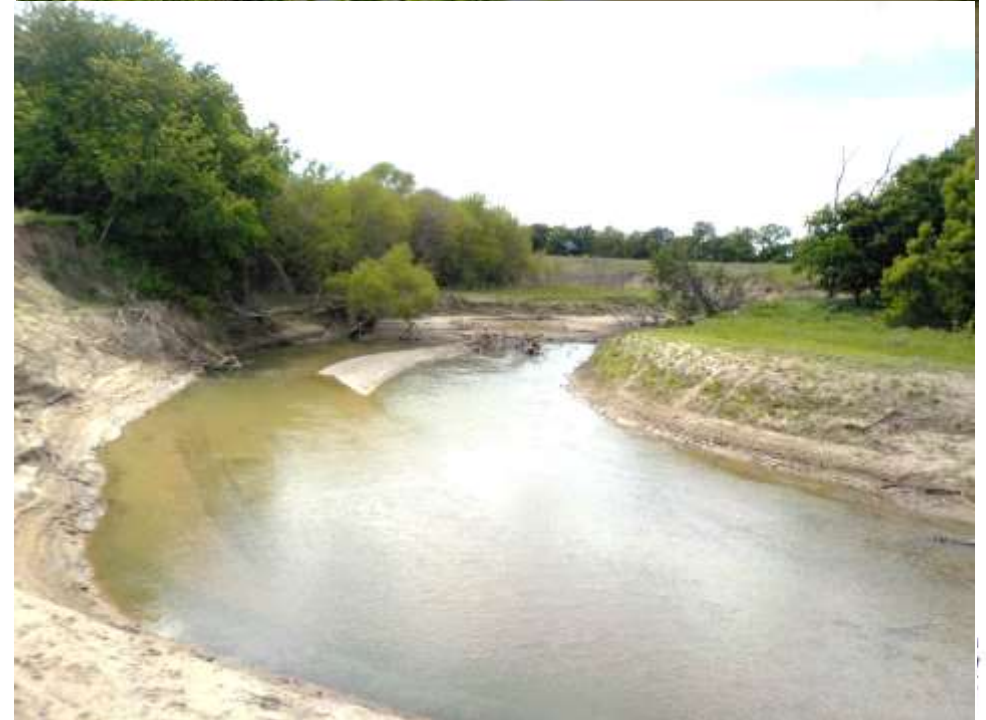
Streambank Erosion

- Induced toe erosion over a larger spatial scale and longer temporal scale
- Periodically damages riparian vegetation

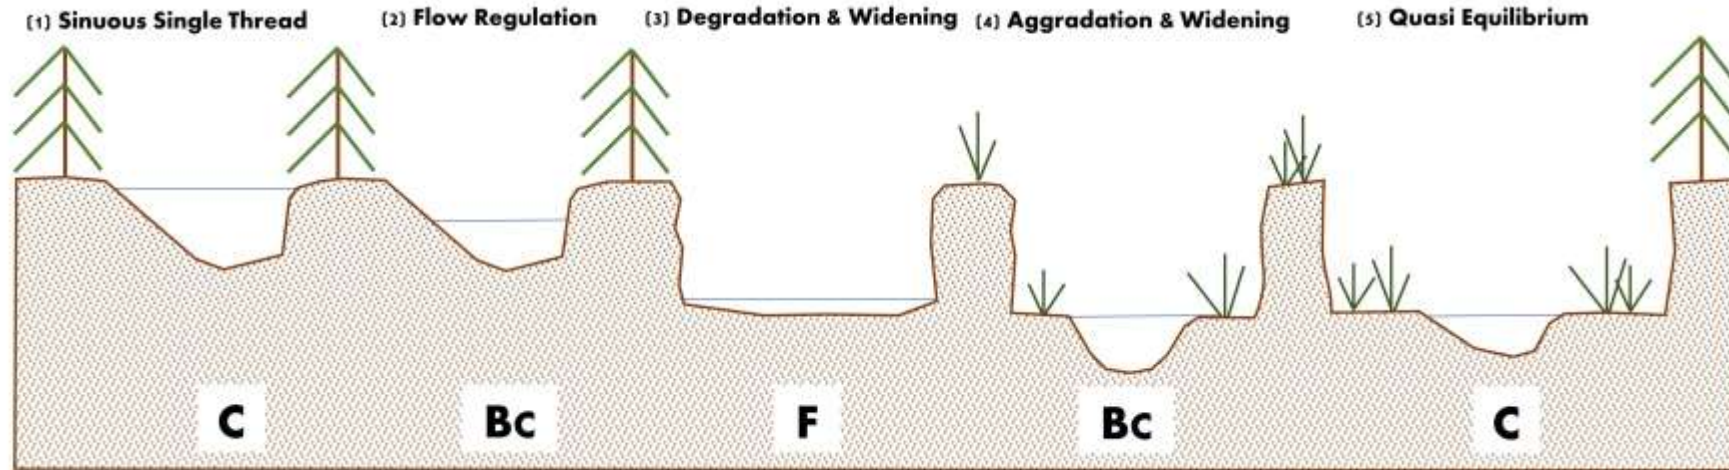
Channel Evolution

Downstream
of Dam (0 -
10 river km)

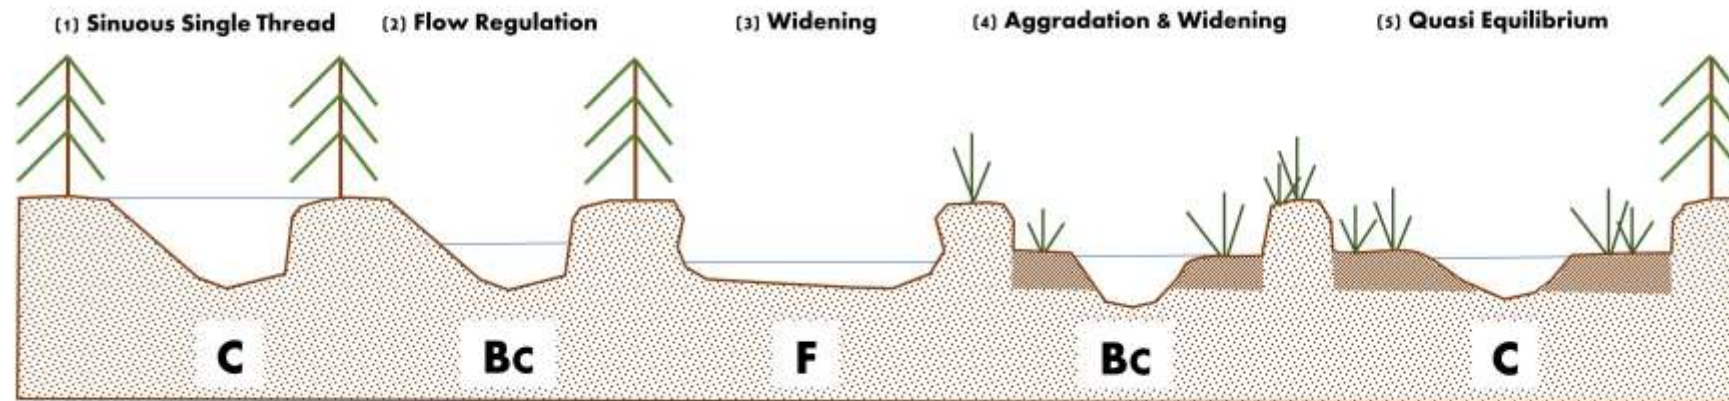
Downstream
of Dam
>10 km)

Bigham, K.A., T. Moore, T. Keane, D. Rosgen (2022). *Observed Channel Evolution Downstream of a Flood Control Dam*. Manuscript submitted for publication.

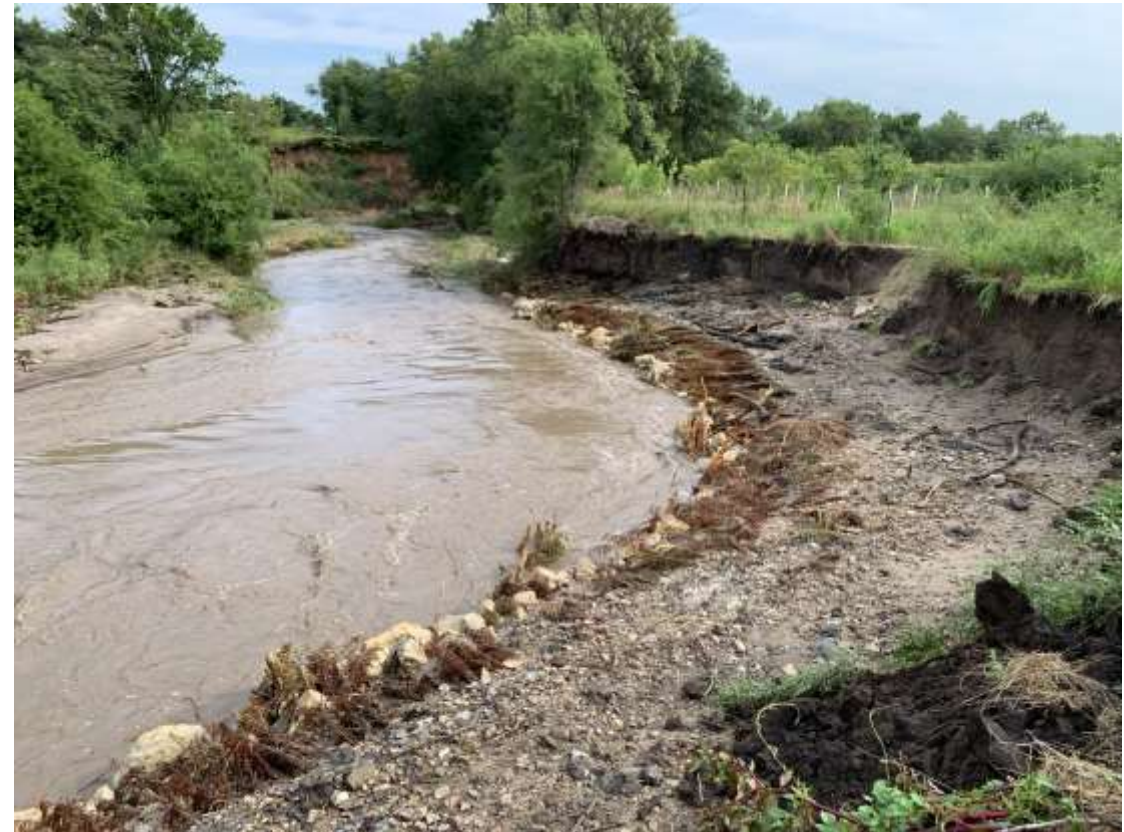
Design completed by Phil Balch
Photos taken by Andy Klein

- *Likely* if we can paint a clearer picture of the river's past, present, and future.
- Different design developed, now to test it.
