Case Study: Watershed-Scale Restoration within 4 Years – RES Robinson Fork Mitigation Bank

Michael Sachs & Ward Oberholtzer, PE

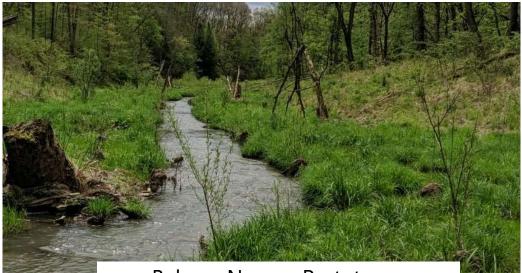
Highlights – Restoring Biodiversity

- High diversity of hydrophytic vegetation and very low invasive cover
- Macroinvertebrates indices improved
- Fish range expanded and population increased
- Mountain chorus frog, RTE species

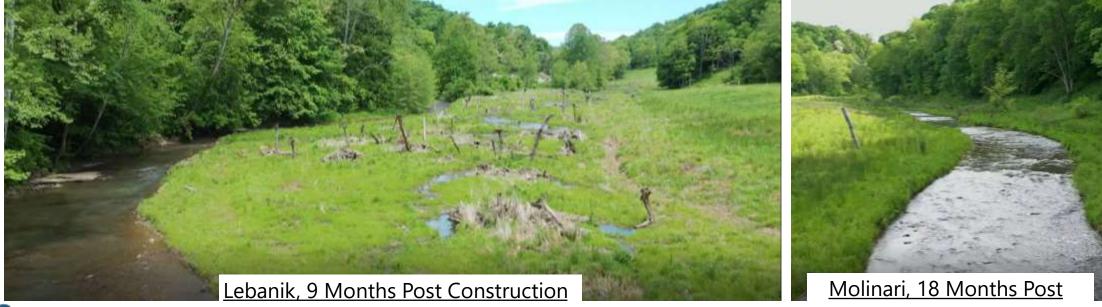
- 1. "How can the stability be assured without reliance on the Natural Channel Design techniques and detailed bank stabilization and grade control structures?"
 - Response: Hydrologic/hydraulic design for sustainable vegetative stabilization, designing for 100-yr storm event
 - Validation: BEHI, pebble counts, pit trap data, profile and cross-section surveys, estimates
 of sediment and carbon deposits

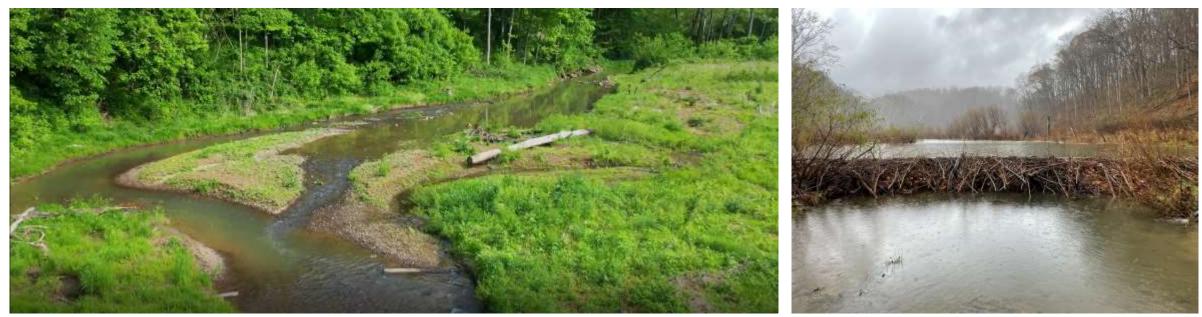
Molinari, Coarse Sediment in Transition Pool

- 2. "If the post-restoration system retains sediment, how can it maintain its geometry given deposition?"
 - Response: Low volume of coarse sediment, suspended sediment accumulation in floodplain
 - Validation: Monitoring surveys, visual observations

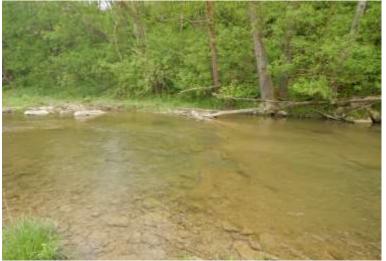
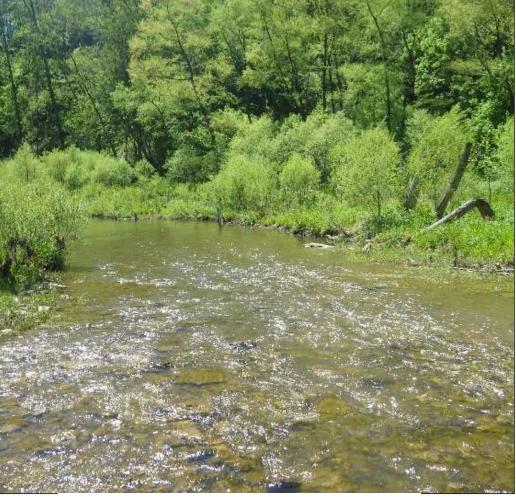
Molinari, Post Restoration Substrate and Bed Facets

- "Will biodiversity be limited if the design does not layout bed facets?"
 - Response: Hydrologic/hydraulic design for very low bedload transport, bedform diversity by design but with little specificity in drawings, LWD
 - Validation: long-pro surveys, LWD data, macroinvertebrate and fish sampling results

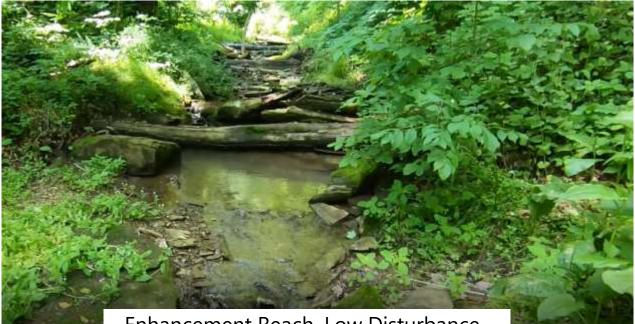
Enhancement Reach, Low Disturbance

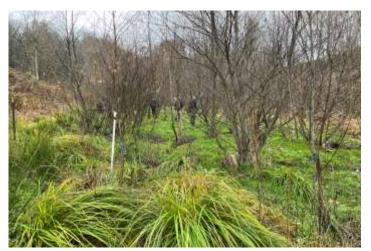
UNT 4D, 6 Years Post Construction

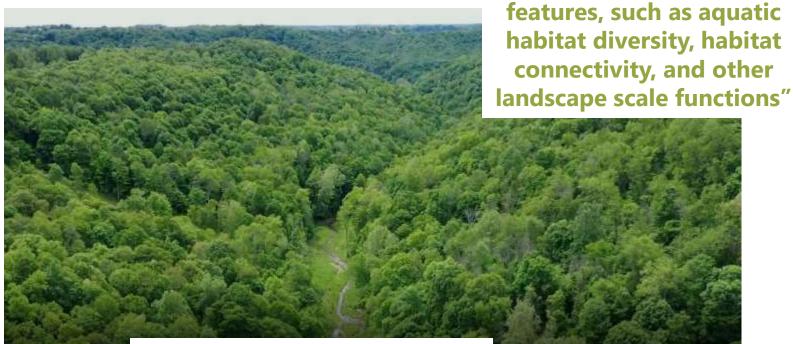
UNT 4, Surrounding Landscape
