# Benefits of Using Wood Structures for Restoring Streams and Reconnecting Floodplains

# Background: Bacon Ridge Branch (Elks Camp Barrett)

# Stream Restoration Project

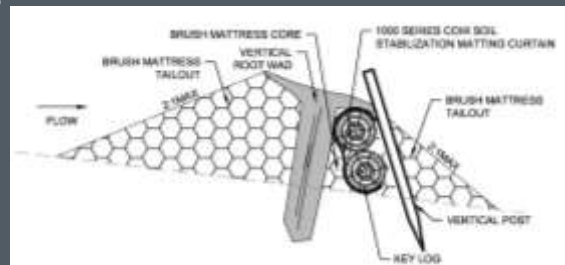
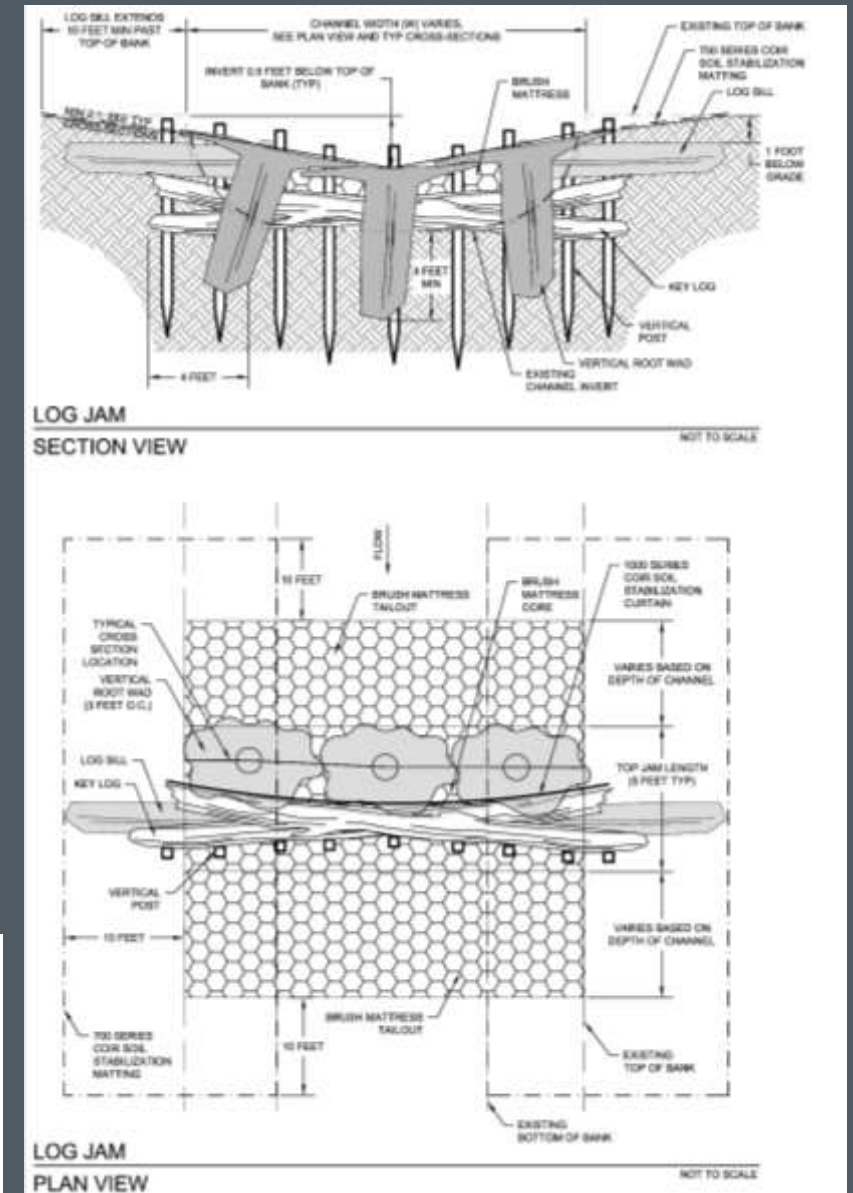
## Elevating Stream Water Surface using Engineered Wood Structures

Use engineered wood structures and soil plugs to raise the stream water surface

# of trees and soil volume depends on channel width/depth

Trunks = bank tie in and structure as well as log sills

No wasted material, contributes to floodplain roughness, habitat enhancements (turtles, skinks, snakes...)

Try not to damage rootwad during installation!

Treetops & limbs build wood and earth 'plug' matrix—just like a beaver (except we don't work 24/7/365)!

Detail has evolved since this project

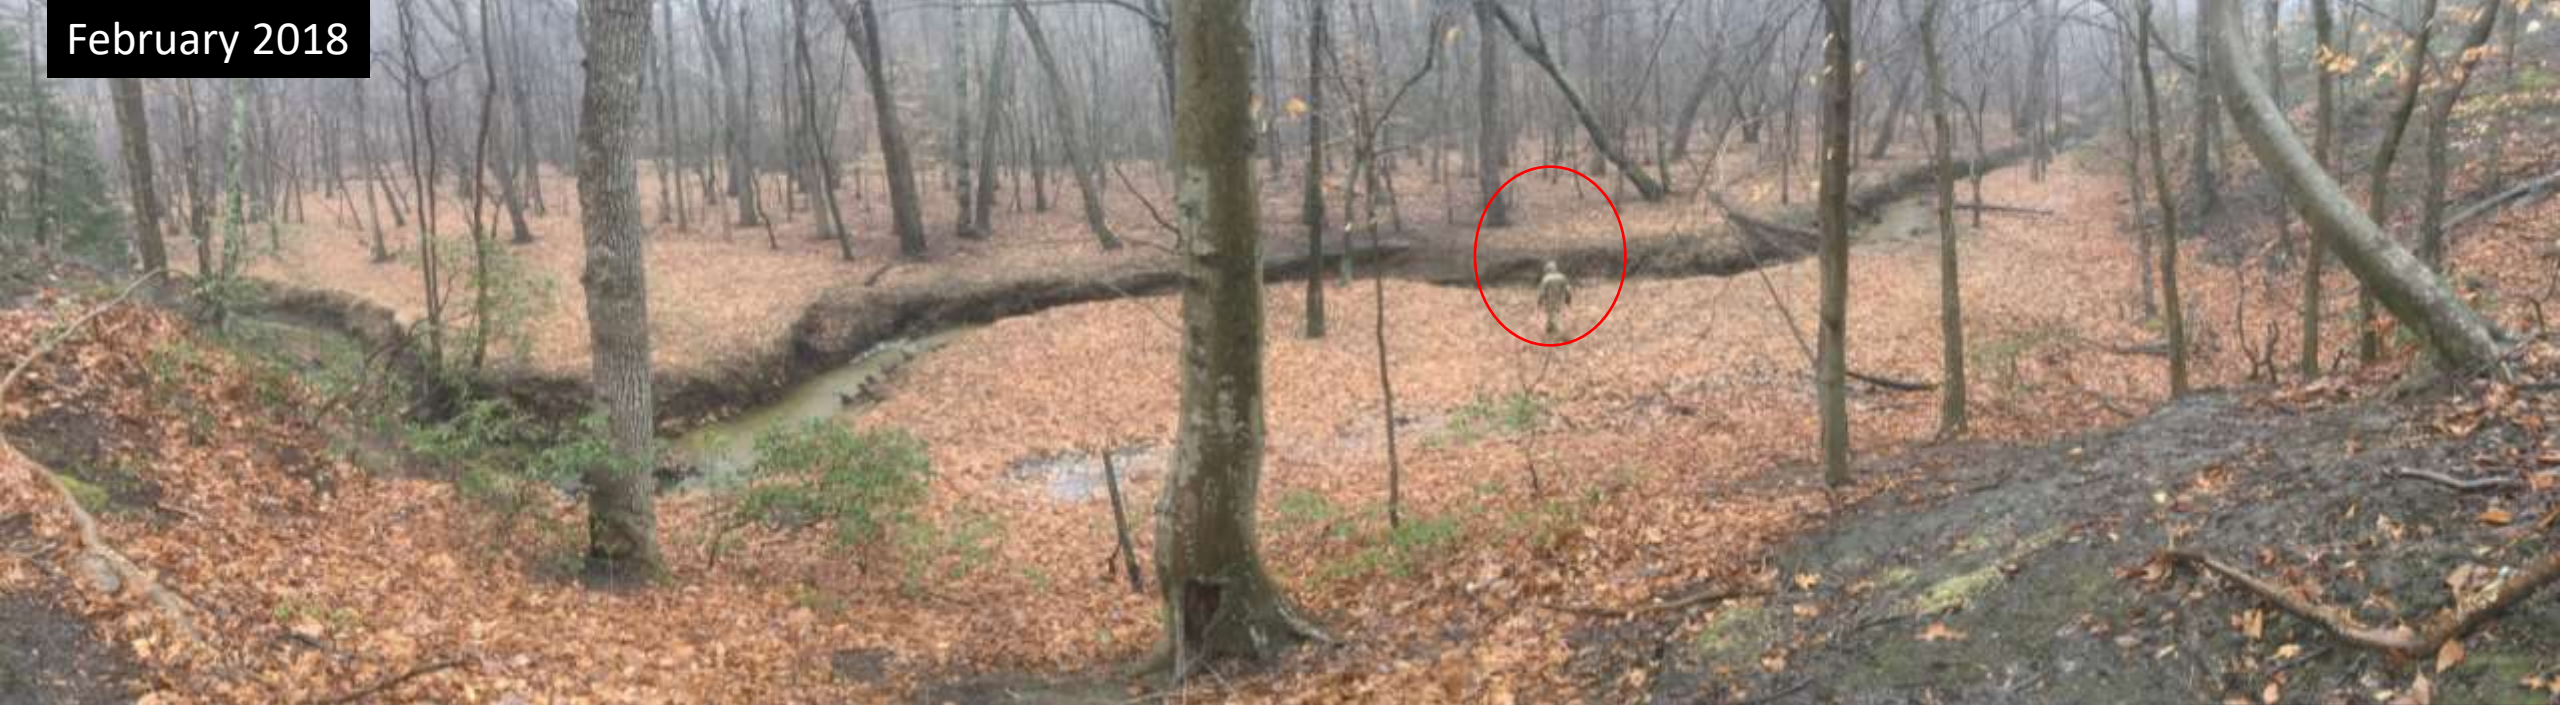
February 2018

# Pre/Post Construction Comparison

Peak attenuation + Increased time of concentration + Groundwater restoration + Enhanced wetland hydrology + Increased area and volume of aquatic resource = **Functional Uplift**

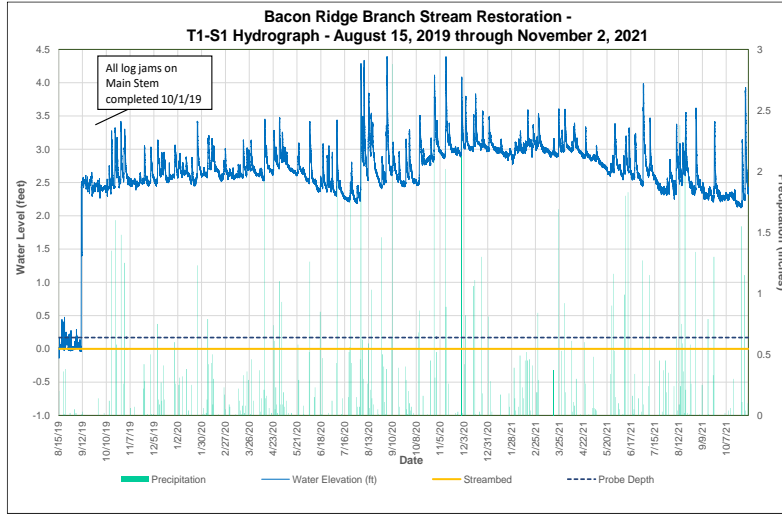
# Elks Camp Barrett Hydrographs: Transect 1

Mainstem Channel

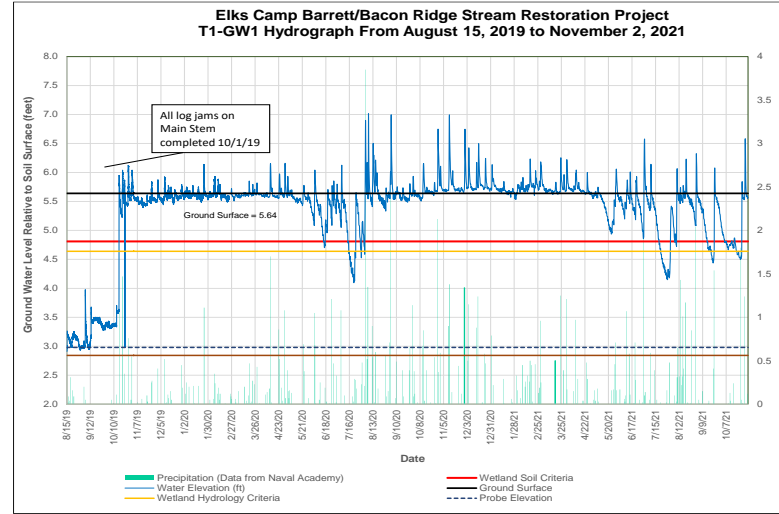
GW1: 50' from Stream

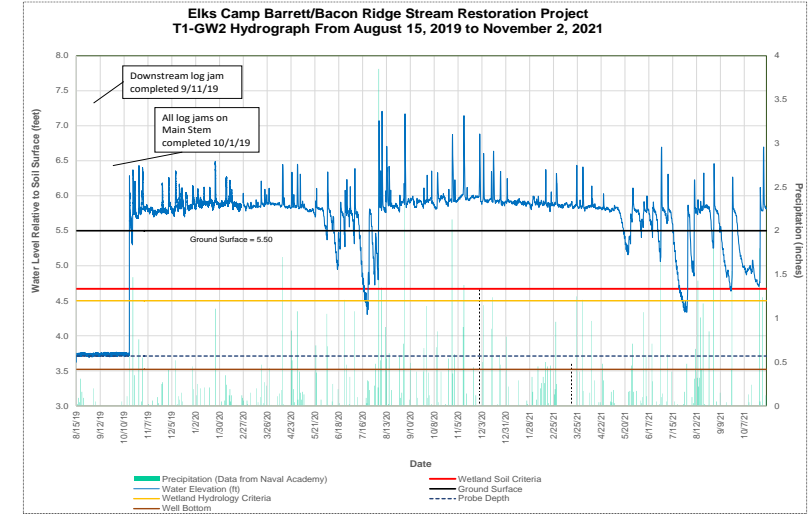
GW2: 100' from Stream

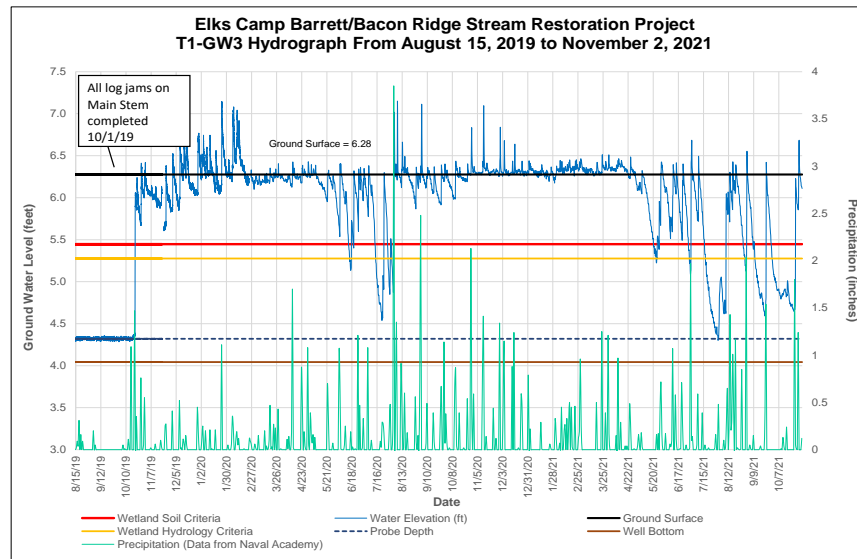
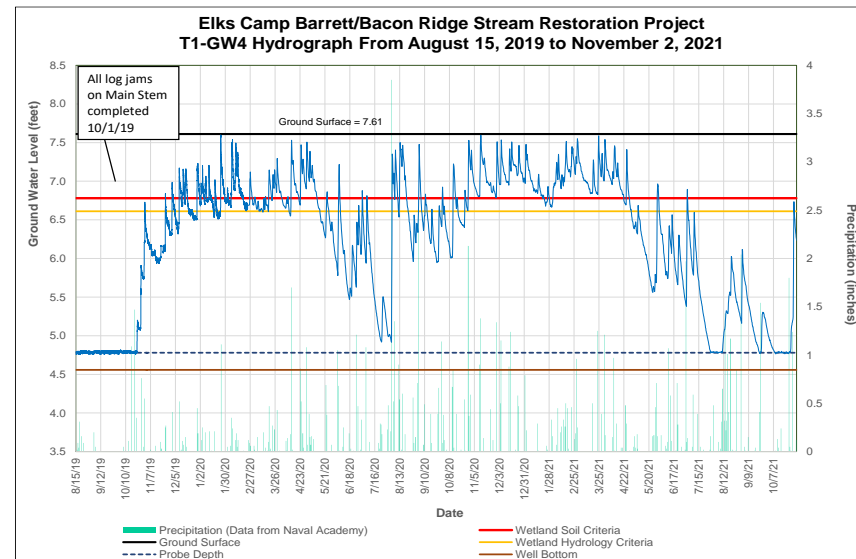
GW3: 200' from Stream

GW4: 300' from Stream

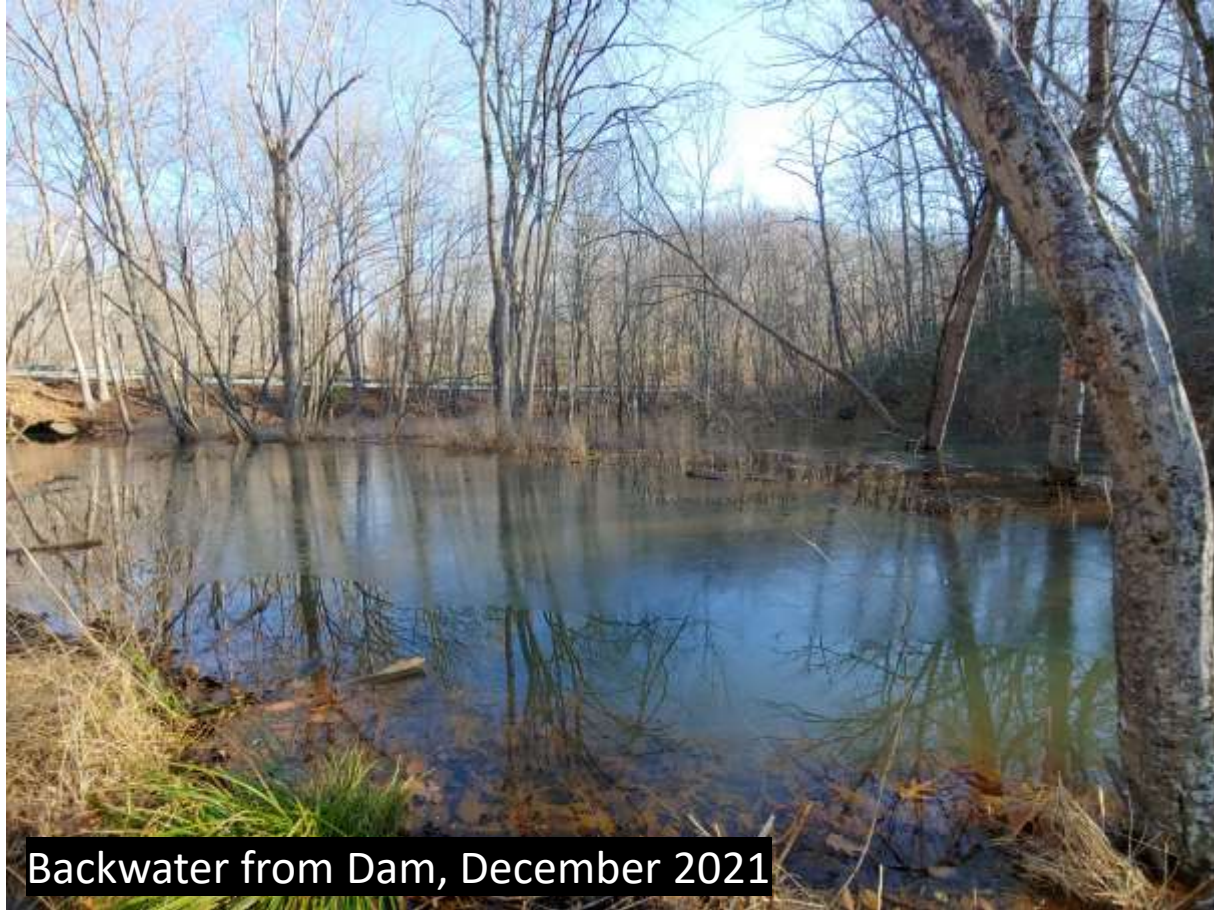
Backwater from Dam, December 2021

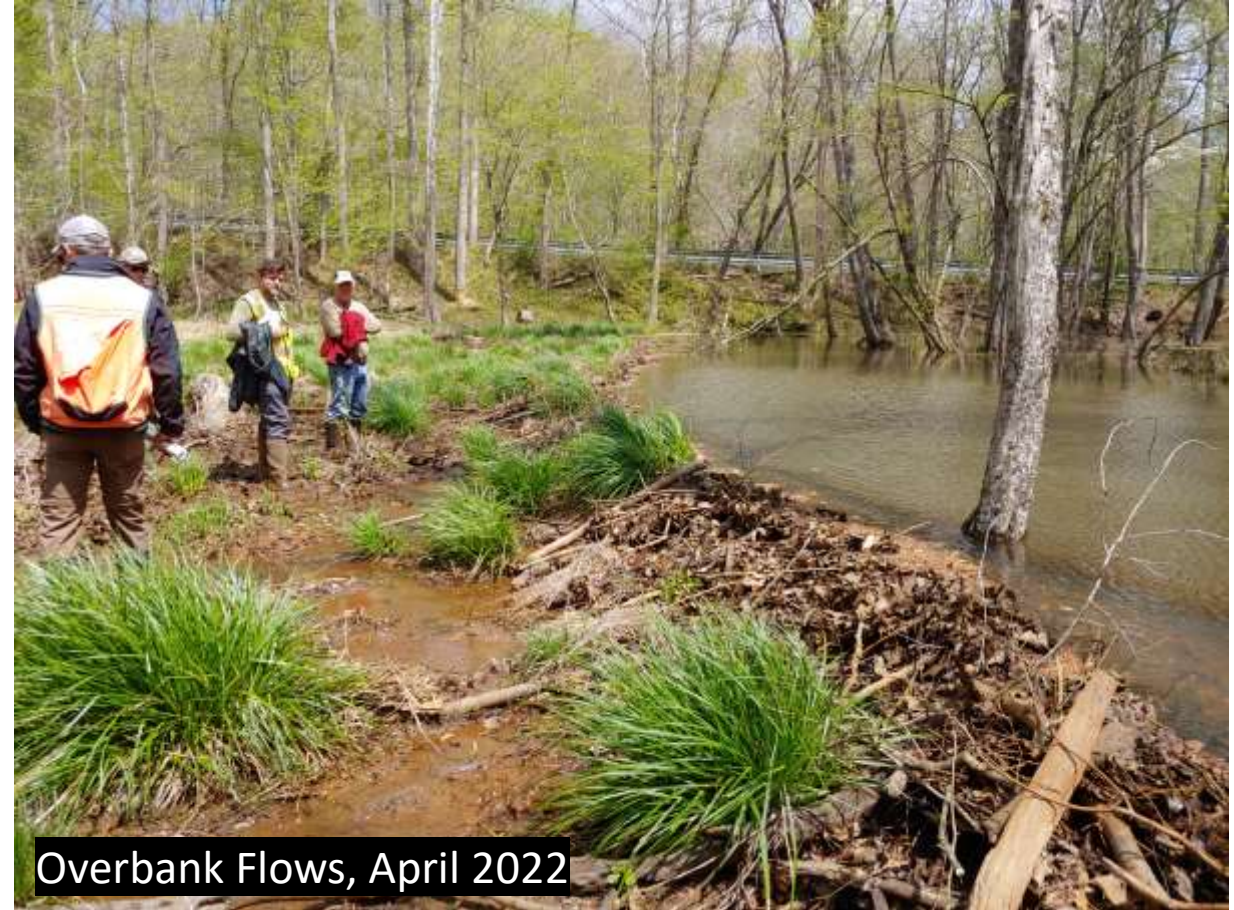
Overbank Flows, April 2022

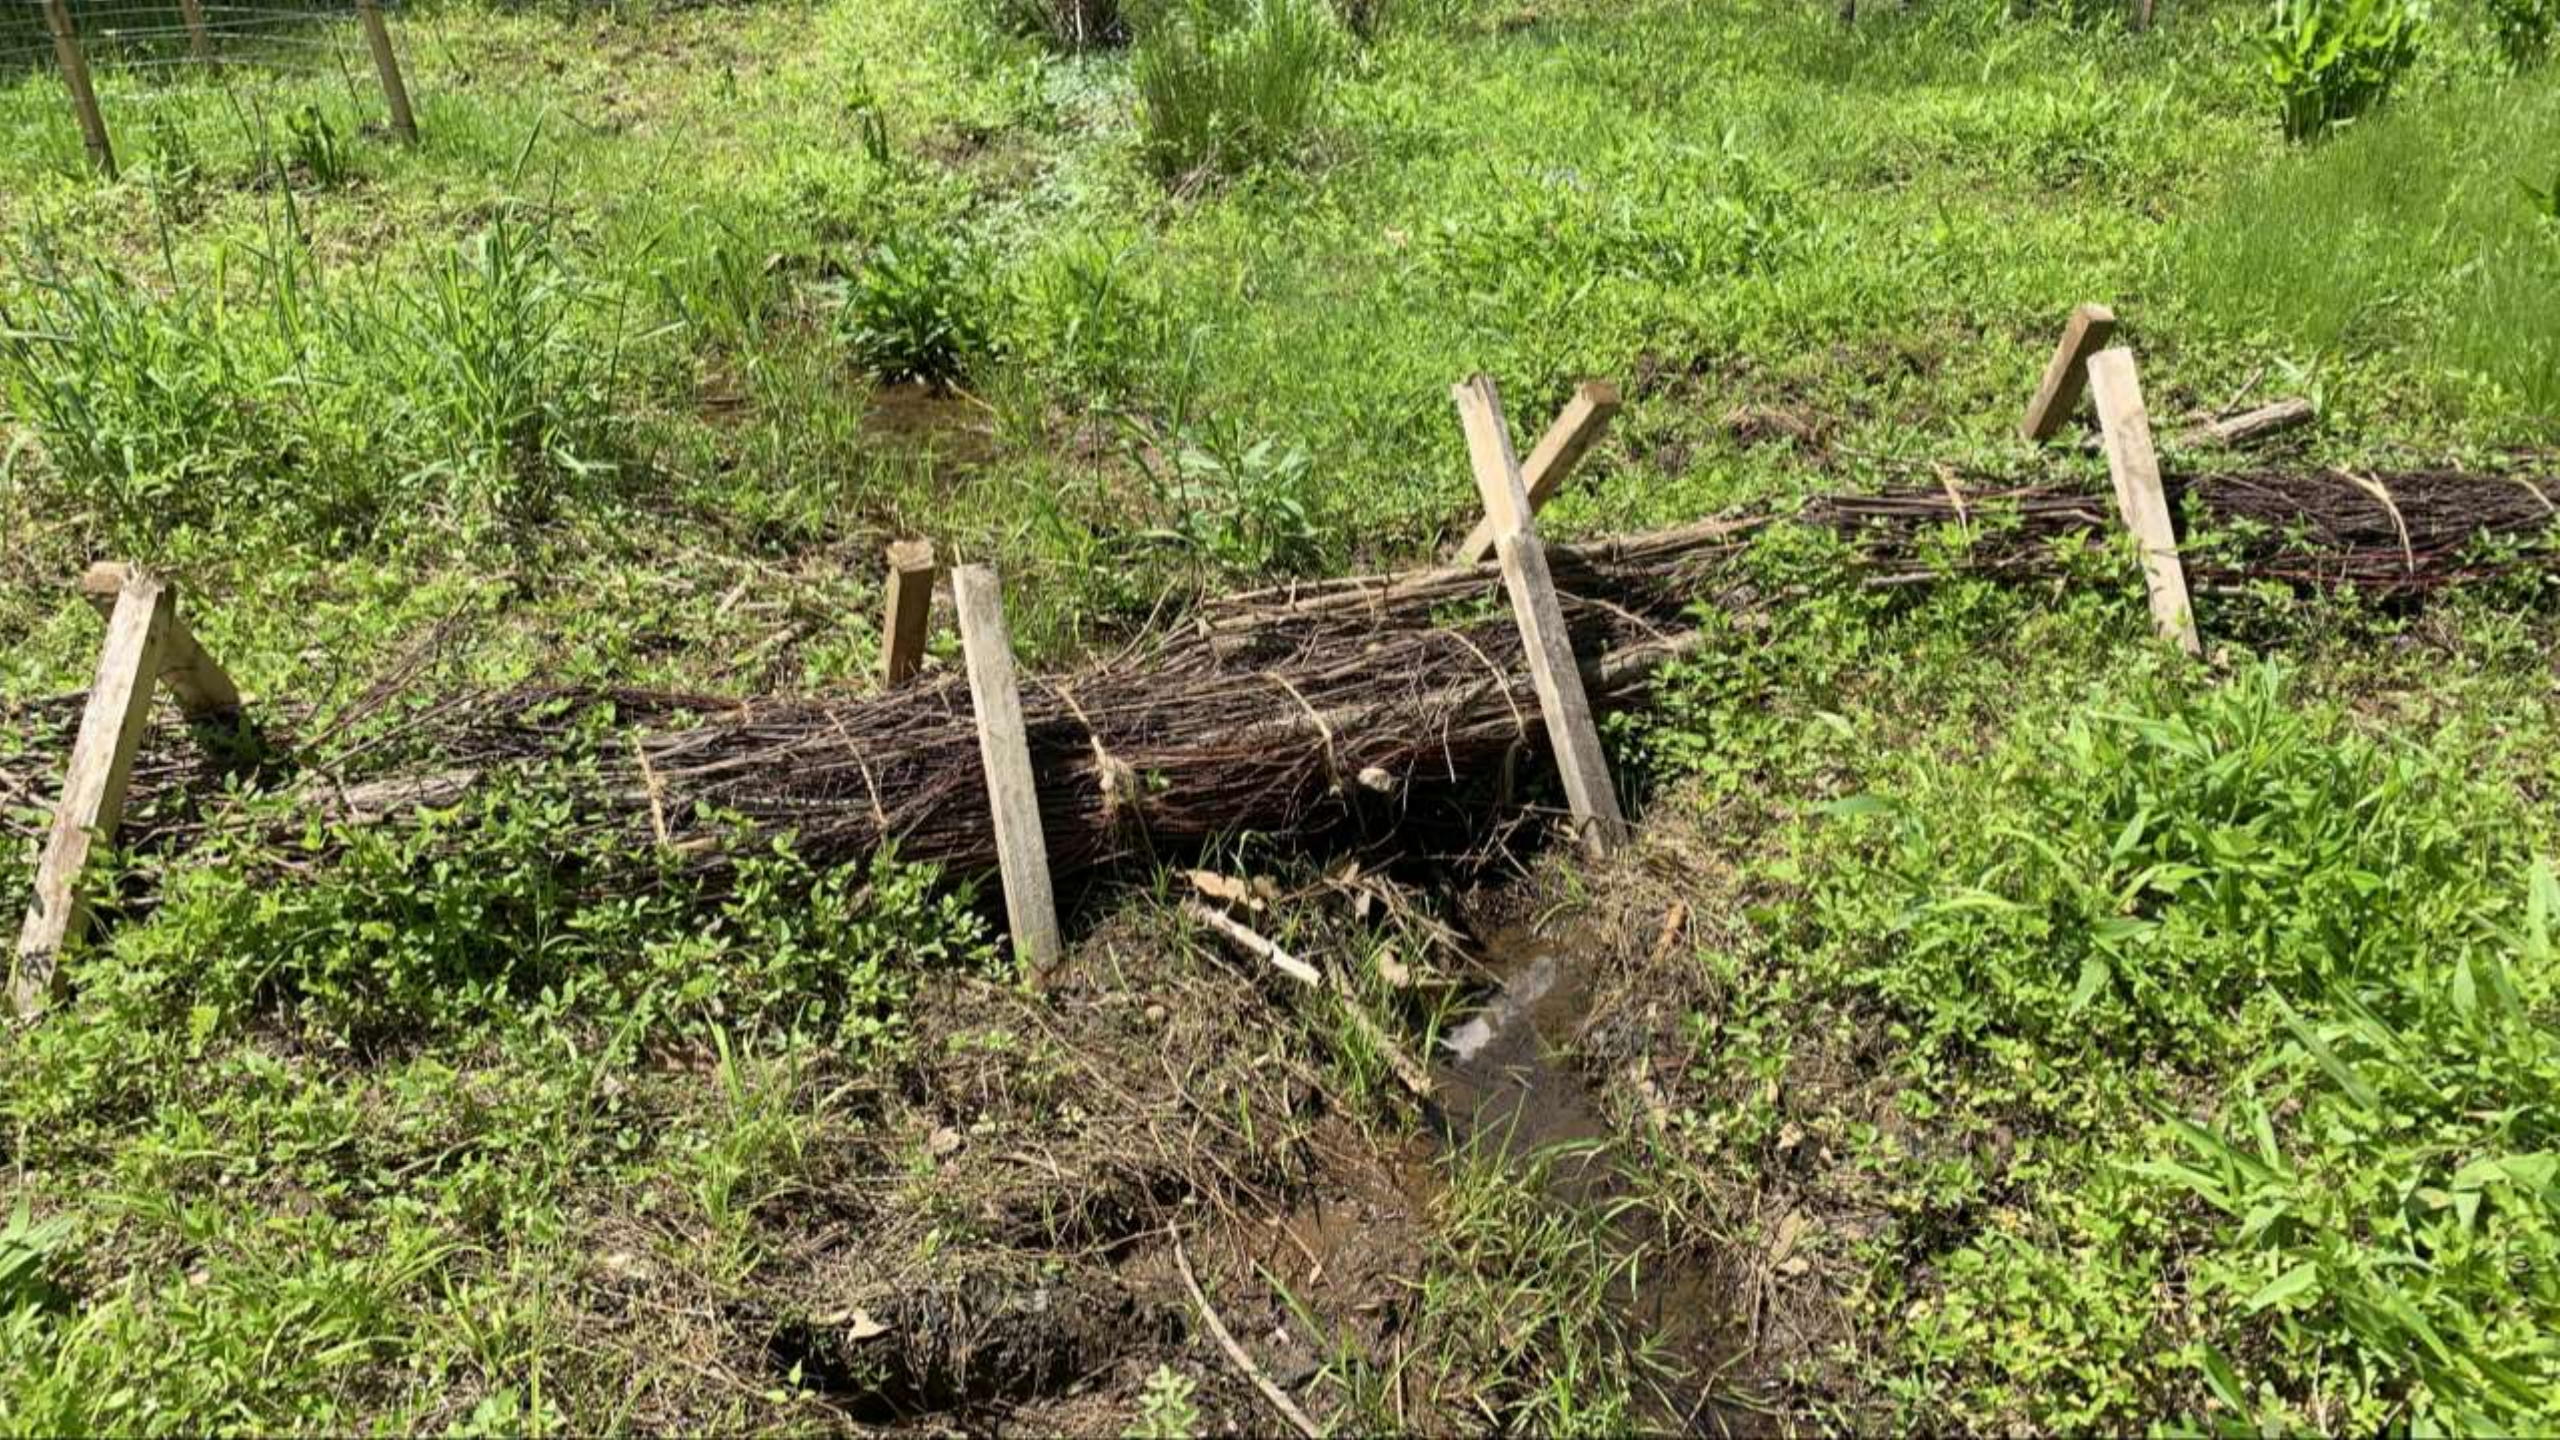
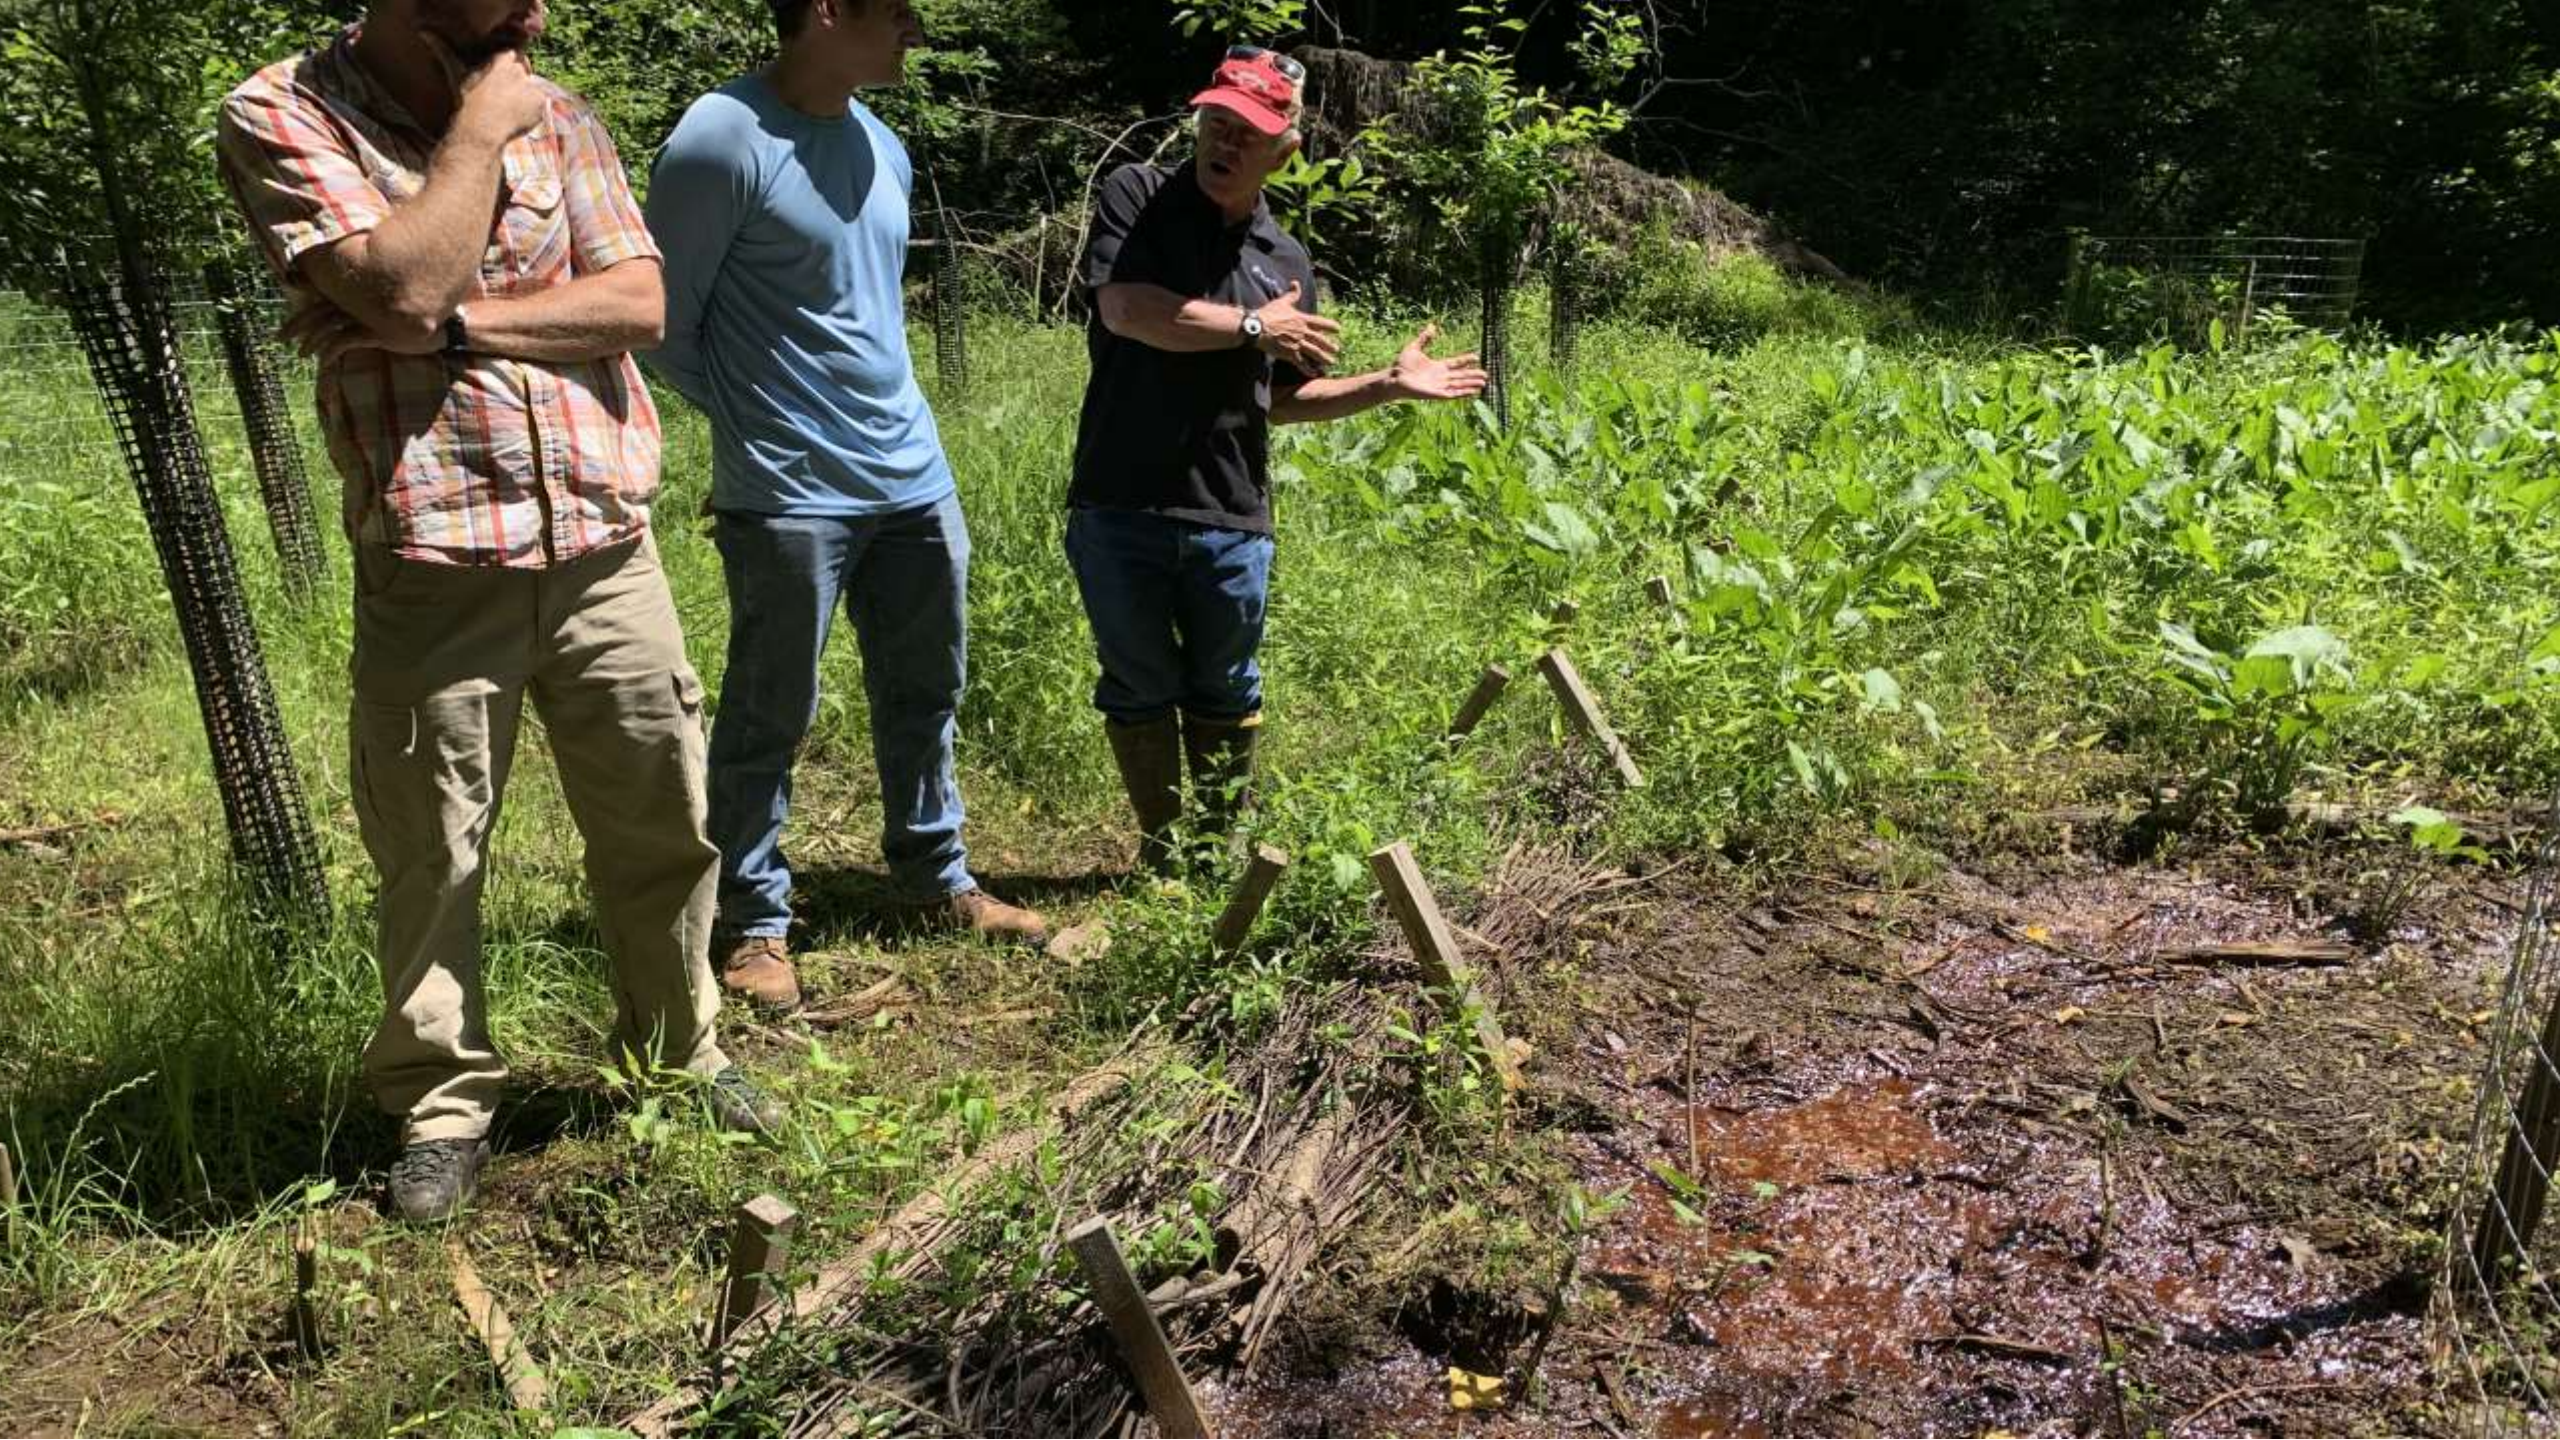
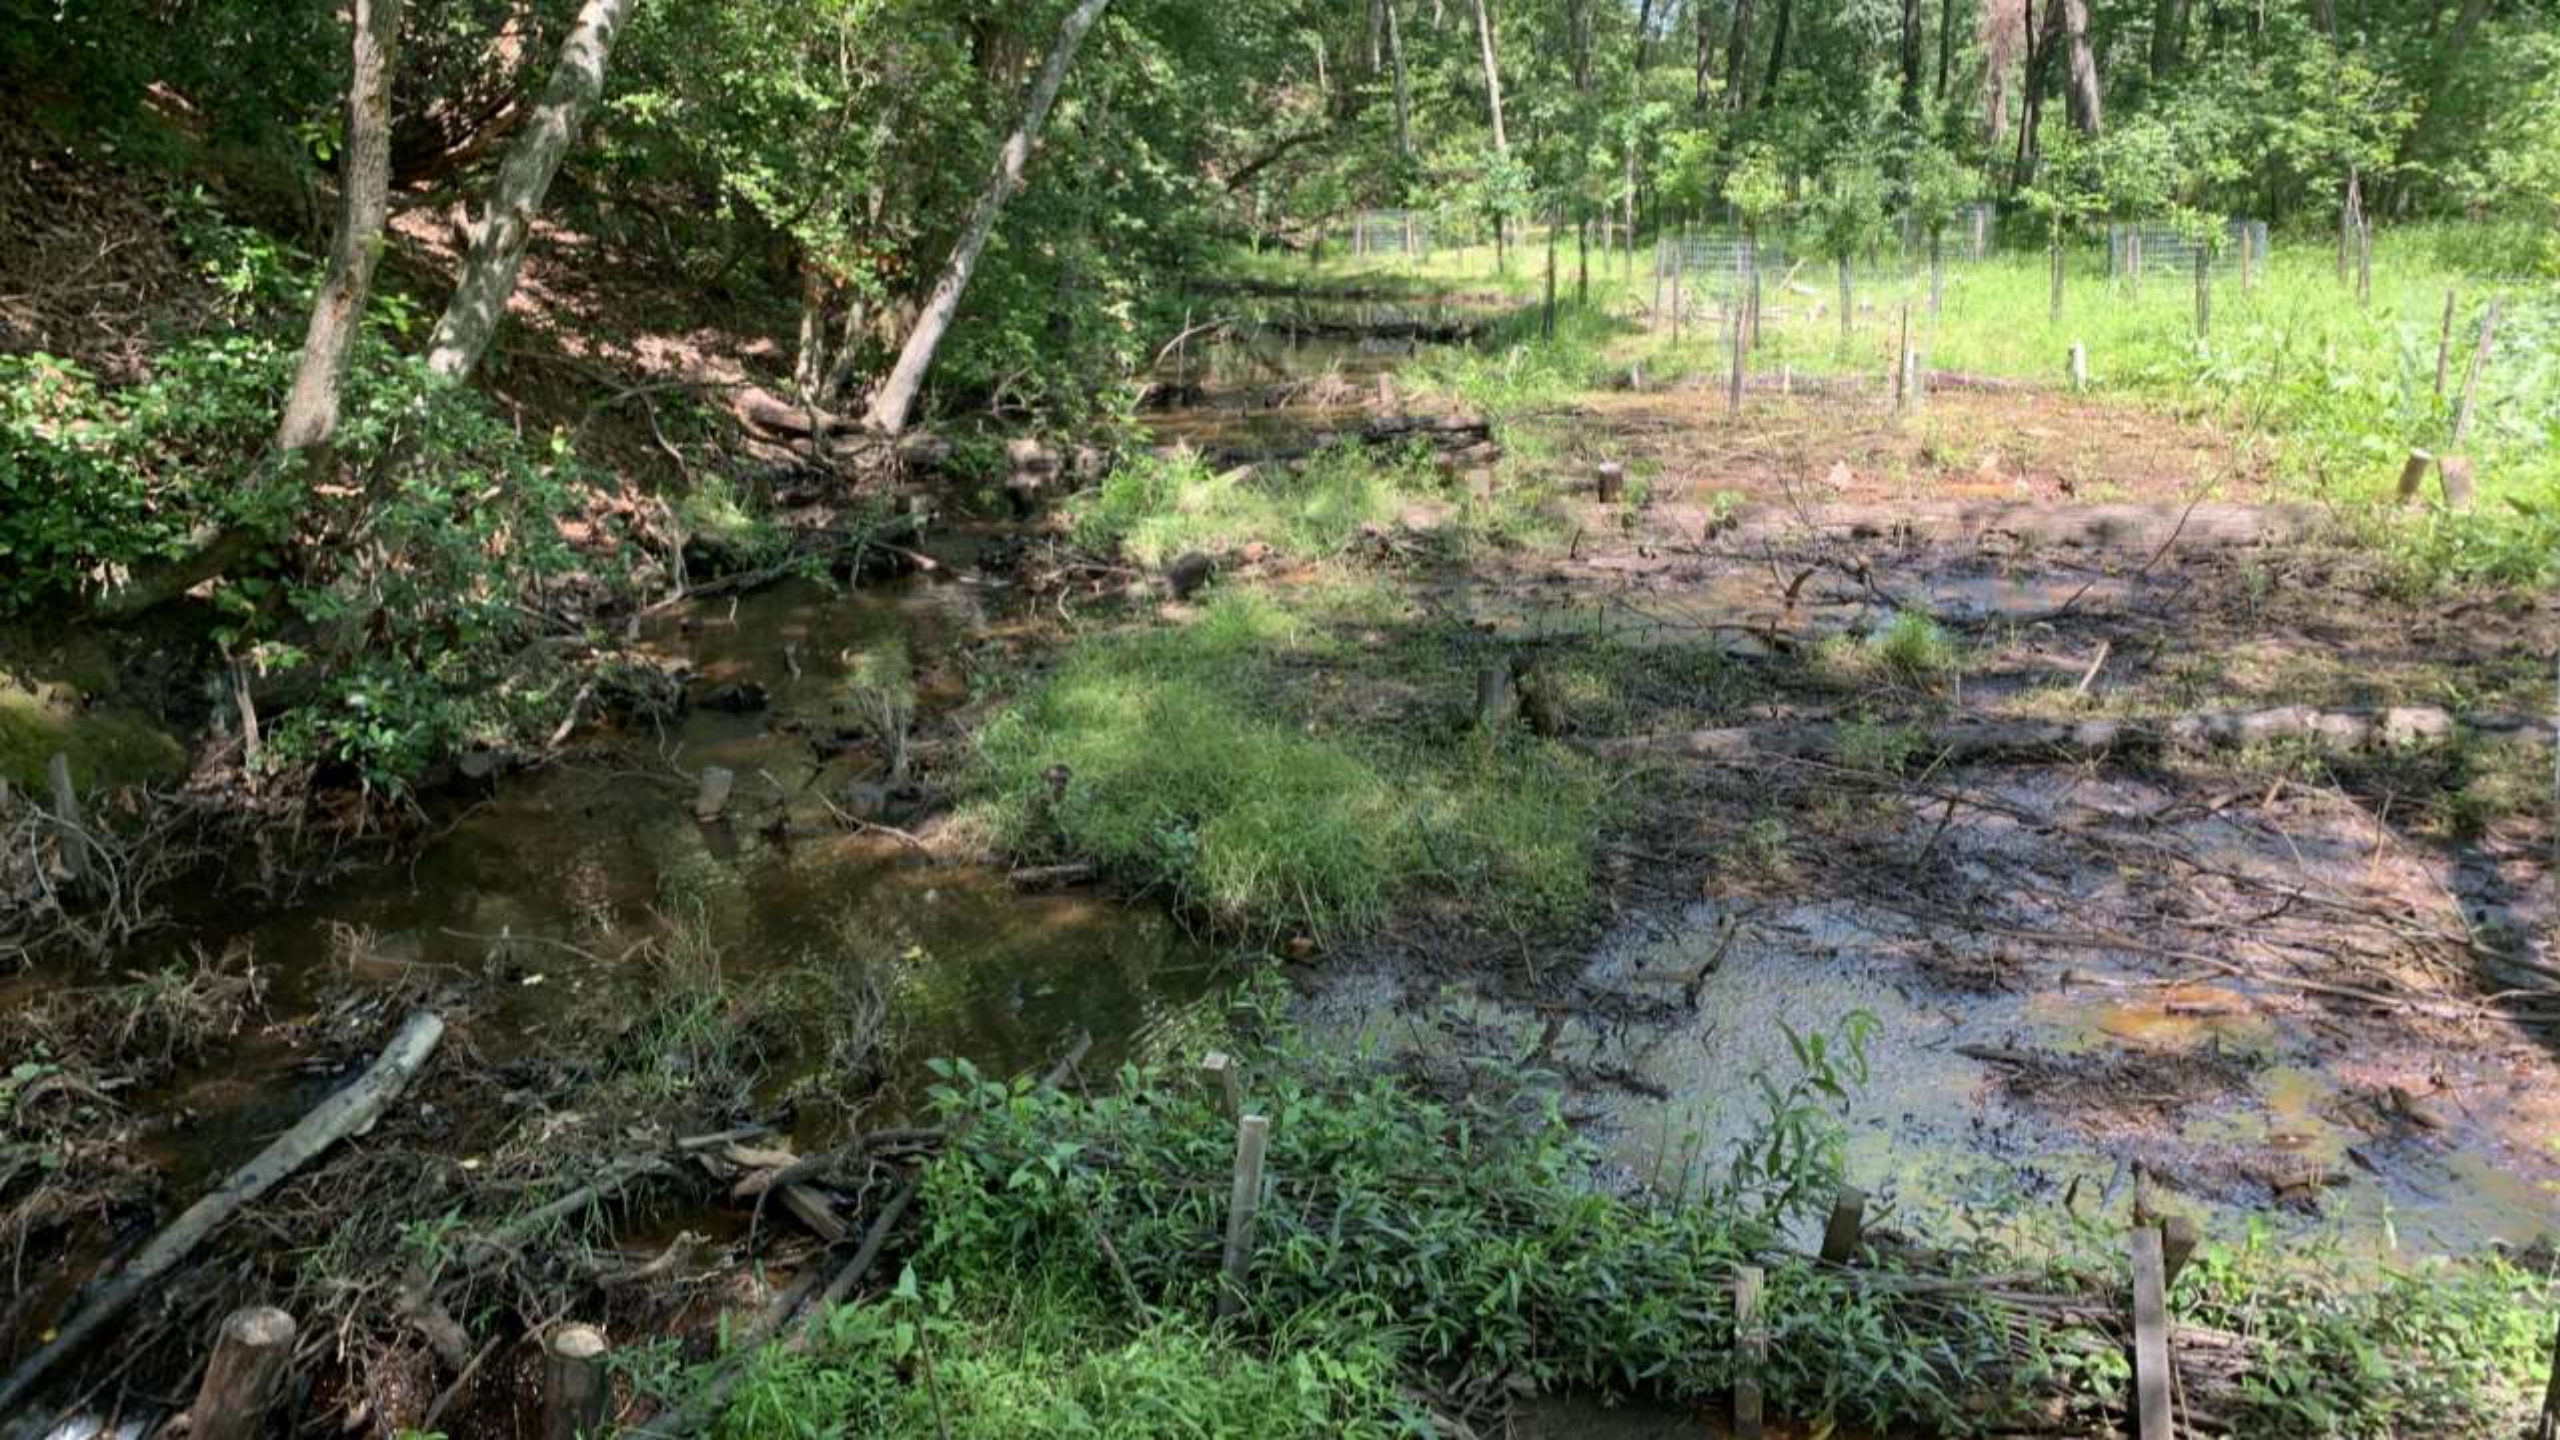
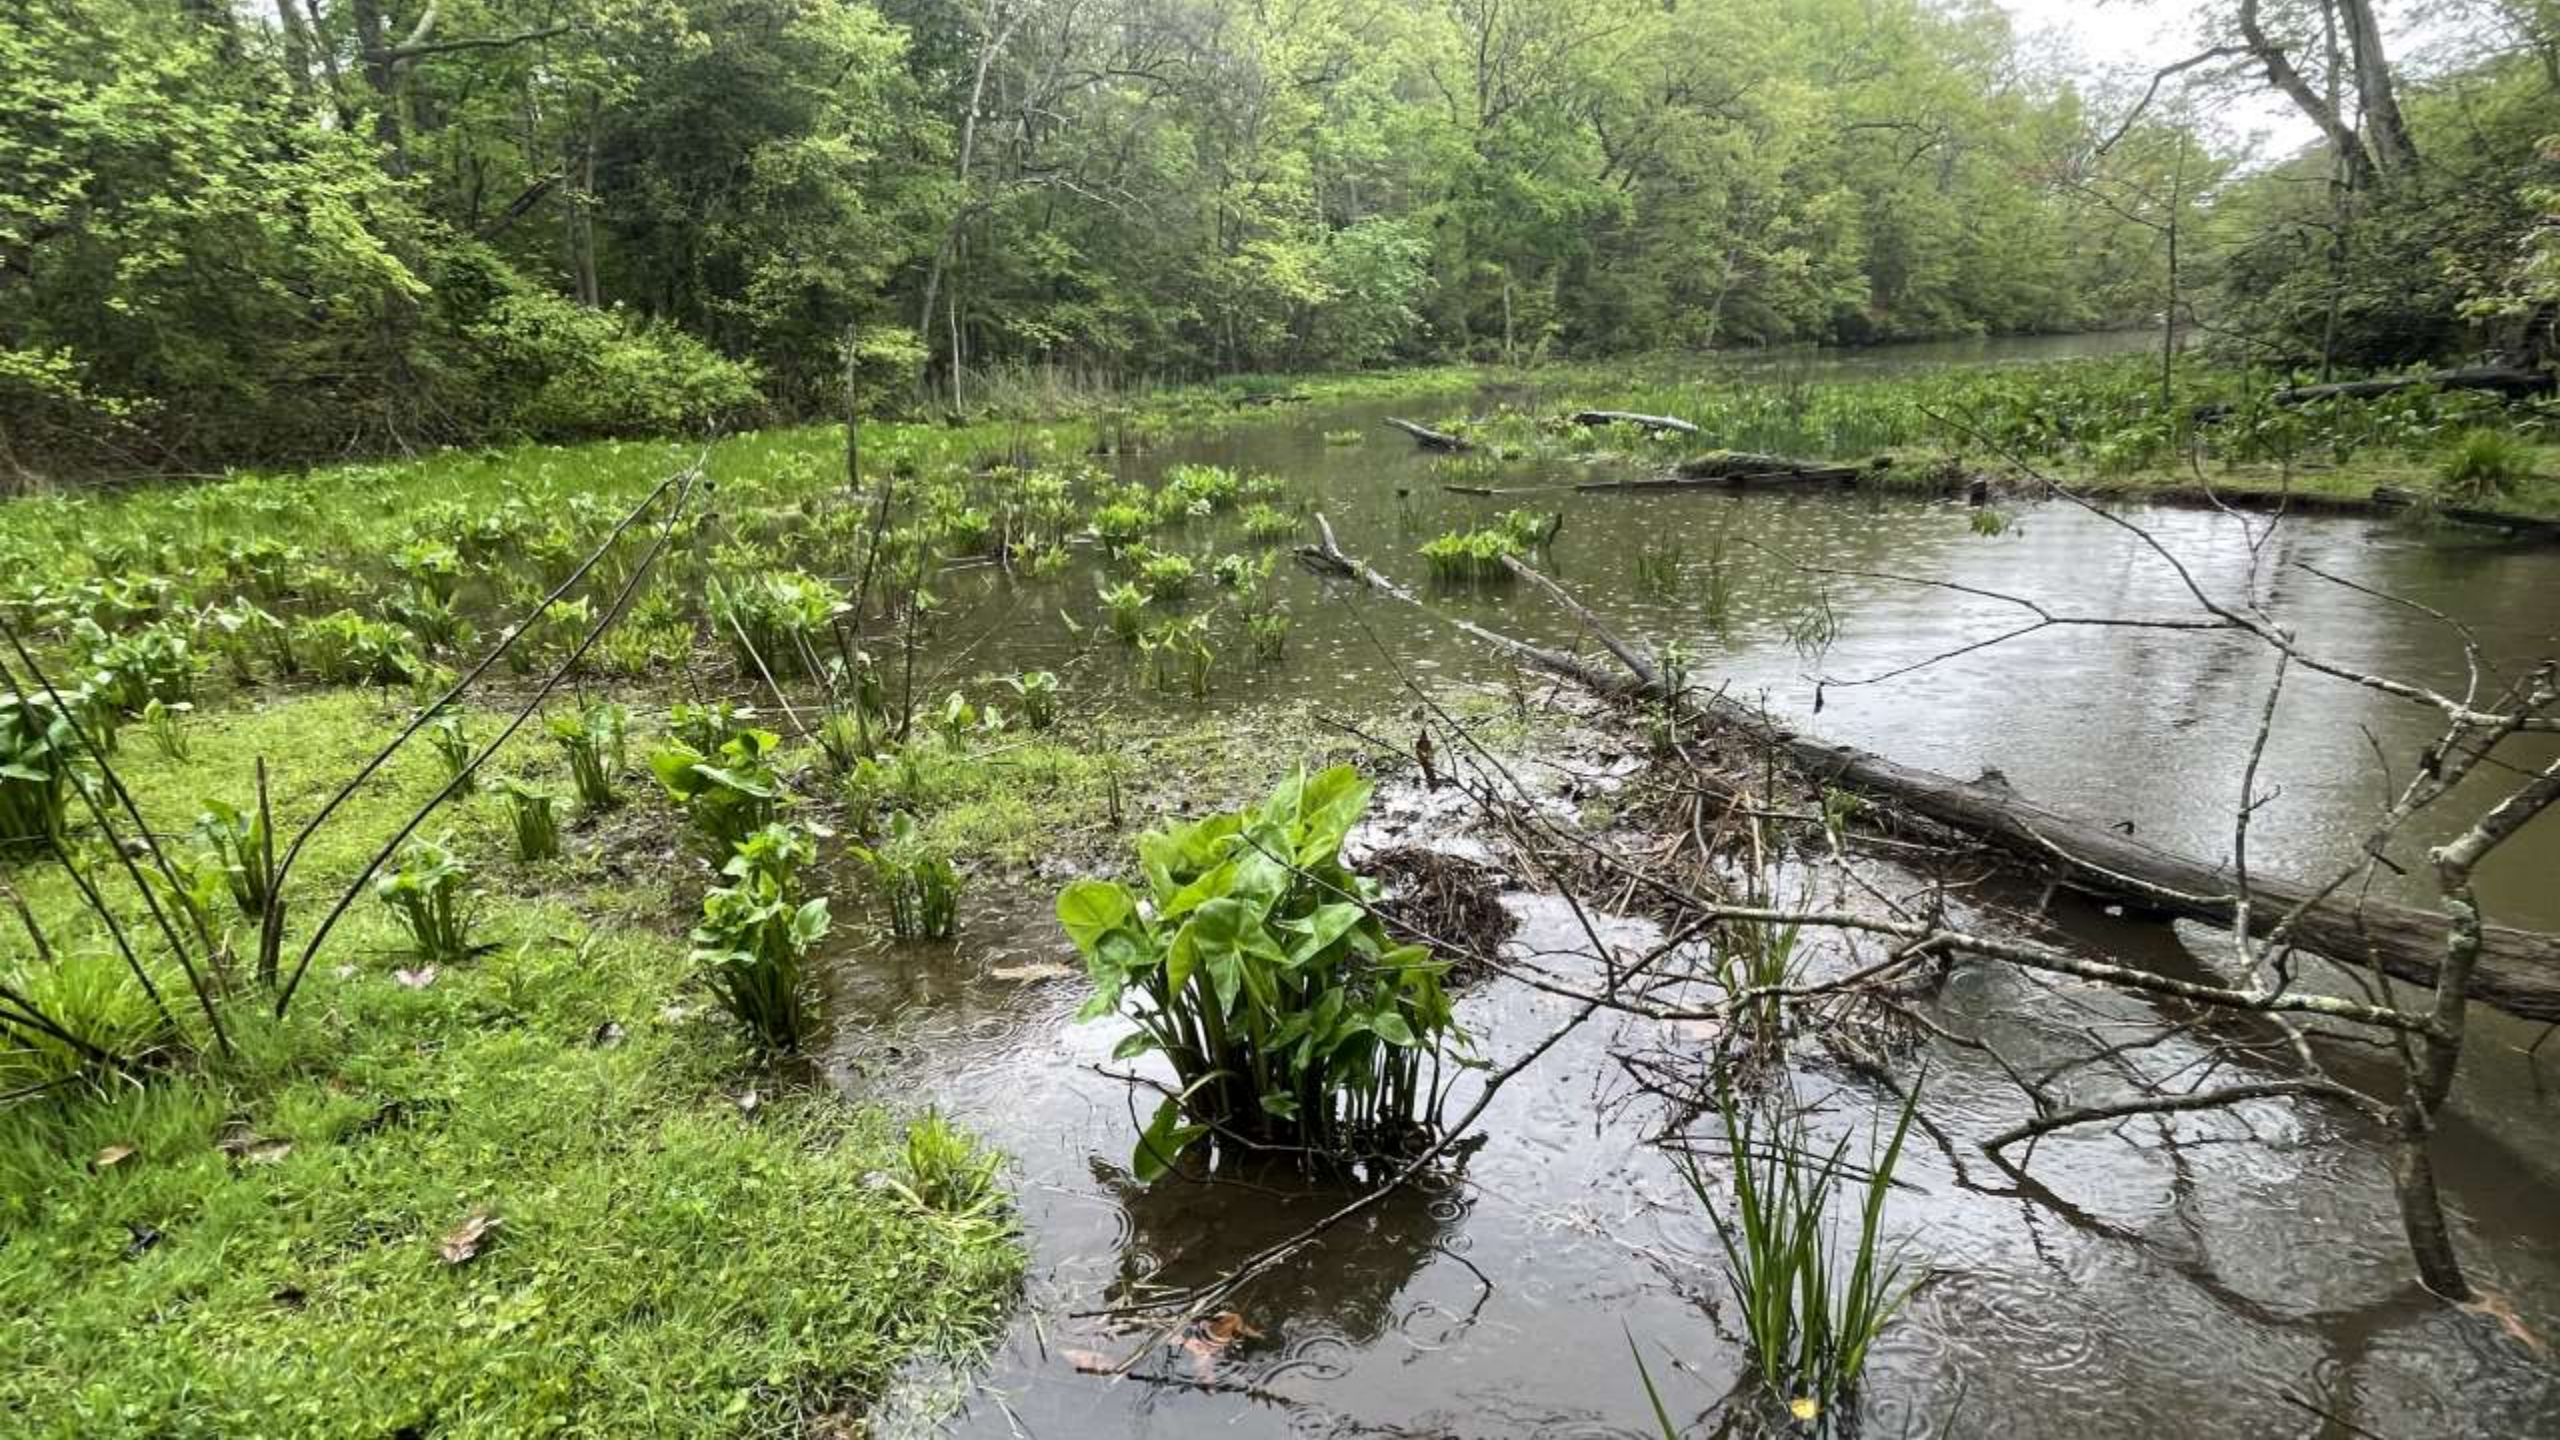
# Transitioning to Tidal Waters

## Low Tech Solution

Using Live Willow Wattles to  
Compliment Engineered Wood Structures
