# Reedy Creek Stream Restoration: A Watershed Scale Design-Build Project in Charlotte, NC

by: Christine Blackwelder and William Harris

# Overview

of the Reedy Creek Project

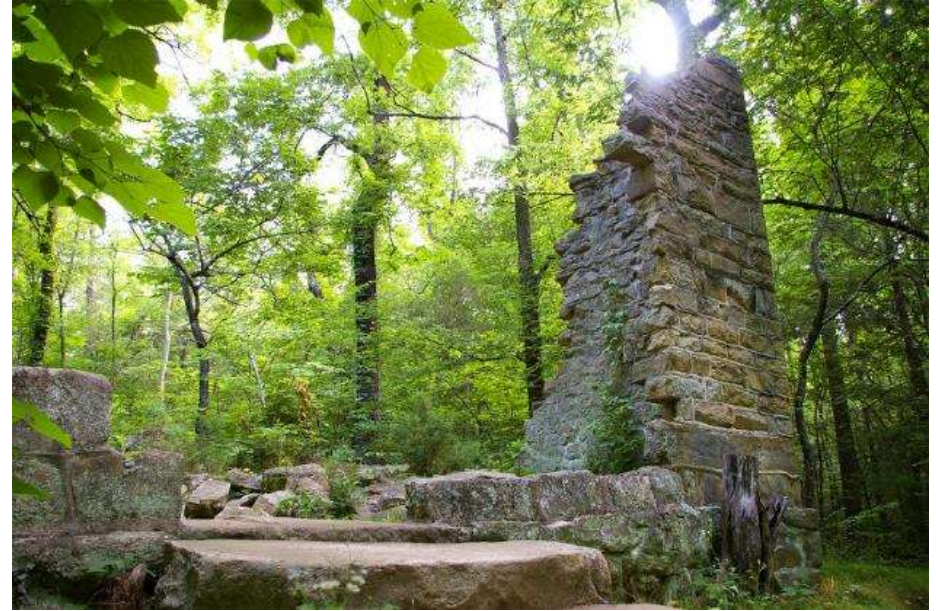
# Past Land Use

- **Historical Robinson Rock House ruins, built sometime in early 1800's**
- **1850's, Rock House known as part of a large plantation**
  - Farmed cotton, also some livestock and crops
  - Channels straightening/ dredging likely
- **1979: acquired by the City of Charlotte to be incorporated into a new park and nature preserve**

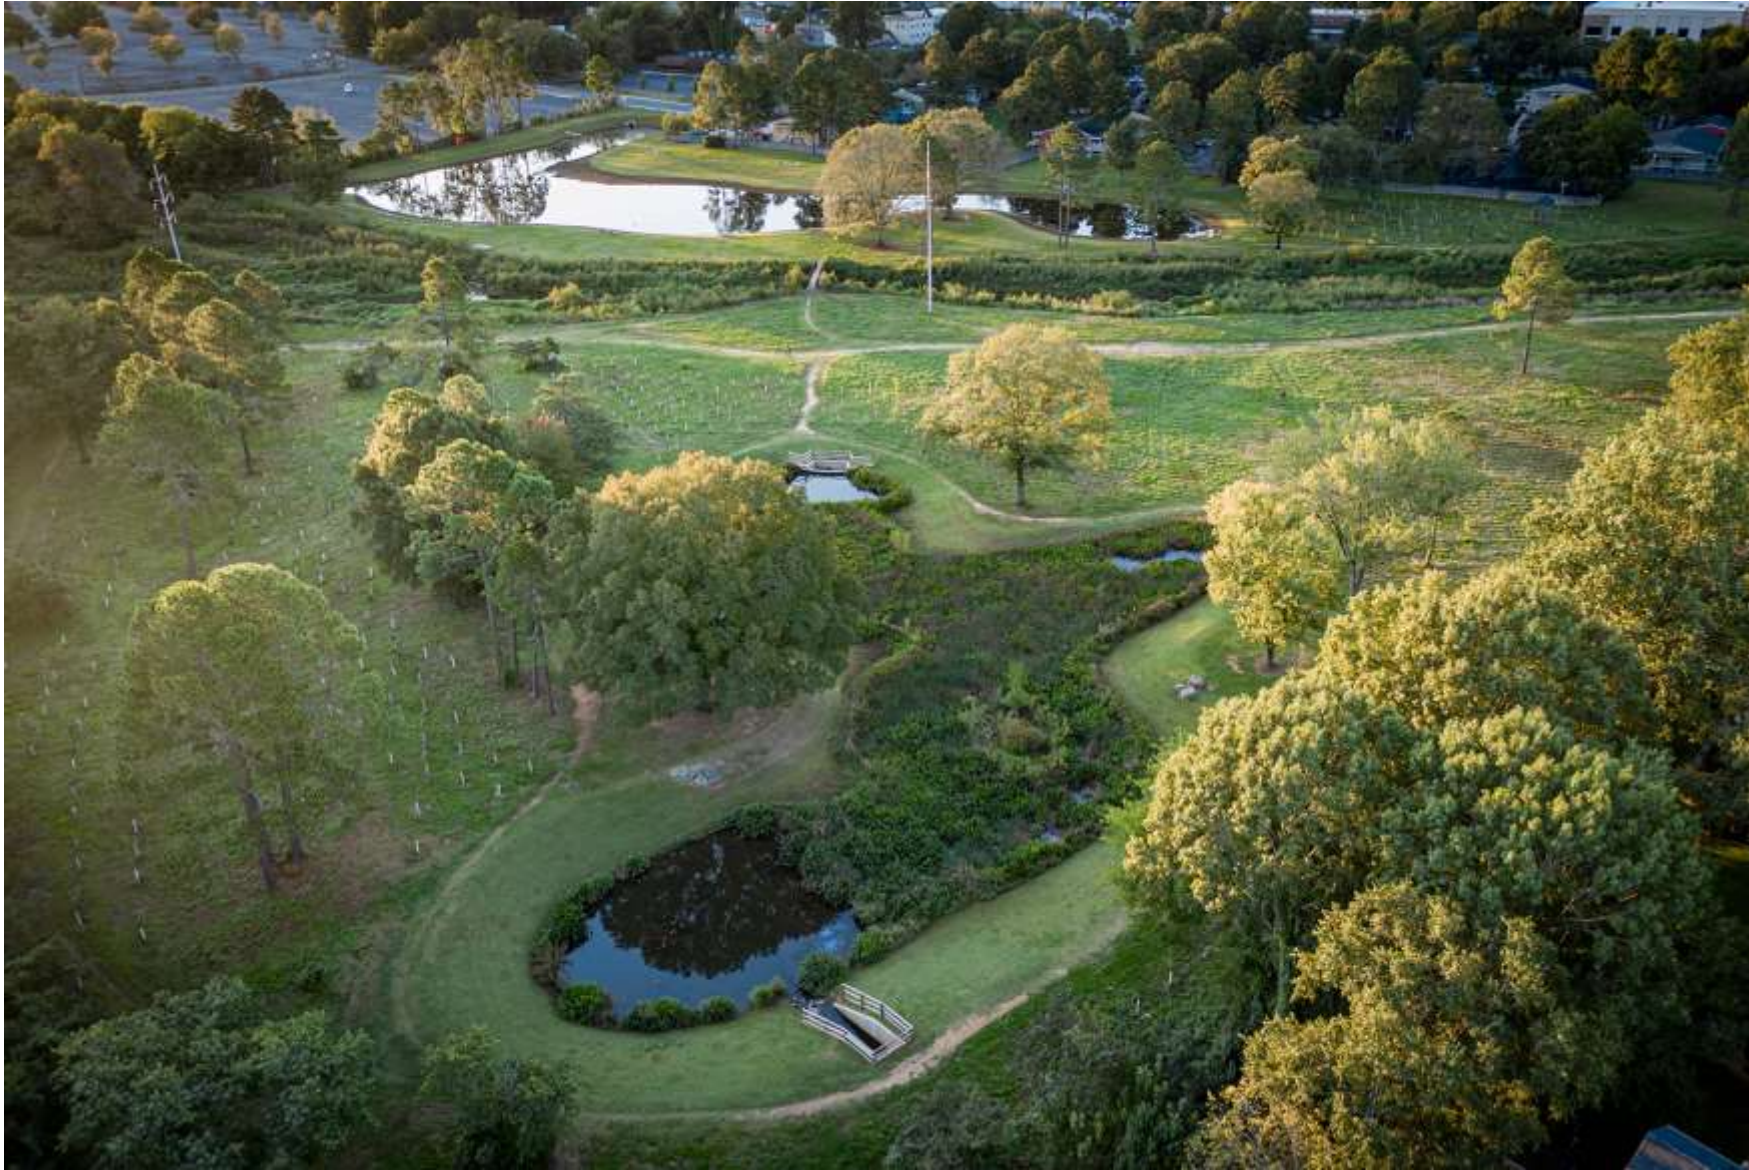
# Design Phase

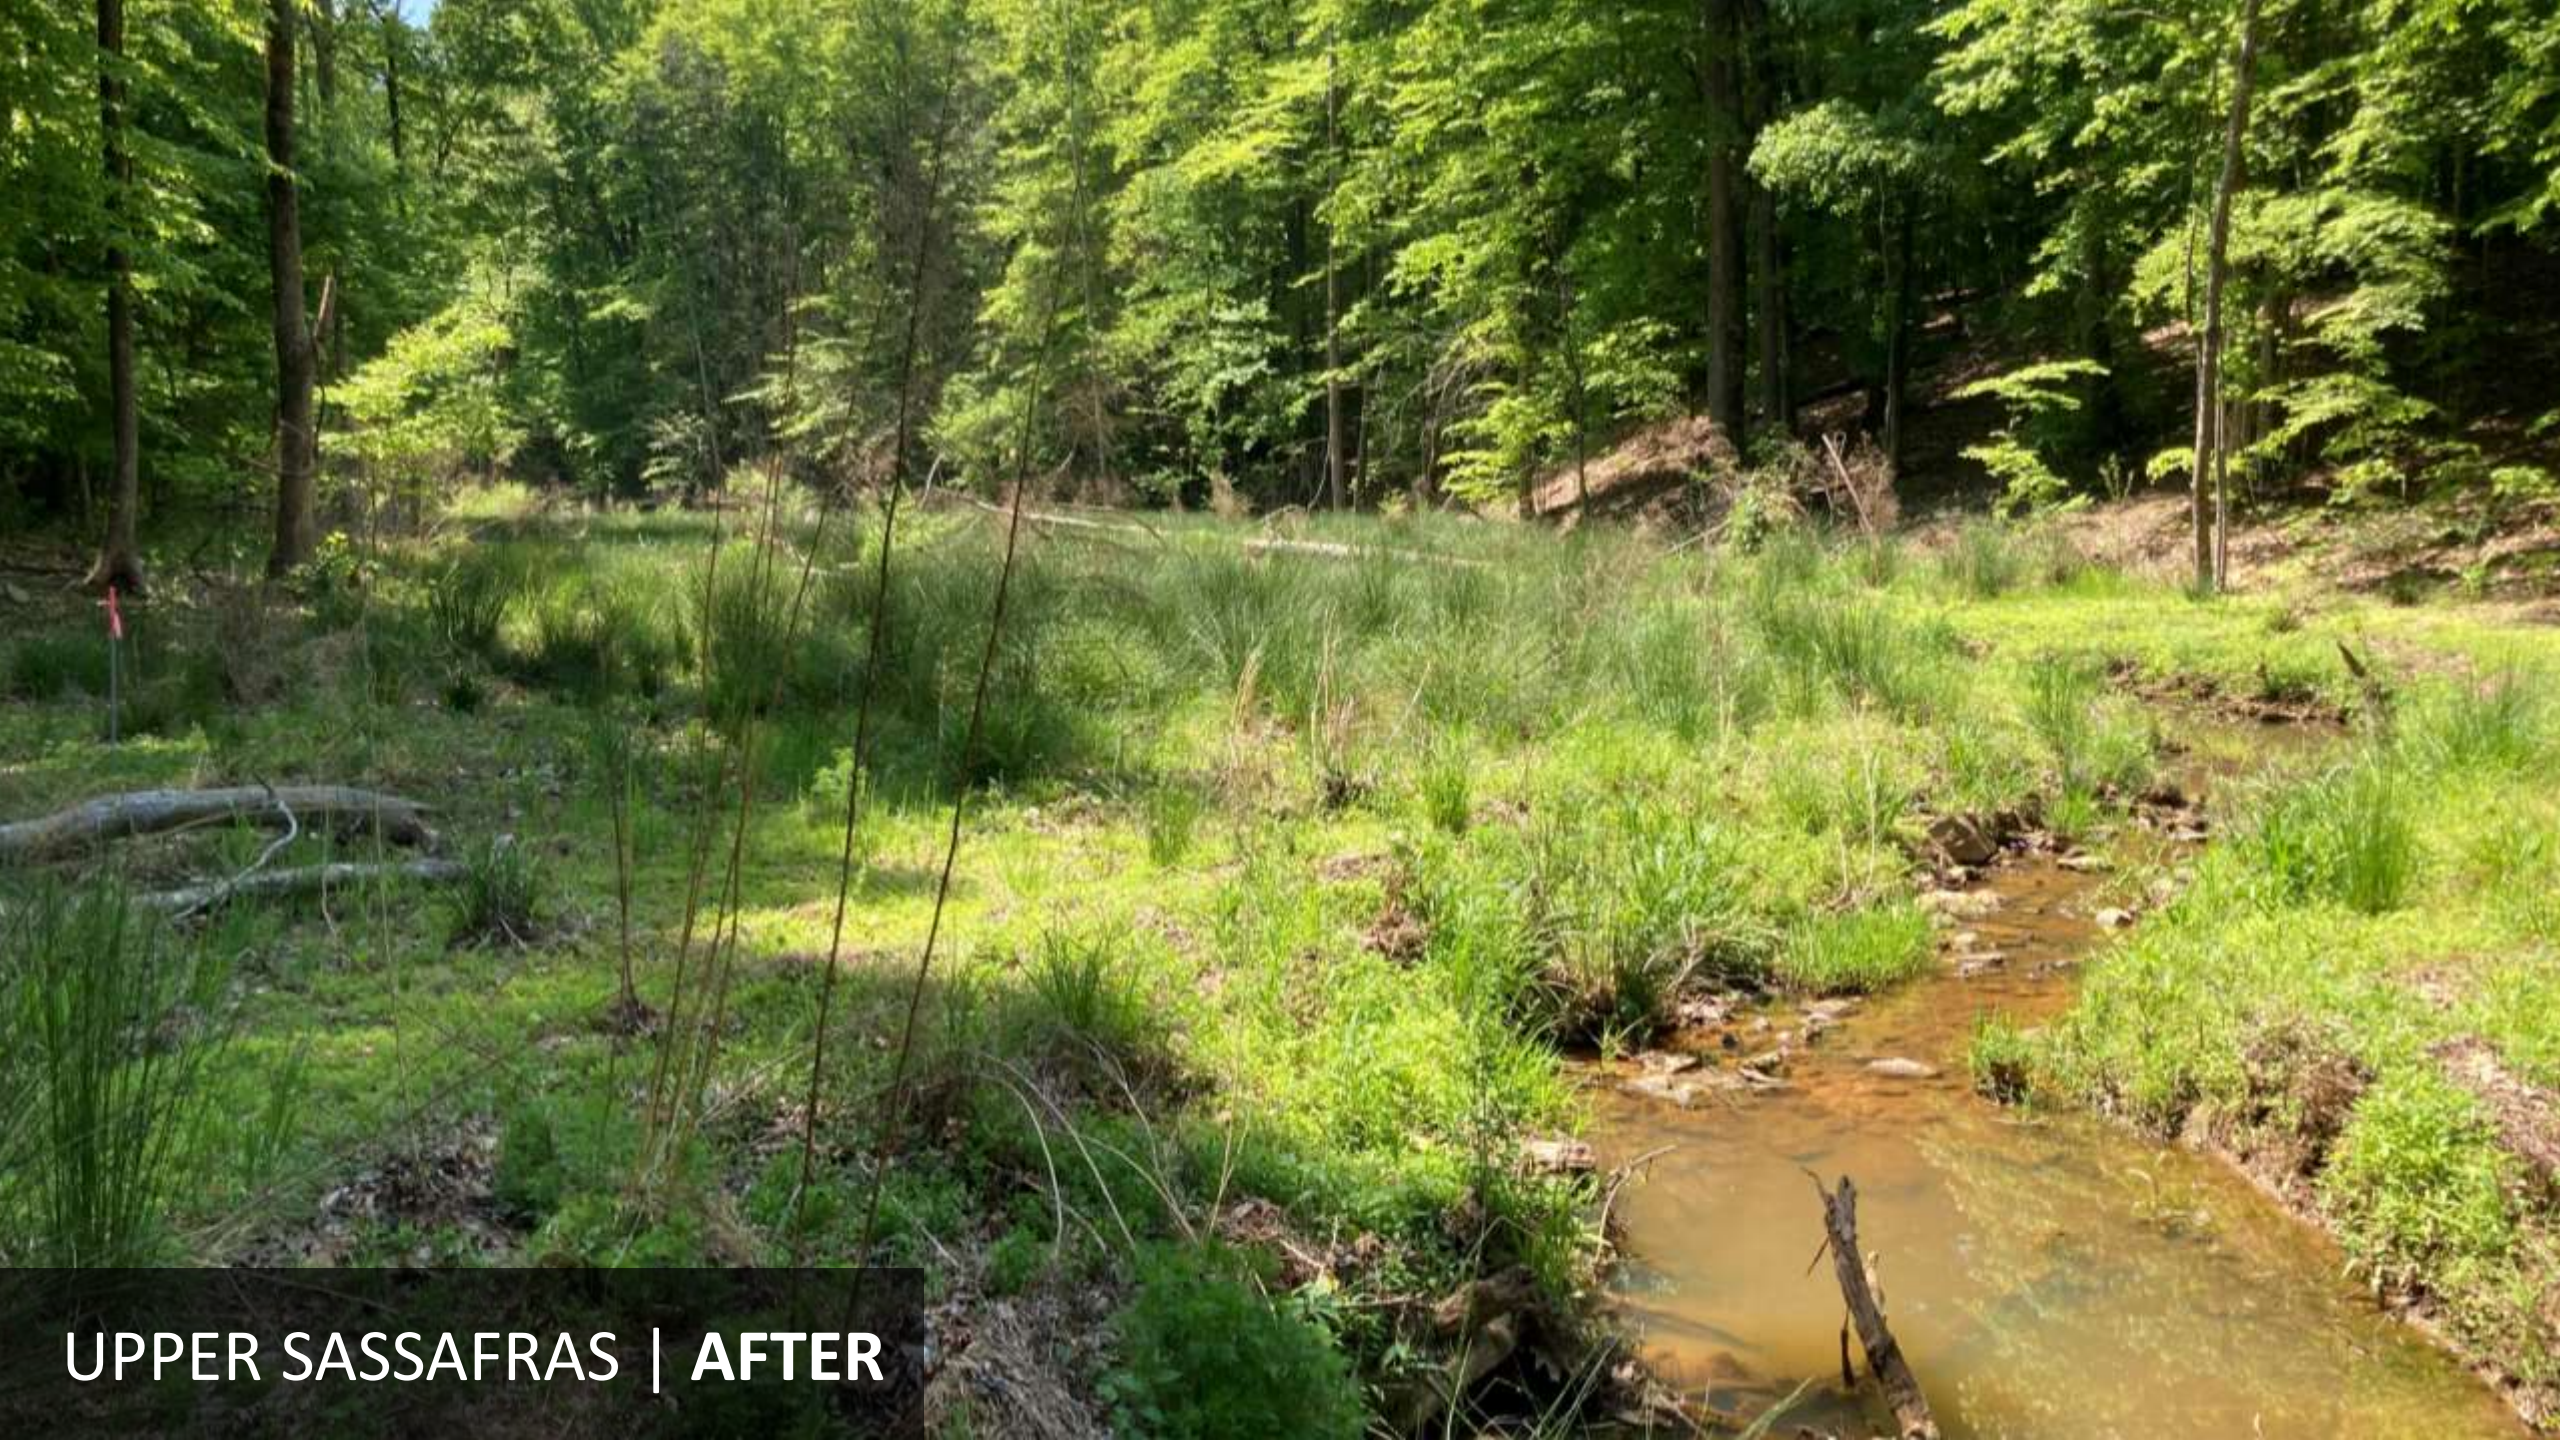
UPPER SASSAFRAS | AFTER

- **Overall, only notable scour on the project is in the Sassafras watershed** (highest % impervious)
  - Also, highest frequency of BKF events first year after construction
- **South Fork watershed** (0.5% impervious, forested)
  - Few 'bankfull' events and bench forming at lower elevation within the channel
  - Sand lens encountered during construction (same soil type as Buckleigh, but sand lens not encountered)
  - Next watershed over (Robinson) hits bankfull often, with similar watershed land use/channel sizing
- **Upper Reedy Creek**
  - Pond immediately upstream
  - Few 'bankfull' events despite sizing channel down
- **Grier / Hodges / Hood**
  - Frequent bankfull events

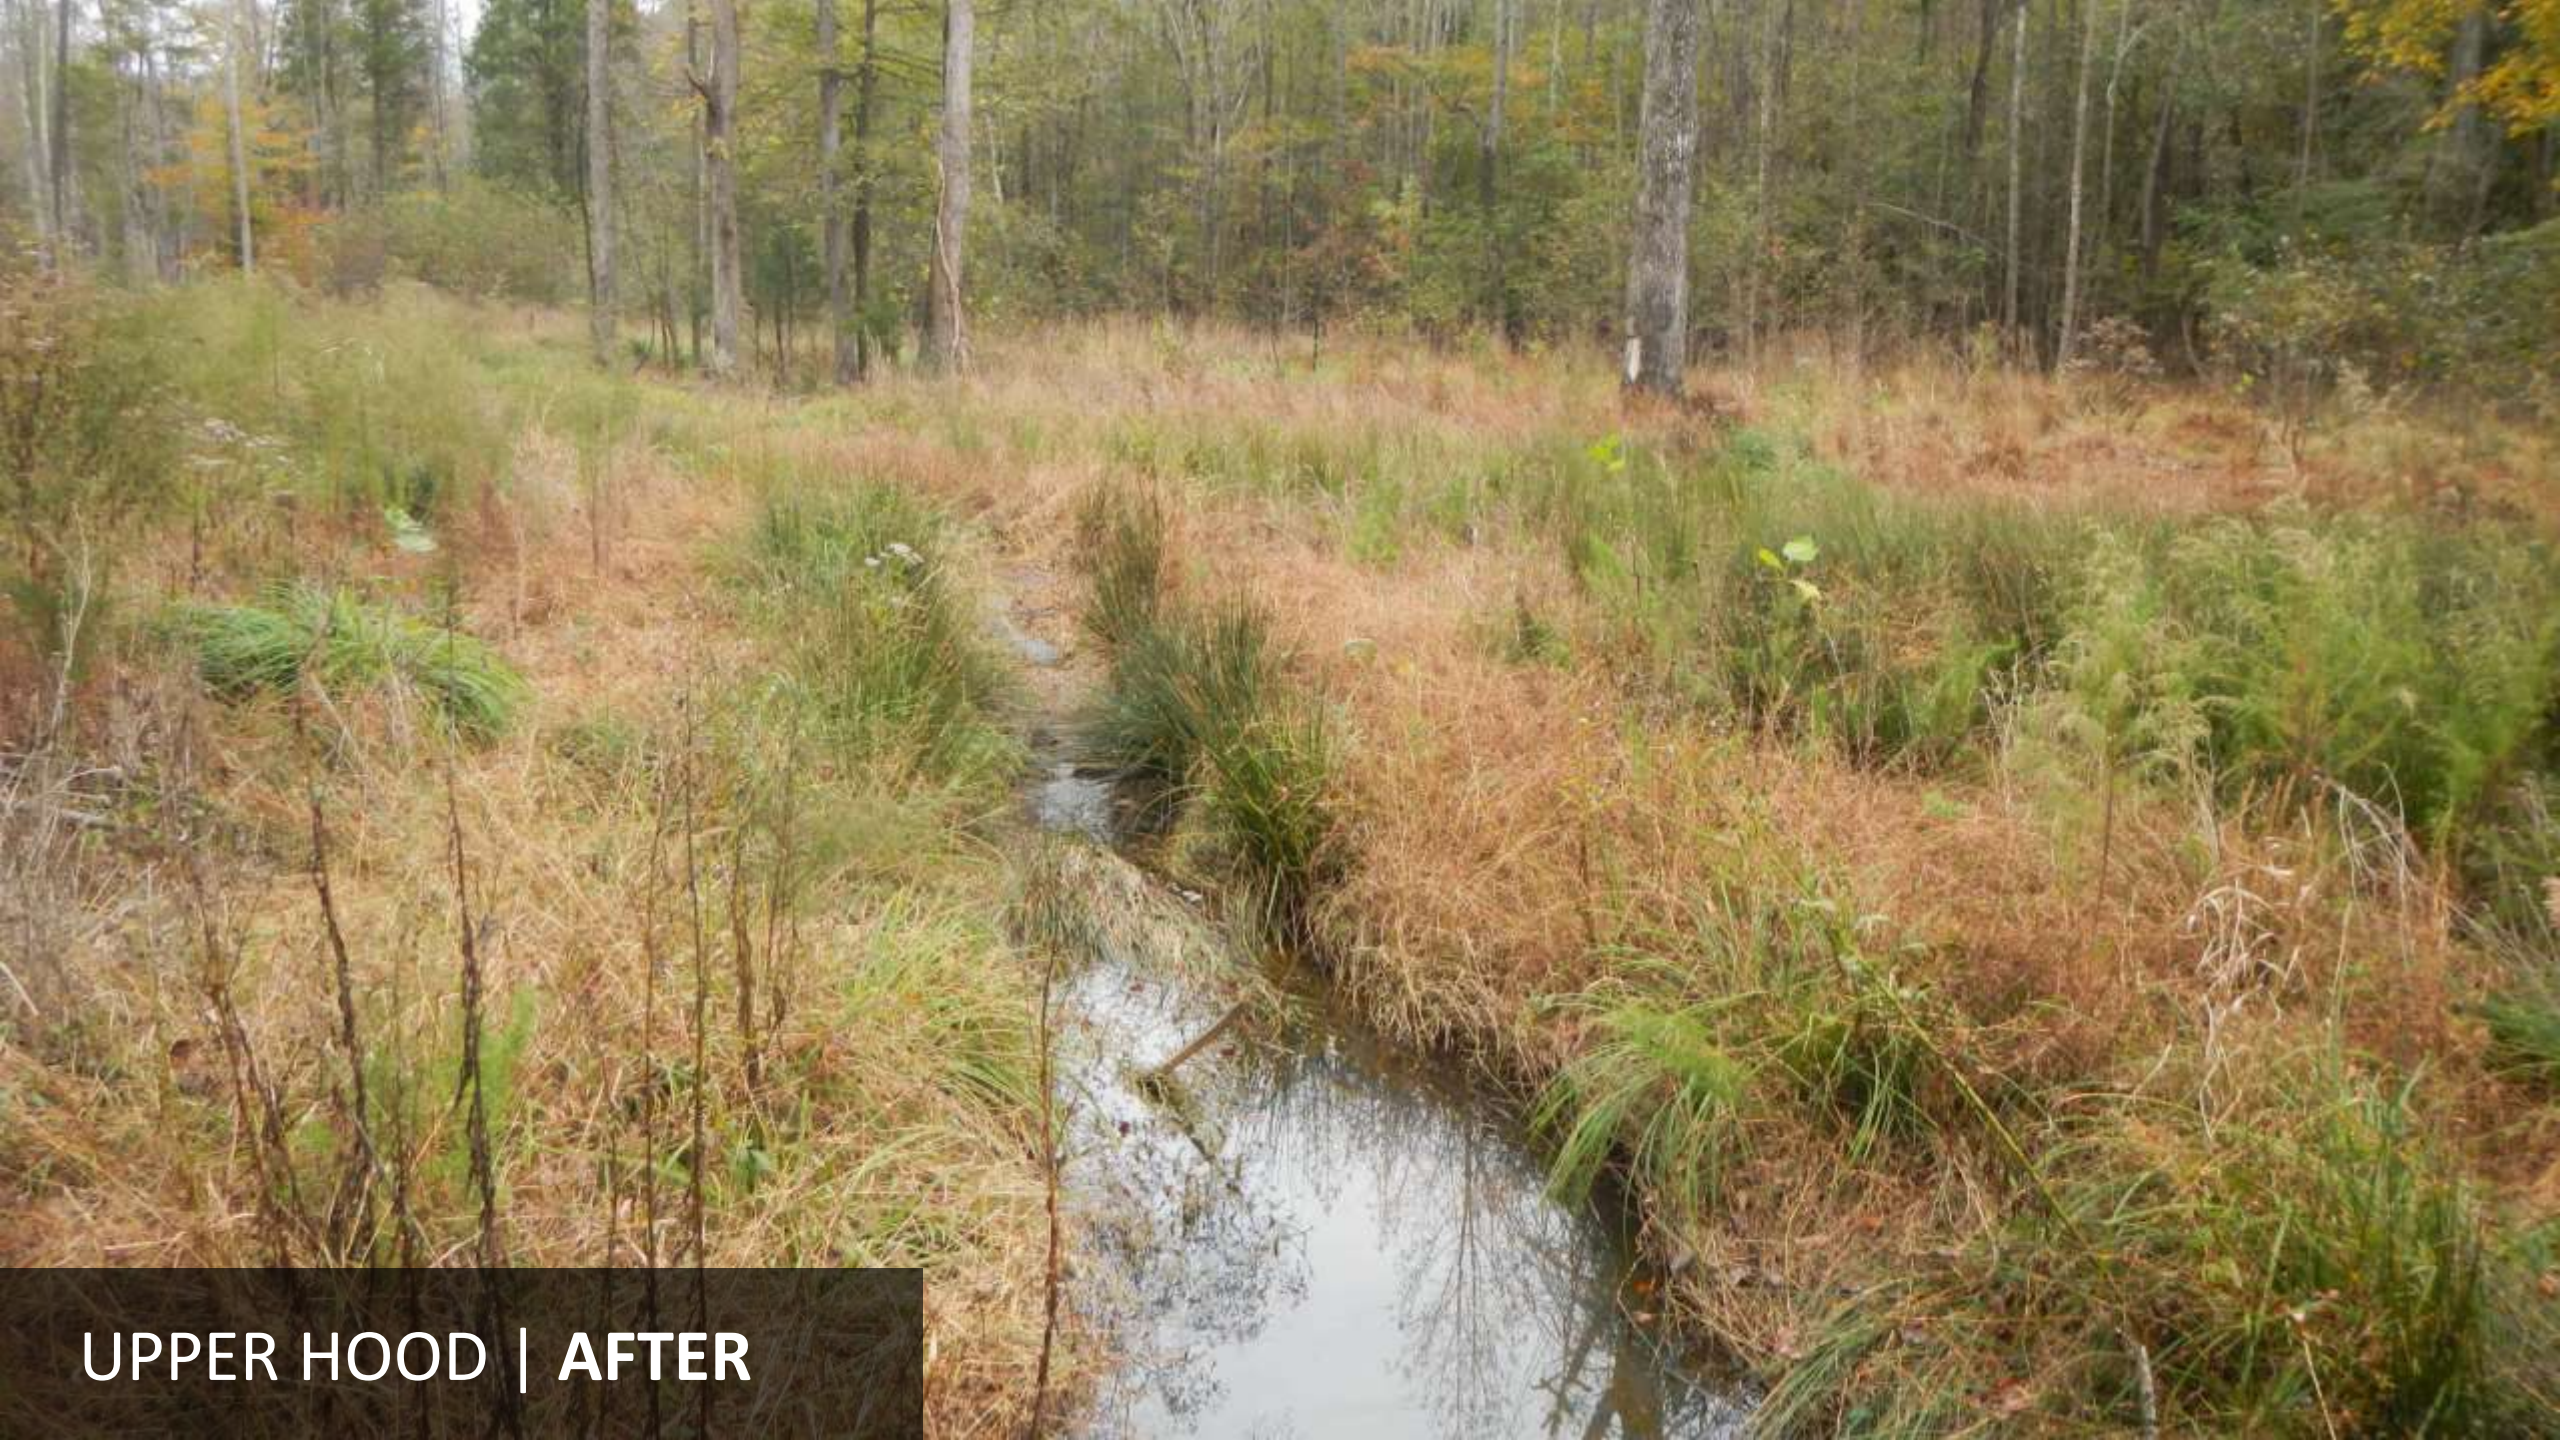
UPPER HOOD | AFTER

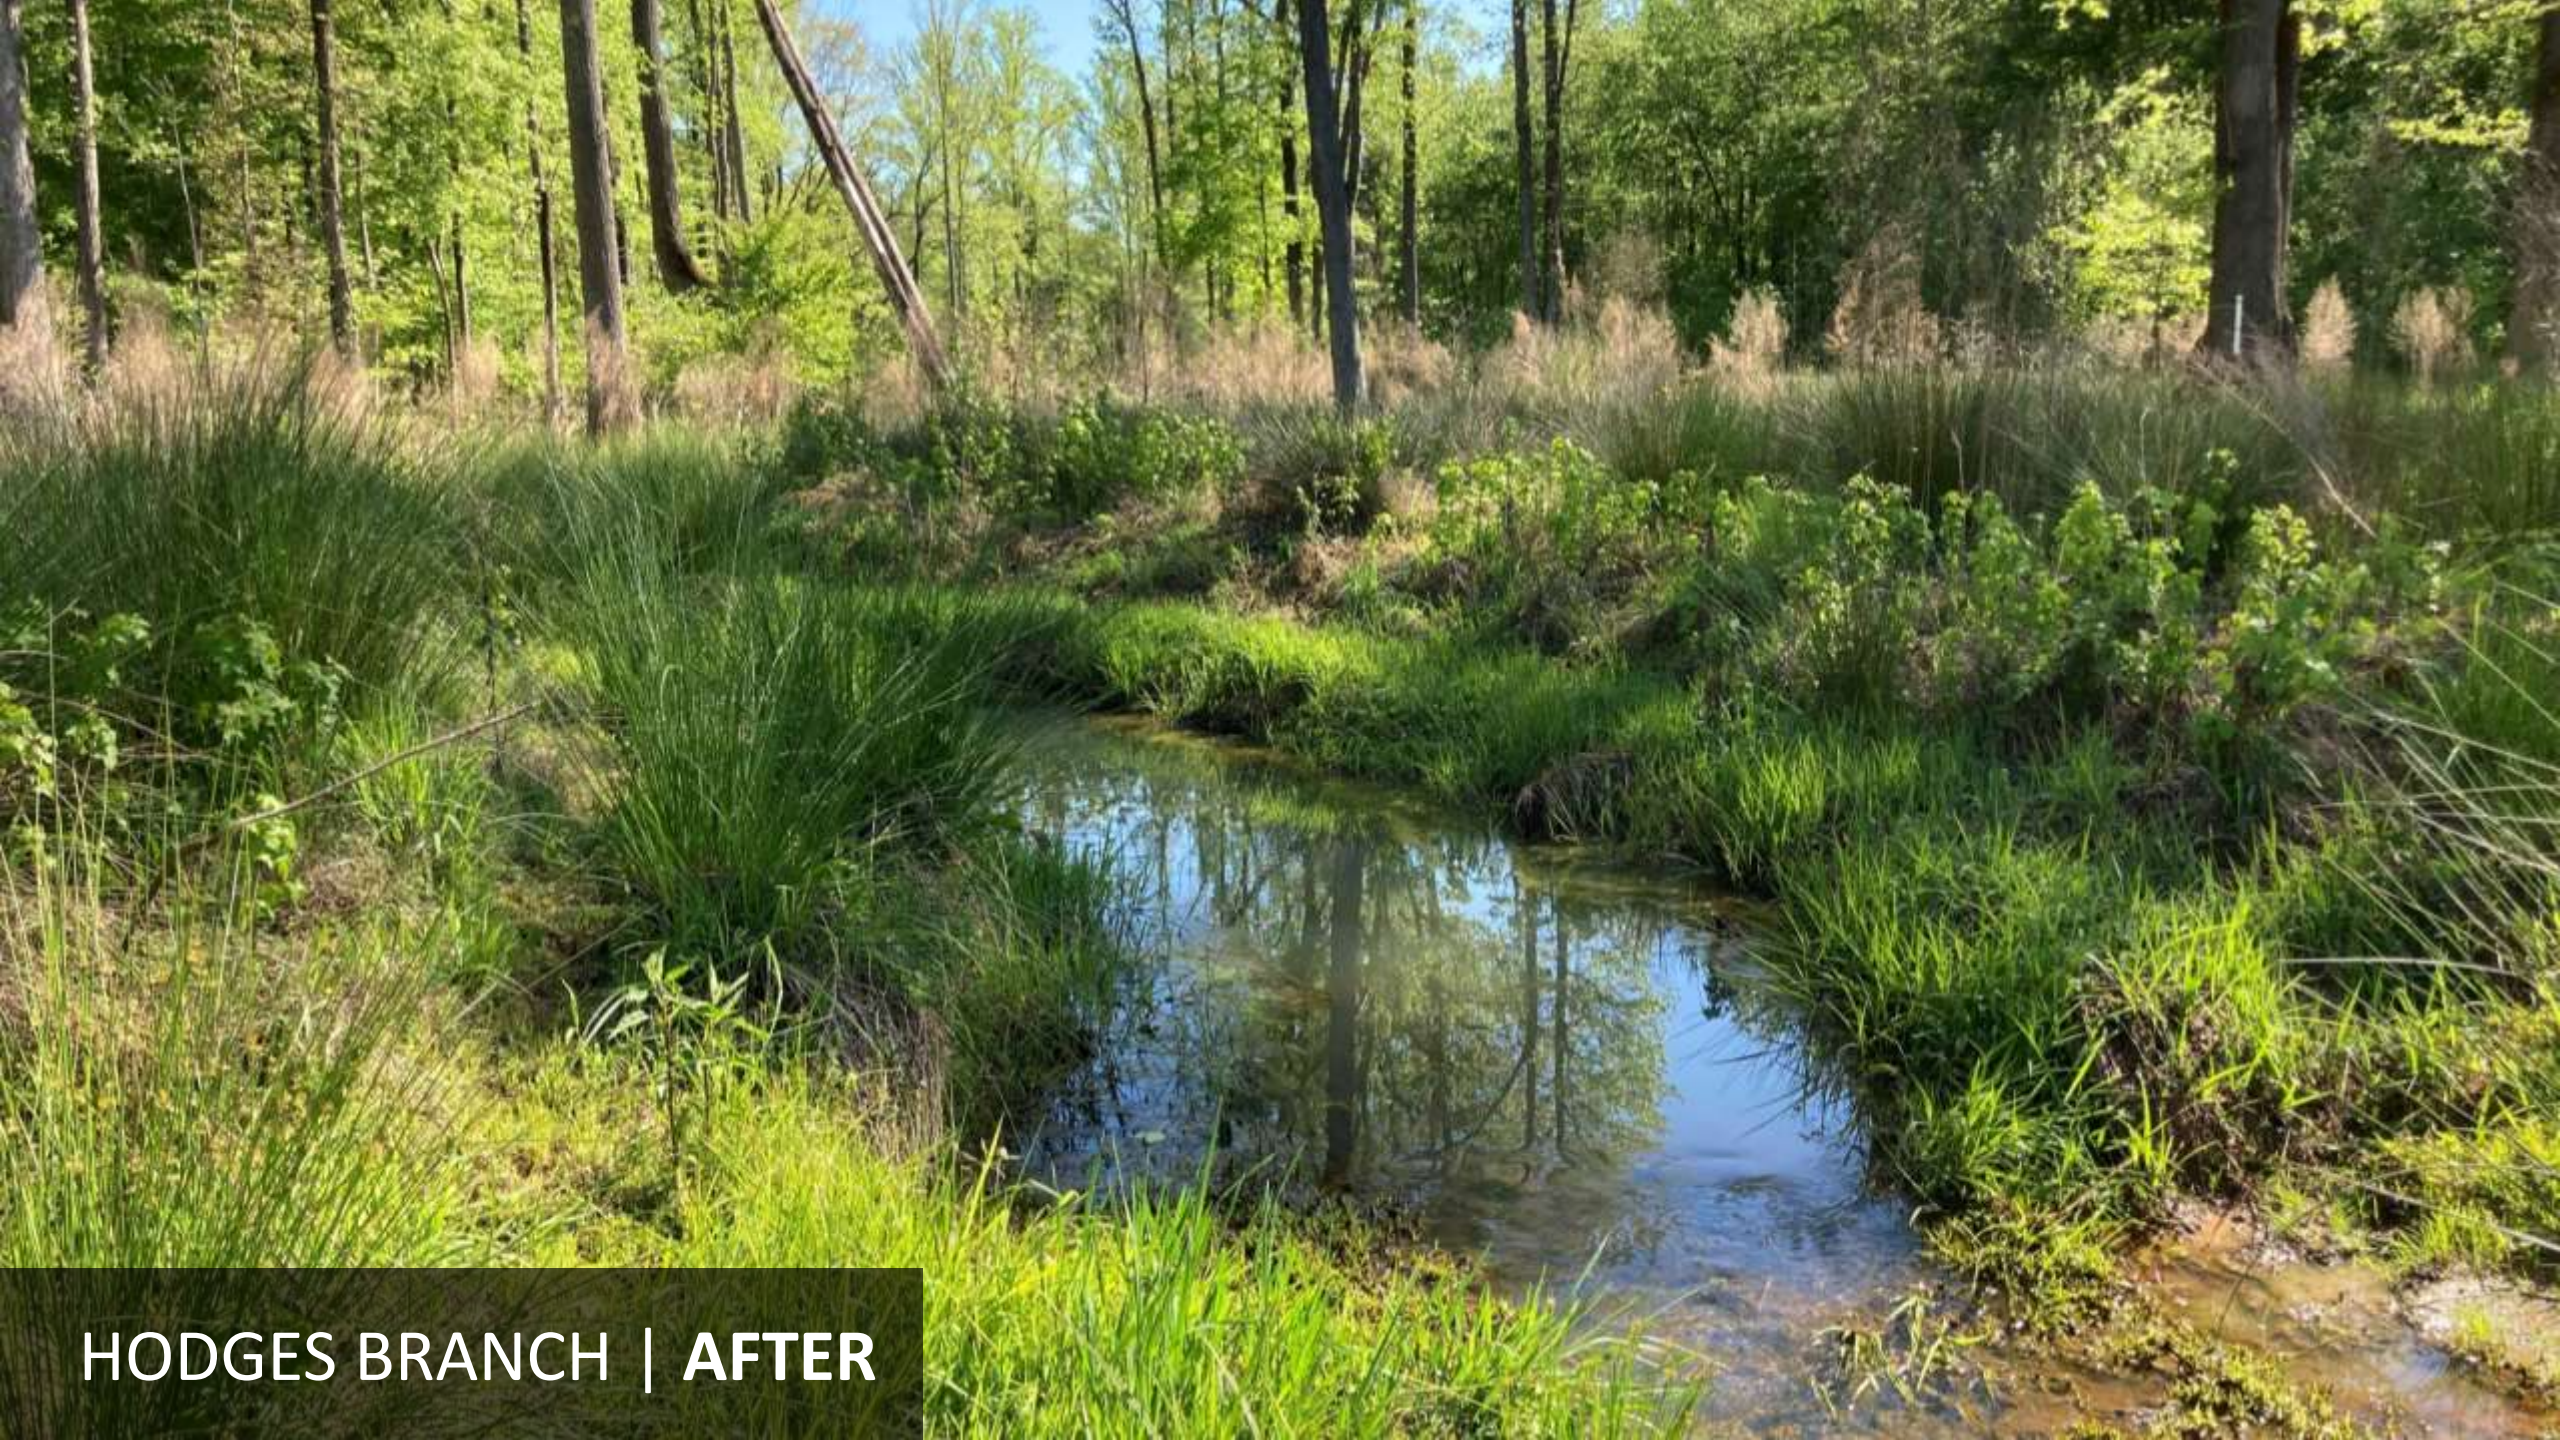
**HODGES BRANCH | AFTER**

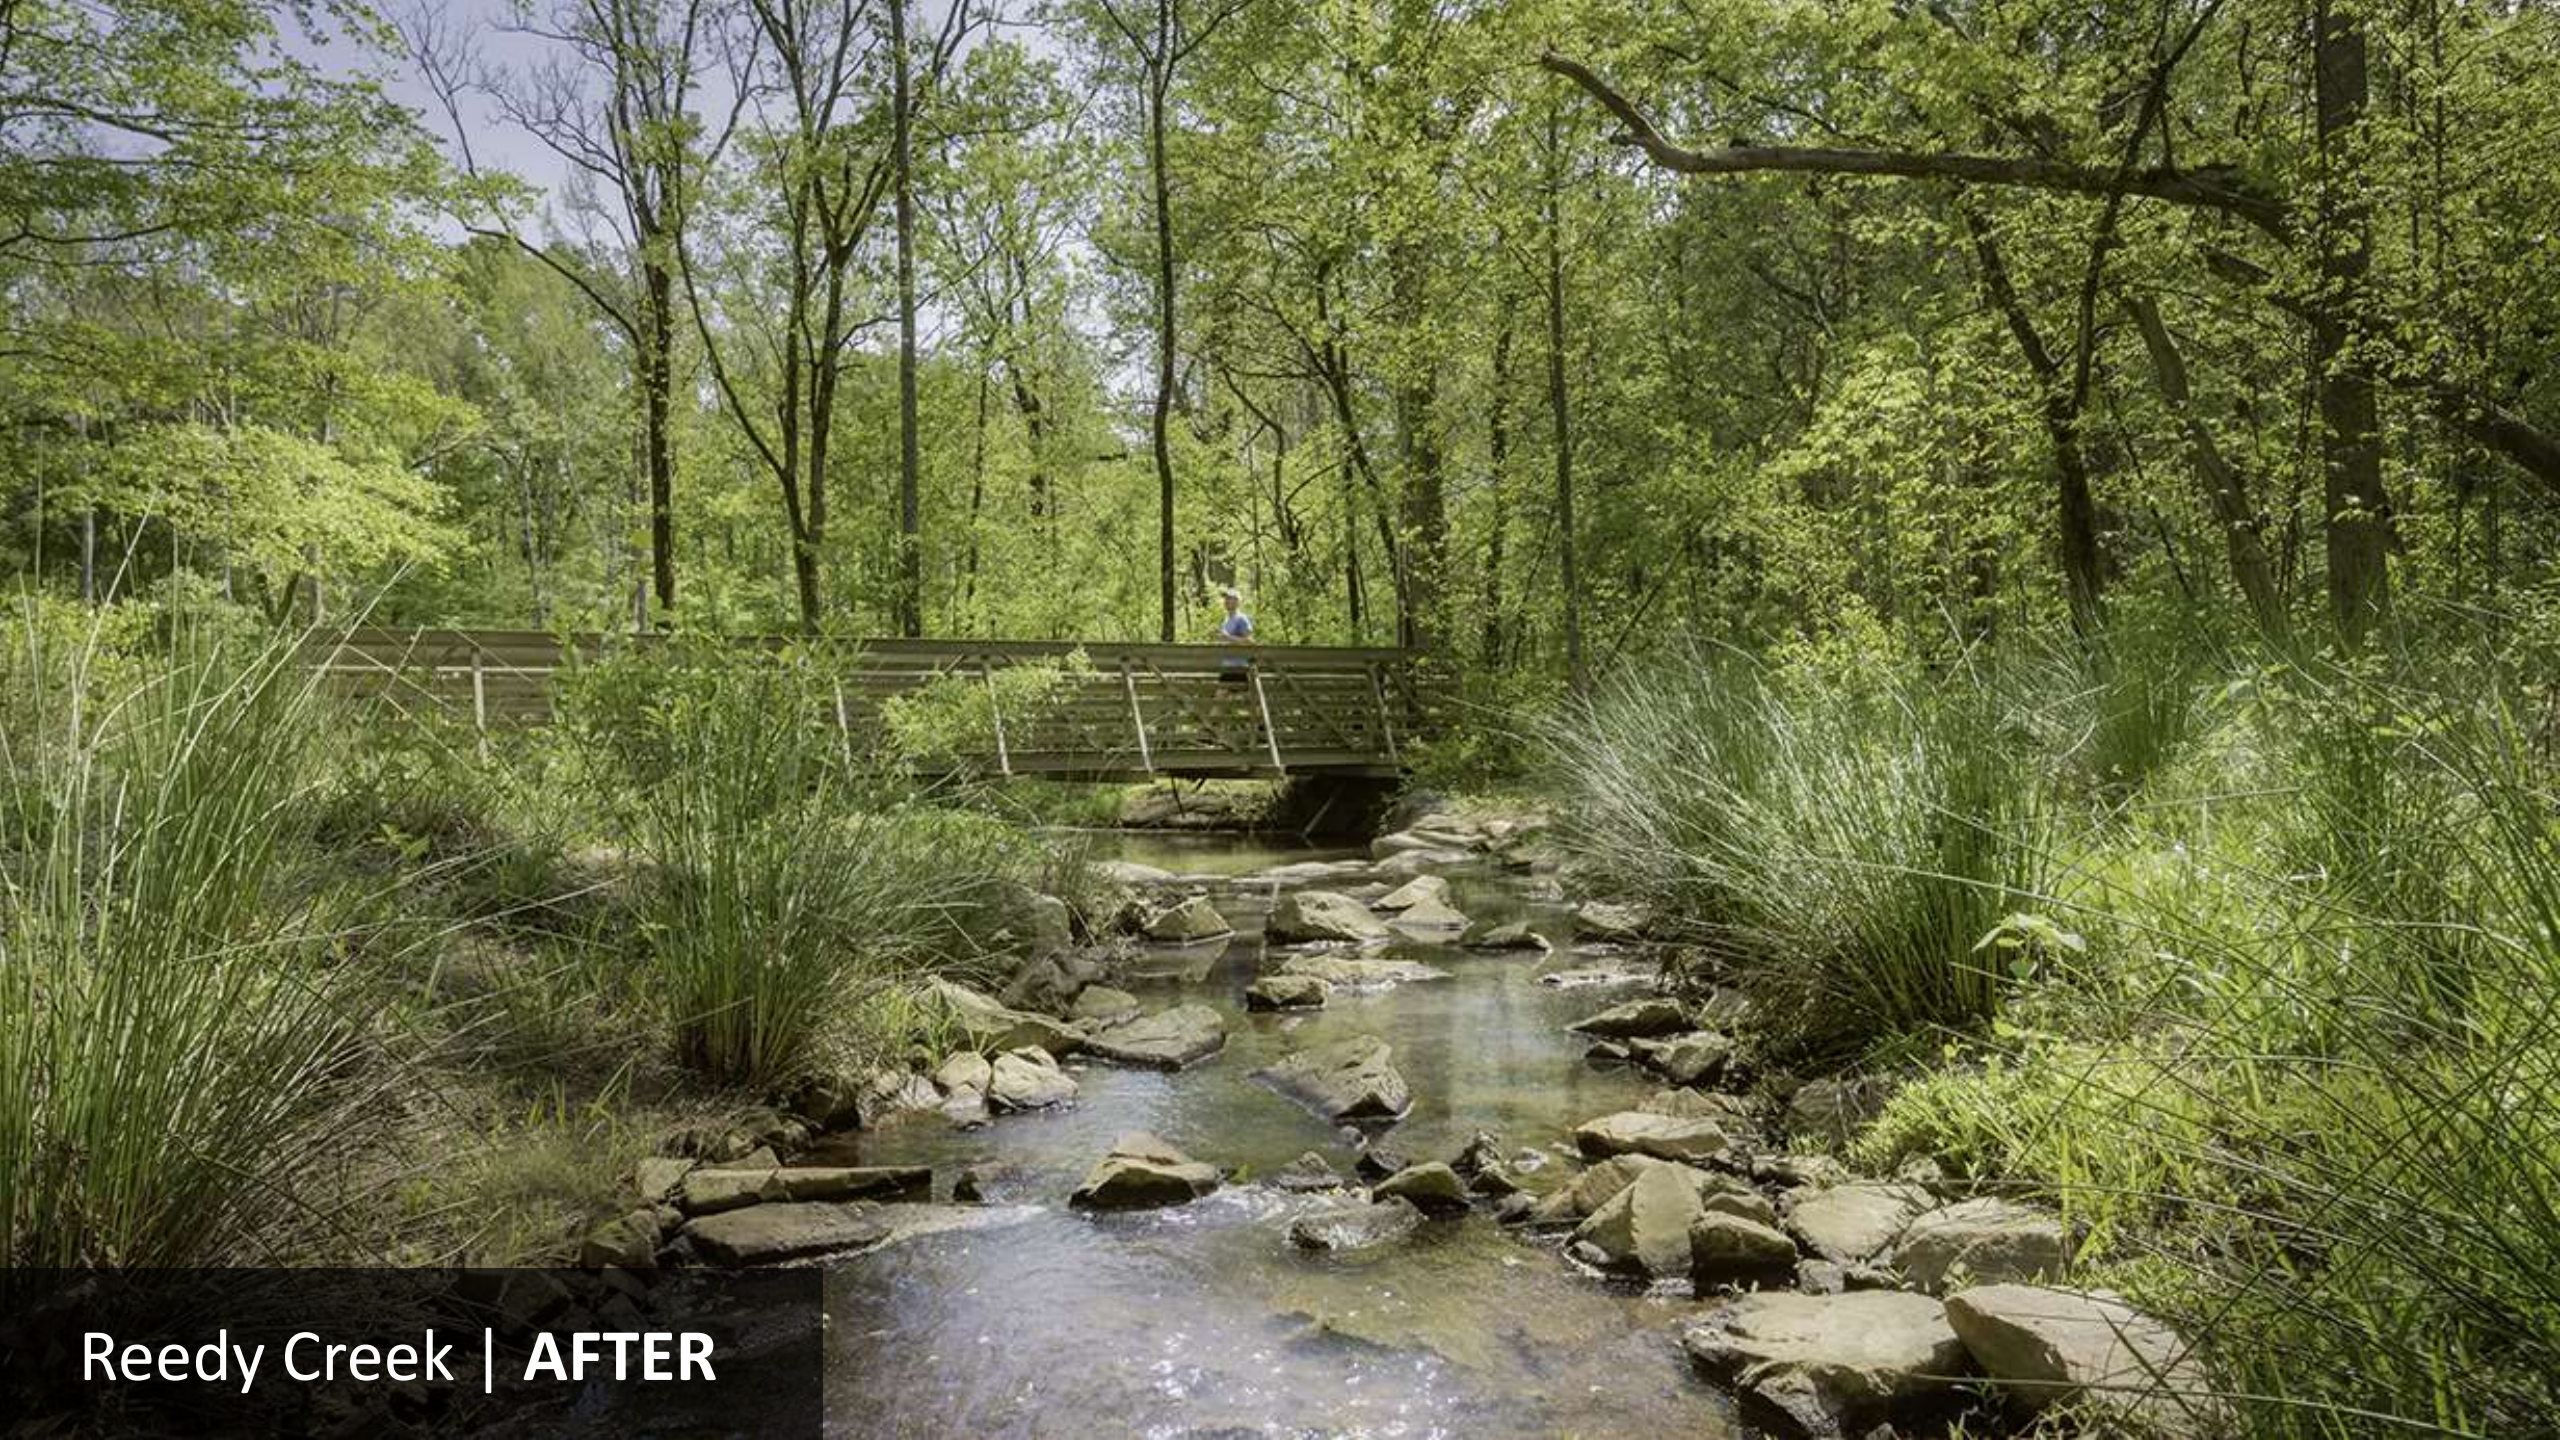
Reedy Creek | **AFTER**
