# Steele Creek Restoration and Flood Mitigation Project

Village of Ilion

Herkimer County, New York

August 2023

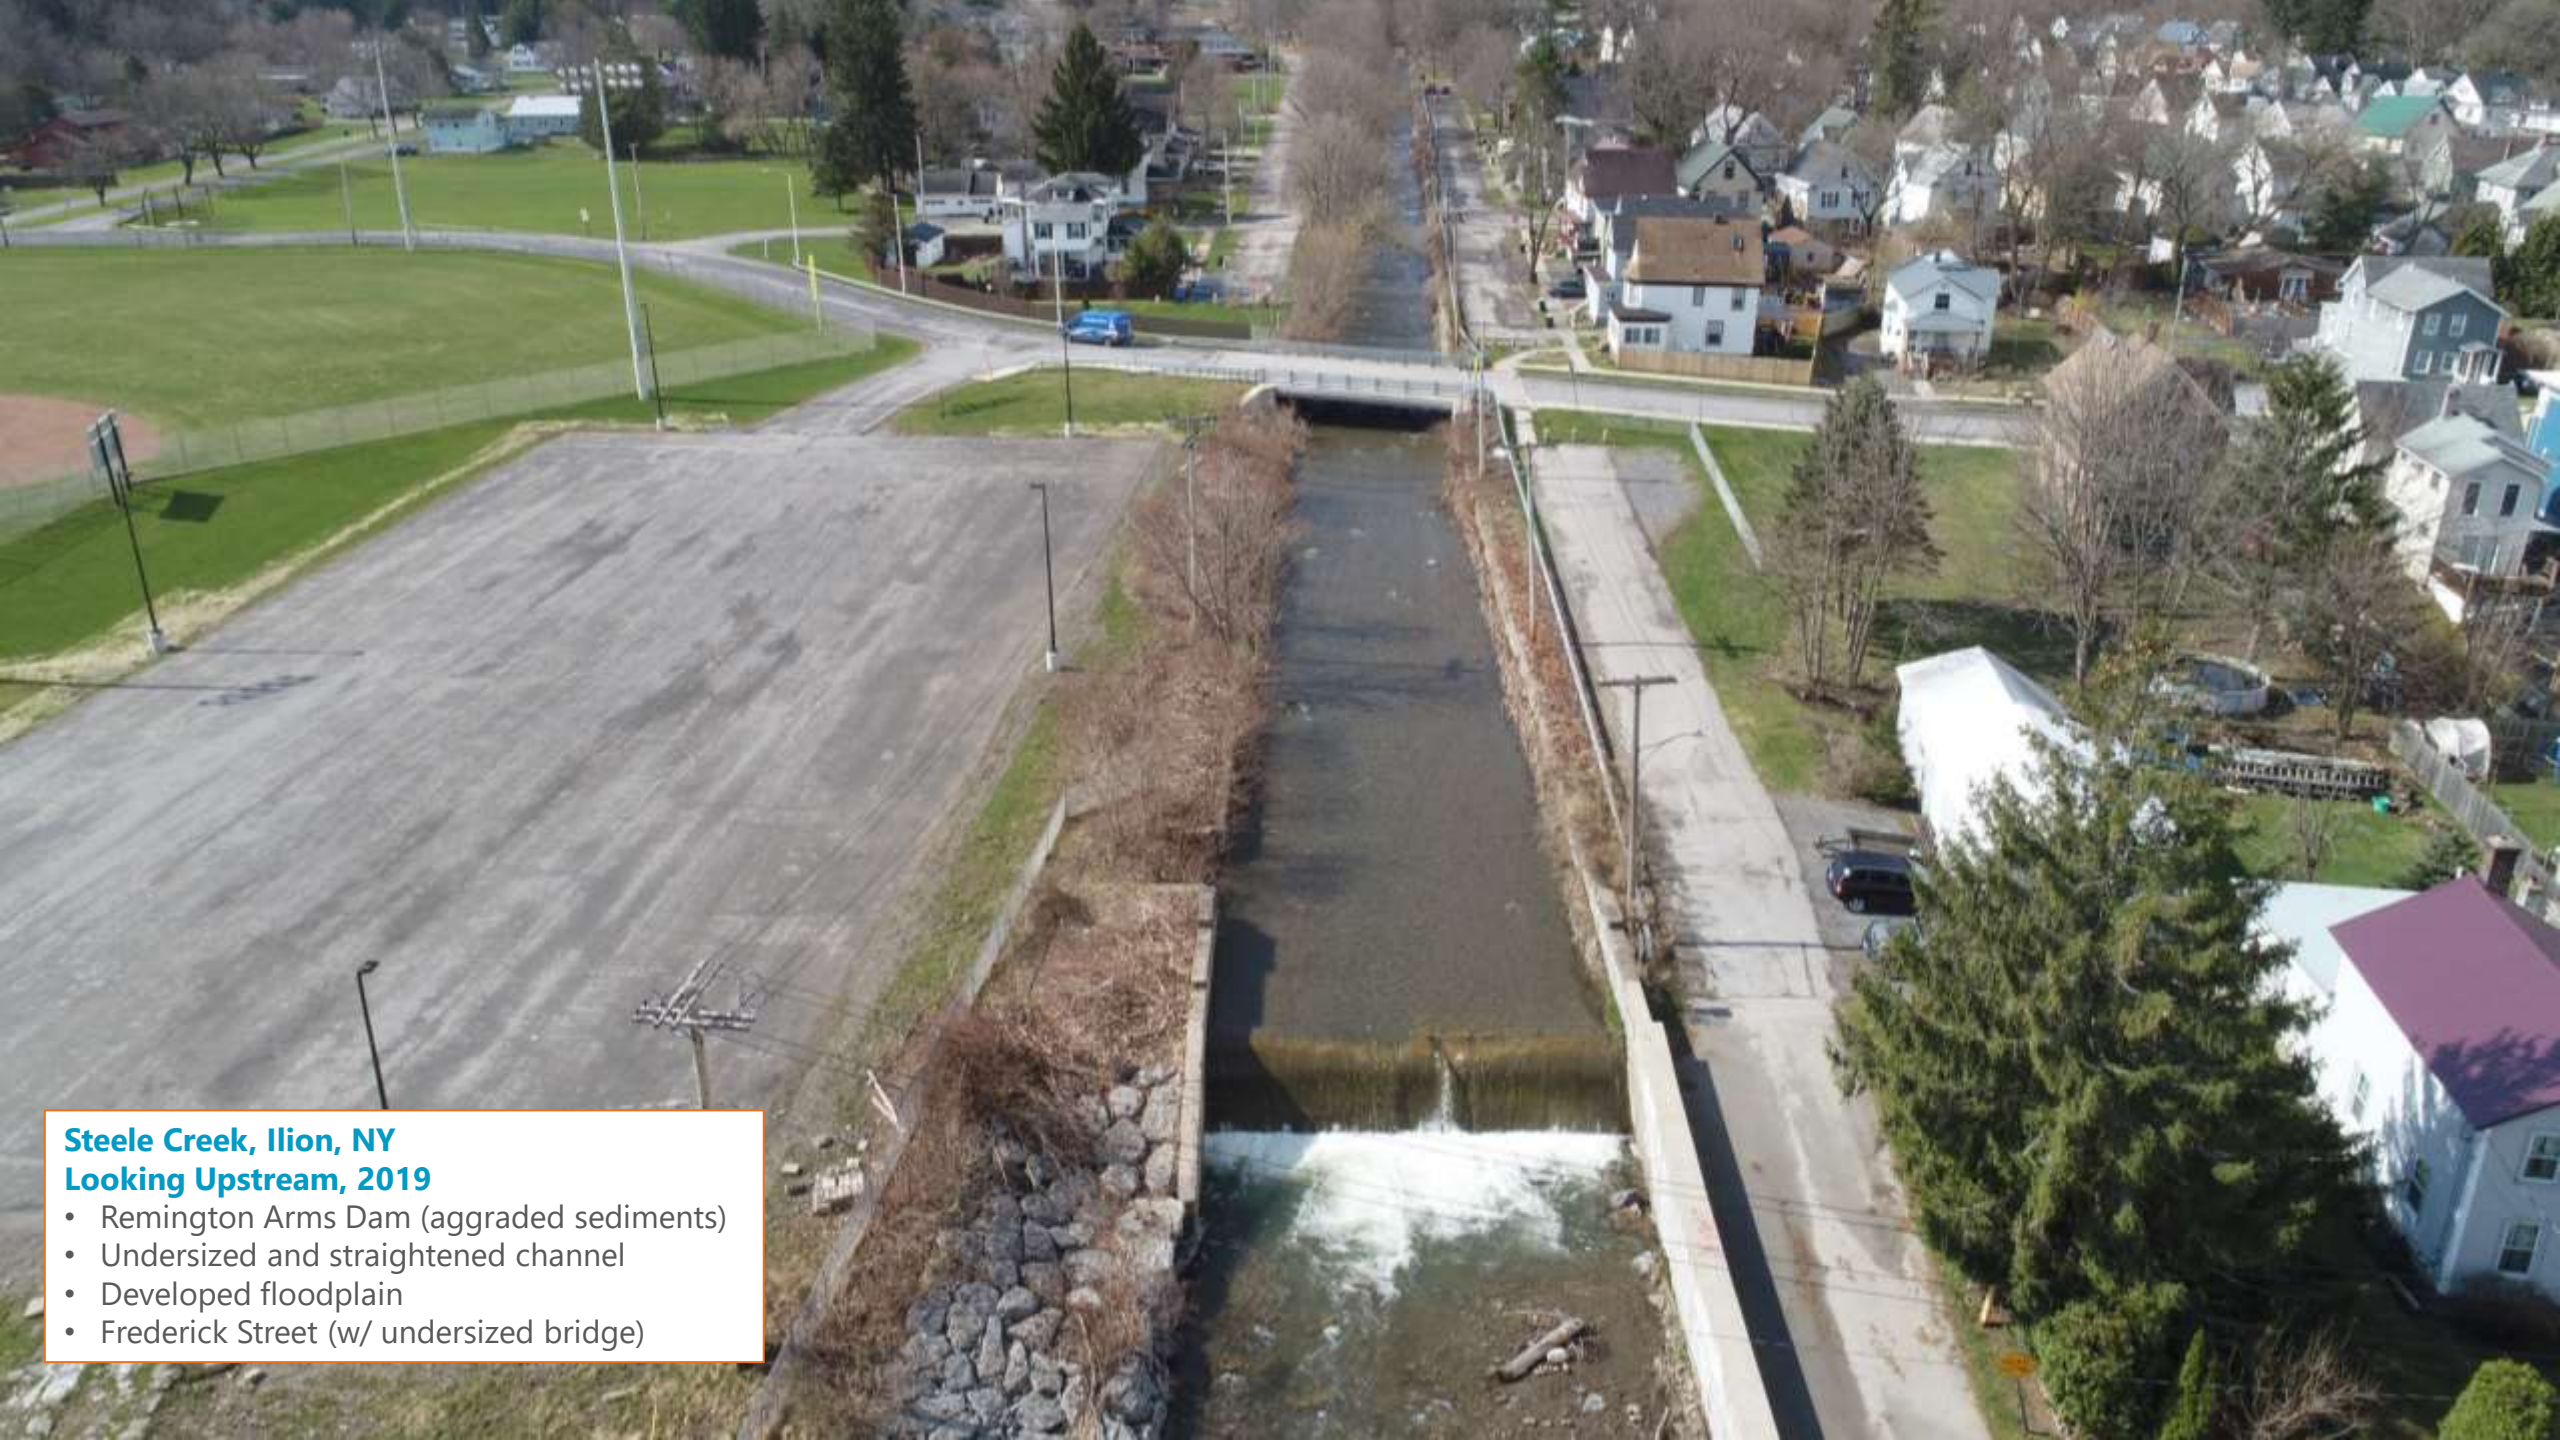
**Steele Creek, Ilion, NY**  
**Looking Upstream, 2019**

- Remington Arms Dam (aggraded sediments)
- Undersized and straightened channel
- Developed floodplain
- Frederick Street (w/ undersized bridge)

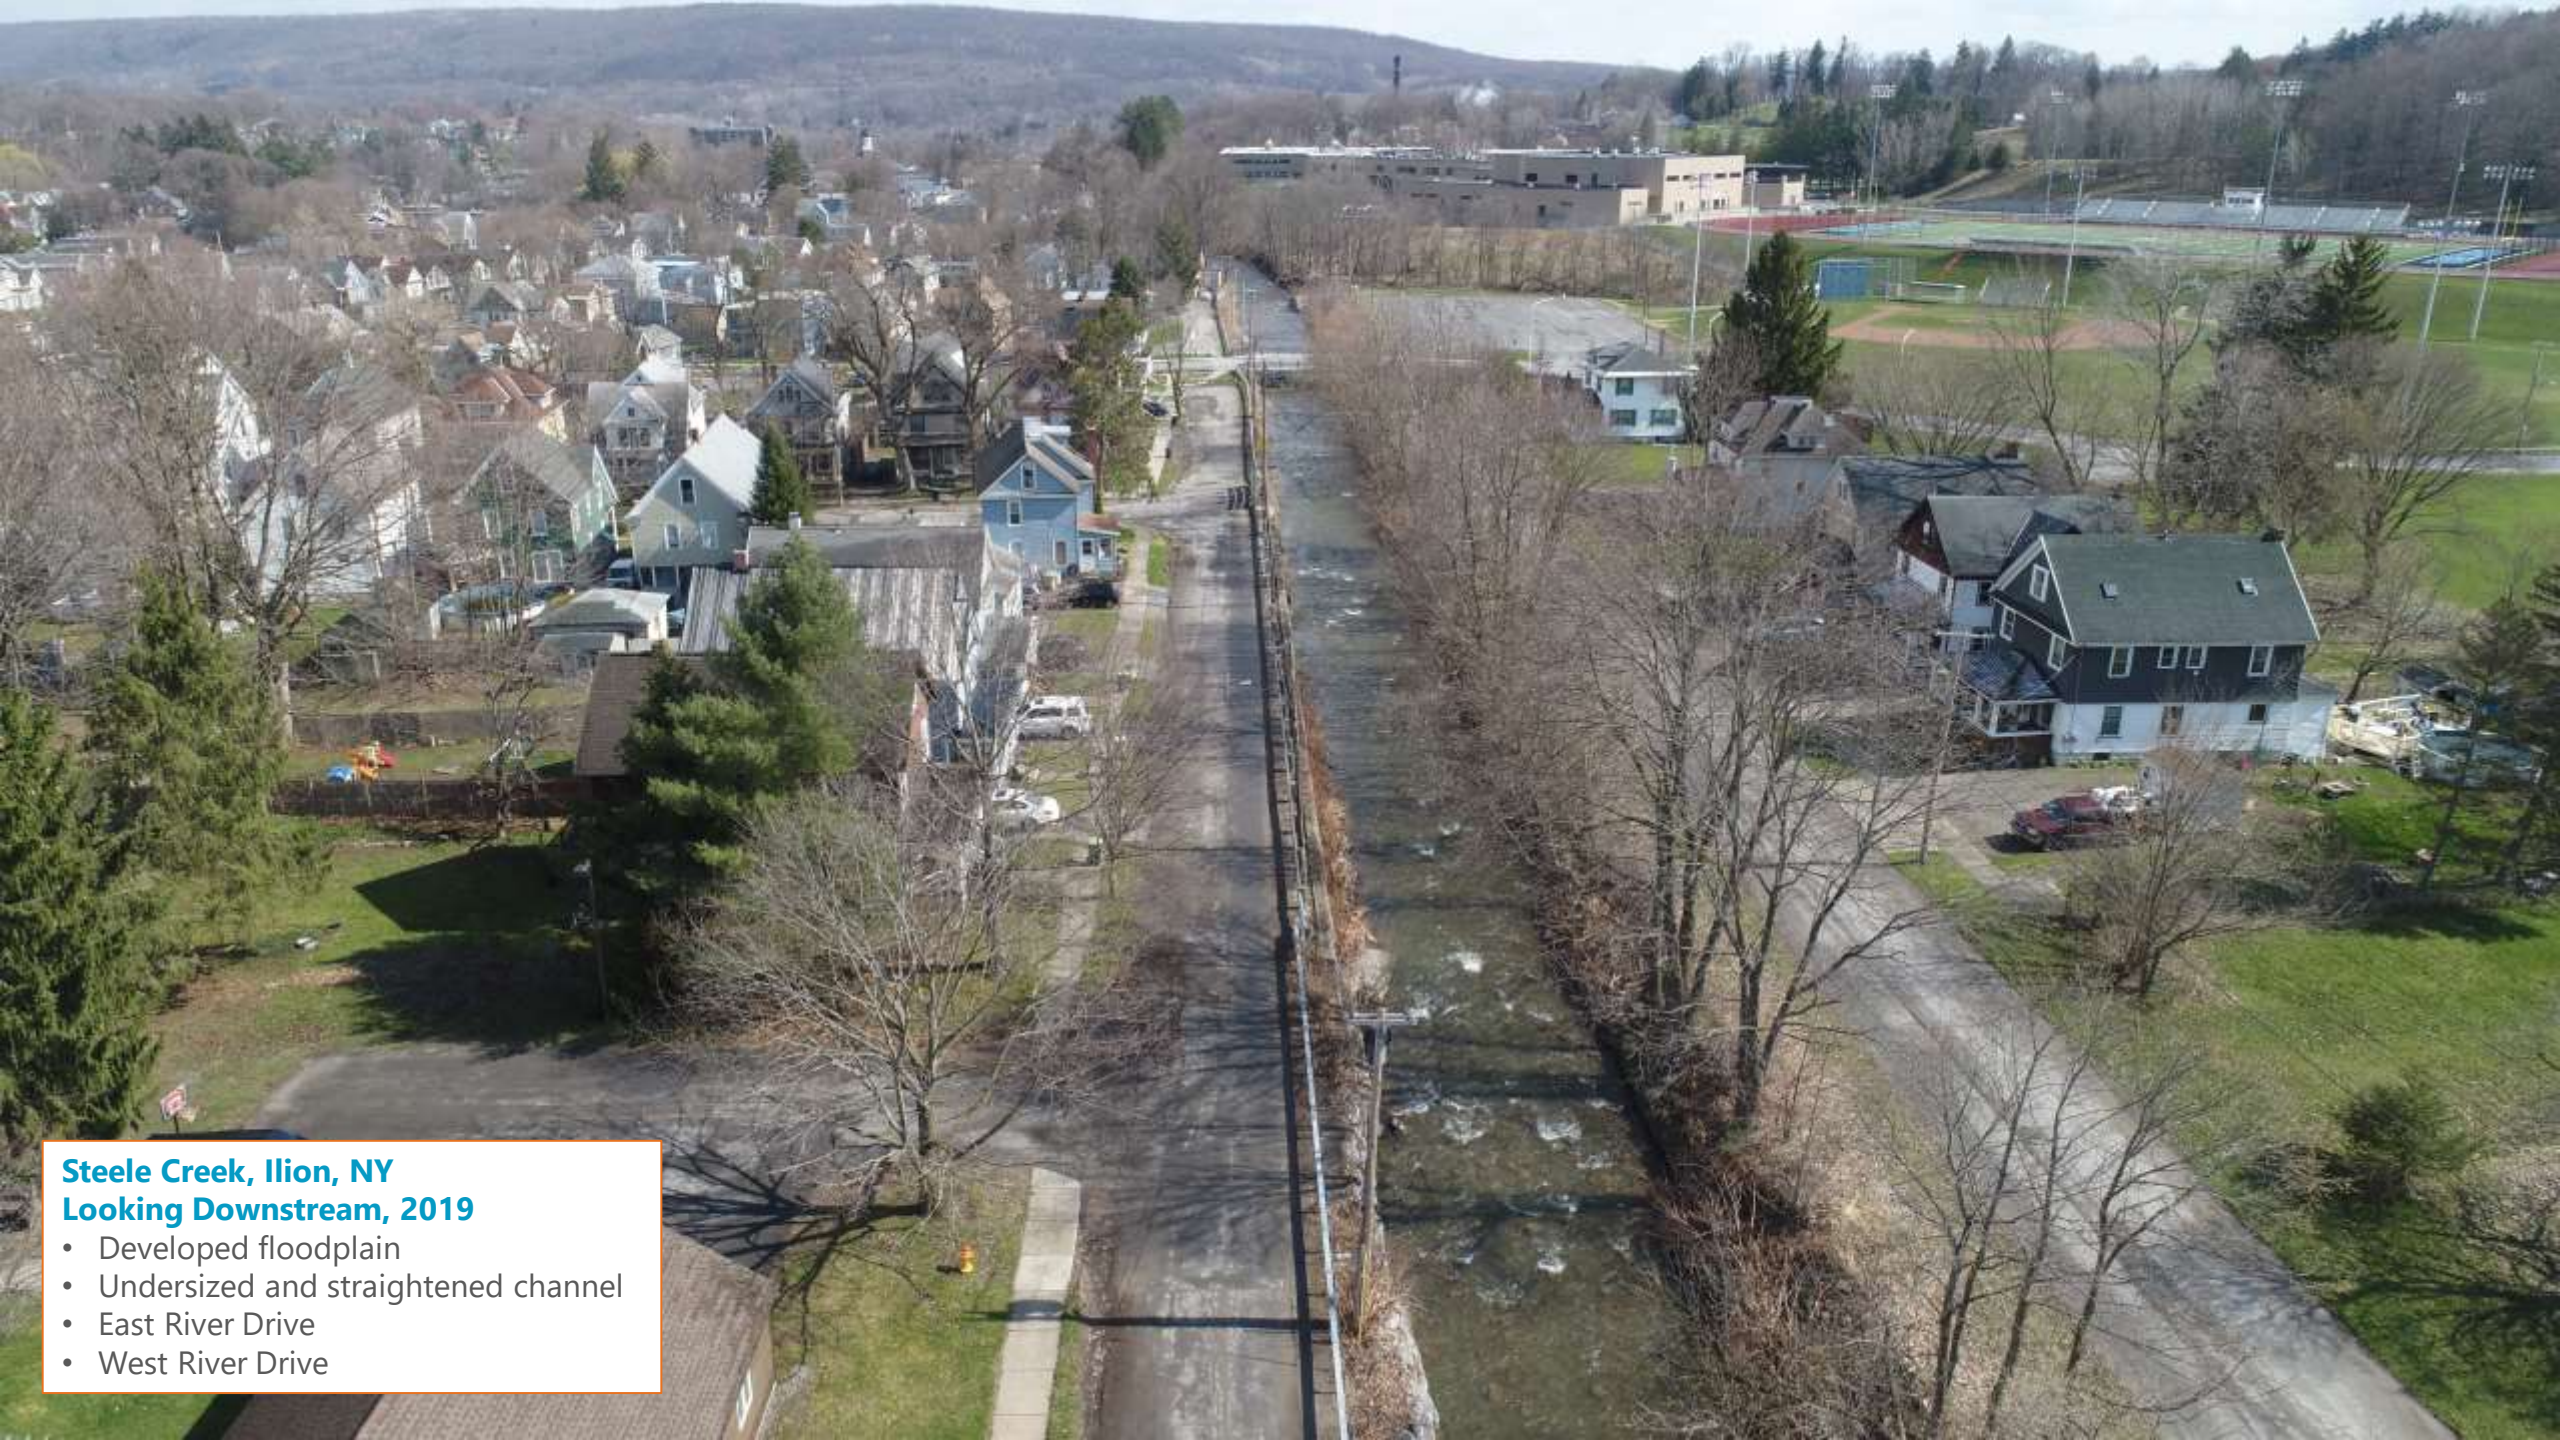
**Steele Creek, Iliion, NY**  
**Looking Downstream, 2019**

- Developed floodplain
- Undersized and straightened channel
- East River Drive
- West River Drive

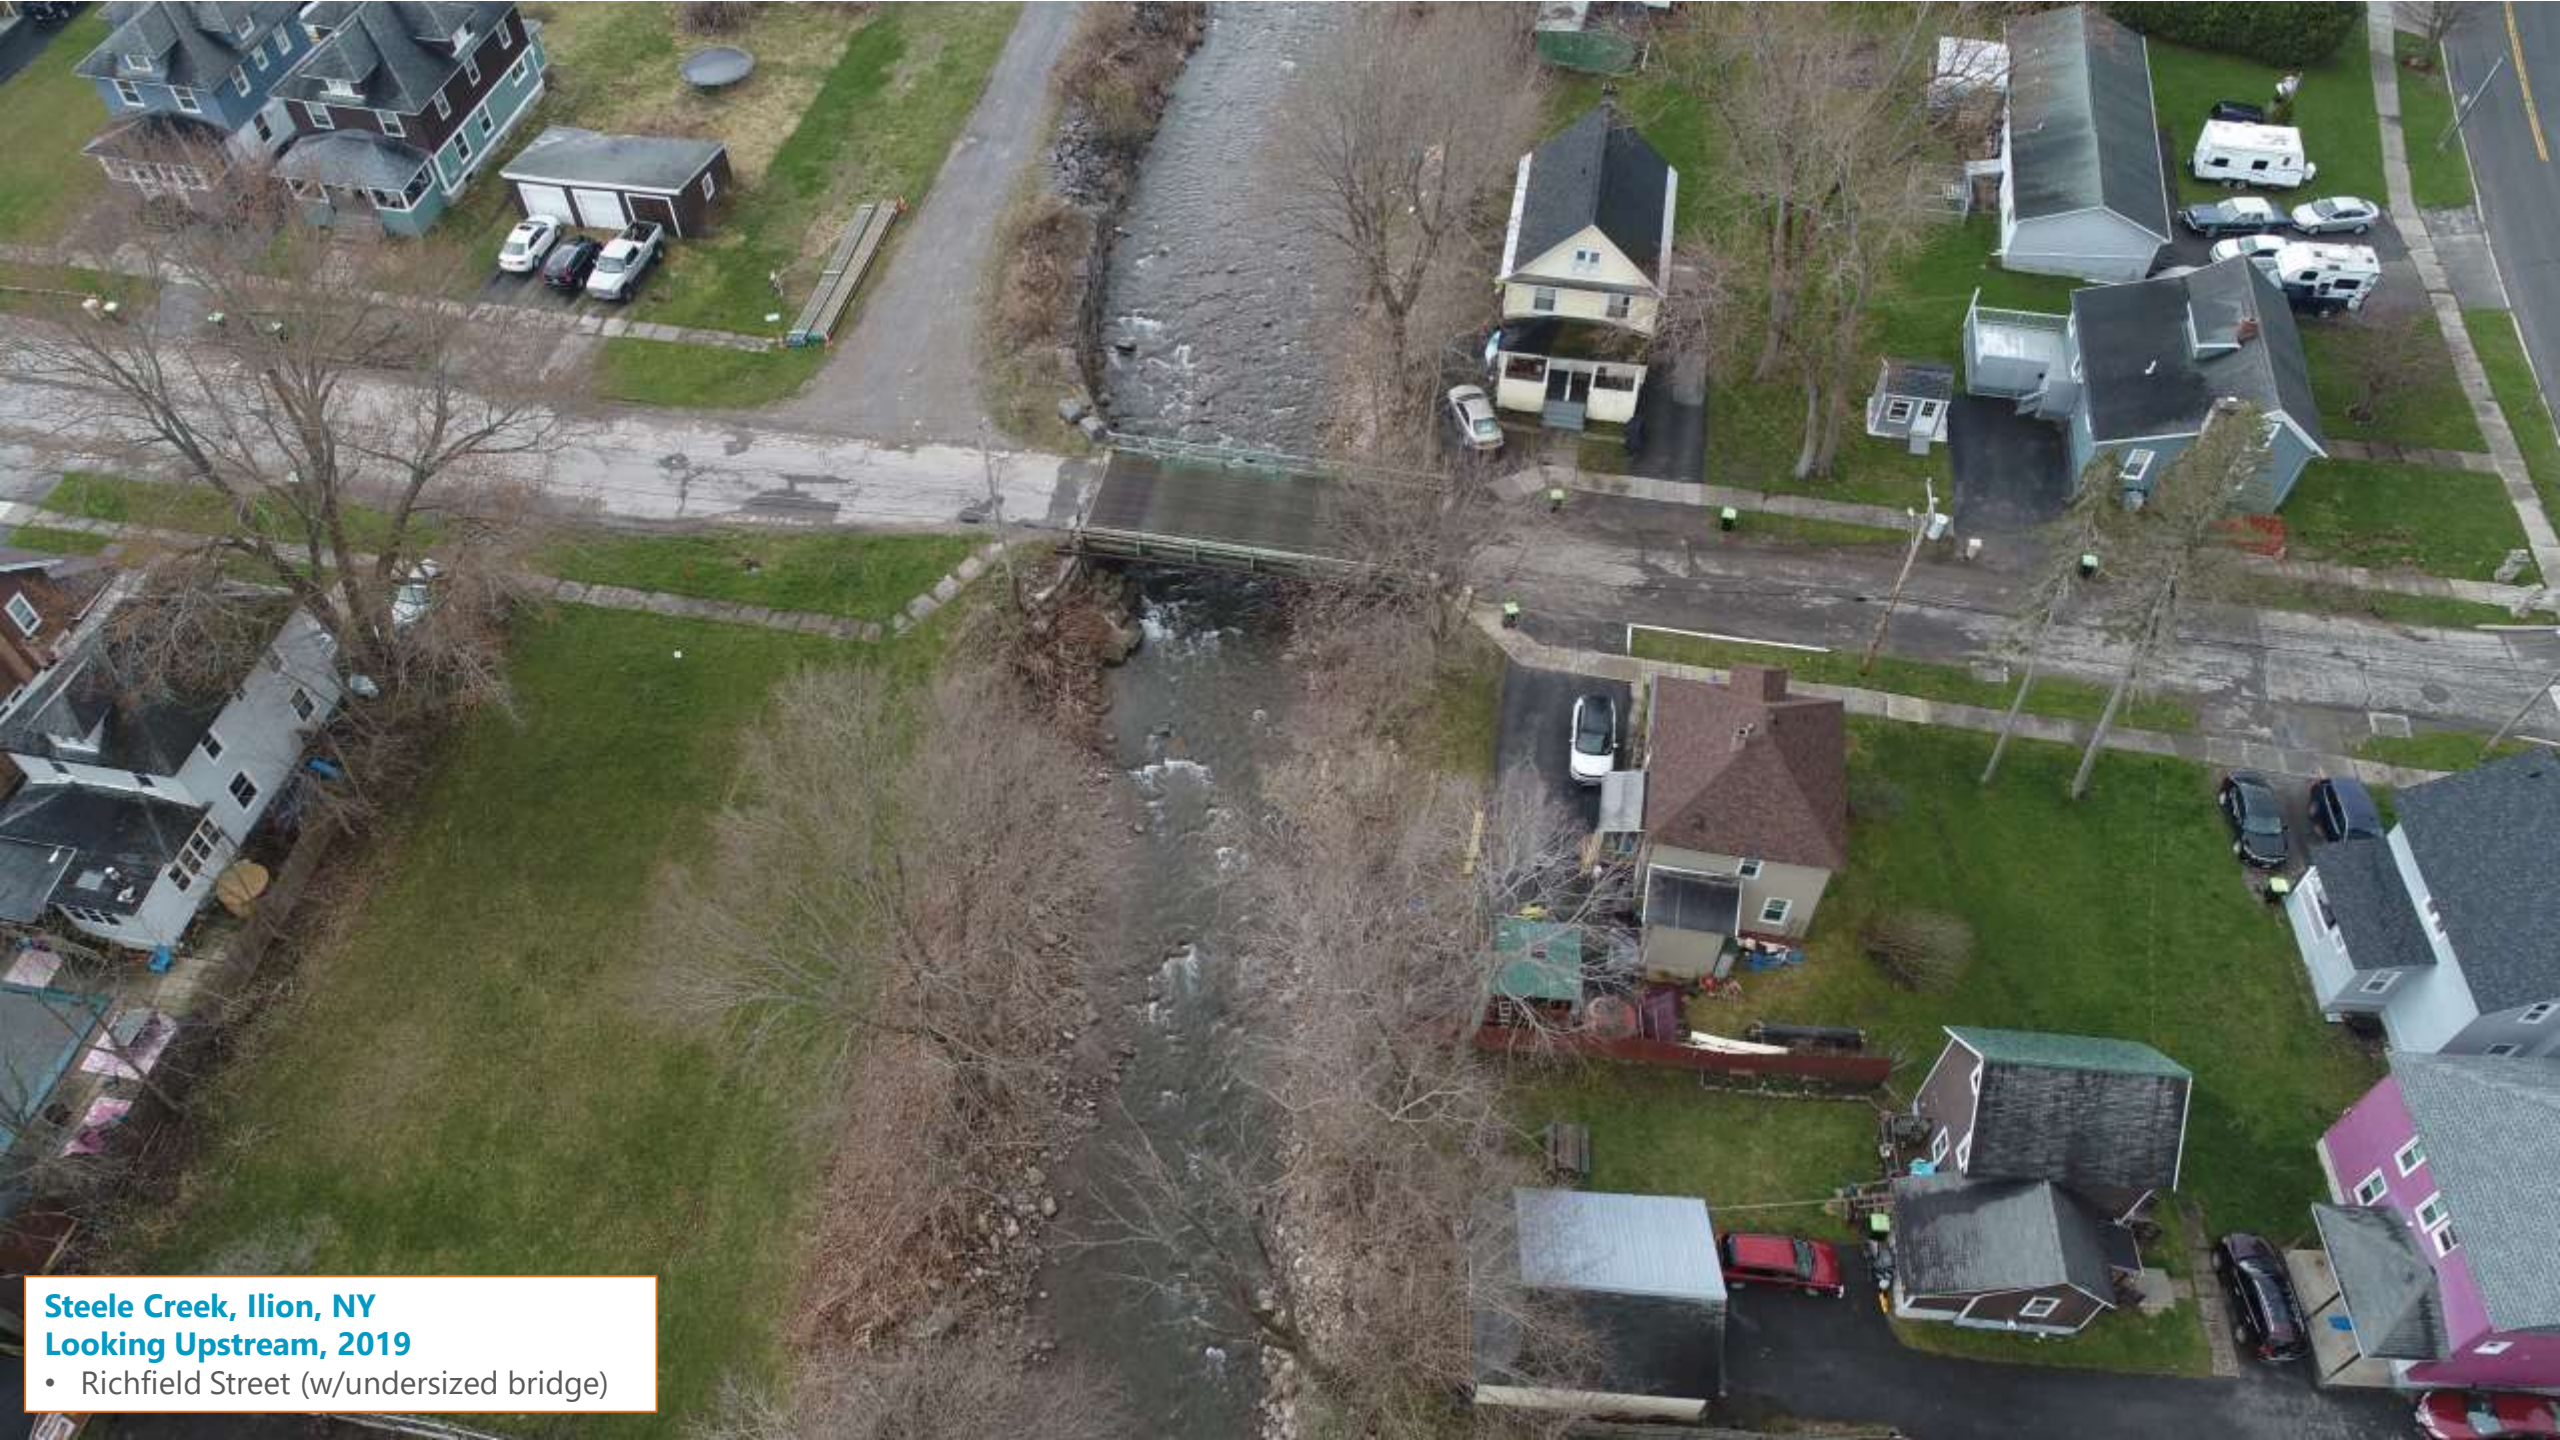
**Steele Creek, Ilion, NY**  
**Looking Upstream, 2019**  
• Richfield Street (w/undersized bridge)

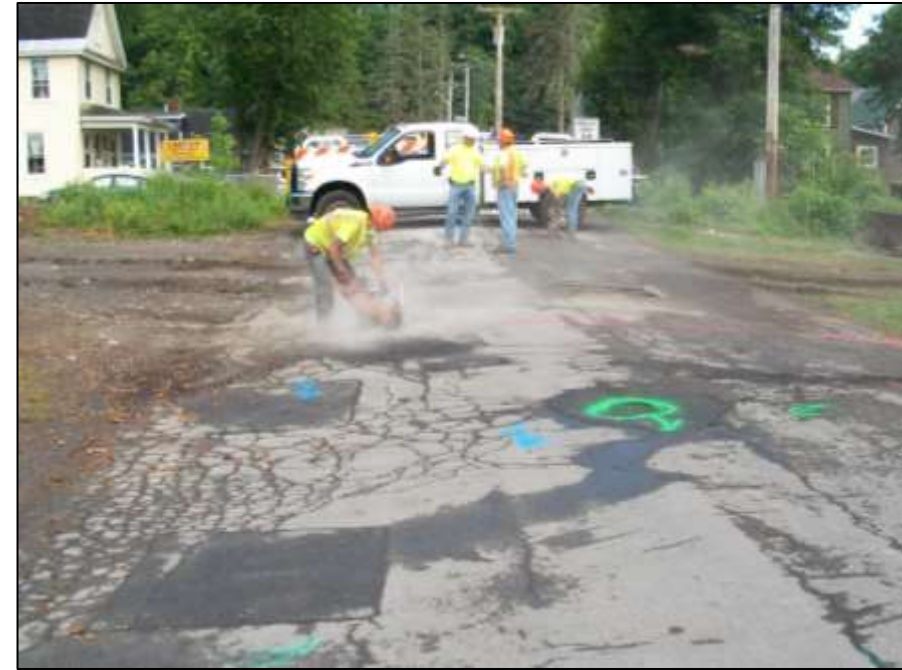
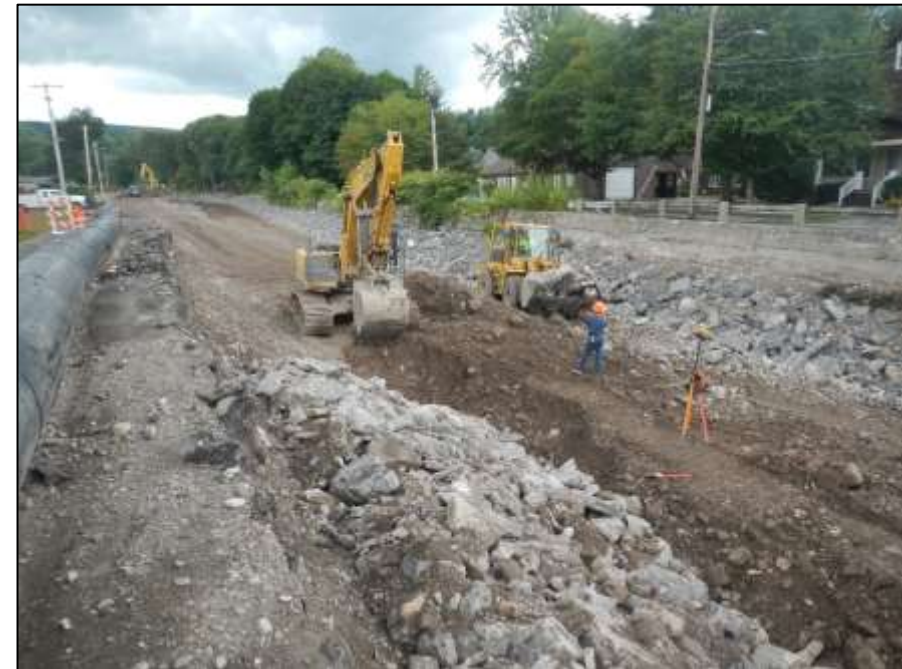
**Top and bottom:** Removal of East River Drive during construction, 2020

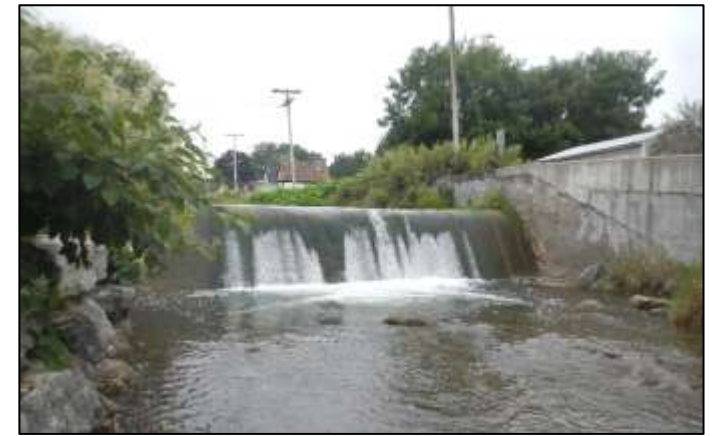
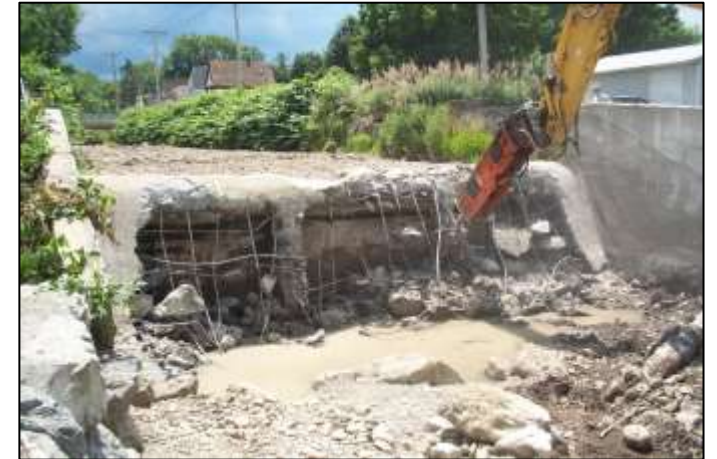
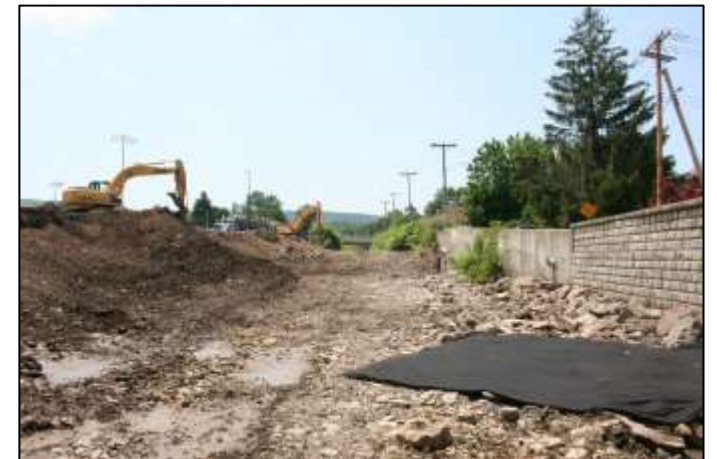
**Top:** Remington Arms Dam, Ilion, NY, before construction, 2019  
**Middle:** During construction, 2020  
**Bottom:** During construction, 2021

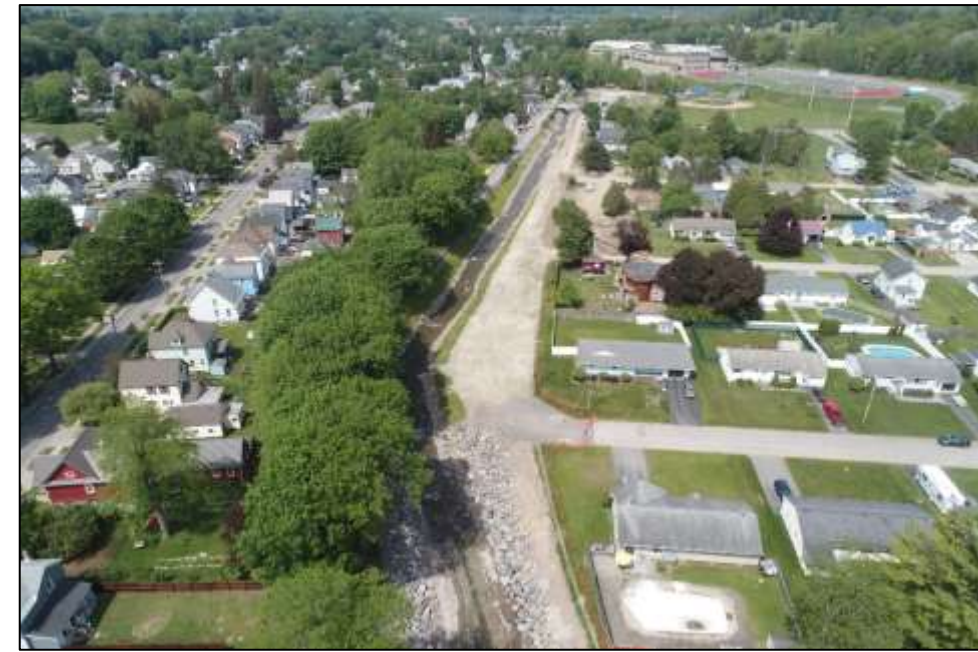
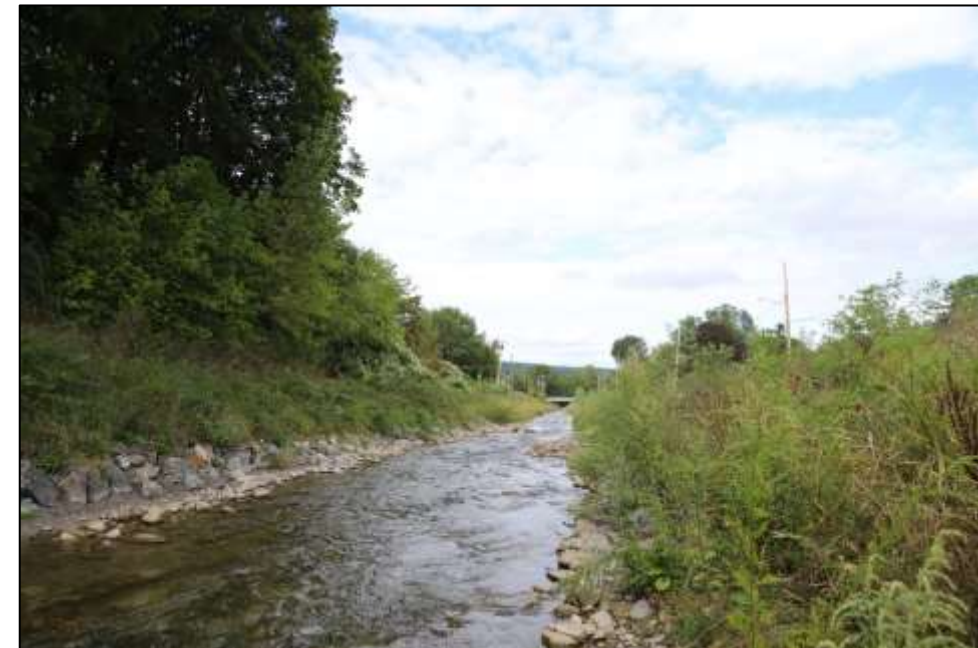
**Top Right:** Steele Creek, Ilion, NY, during construction, 2020  
**Bottom Right:** after construction, 2022

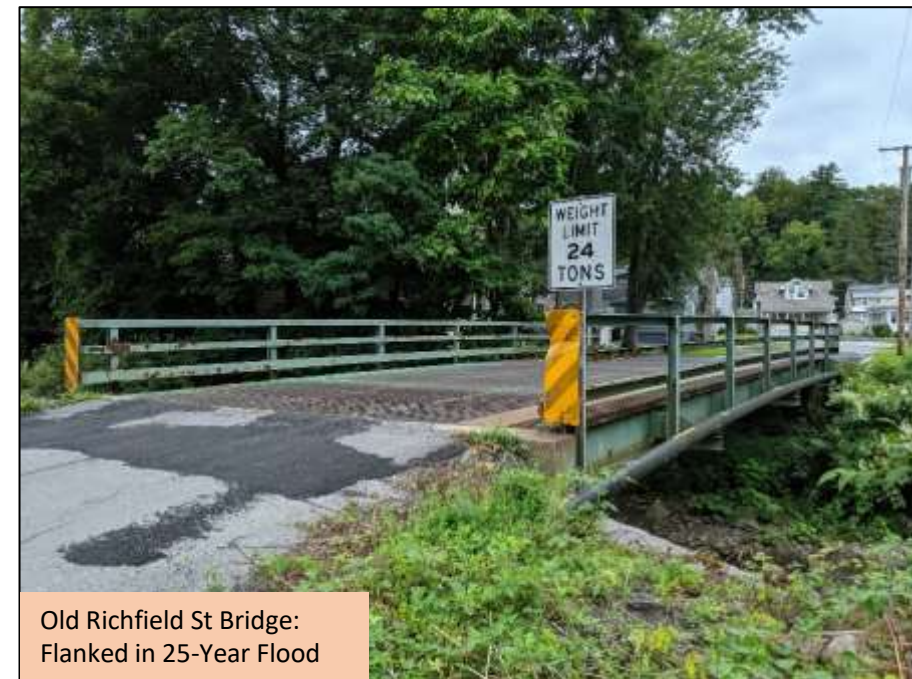
Old Richfield St Bridge:  
Flanked in 25-Year Flood

**Top:** Old Richfield Street Bridge, 2019  
**Bottom:** New Richfield Street Bridge, 2021

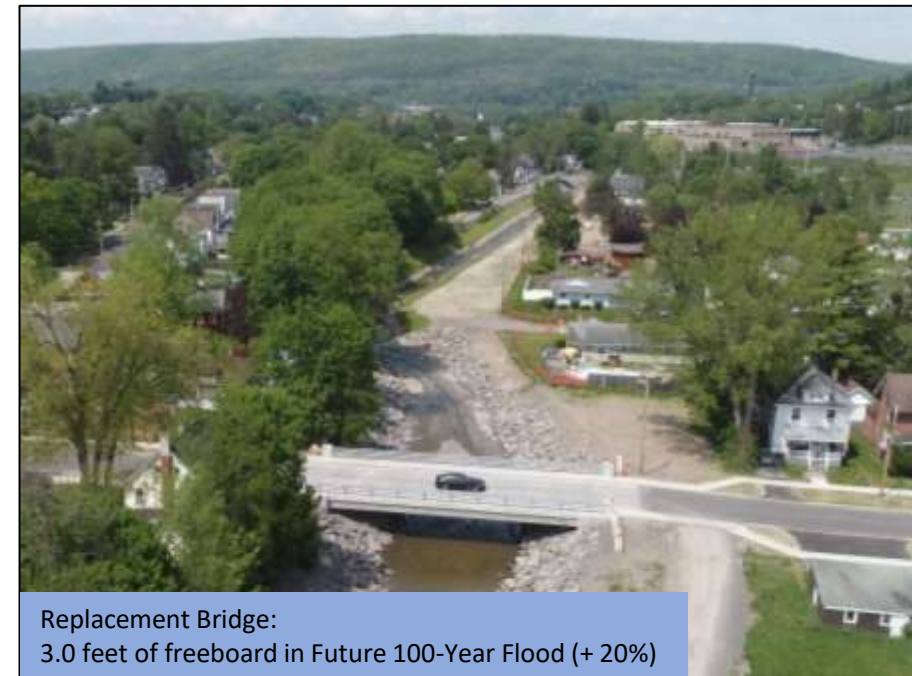
Replacement Bridge:  
3.0 feet of freeboard in Future 100-Year Flood (+ 20%)

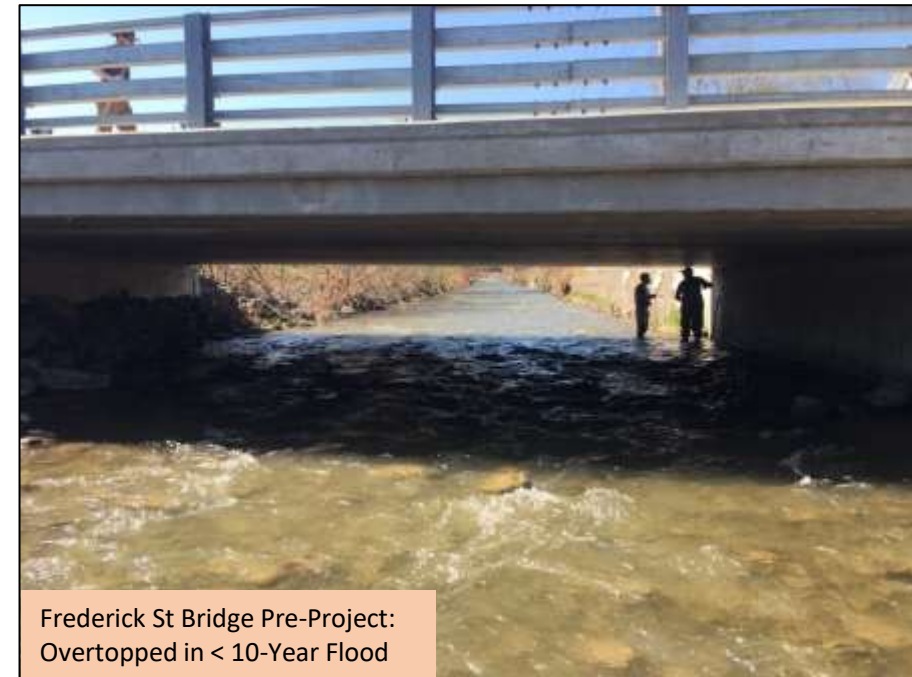
Frederick St Bridge Pre-Project:  
Overtopped in < 10-Year Flood

**Top:** Frederick Street Bridge Pre-Project, 2019  
**Bottom:** Frederick Street Bridge Post-Project, 2021

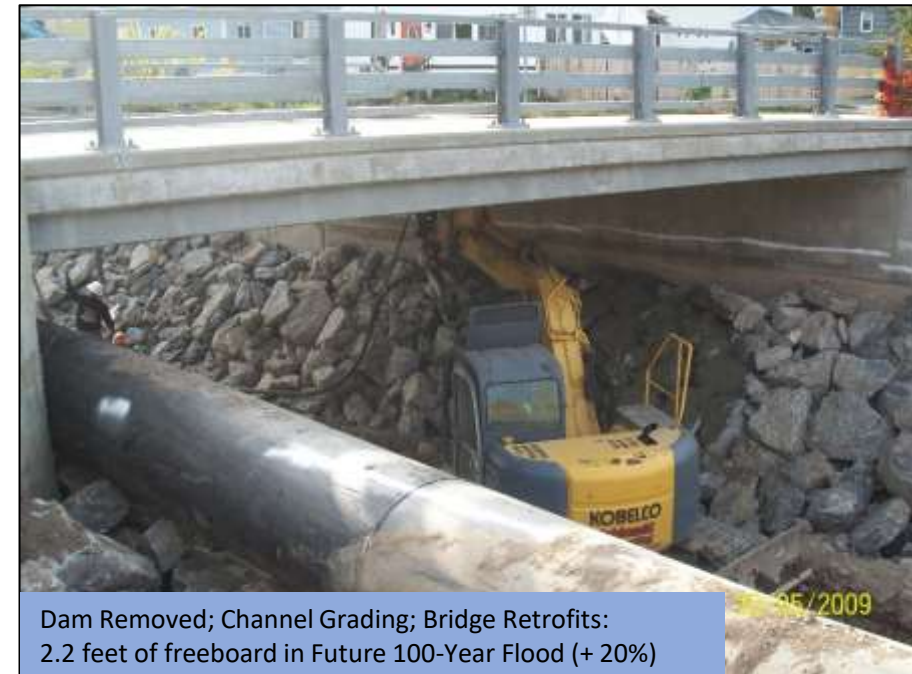
Dam Removed; Channel Grading; Bridge Retrofits:  
2.2 feet of freeboard in Future 100-Year Flood (+ 20%)

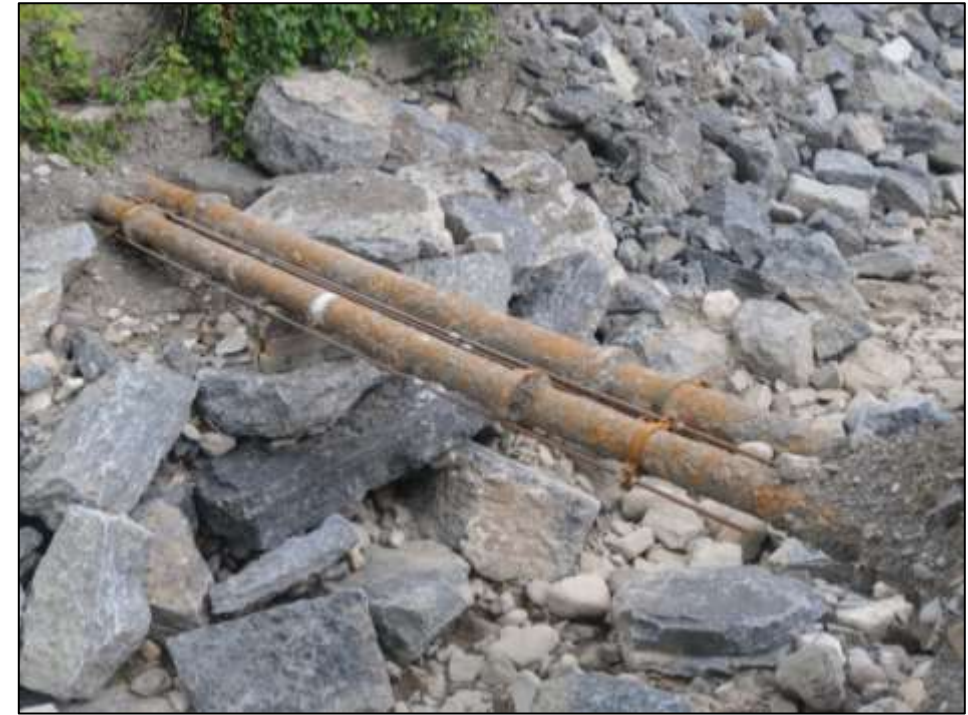
**Top:** Utilities crossing Steele Creek, during construction, 2020

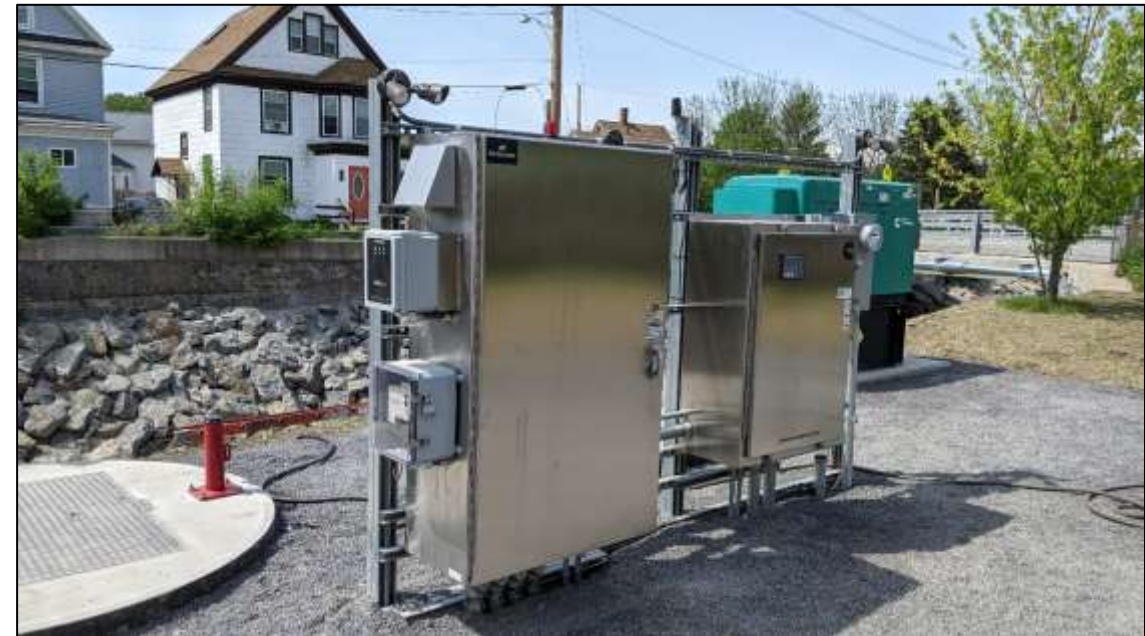
**Bottom:** Sanitary pump station after construction, 2021

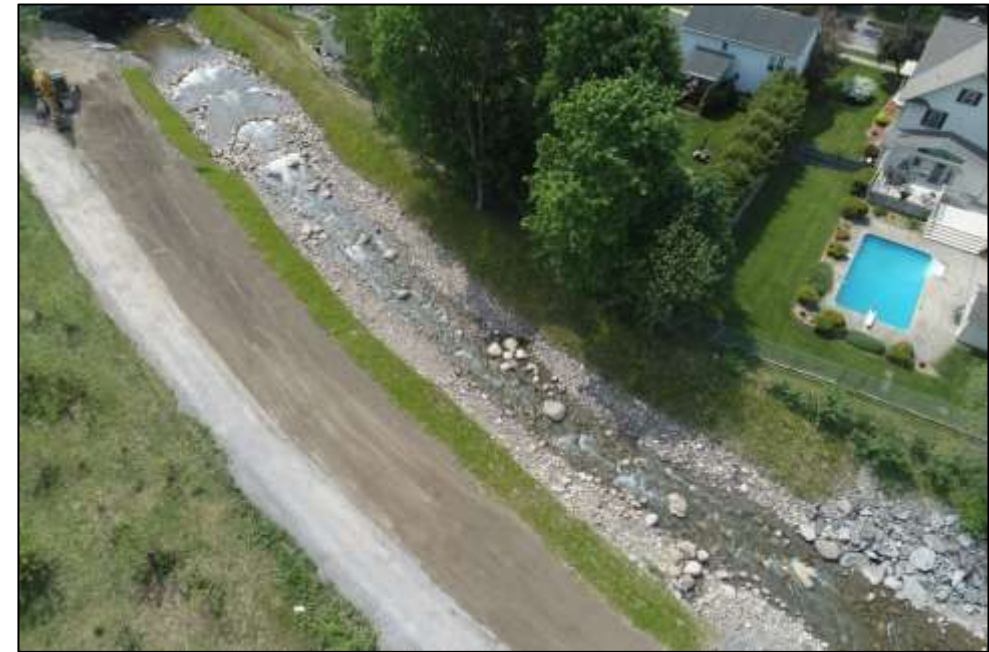
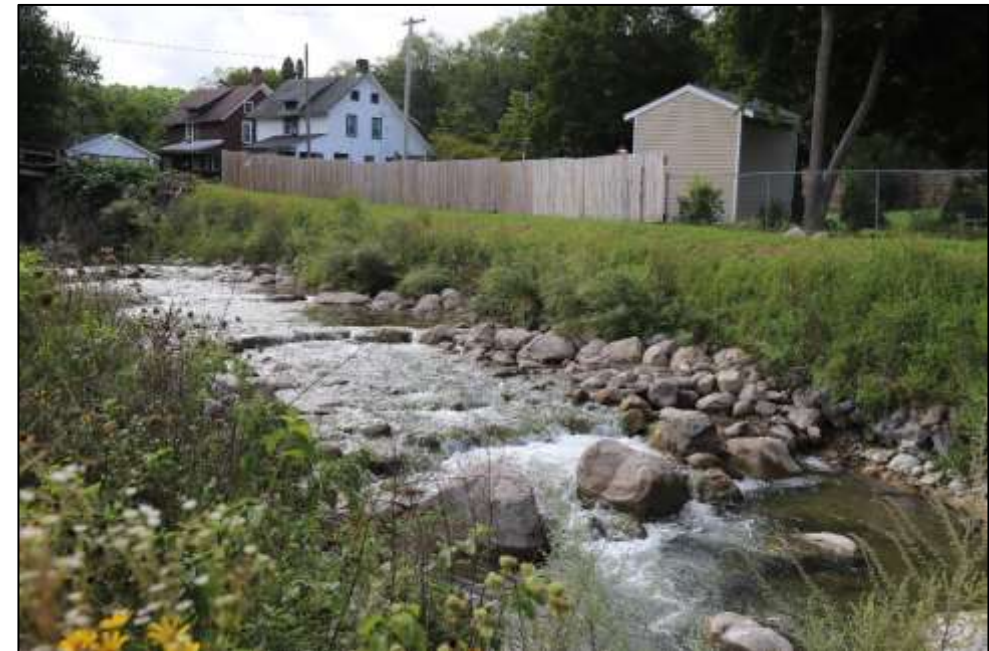
**Top and Bottom:** Steele Creek after construction, 2022
