# Monitoring Kentucky Wetland and Stream Mitigation Projects: Past, Present and Future

National Stream  
Restoration Conference  
August 2022

Mitchell Boles & Bethany Mulhall  
Kentucky Department of Fish  
and Wildlife Resources  
Kentucky Wetland and Stream  
Mitigation Program  
Frankfort, KY

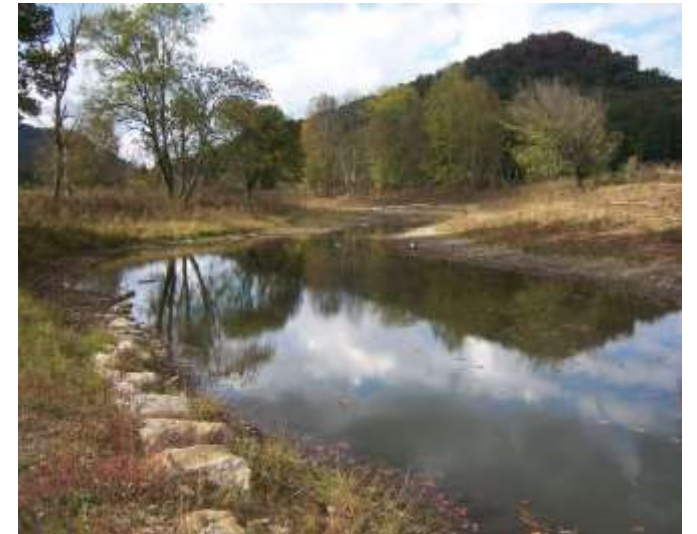
Year 1 Monitoring Report (2008)  
Red Lick Stream Restoration Project  
(Estill Co.)

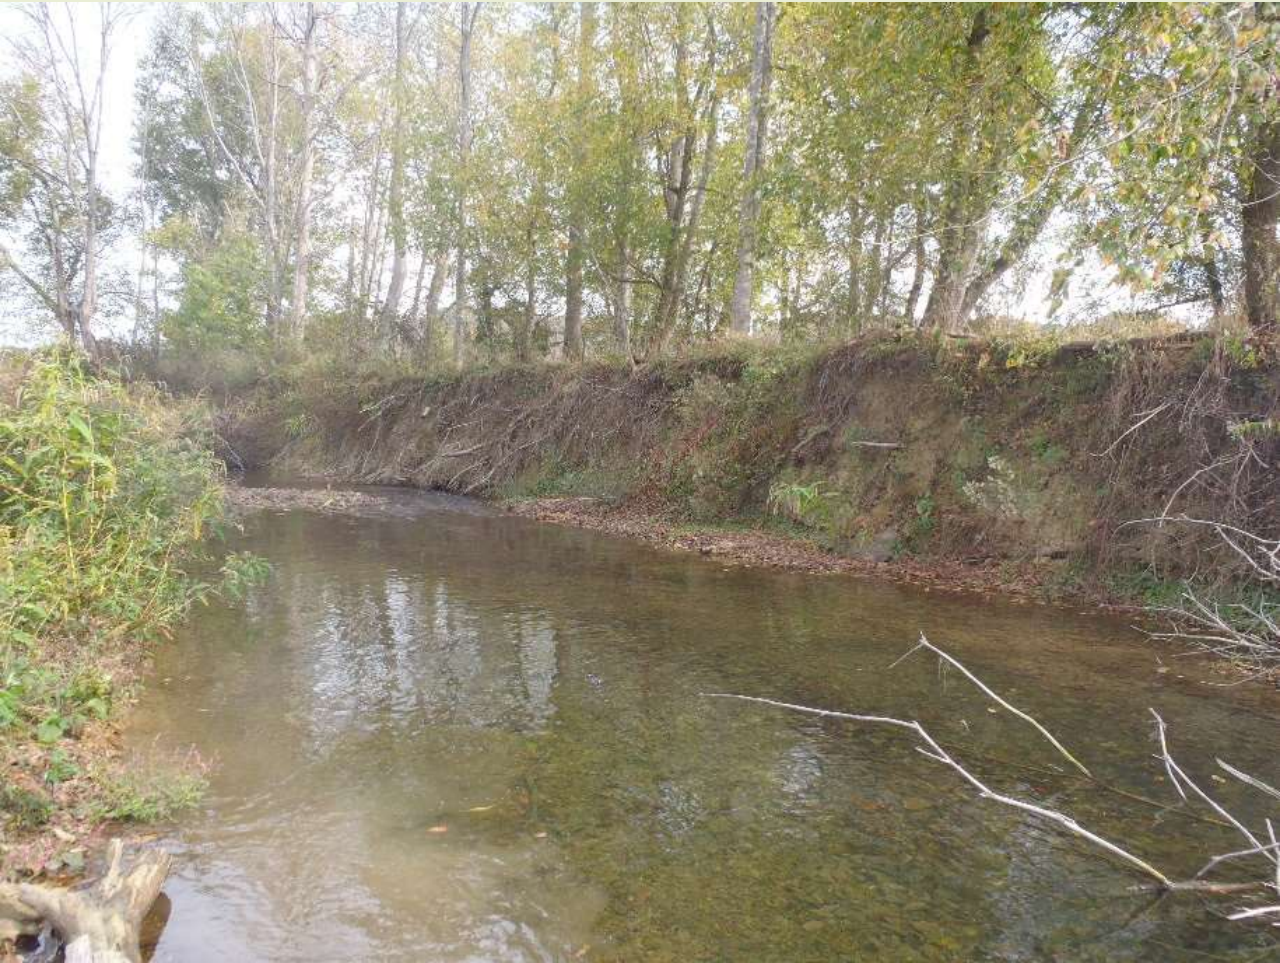
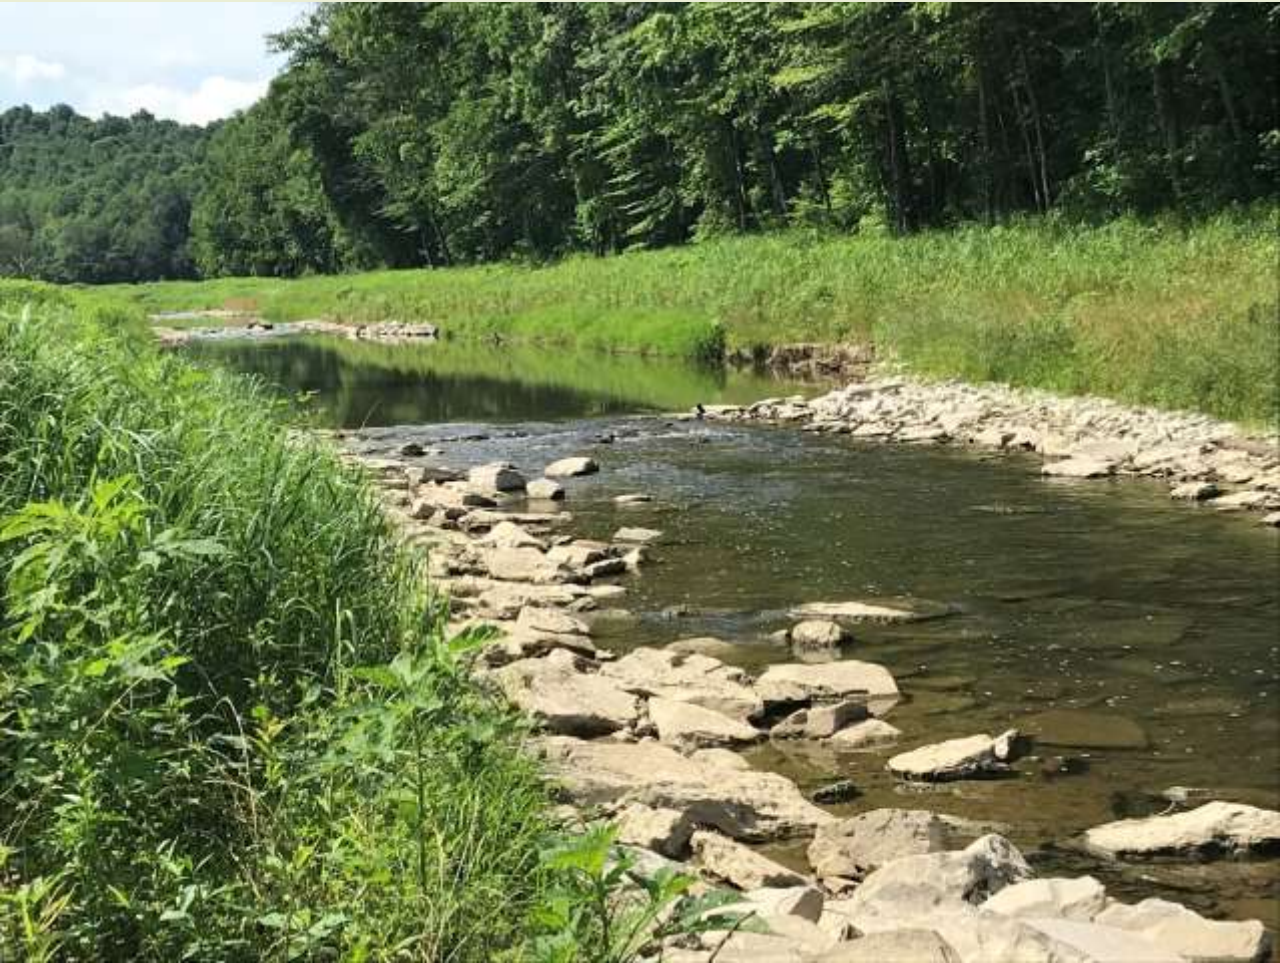
## Mitigation Project Monitoring Case Study: Goose Creek

- Drainage Area: 42.3 sq. mi.
- 13,226 ft. of Stream Restored
- 8.6 ac of Wetland Restored

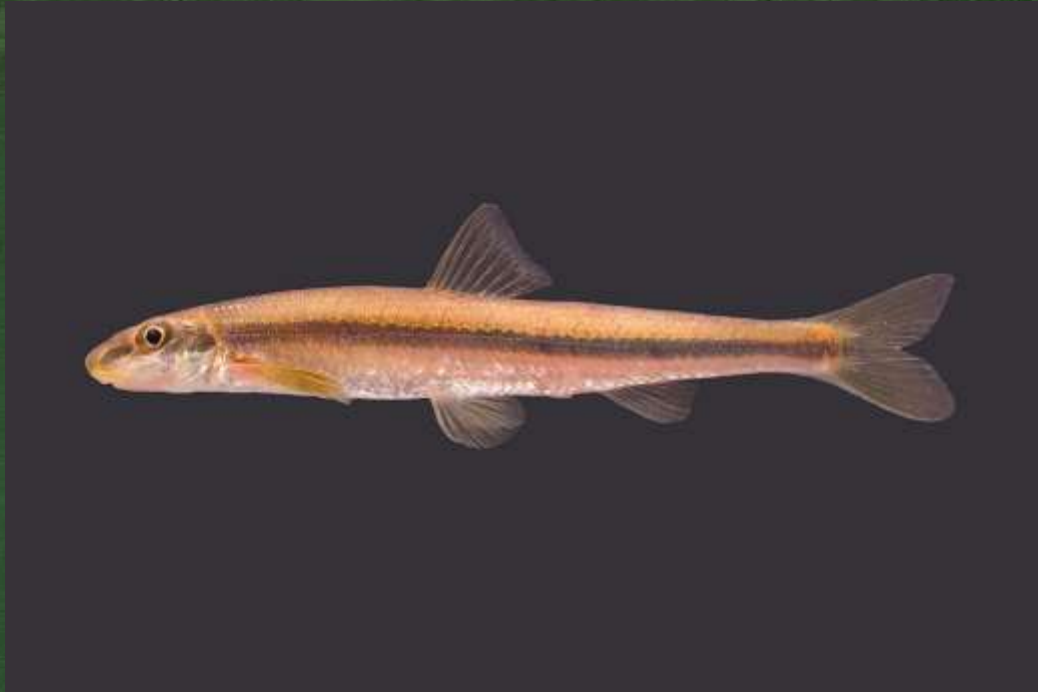
# Stargazing Minnow

## *Phenacobius uranops*

“Clear Water”

“Clean Pebbles or Gravel”

“Riffles and Runs”

“Species of Special Concern”
