NCD For Extreme Event Restoration- Improved Resilience

Thomas Graupensperger

2022 First National Stream Restoration Conference
August 02, 2022

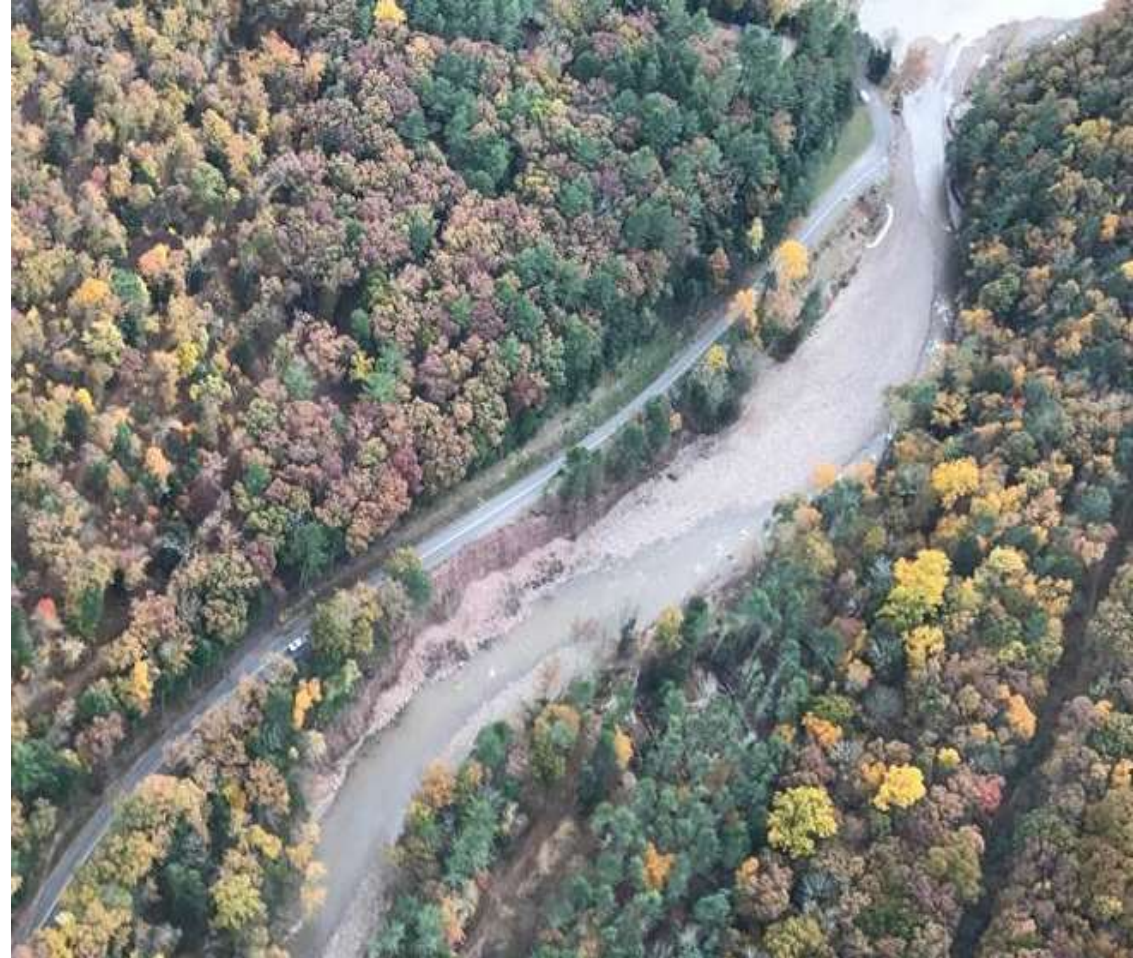
Confined Valley: Post-Extreme Event Below

- Confined Valley Floodplain-Floodprone Reach w/ Low Sinuosity
- Infrastructure- Roadway Embankment Encroachments present along Confined Valley Channel
- Reaches Typically Discharge to Receiving Stream Channel Confluence or its Floodplain
- Downstream Receiving Reach Characteristically Lower Gradient Channel Slope and/or Wider Level Floodplain Area
- Lower Gradient Results in Downstream Receiving Confluence Zone Transitional-Depositional Reach
- Bridges, Culverts and Roadways- Along or Across Channel Lacking Capacity-Result in Scour & Aggraded/Depositional Zones
- Long-Term Historical use of Adjacent Roadway and Bridge Crossings Typically Areas of Multiple Prior Replacements
- Diminished Capacity of Structure Crossing Results in Increased Maintenance(Debris-Sediment Removal) Following Flood Events

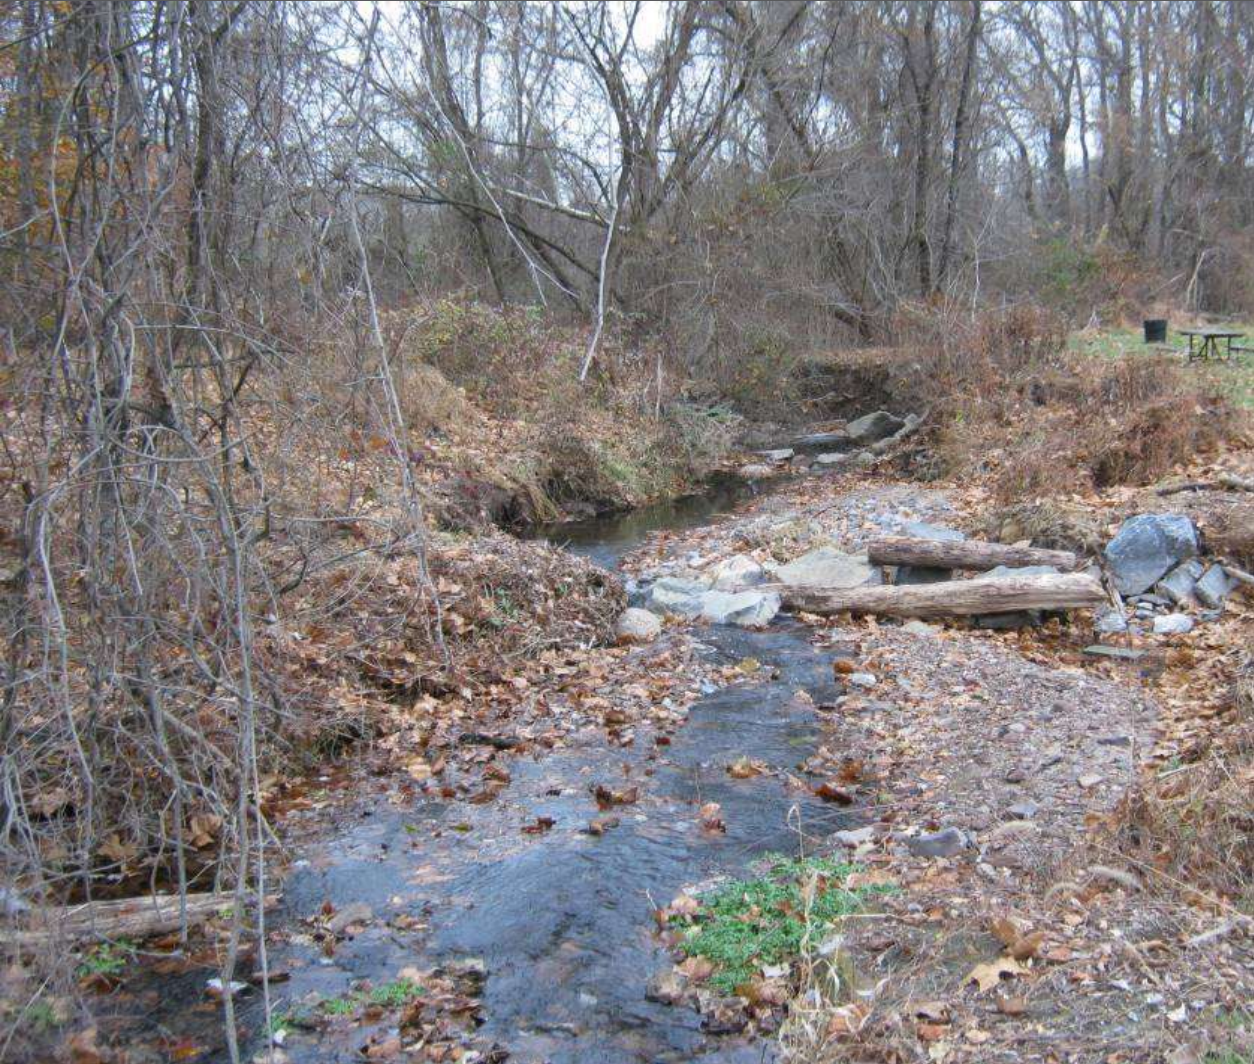
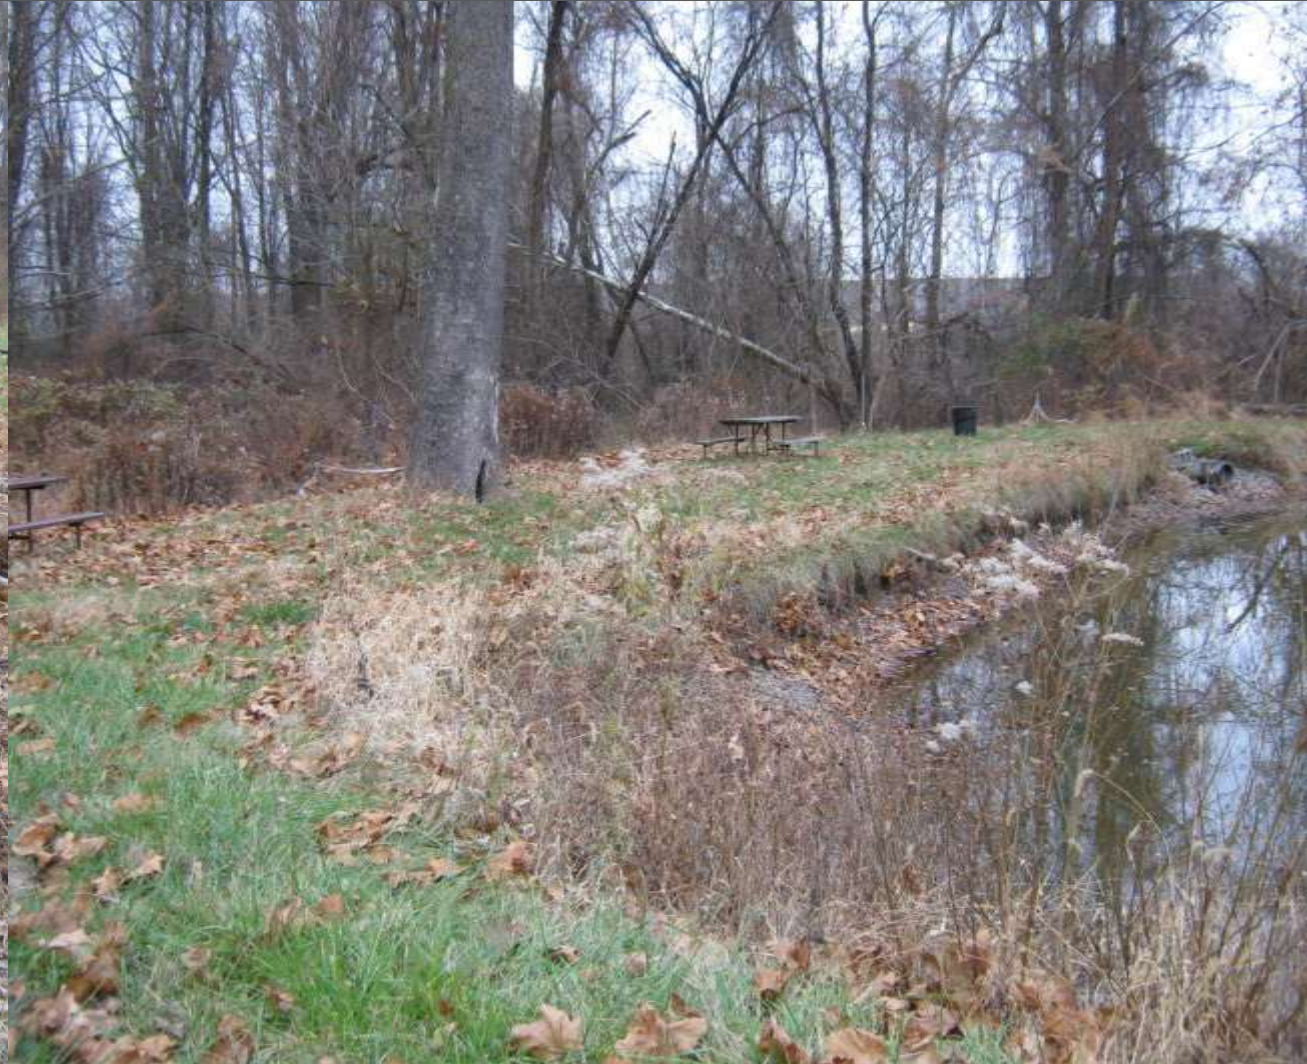
Unstable-Impaired-Disconnected Stream Channels

Historic Prior Fill Placed in Left Bank

Pond Embankment Right Bank

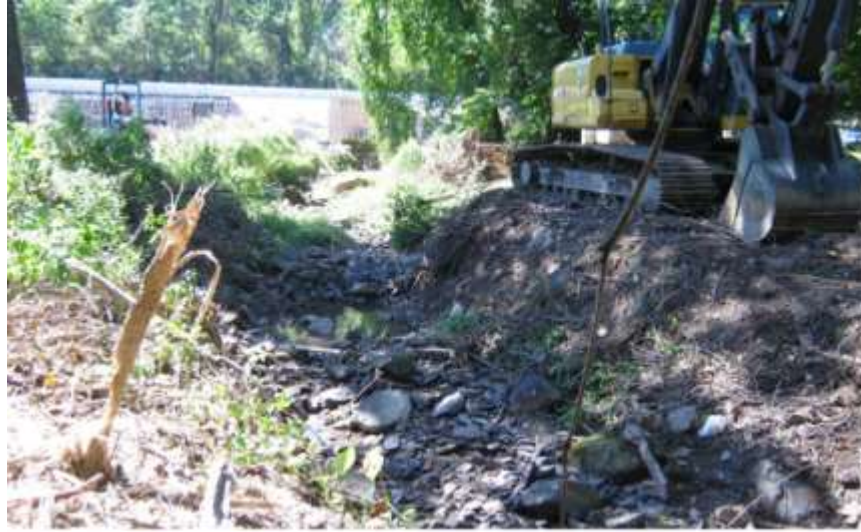
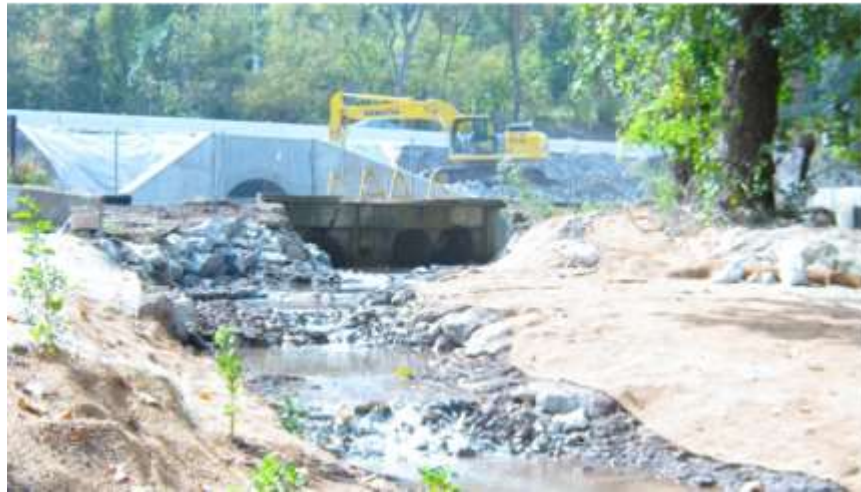
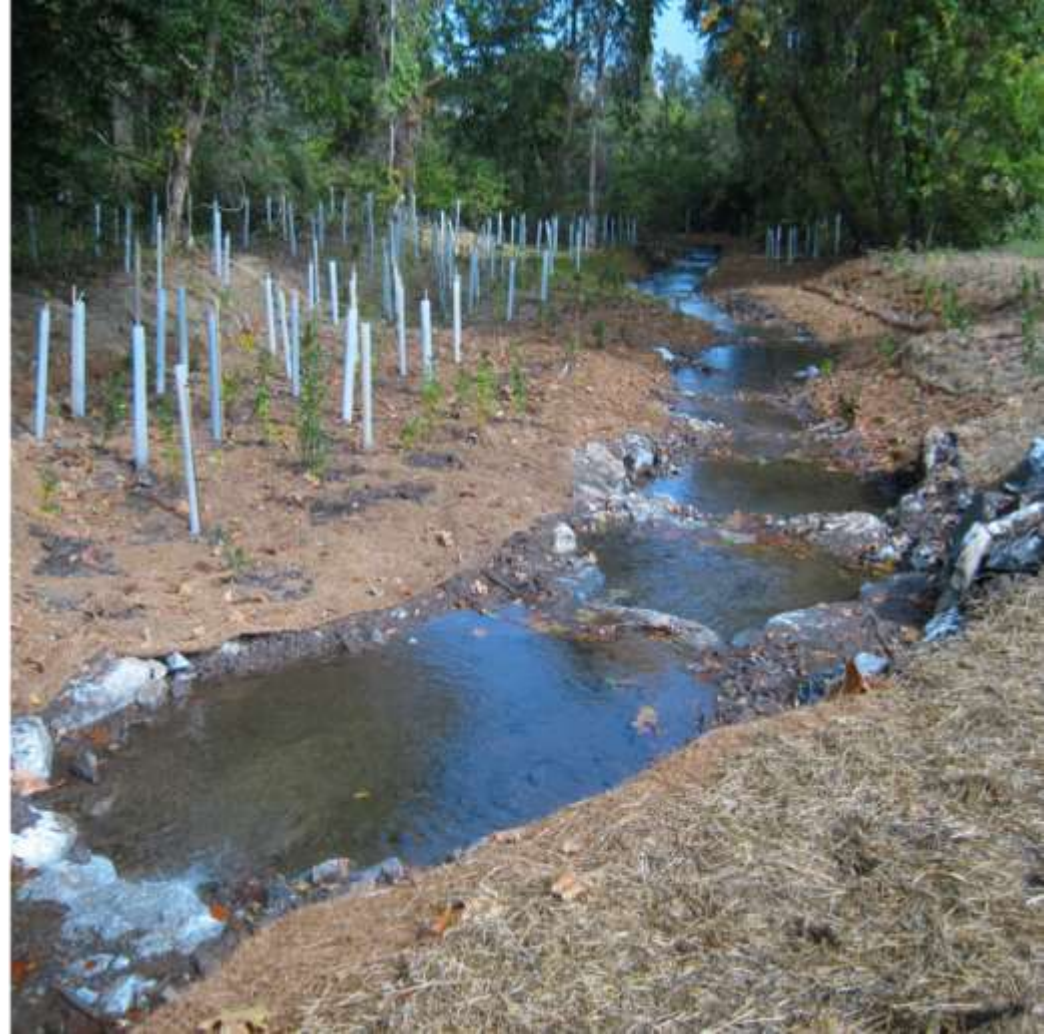
NCD Stream Restoration – Bankfull Bench & Floodplain Reconnection

*Provides: Outfall Step-Pool Stability / Storm-Flood Hazard Mitigation / Sediment Retention- TMDLs
Treats 1st -3rd Order Stream Channels, Riparian Restoration, Reduced Velocity: Scour and Shear: Erosion*

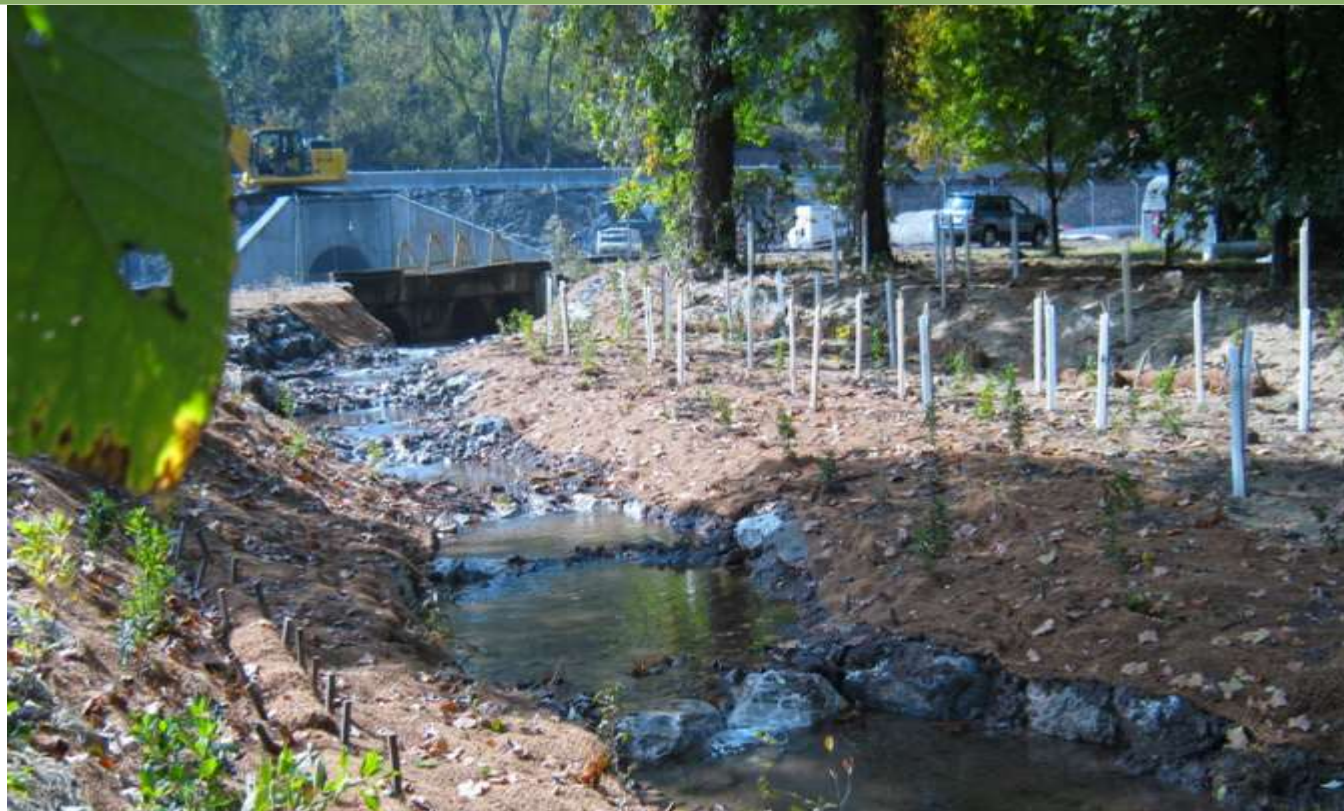
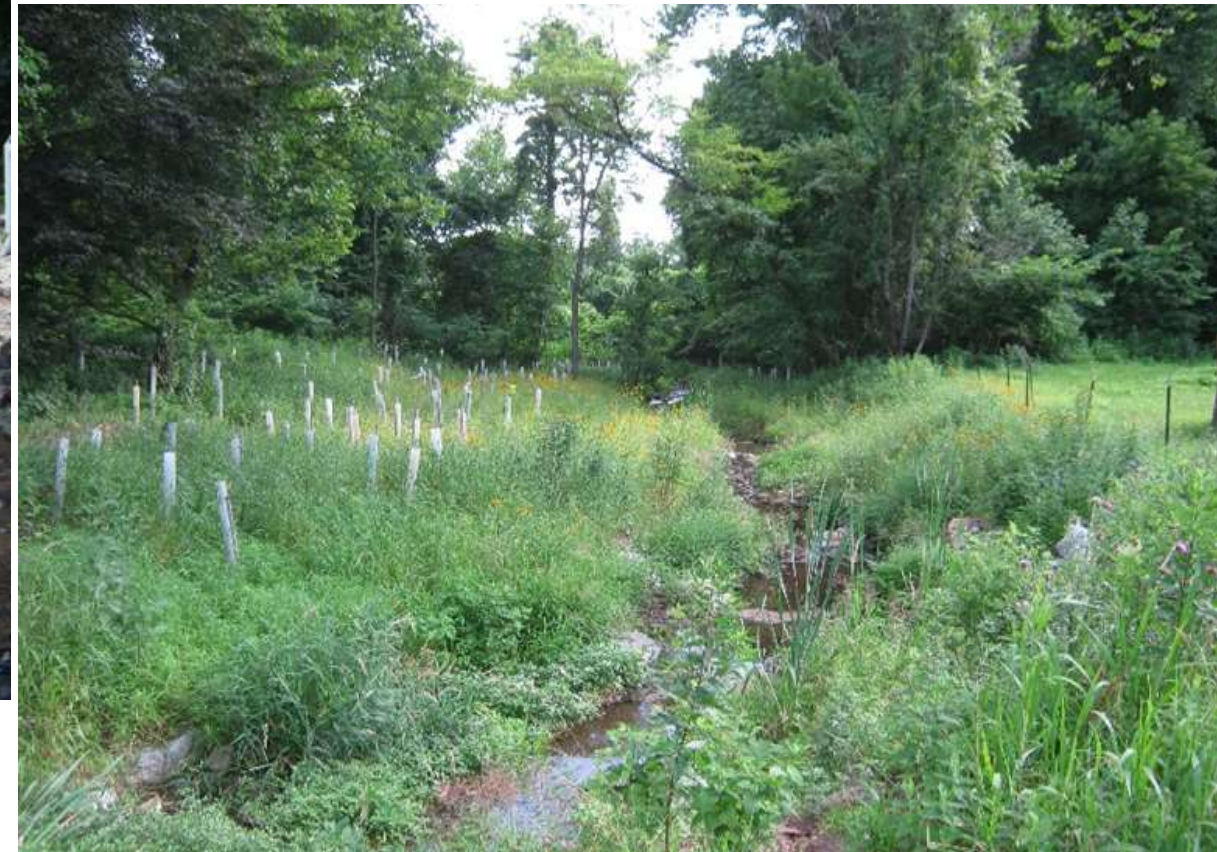
Upstream Culvert and Highway Construction

NCD Downstream One Year Later (2017)

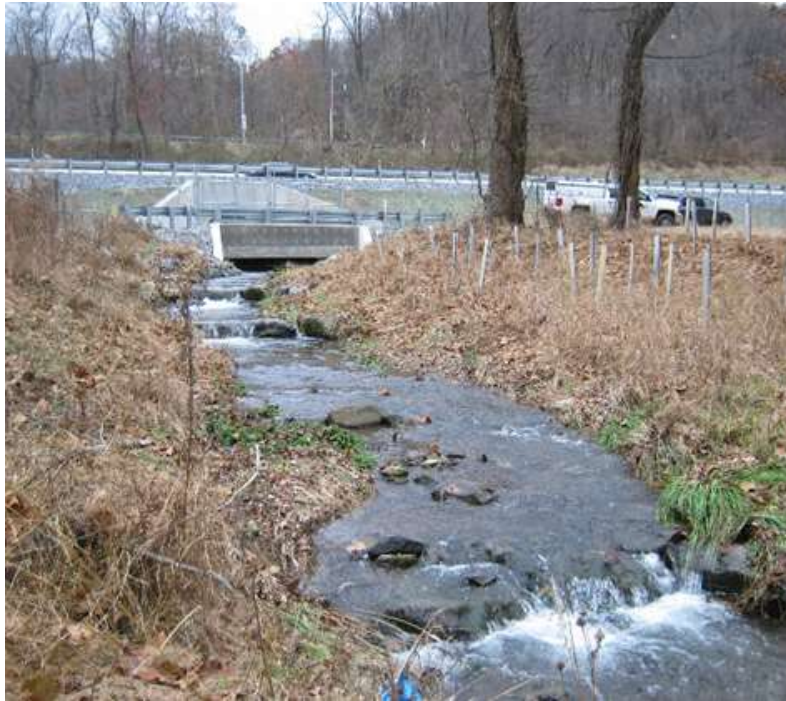
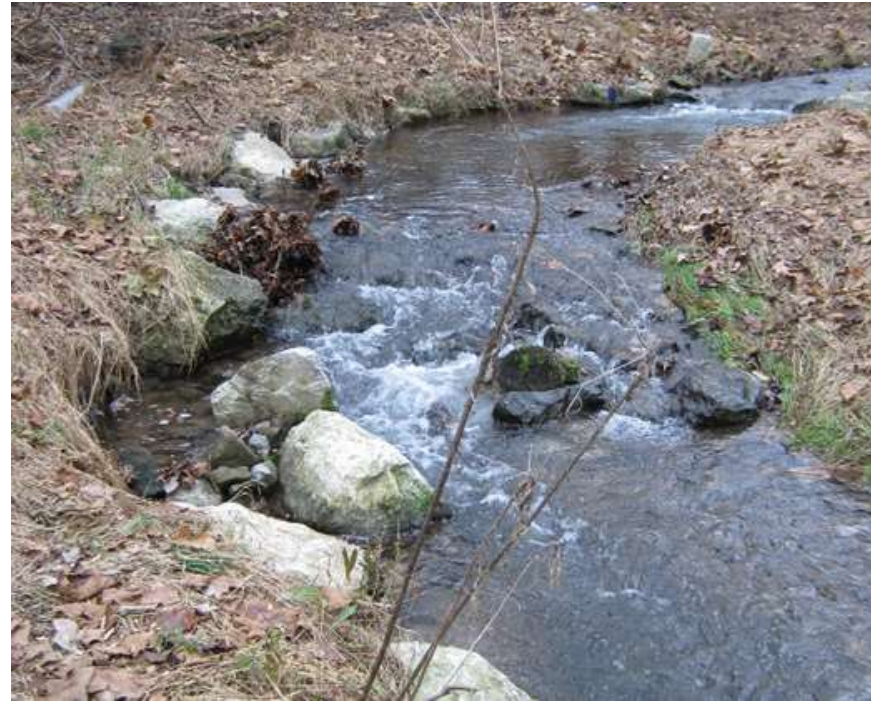
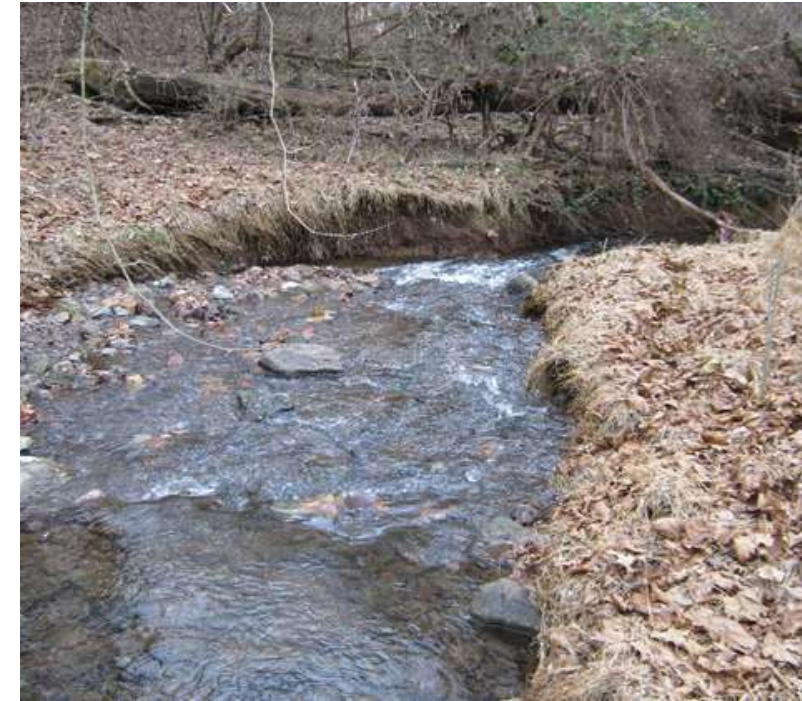
Stream Restoration (11-2018) Extreme Event Impacts

*2018 into Early 2019 : 12 Rainfall Events greater than 1" in 24 Hours- Many 0.25-0.5 iph
(Central PA 2018 Rainfall 67"+ / Average Annual Rainfall is 42")*

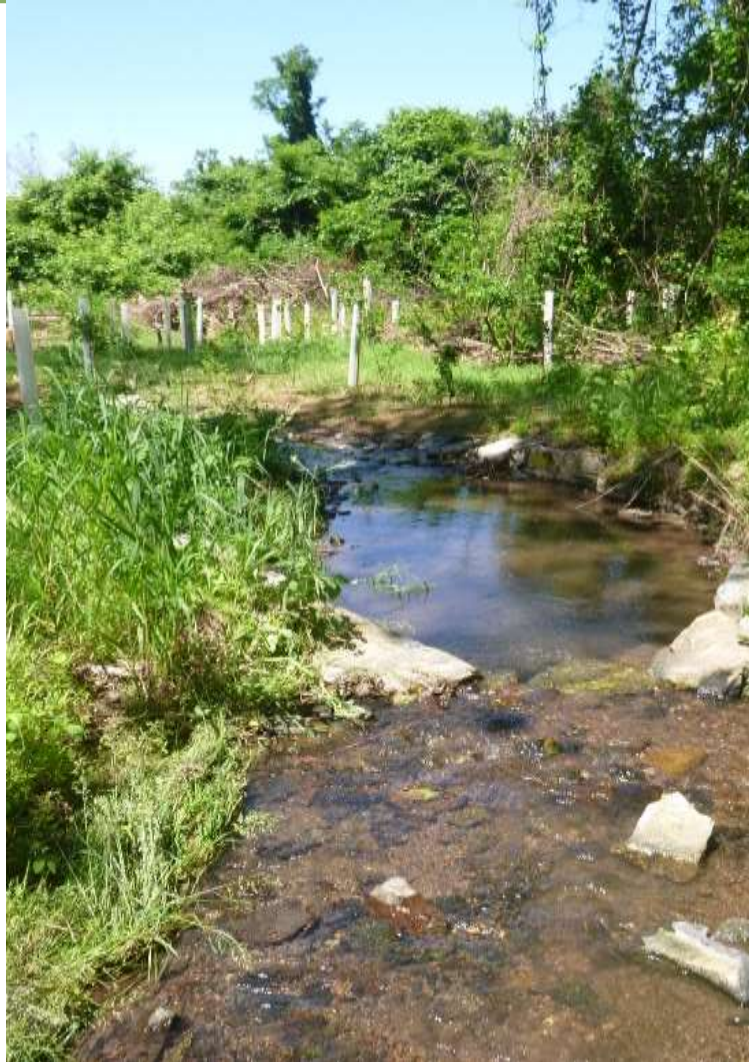
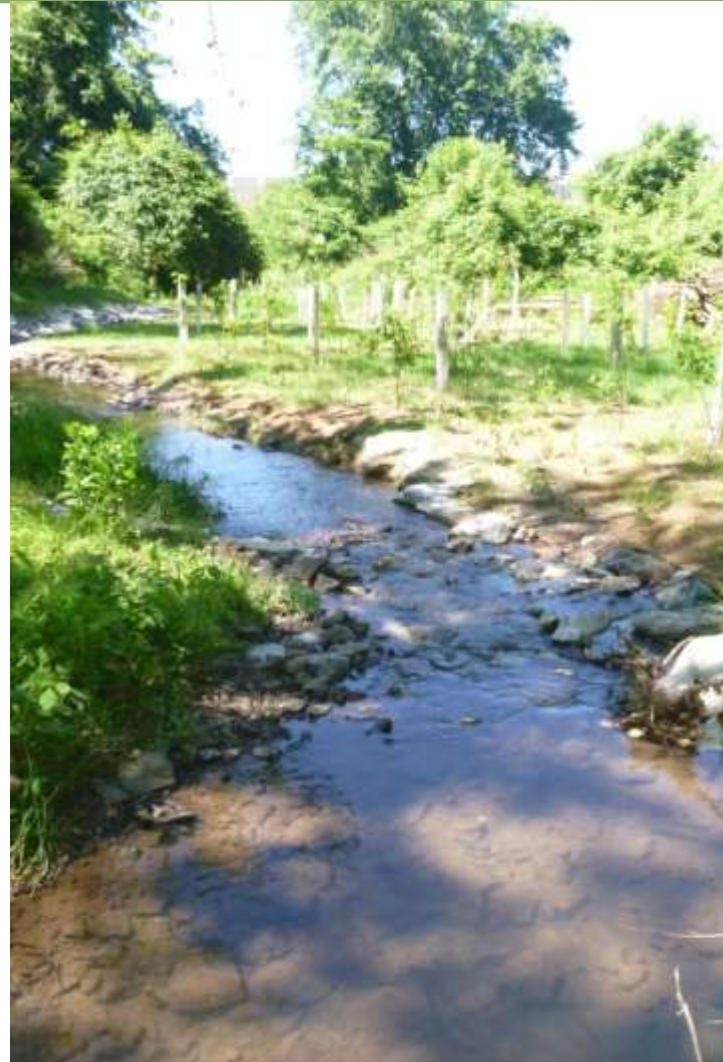
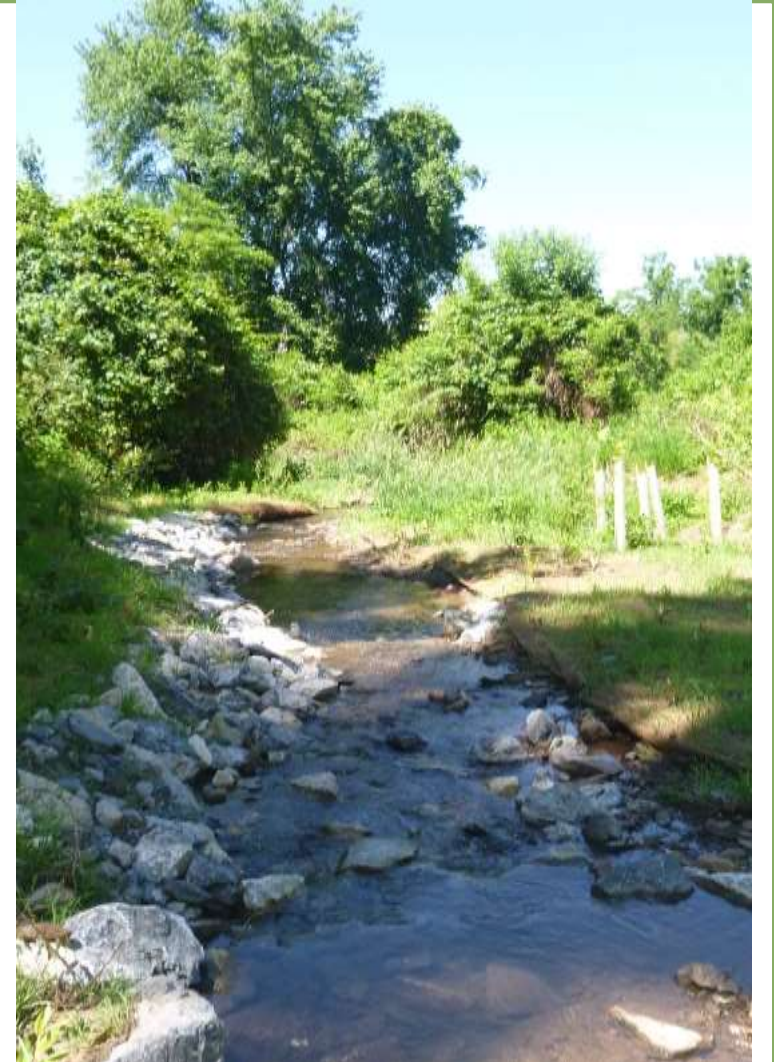
Stream Repairs - Bankfull Bench Restored May 2020

Post 2018 PA Rainfall 67"+ Multiple Extreme Events (Average Annual 42")

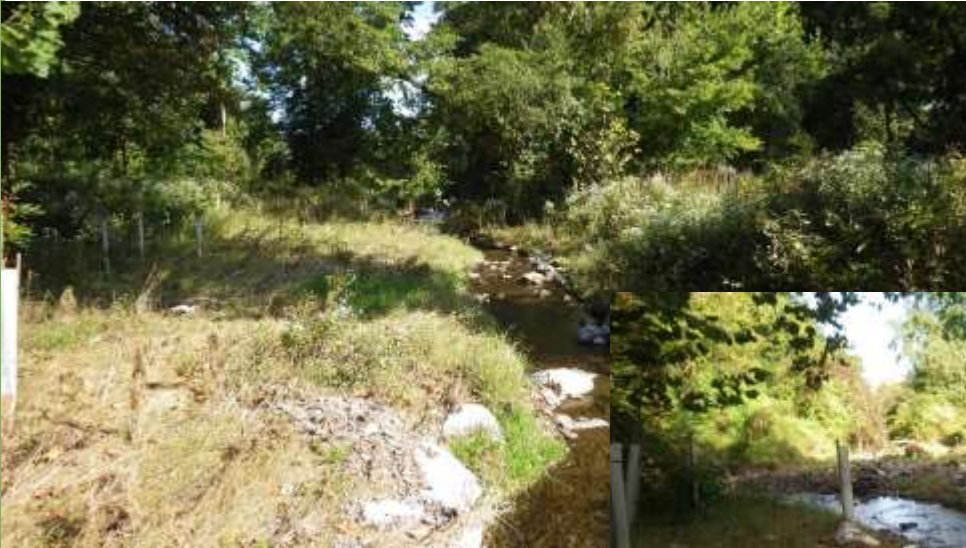
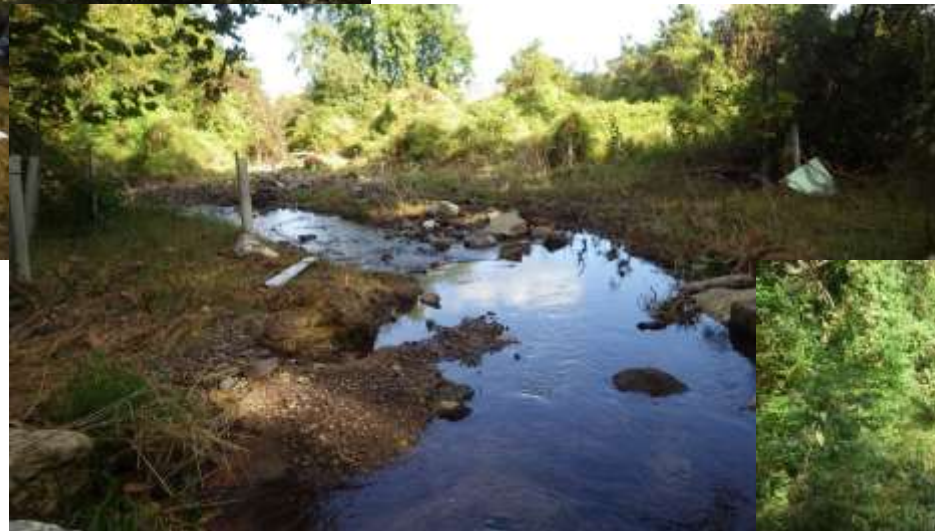
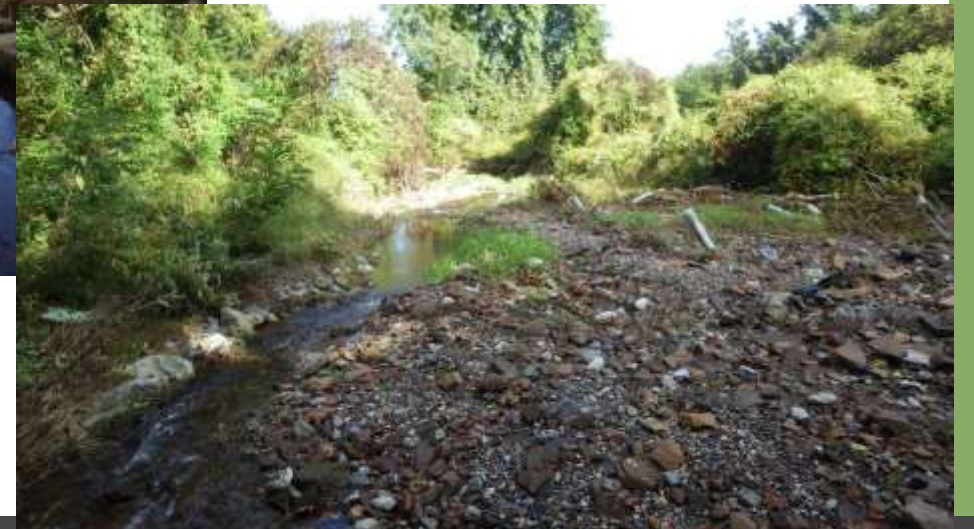
Stream Restoration: Post-Ida Repairs Resulting From Upstream Embankment Failure

Restored Area Downstream Deposition
September 1, 2021 Tropical Storm Ida 5"+ Rainfall in 17 Hours (2 Periods @ 0.92 iph)

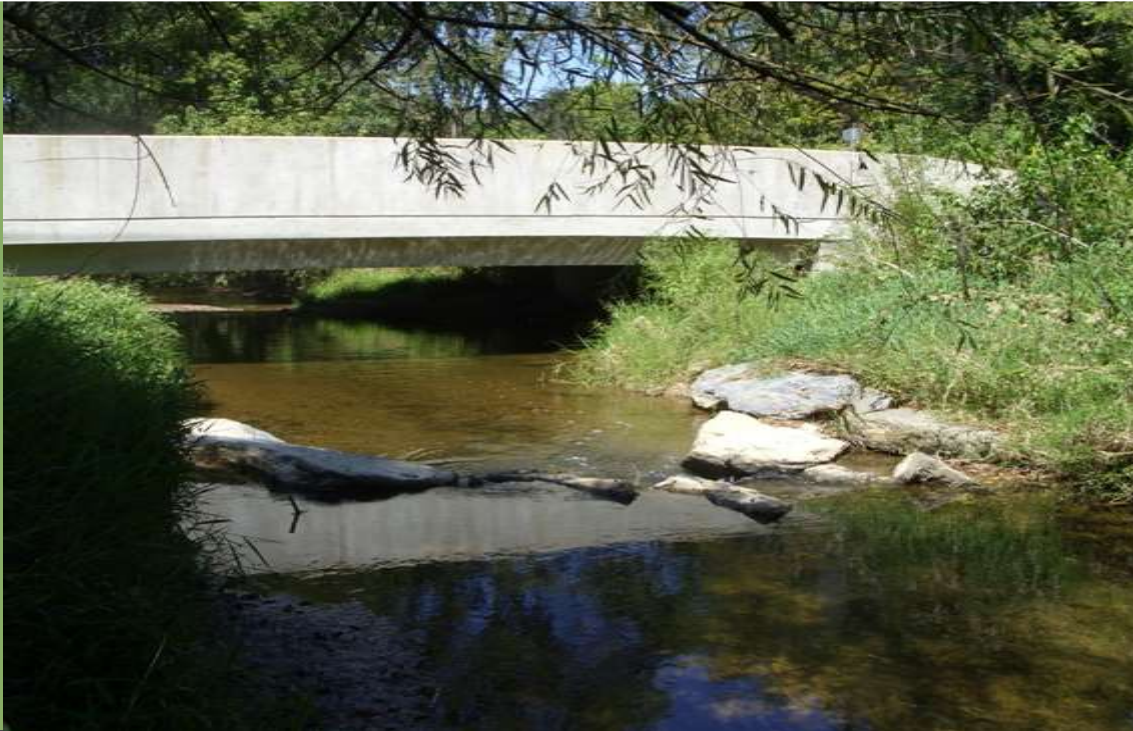
Bridge Scour Assessment for Sediment Load and Risk Reduction

Scour undermines bridges and may cause bridge failures due to structural instability. **In the last 30 years, more than 1,000 bridges collapsed in the U.S. and about 60% of the failures are related to the scour of bridge foundations.**

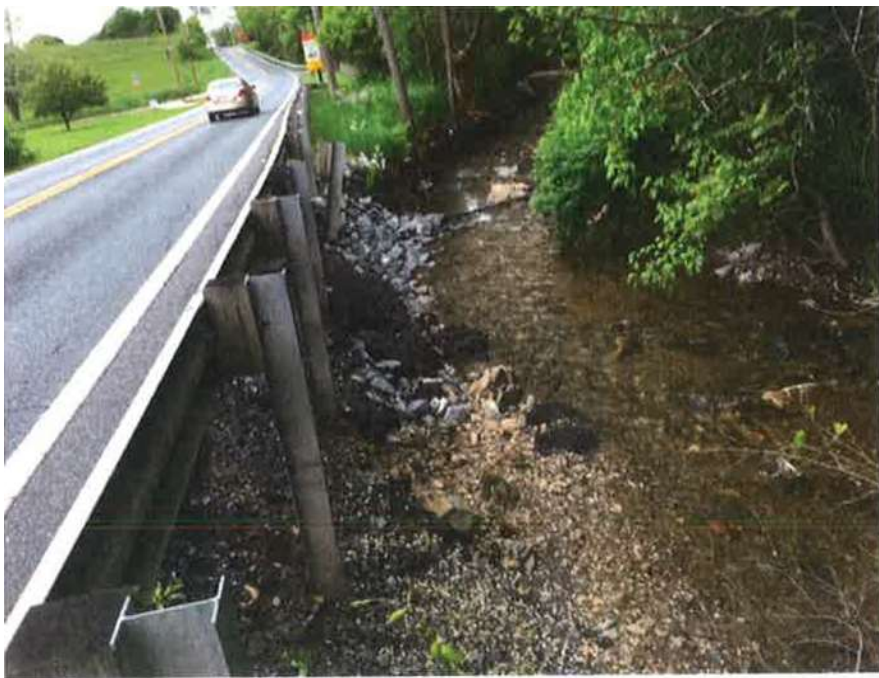
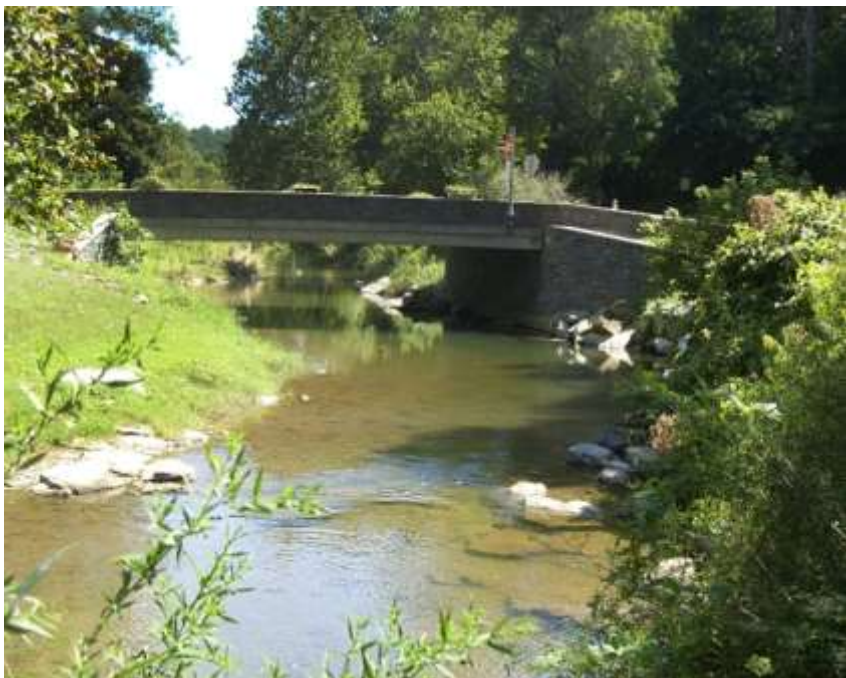
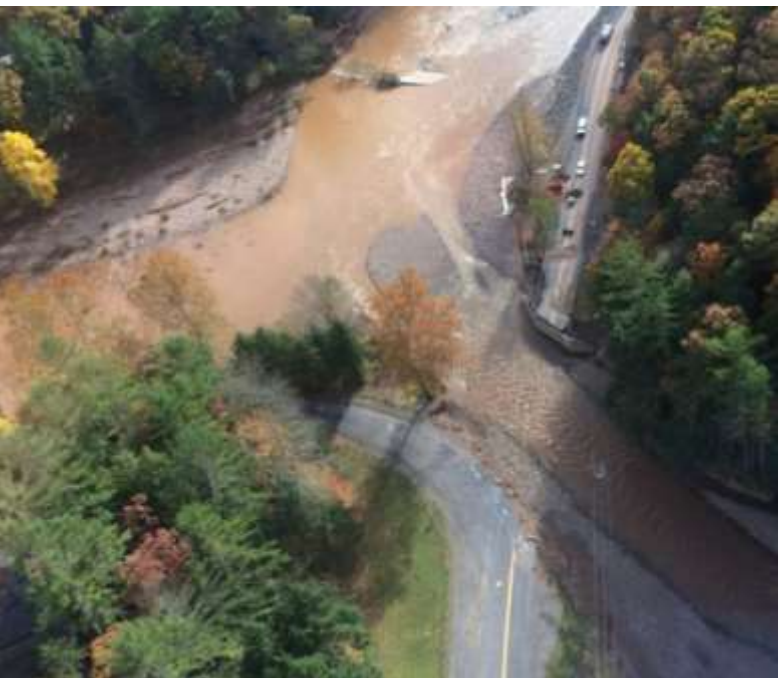
Improving Resiliency & Sustainability of Vulnerable Infrastructure – Natural Channel Design Restoration

MD355-UNT Monocacy R, Frederick Co. MD

SR2075-Muddy Creek, South York Co. PA

SR1003-Wallis Run, Lycoming Co. PA

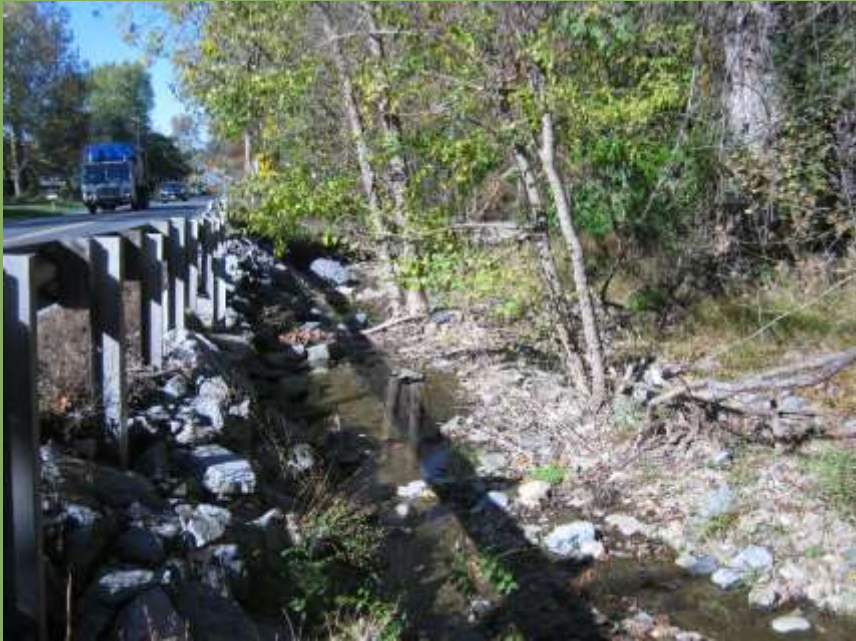
NCD Stream Restoration Tributary to Monocacy River

- *Infrastructure Stabilization Alternates: Walls, Slope Trtmnts w/ NCD Restoration*
- *Hard Shale Channel in Confined Narrow Valley w/ Roadway Encroachment*
- *Multiple Repeat Extreme Events Followed by Required Maintenance Riprap*

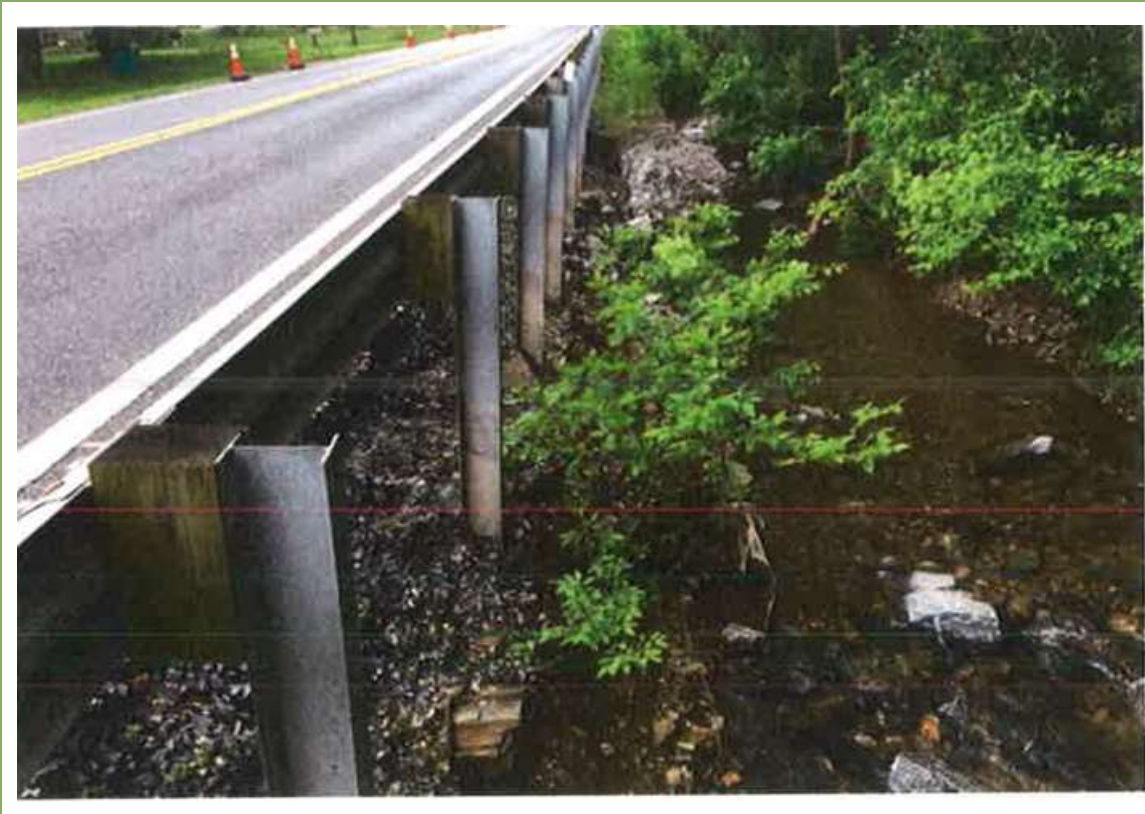
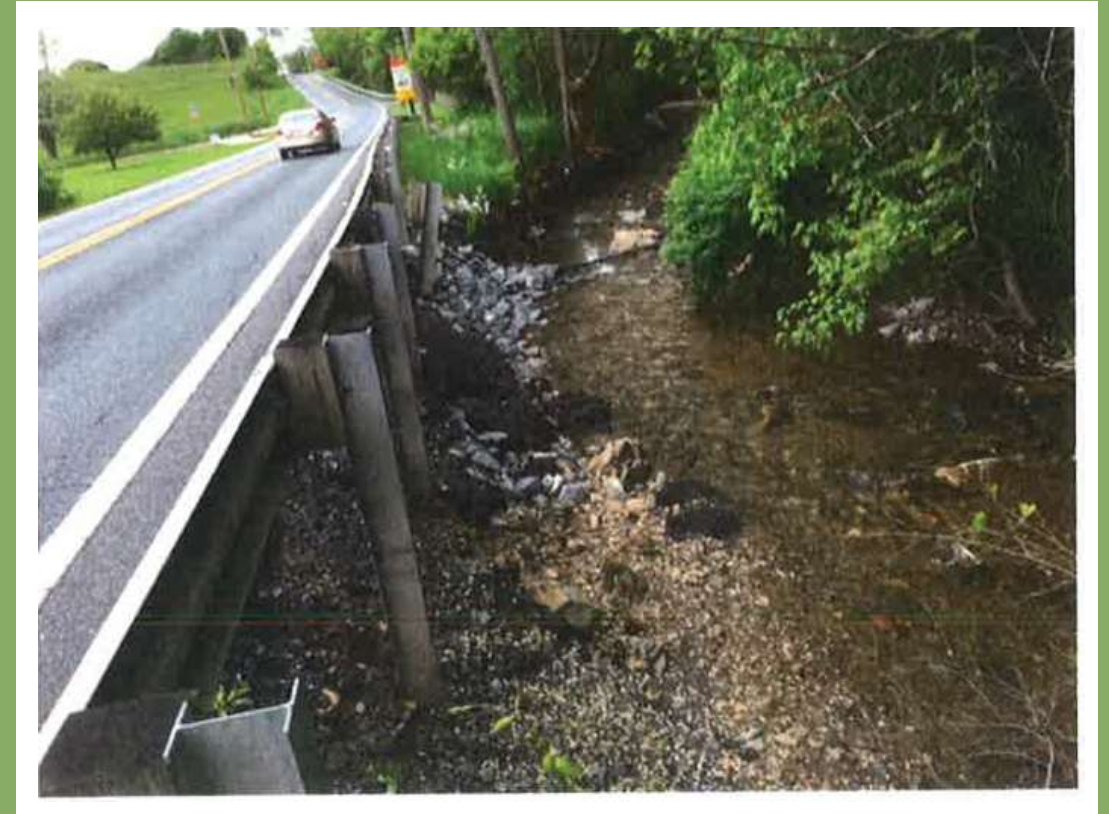
Scour Prone Roadway Embankment Infrastructure Constraints & Constructability Issues (MD-355 Urgent Needs)

Post-2015, May 2018, May 2019 | Repeat Extreme Storm-Flood Events (4-5" in 2-4 hours)

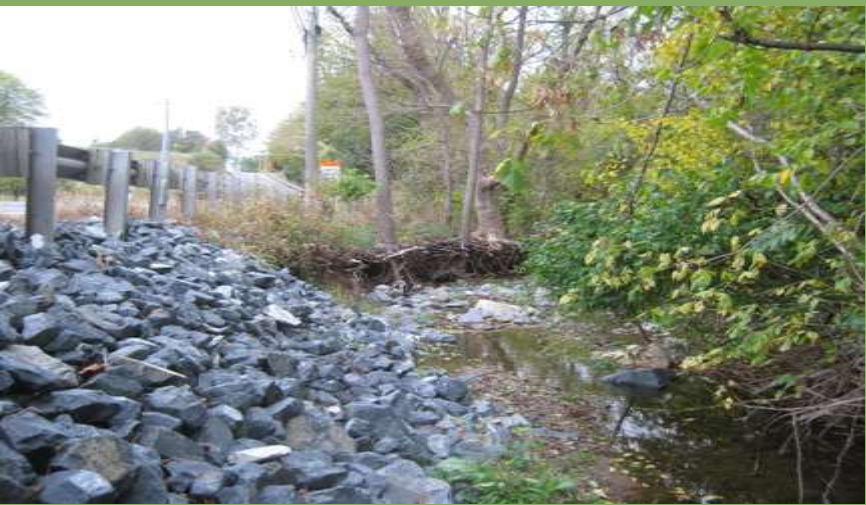
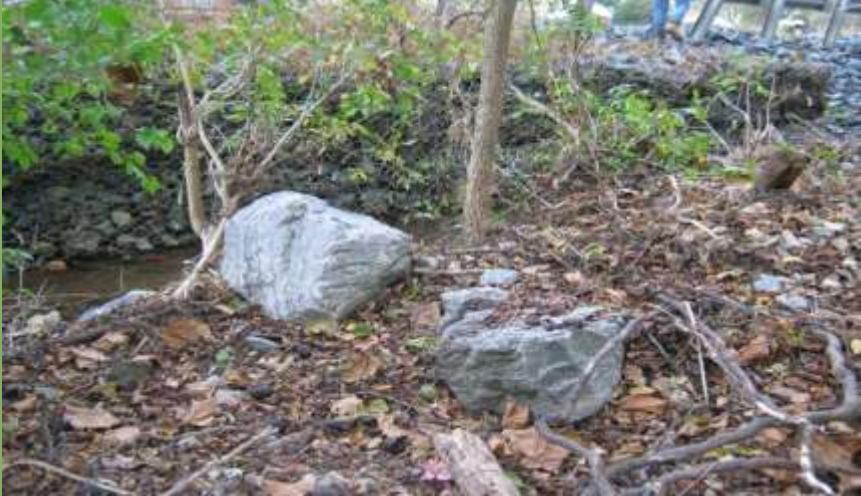
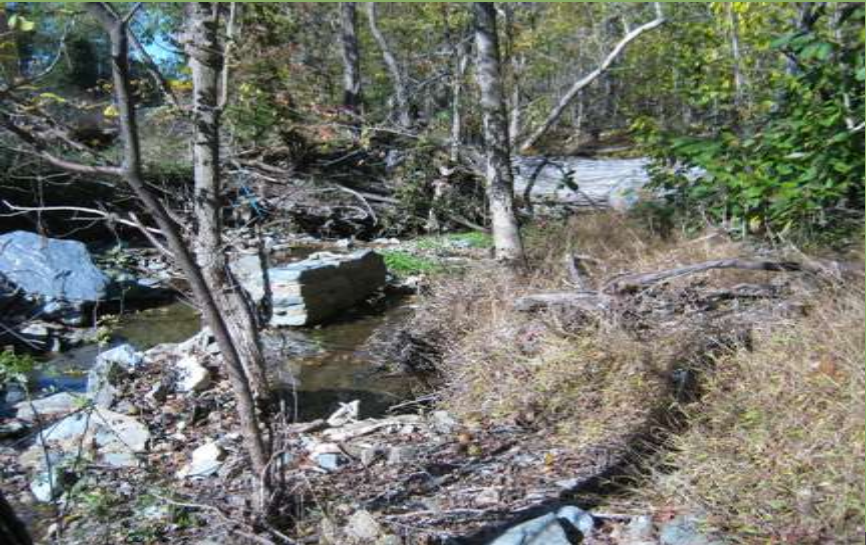
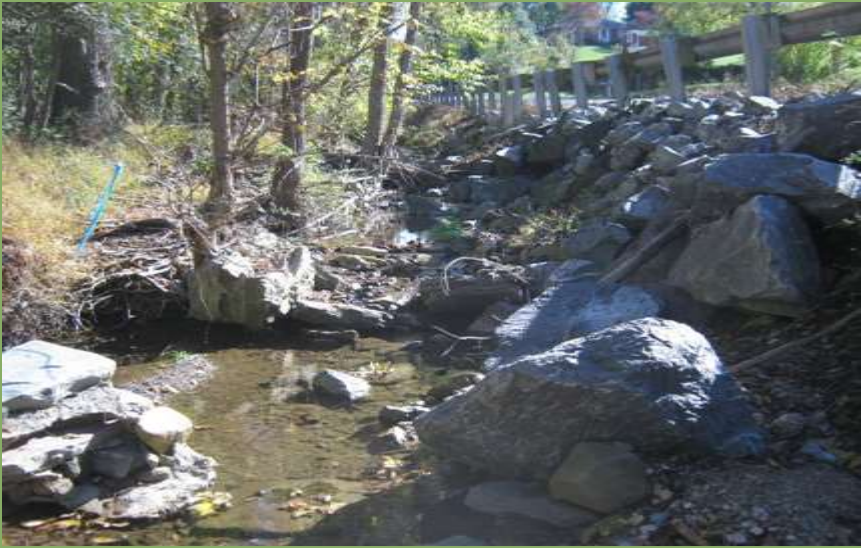
NCD Restoration Tributary to Monocacy River MD-355

*Infrastructure Stabilization- Restoration | Proprietary Wall, Imbricated or Rock Lined (NPS)
Scour Designed to Shear Stress Values: HEC-RAS Calibrated to D85%(20" Dia.) Particle Moved*

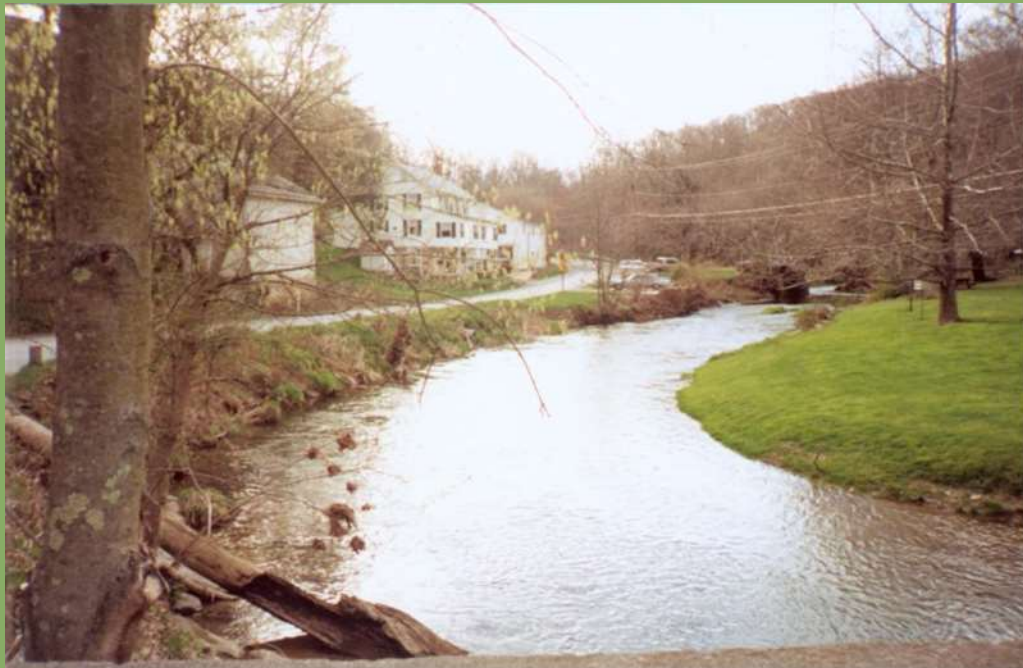
SR 2075 Bridge Replacement Over Muddy Creek, Tributary to the Susquehanna River

- Lower Piedmont, confined valley floodplain/deep alluvium/scour undercut right foundation
- Historic alterations- former railroad, RR bridge, RR station & roads
- Upper Chesapeake Bay area subject to frequent extreme events

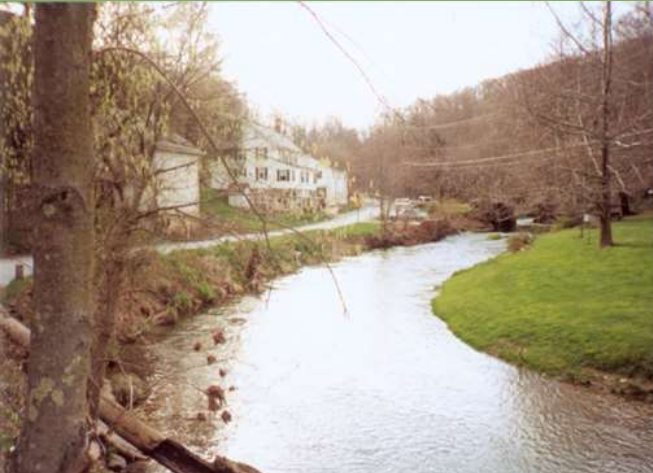
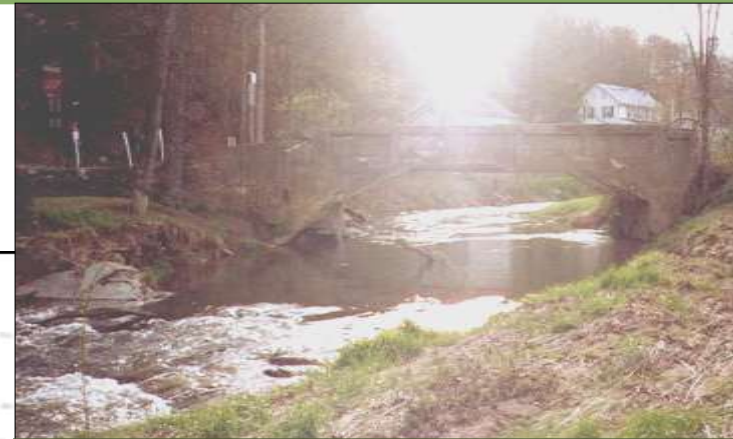
BEFORE ABOVE

Isolated 7.5" Rainfall Event Over 4 Hours September 2001 & Again on August 31, 2018 – 8" Event in 3 Hours
