NCD For Extreme Event Restoration- Improved Resilience

Thomas Graupensperger

2022 First National Stream Restoration Conference
August 02, 2022

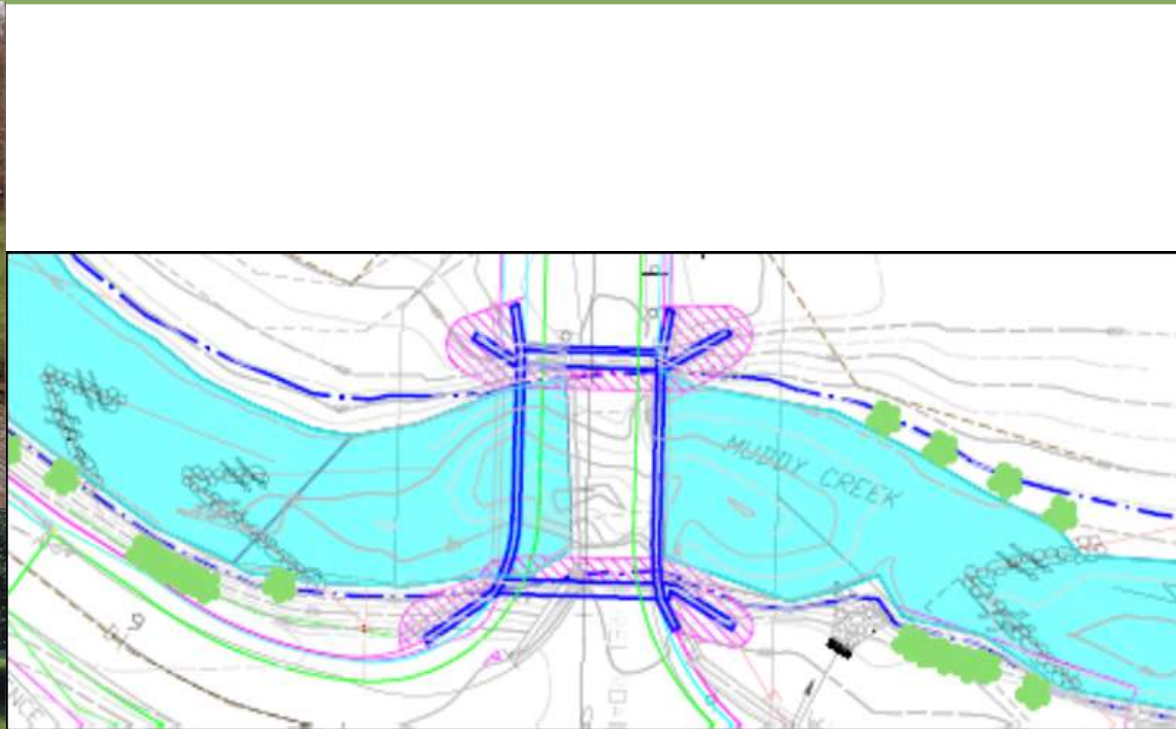
Isolated 7.5" Rainfall Event Over 4 Hours September 2001 & Again on August 31, 2018 – 8" Event in 3 Hours

BEFORE ABOVE

AFTER BELOW

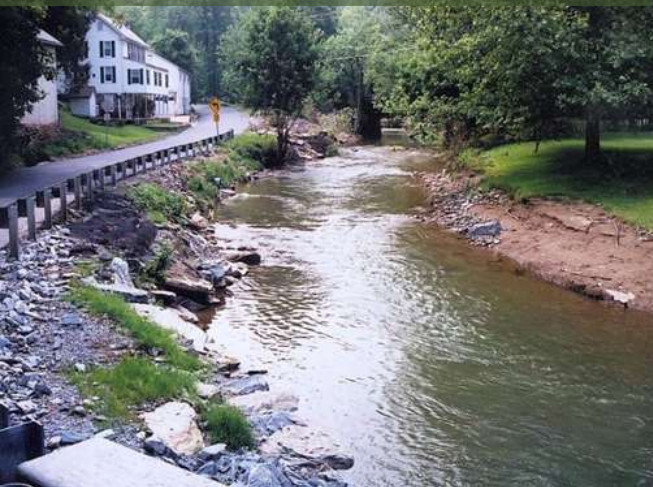
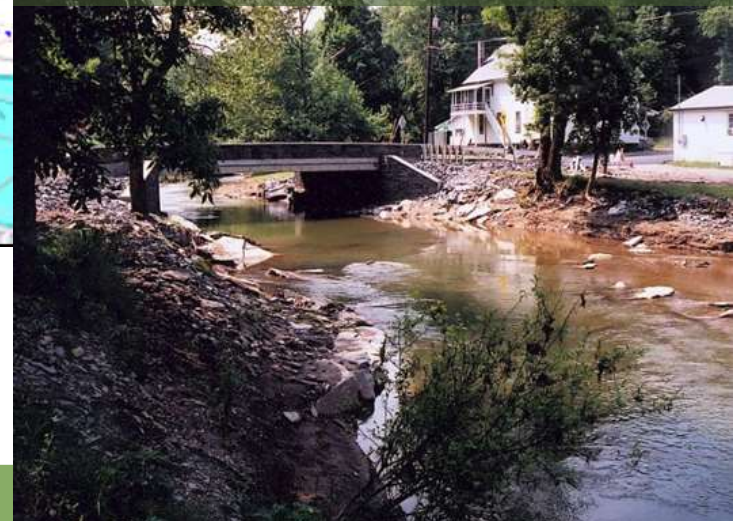
Natural Stream Stabilization / Restoration at Structure Crossings

**Two Right Bank Rock J-Hook Vanes, Imbricated Rock Wall at Right Upstream Abutment with Downstream Bridge Cross-Vane*

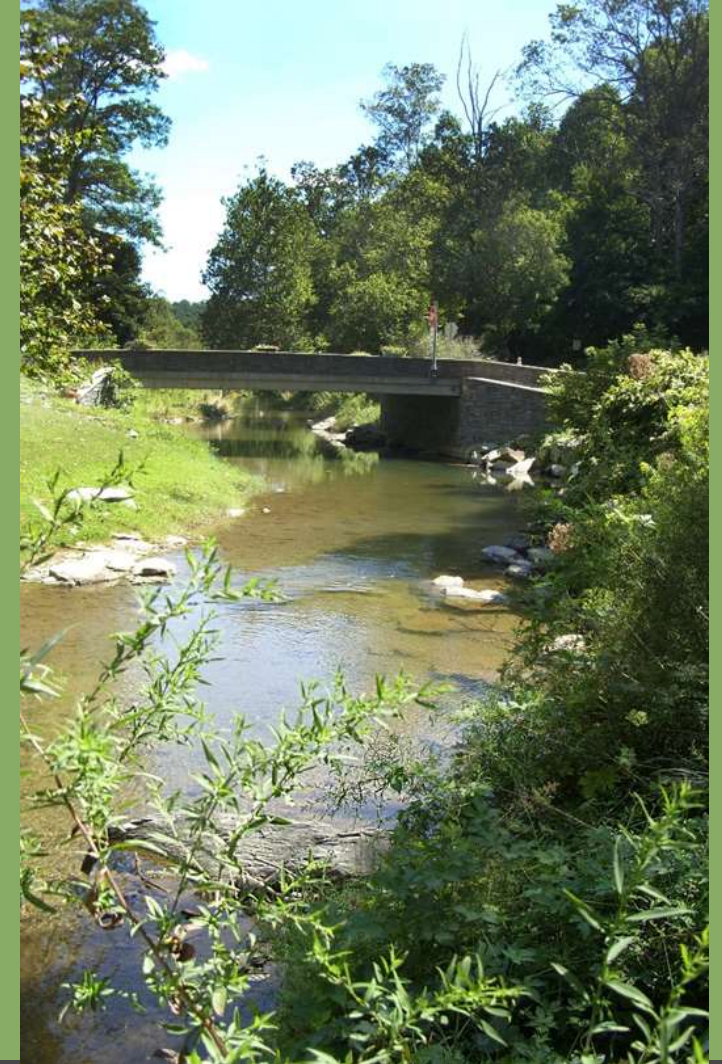
- Reduced Sediment Discharge
- Stable Channels and Streams
- Scour Protected Bridges, Structures & Streambanks
- Stream Habitat and Fisheries Improvements
- **Improved Resiliency through Redundant Measures**

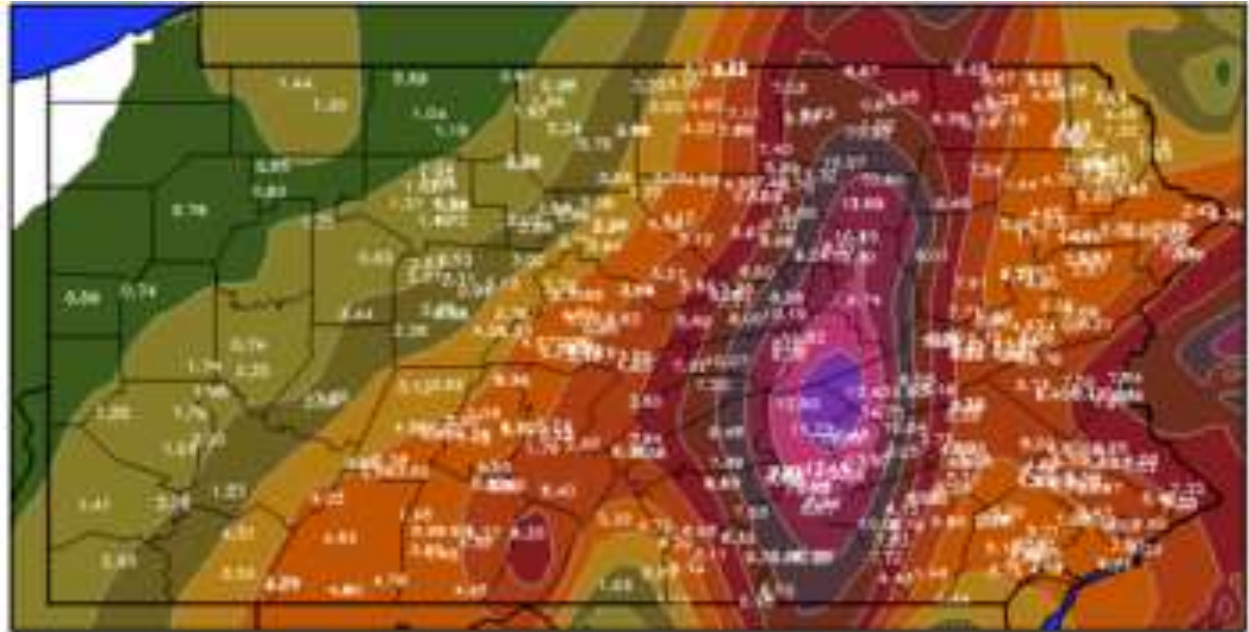
SR 1003, Bridge Replacement, Stream and Embankment Restoration, Wallis Run, Tributary to Loyalsock Creek

- Valley Ridge-Middle Section, Allegheny front, glacial outwash and terminal deposition
- **Confined hemlock forested valley, confluence grade flattening-deposition**
- Gas pipeline, 2-span bridge, road embankment infrastructure impacted
- **Prior damage, debris accumulation Tropical Storm Lee 8-9" September 8, 2011, (10 days post Irene) SHOWN**
- **Extreme Event S-N : October 21, 2016 : 8+" rainfall over 4.5 hours**

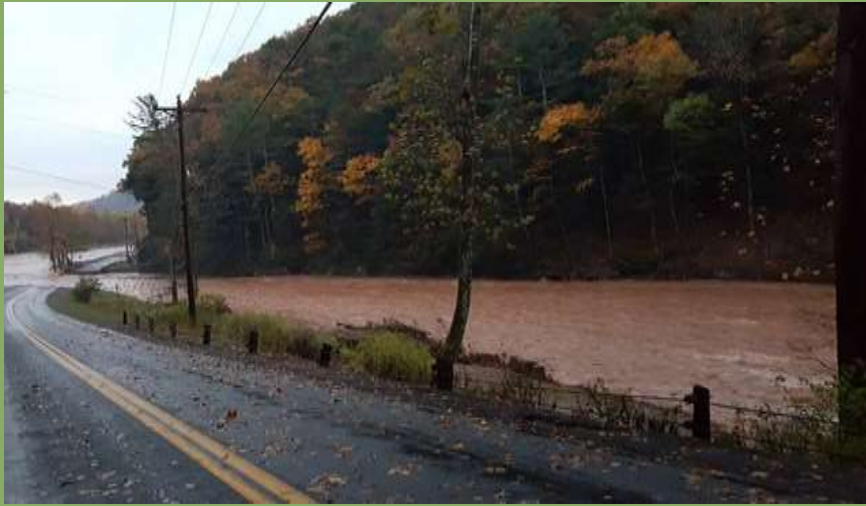
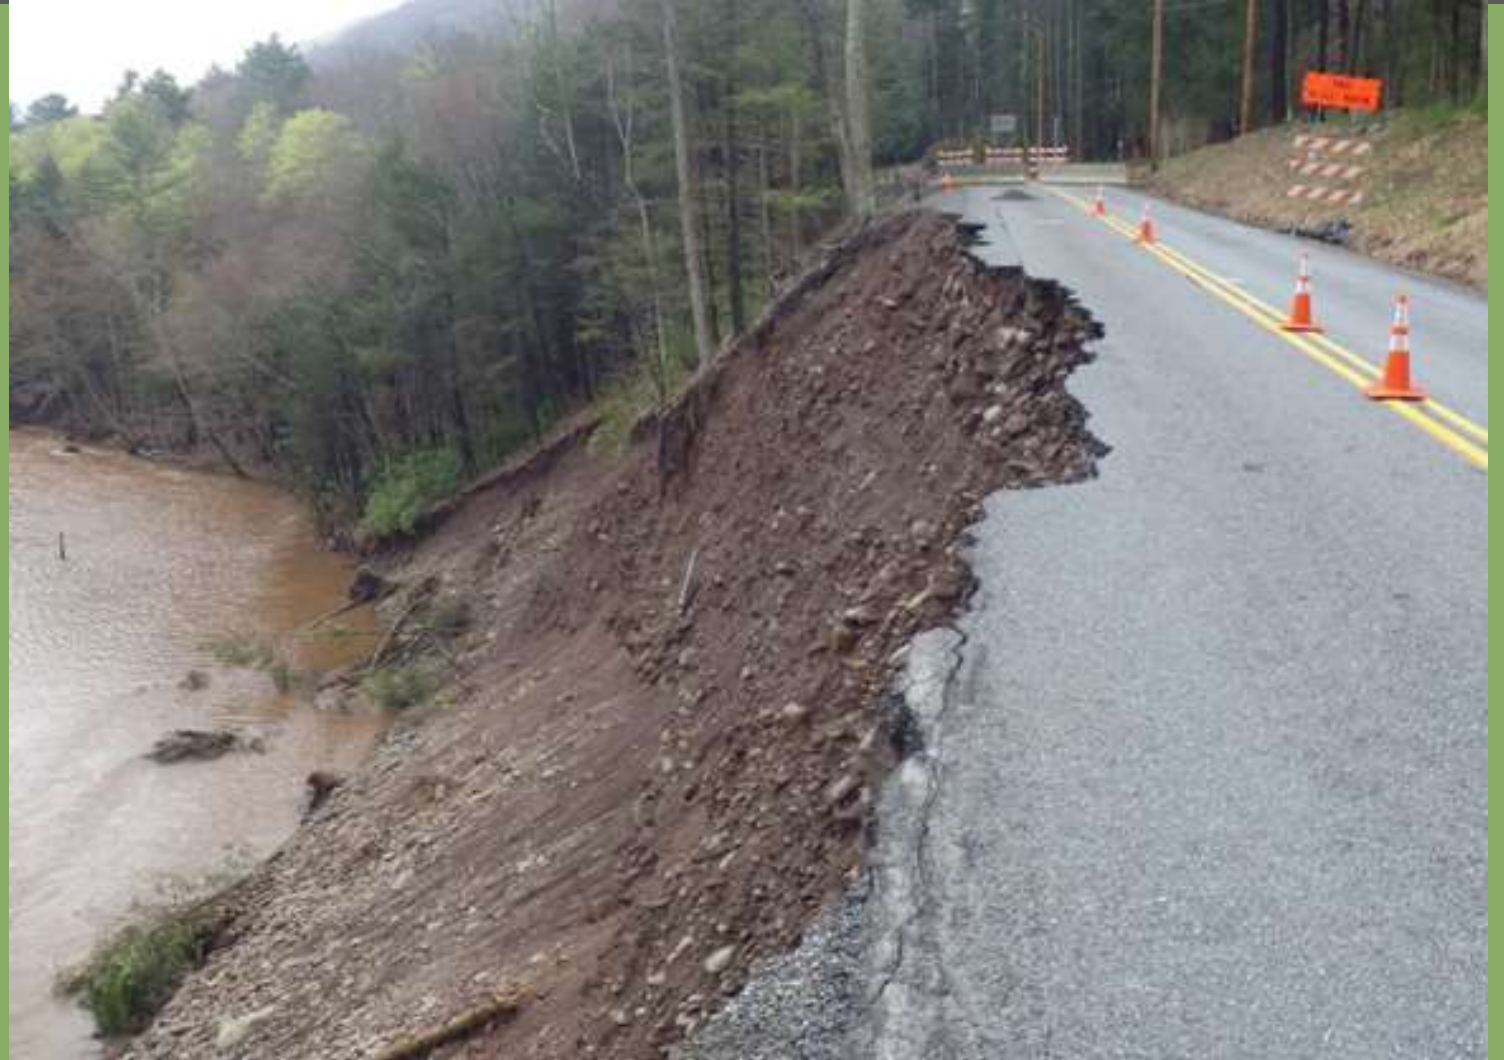
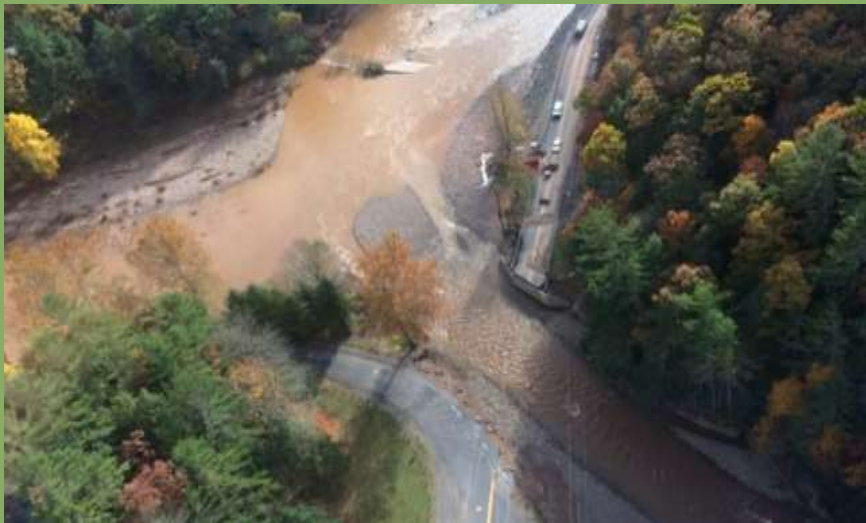
PA SR-1003 Over Wallis Run- Tributary to Loyalsock Creek

October 2016 Extreme Rainfall Event 8"+ 4.5 Hours, 36 SM DA: 1000-Yr Event
2-Span 20'X80' Bridge Deck Floated into Main Stem(See Top-Lower Left Image)

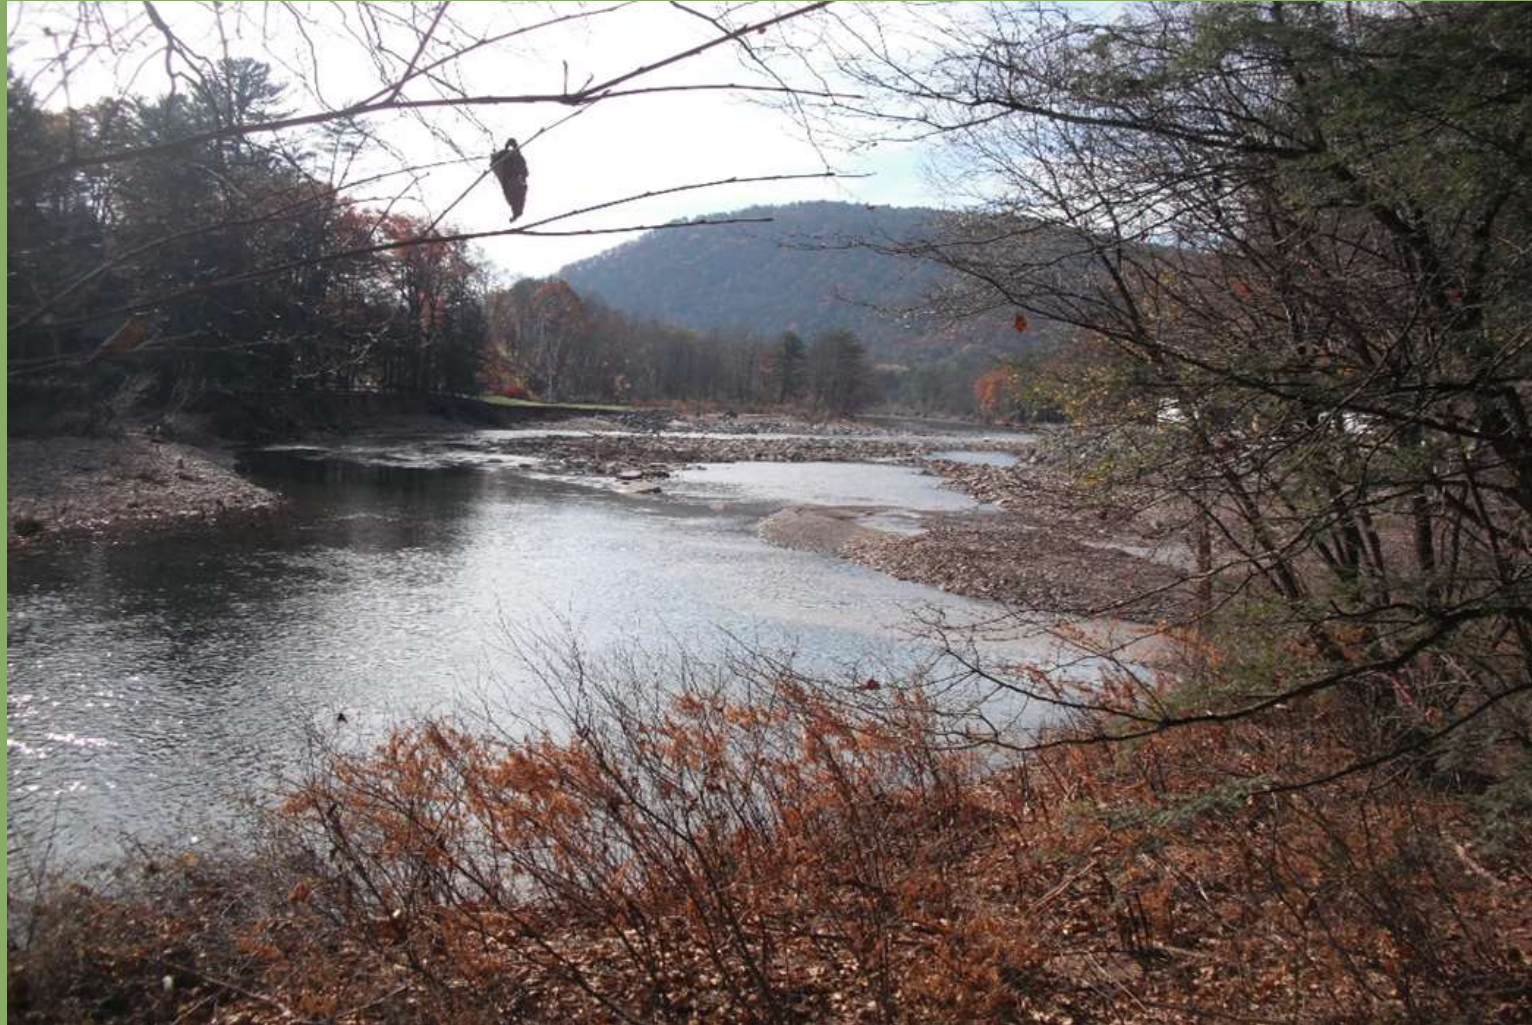
Stream Channel, Embankment, and Bridge Storm Damage(10-2016)

Opposing Loyalsock Bank Scoured 12-18' High

Deposits from 320' Long x 60-70' High Glacial Embankment Scoured by Event

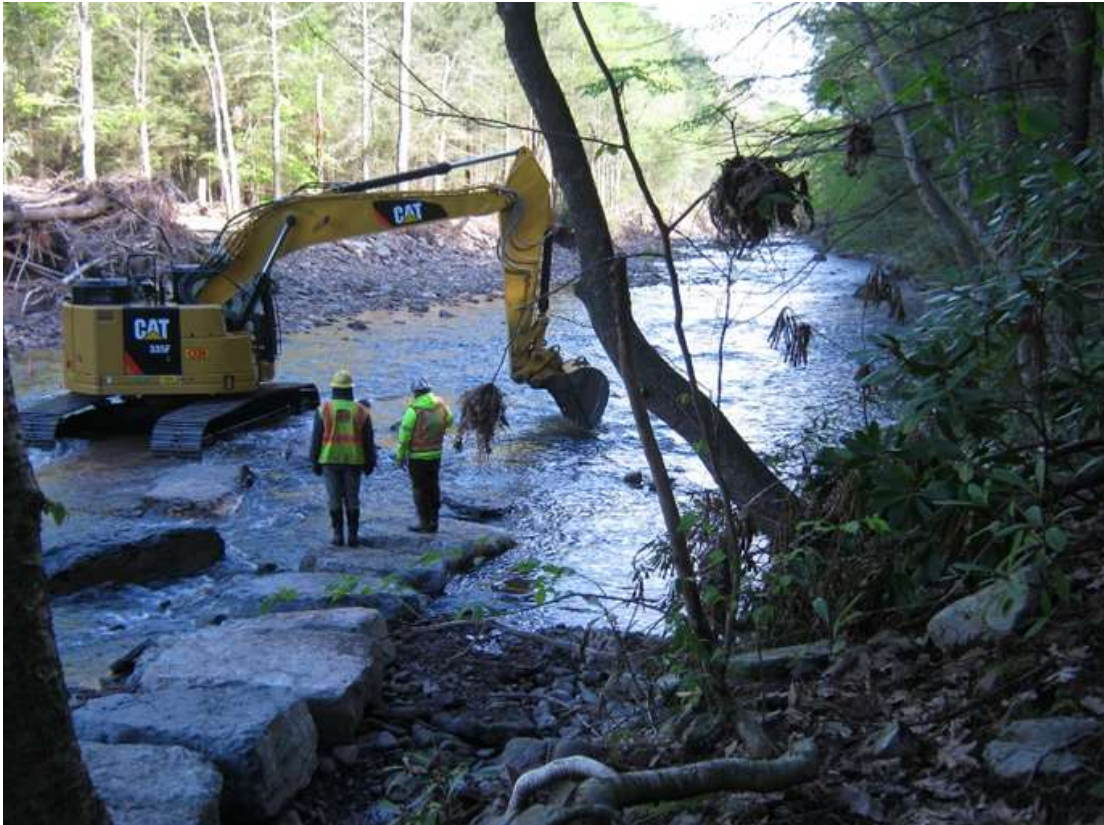
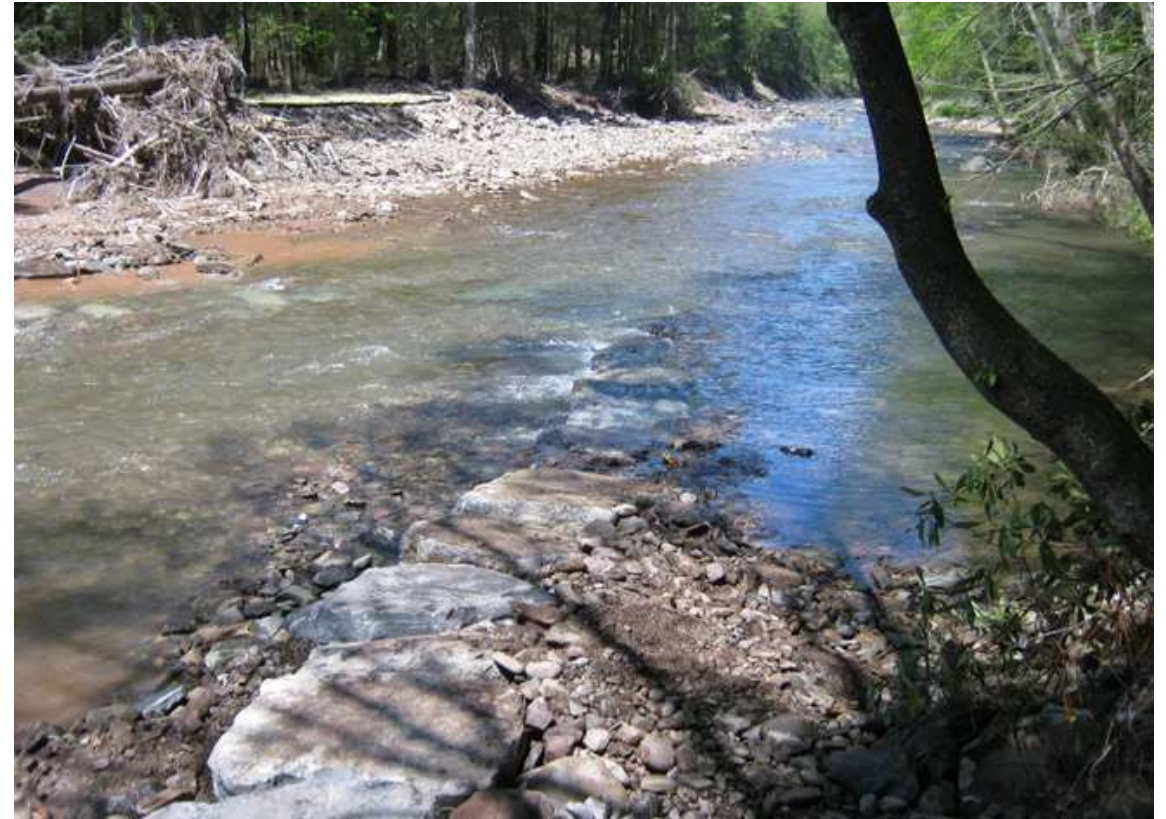
Upstream Channel Restoration and Rock J-Vane Construction

*Rock J-Hook Vane designed to redirect flow away from embankment toe
Note Hemlock Debris & Snag in Tree – Level with track hoe arm- 16' flow depth*

- 3-5 ton rock vanes
- Constructed to bankfull elevation

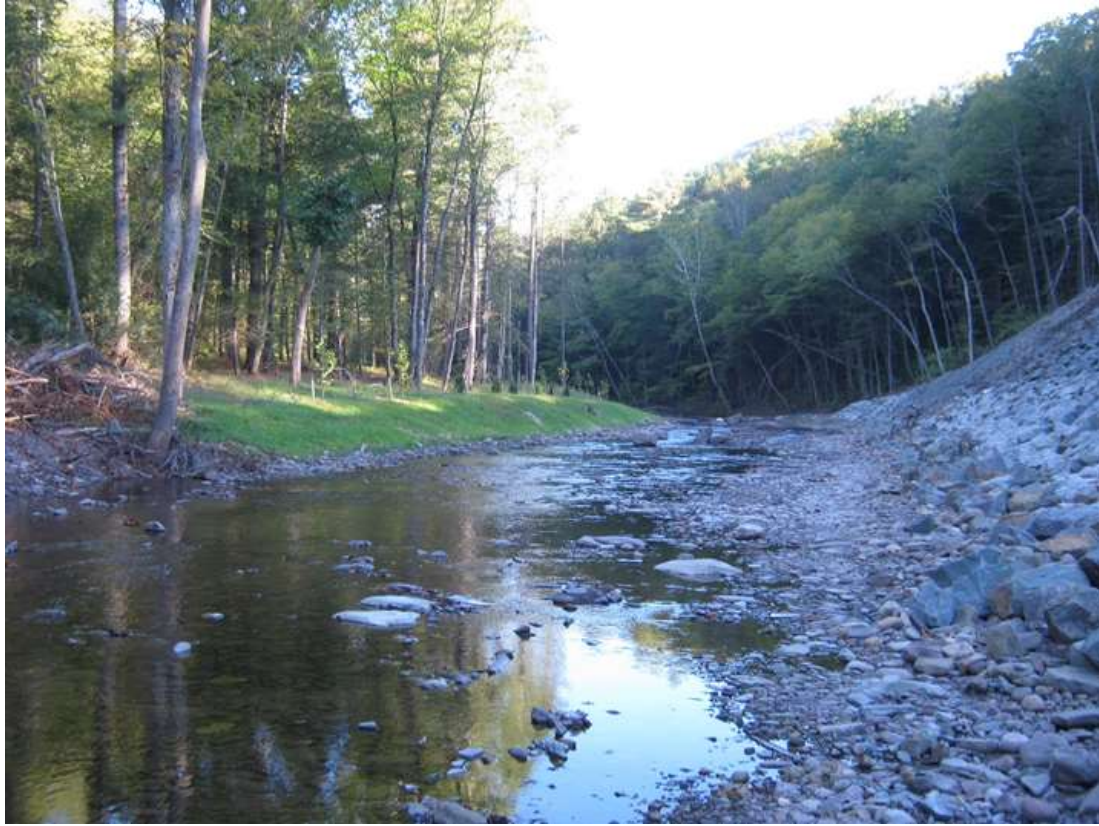
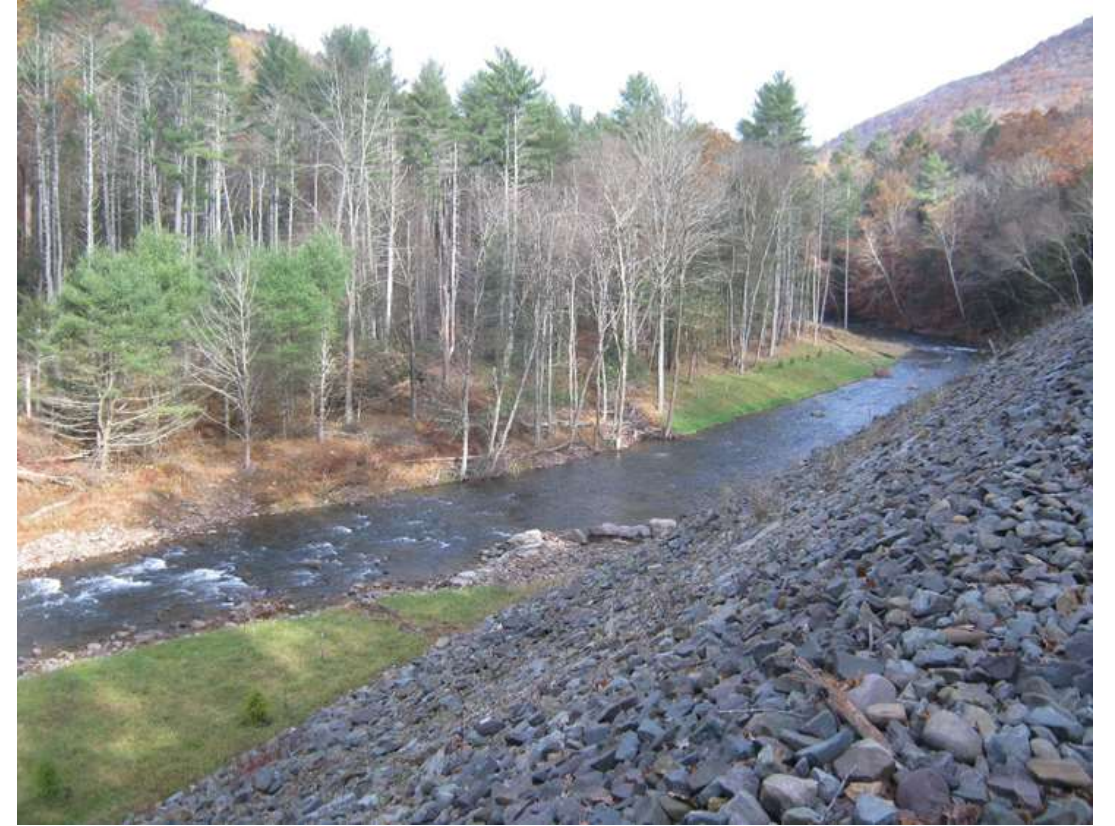
Mid-Stream Restoration Embankment Reconstruction

Habitat Boulders Launched into Place after rolling downslope from Occasional Boulder Lost During Rock Embankment Construction

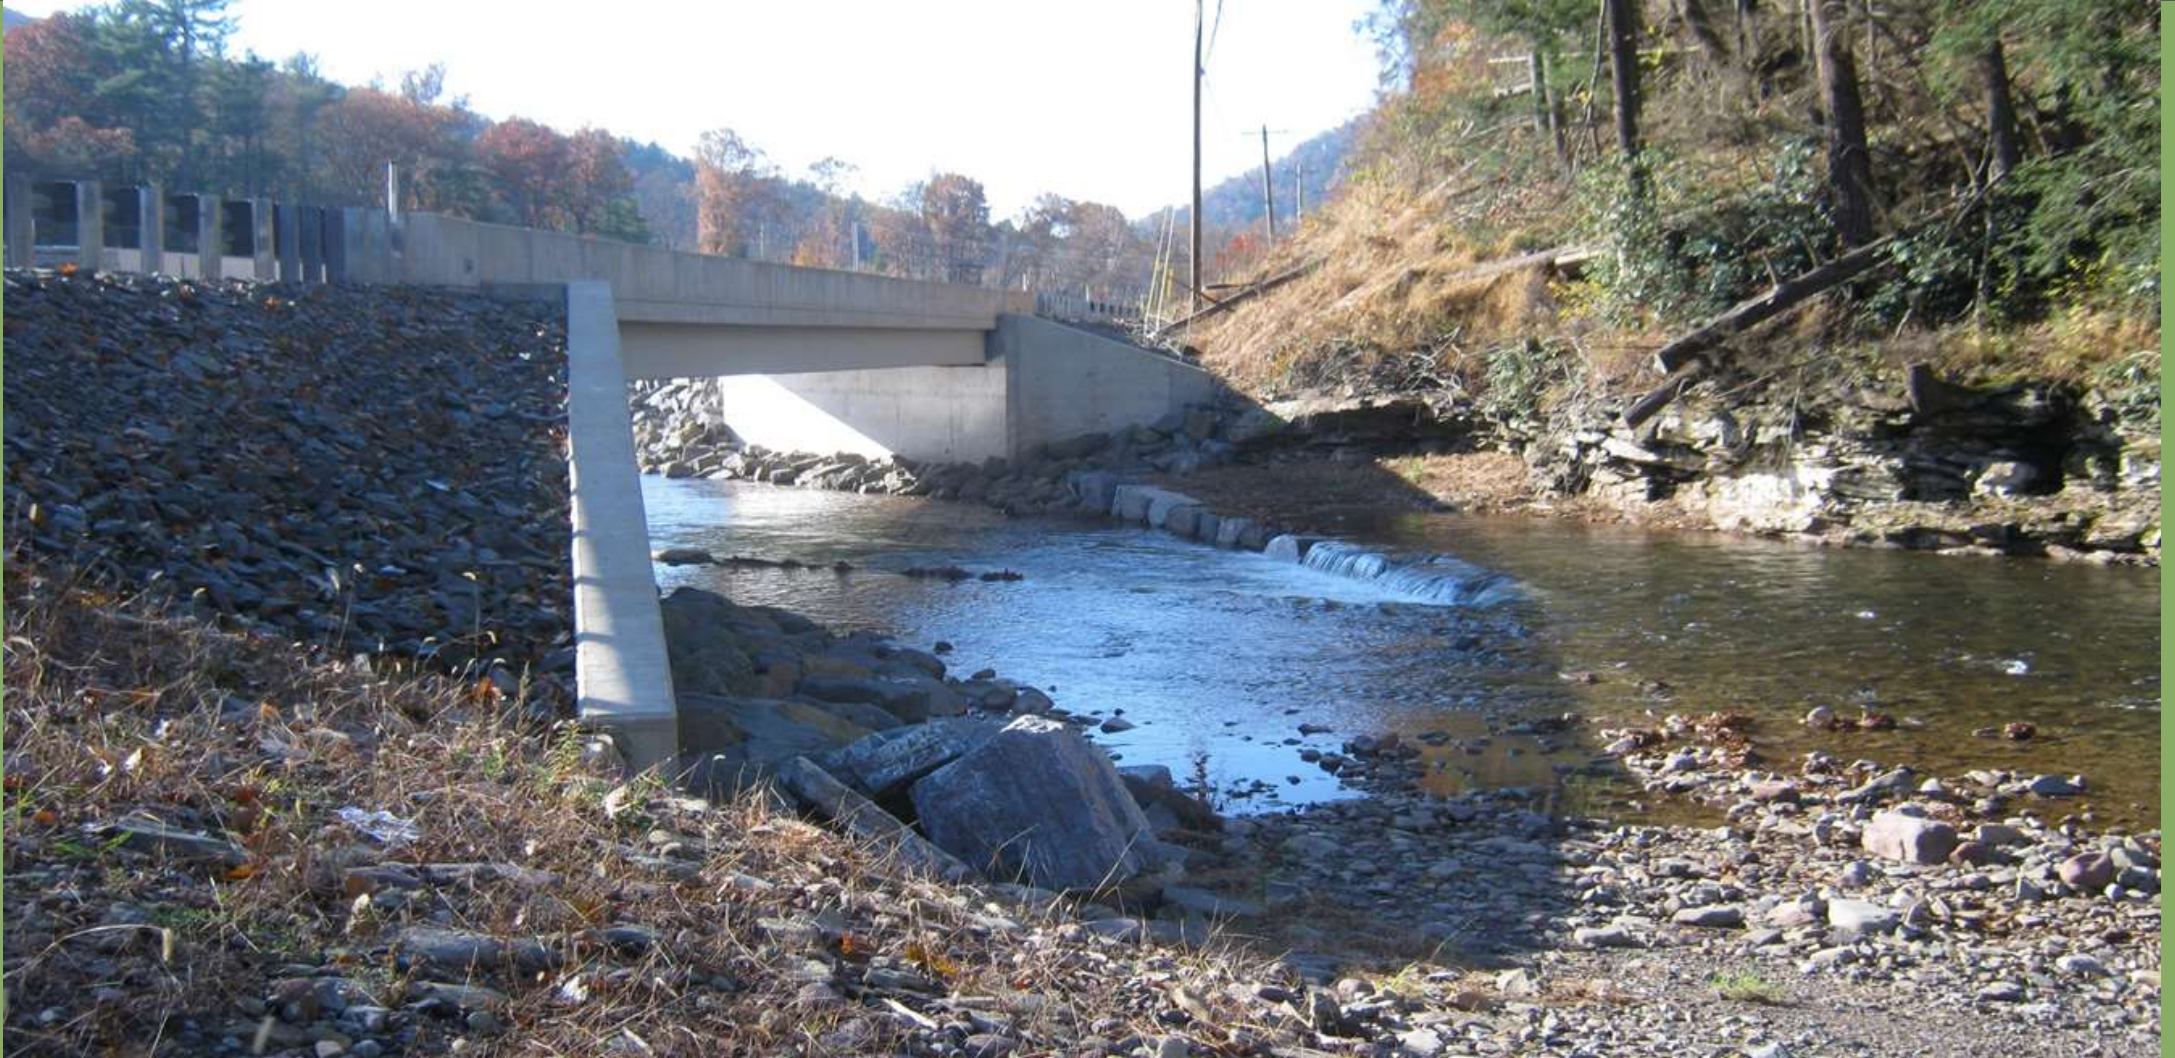
Bridge Replacement and Rock Cross Vane Completion

Scoured Bedrock-Right Bank / Point Bar on Glacial 60-feet+ to Rock- Left Bank

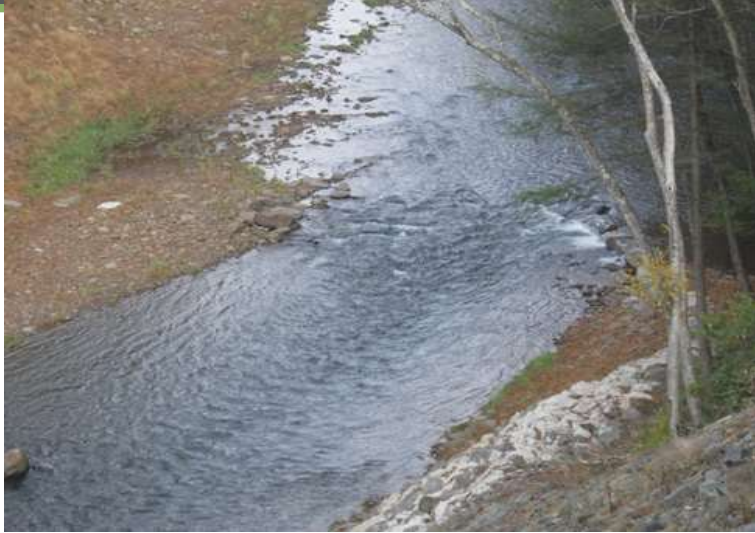
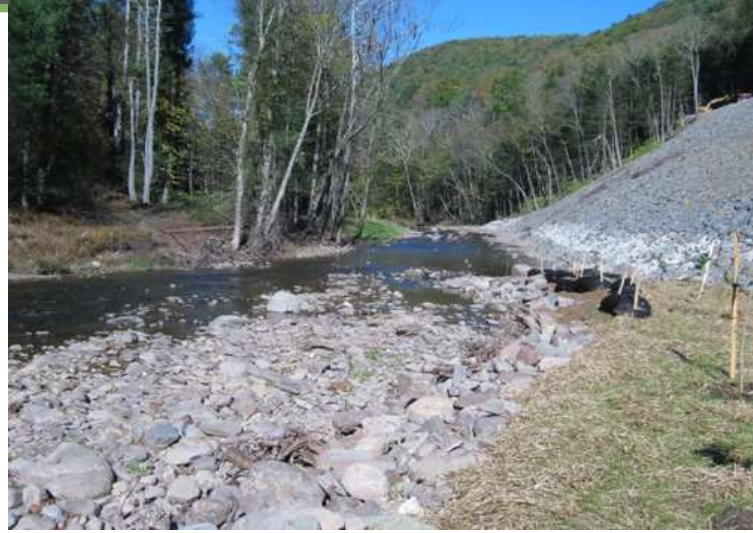
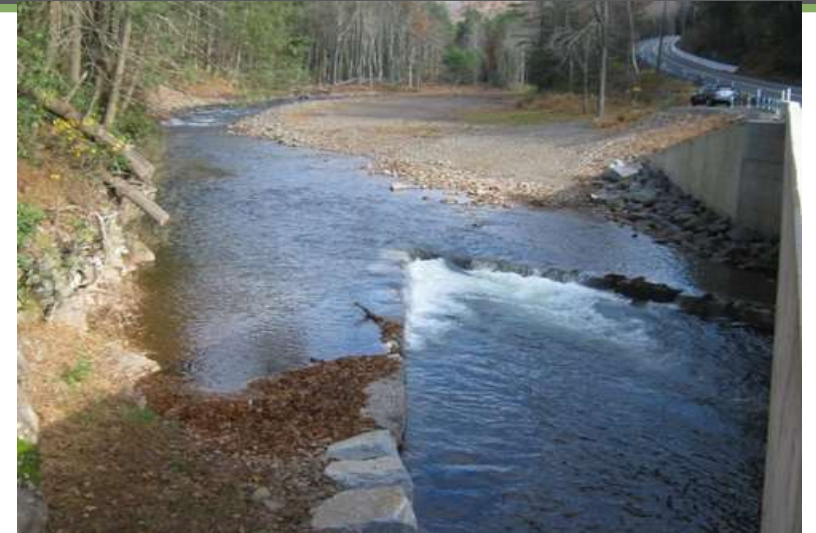
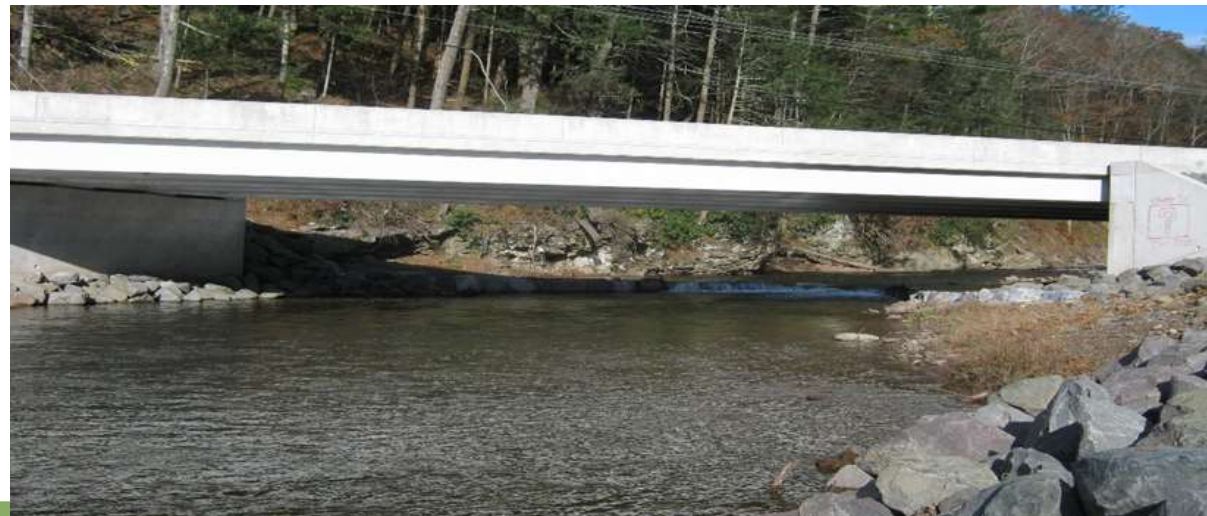
SR 1003 Bridge, Embankment, and Wallis Run Restoration

Completed September 2018

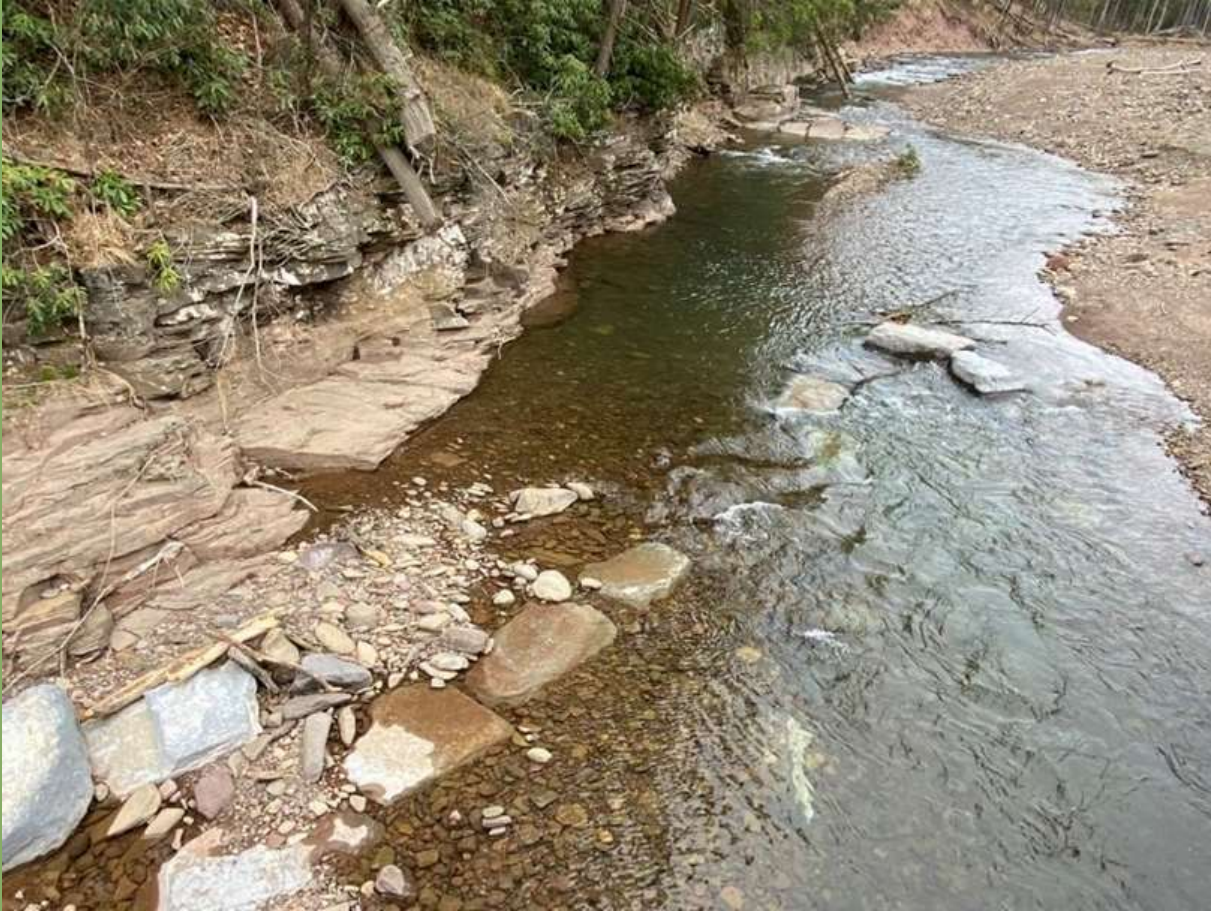
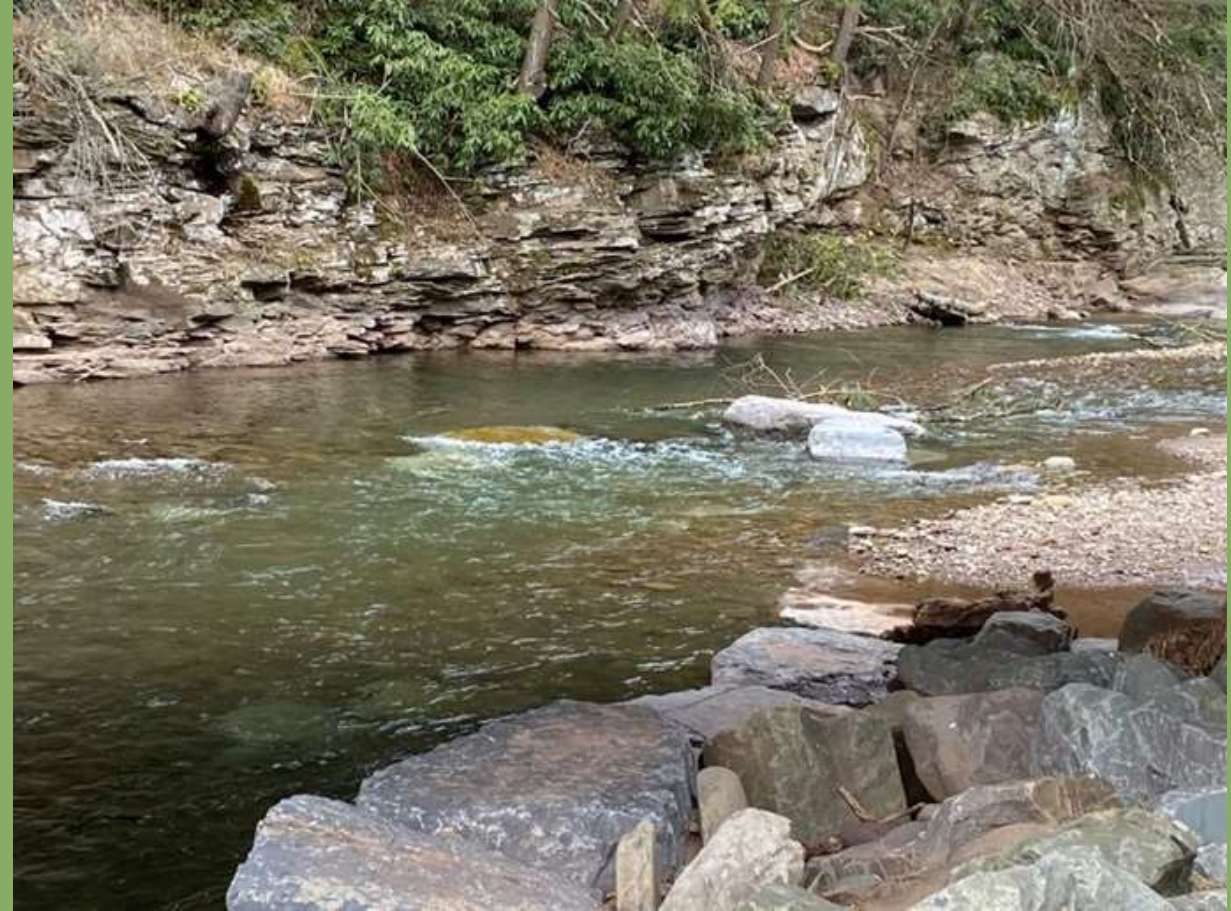
SR 1003 Wallis Run Restoration at Bridge Replacement

*Post-Construction September 2019- Repeat Extreme Event- Reconfigured Vane to J-Hook Vane
Greater Habitat-Flow Diversity Resulted on Wallis Run- Native Wild Trout Waters*

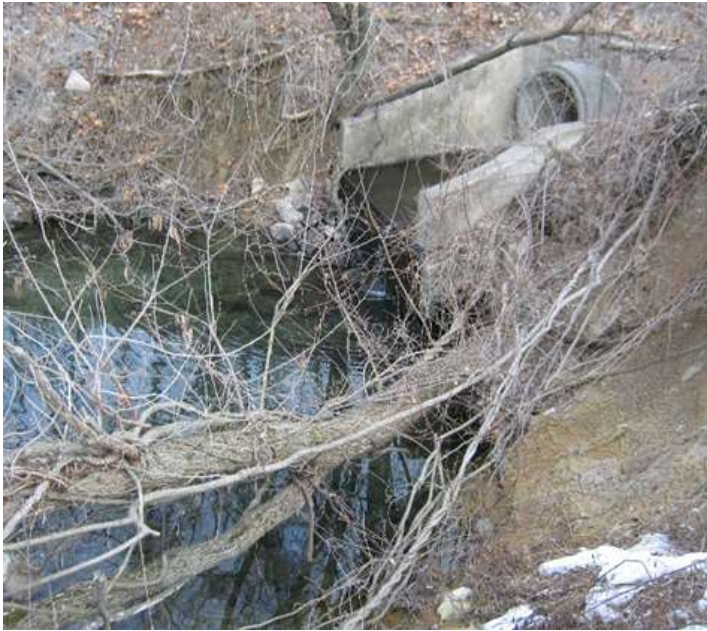
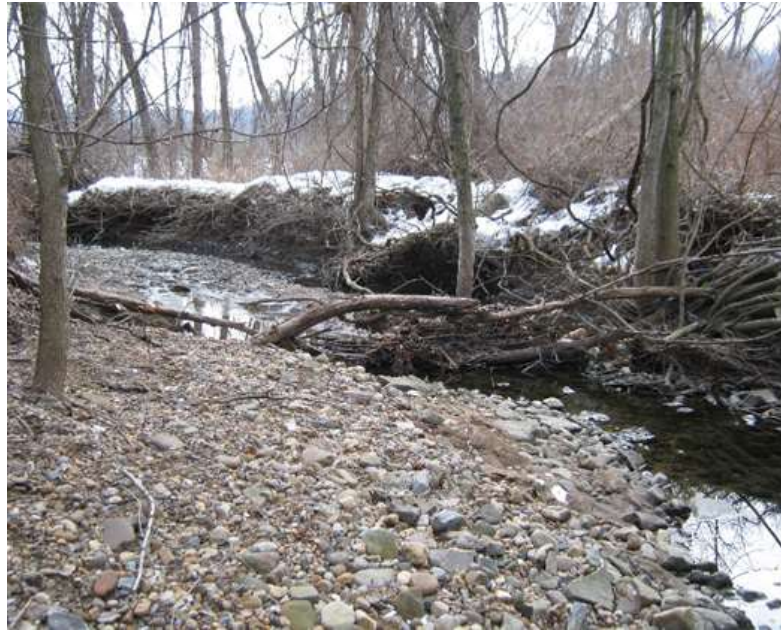
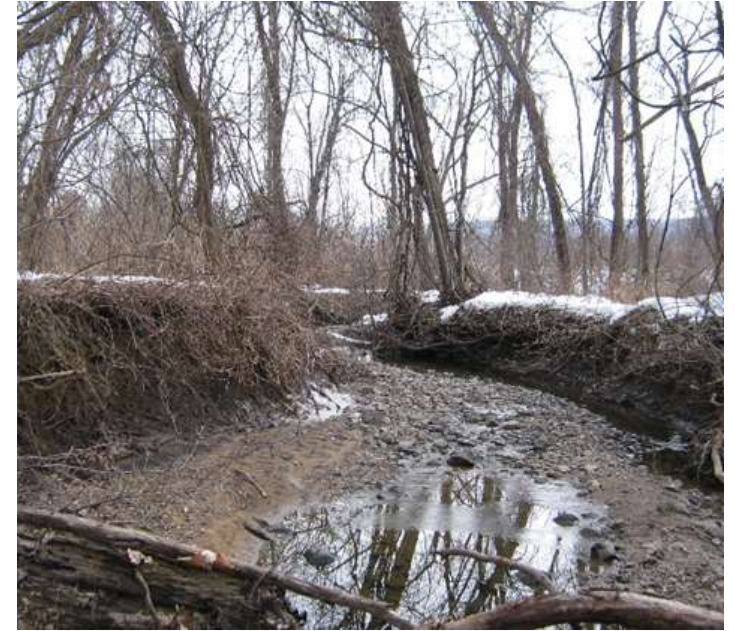
MS4 Stream Restoration TMDL Credit Examples

Sediment Pollutant Reduction (TMDL) (2018- Extreme Events)

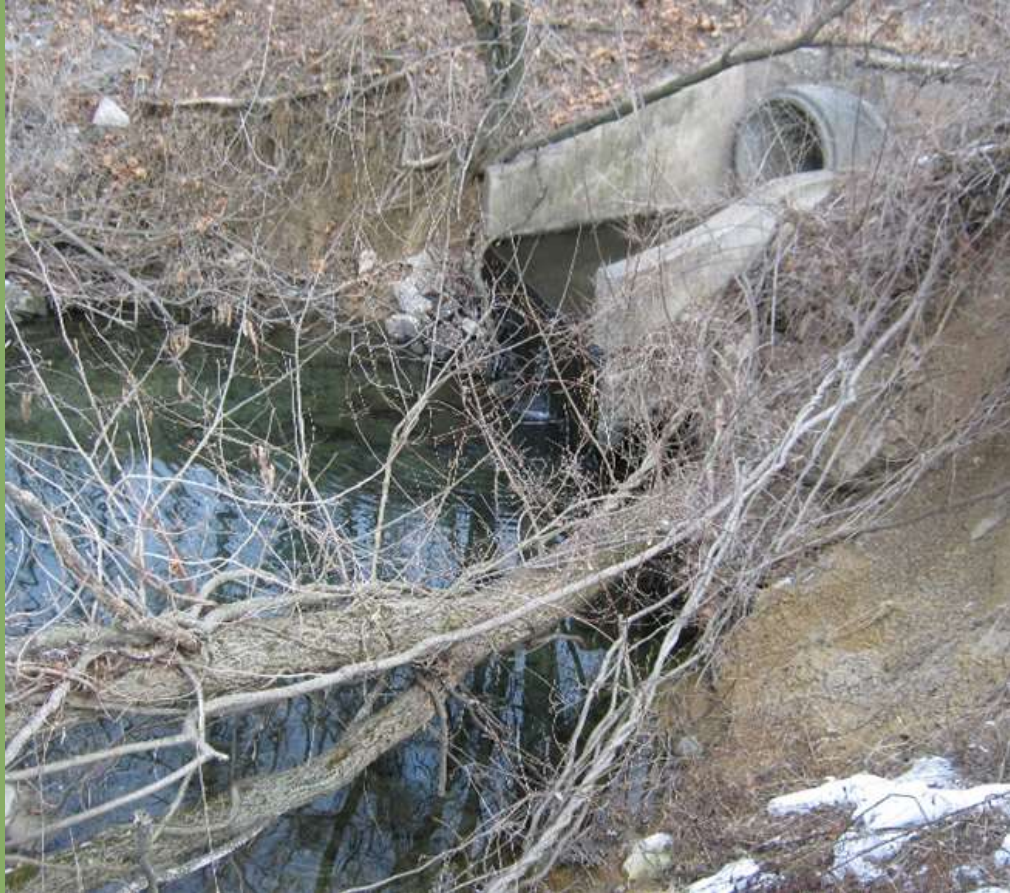
Priority 5: Outfall / Gully Step-Pool Restoration / Stabilization

- Potential locations within the RMS-BMS inventory system in each District
- MS4 Stream Restoration-Outfall Stabilization for Pollutant Reduction-TMDL Credits

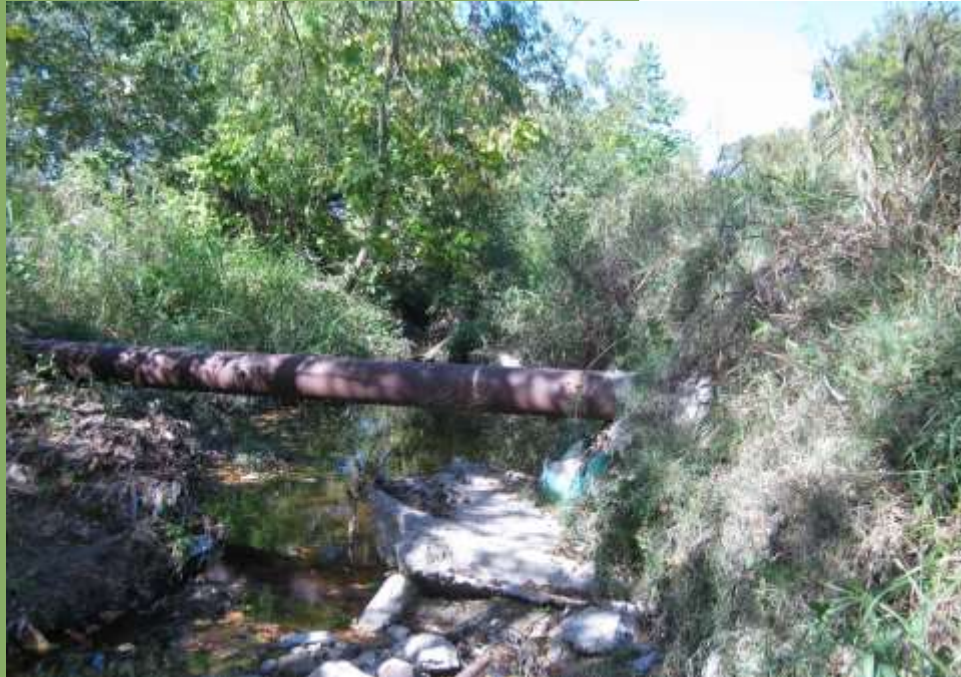
Channel Reconstruction Step-Pool Stabilization/Restoration

ROCK/BOULDER TOE BANK
N.T.S.

SECTION VIEW
SMALL STREAM TRIBUTARY ROCK STEP-POOL
N.T.S.

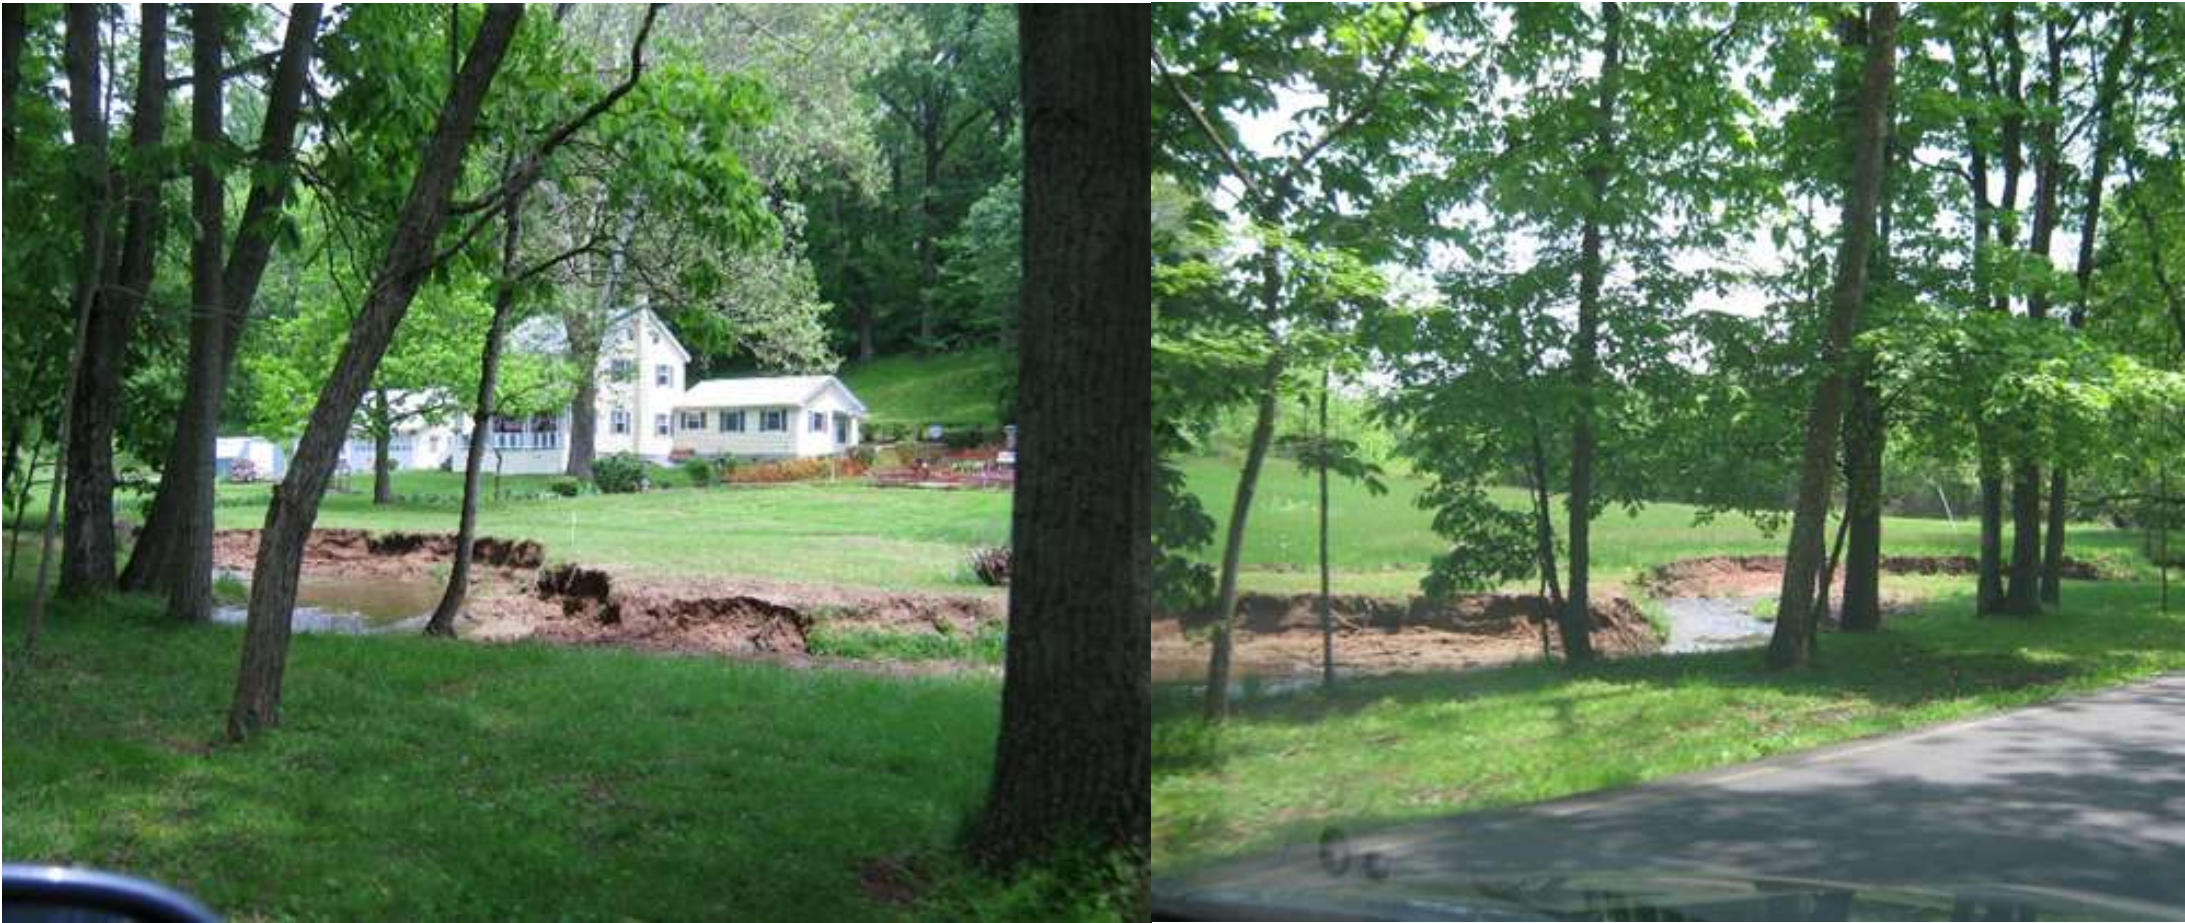
Extreme Storm – Flood & Scour Impacts to Local Infrastructure

Isolated Extreme Event- Upstream Rural Forested Watershed : Late May 2019
