NCD For Extreme Event Restoration- Improved Resilience

Thomas Graupensperger

2022 First National Stream Restoration Conference
August 02, 2022

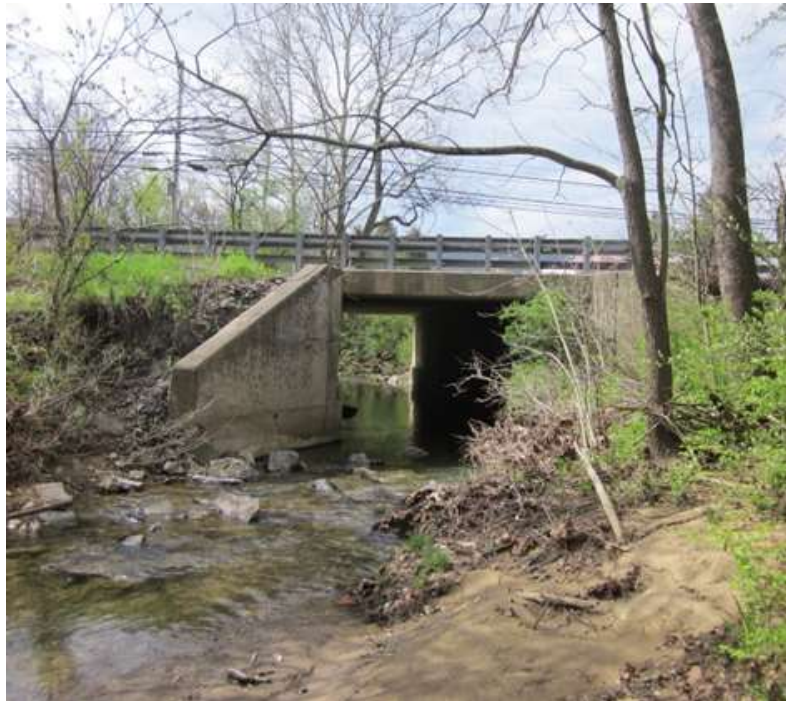
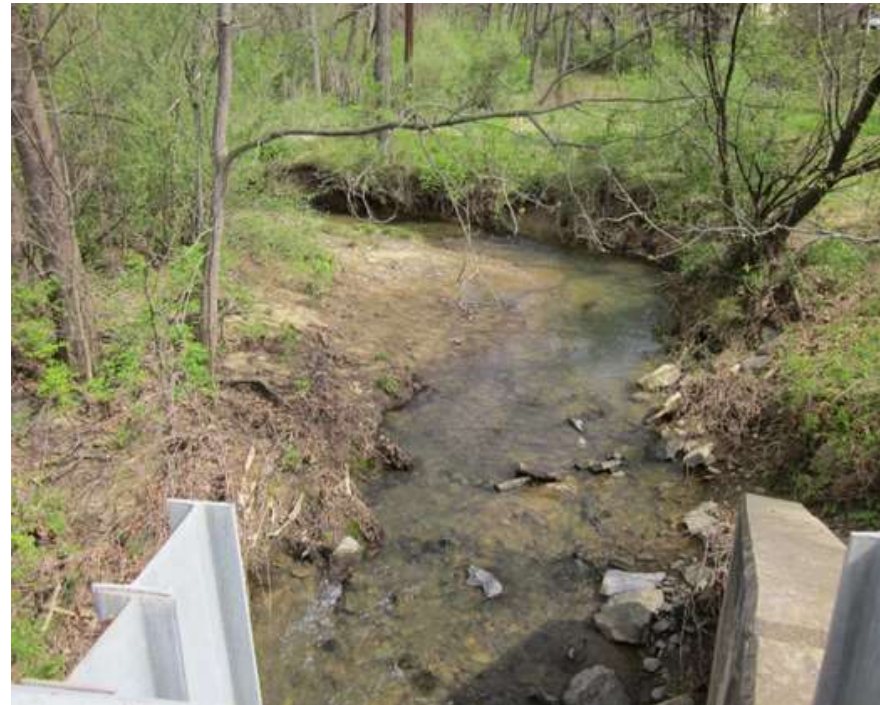
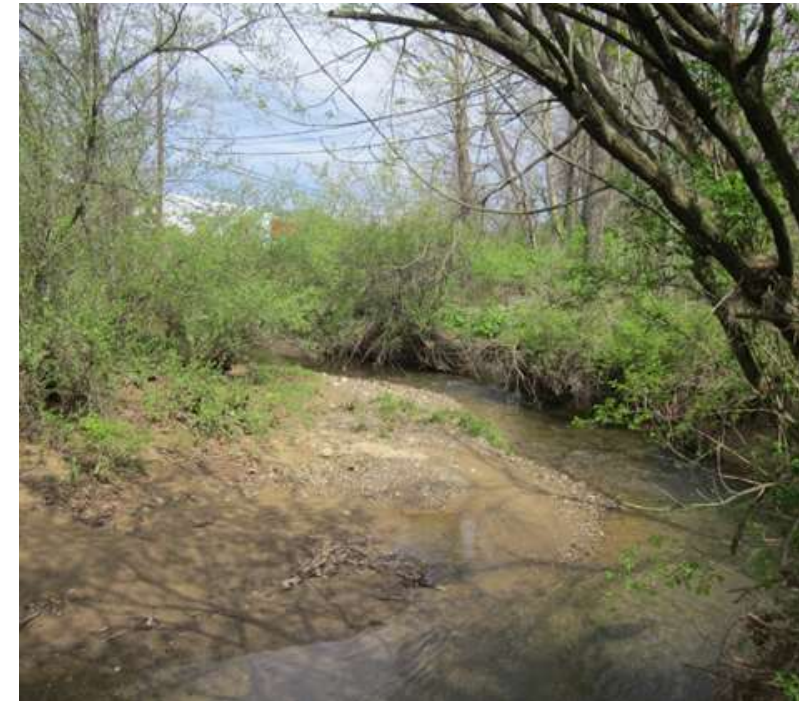
SR 2014 Over Bennetts Run

Sediment Impacted Small Drainage Area- Tributary WB Susquehanna River near Loyalsock Crk.

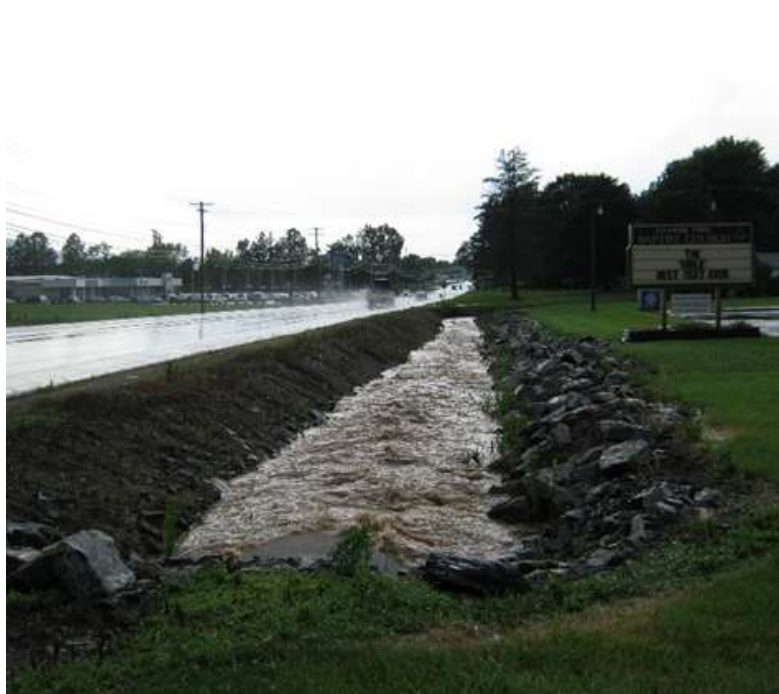
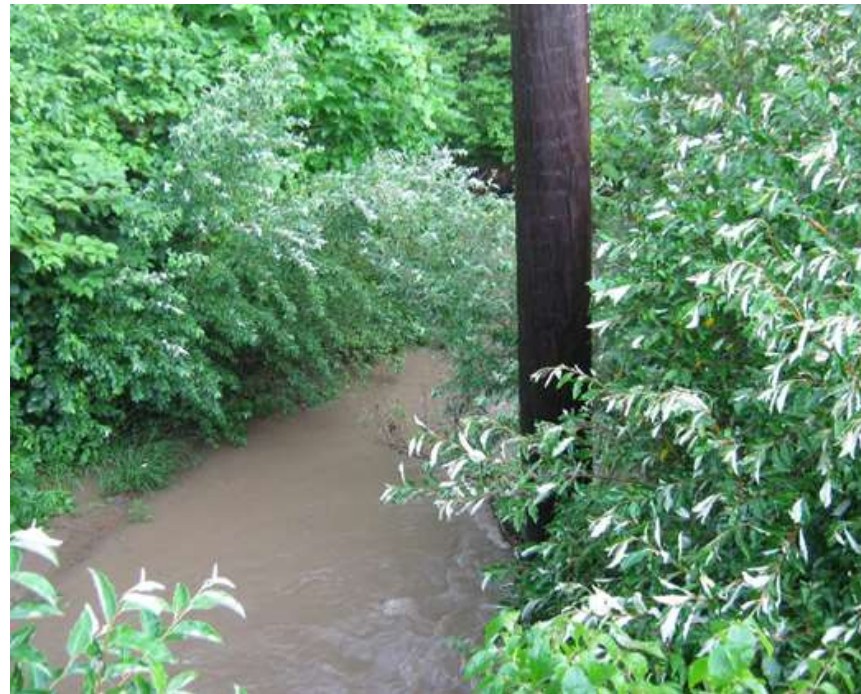
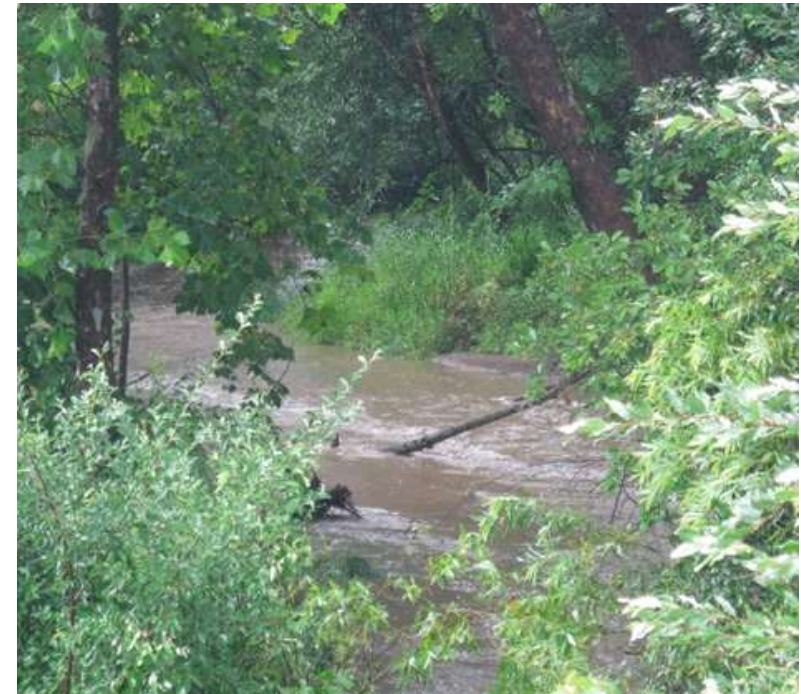
SR 2014 – Bennetts Run

2019 | July 30 Isolated Extreme Rainfall- Thunder Storm (1" in 15 minutes : 4"/ Hr Rate)

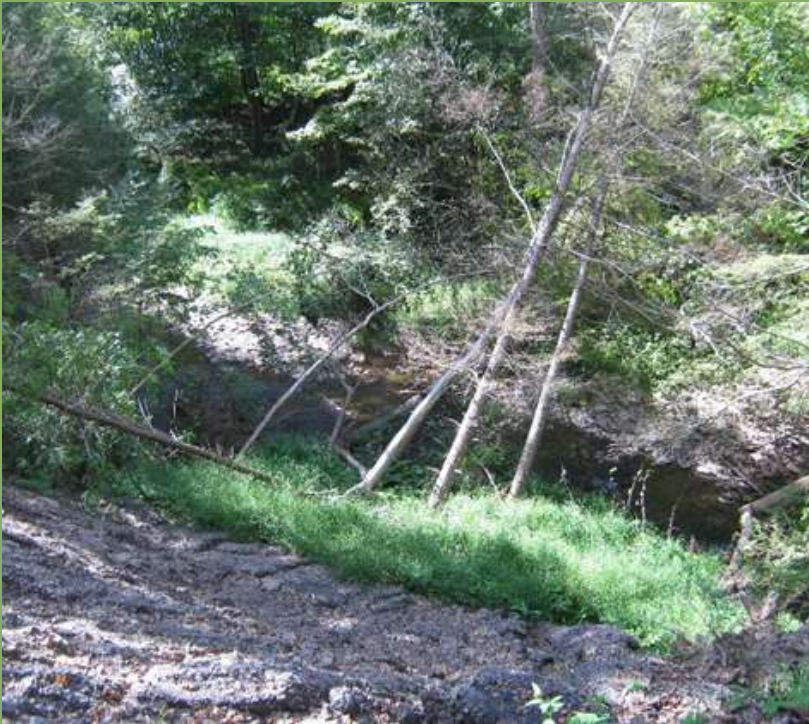
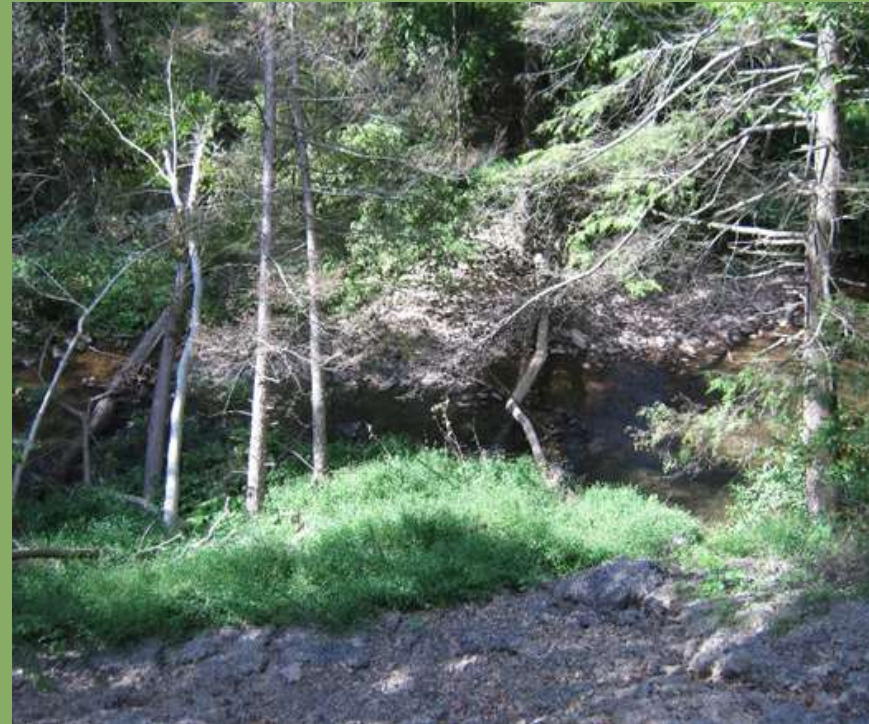
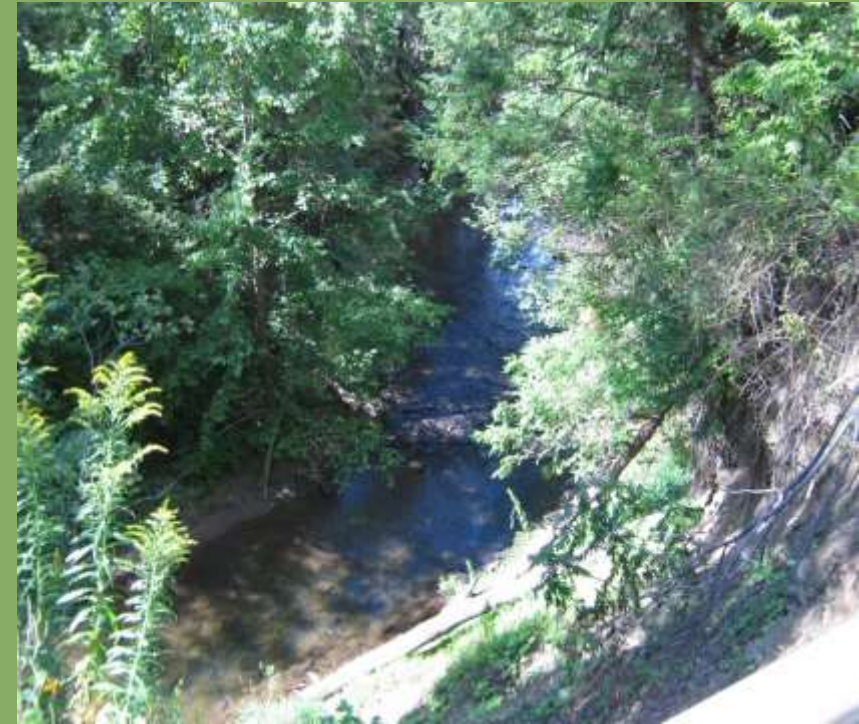
Warrensville Road Mill Creek, Lycoming County, PA

Extreme Storm – Flood Impacts, Upstream Embankment Toe Scour, Dry & Wet Slope-Landslides
