Urban Restoration – 2013

Adaptive Management

Implementation

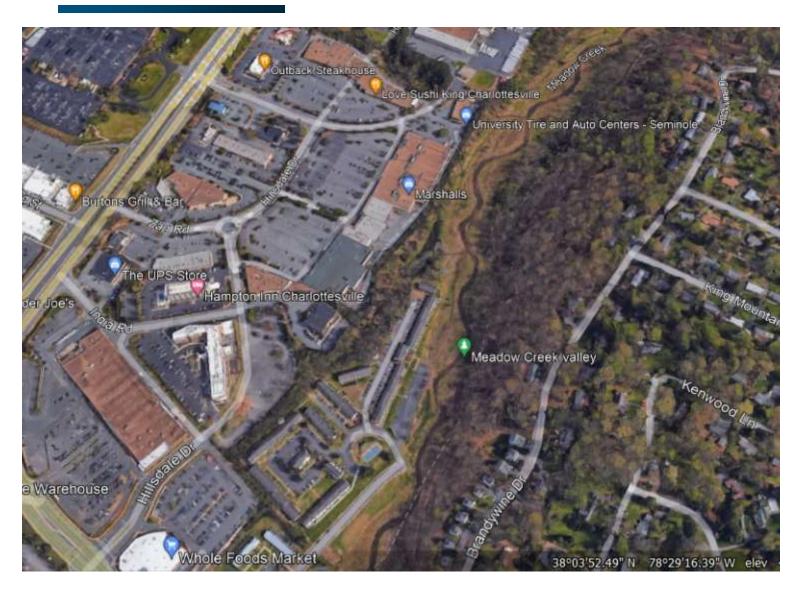
7,372 LF OF RESTORATION

4.5 SQ MI DRAINAGE AREA

CONSTRAINTS:

- VALLEY WALLS
- UTILITIES
- DEVELOPMENT
- SW OUTFALLS

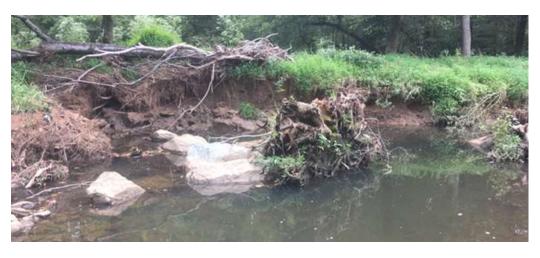
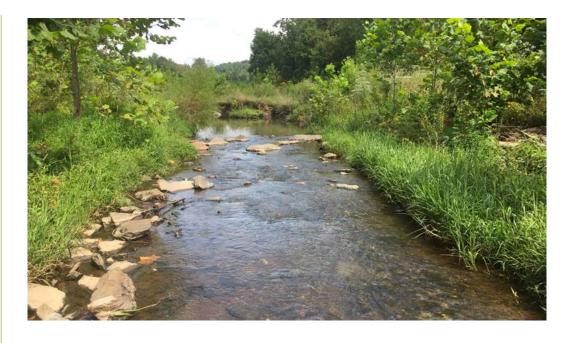
EXCESSIVE OUTER BANK SHEAR STRESS LED TO:

- DEEPENING POOLS
- UNDERCUTTING BANK STRUCTURES
- REMOVAL OF OUTER BANK VEG MATERIAL AND DEPOSITING MORE OF THIS MATERIAL ON RIFFLE INNER BERMS AND POINT BARS
- ULTIMATELY BANK EROSION FOLLOWING STRUCTURE FAILURE
- LACK OF FLOODPLAIN CONNECTIVITY AT MEANDER BENDS

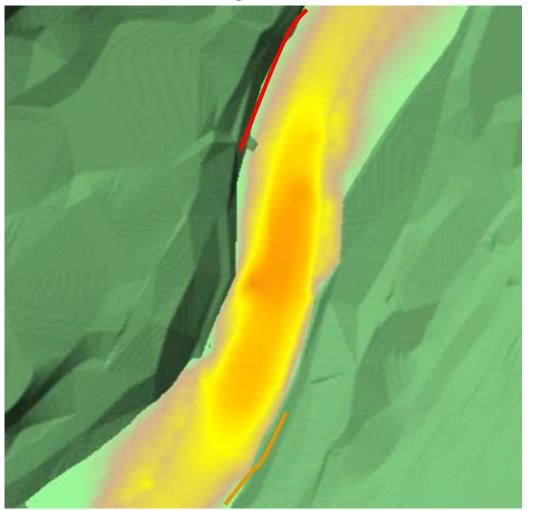
2-D Model Analysis

Hydraulic Assessment

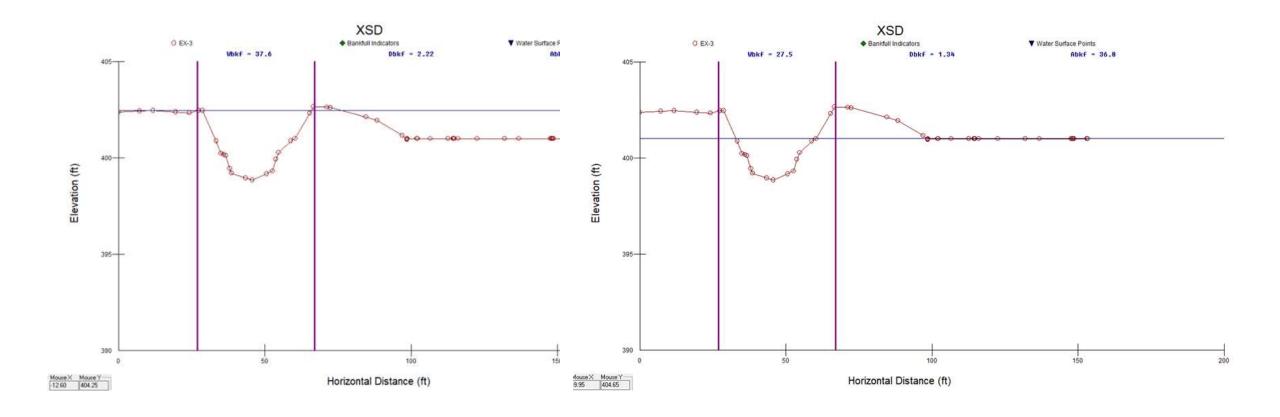
Hydraulic Geometry

Original Design Geometry

Proposed Geometry

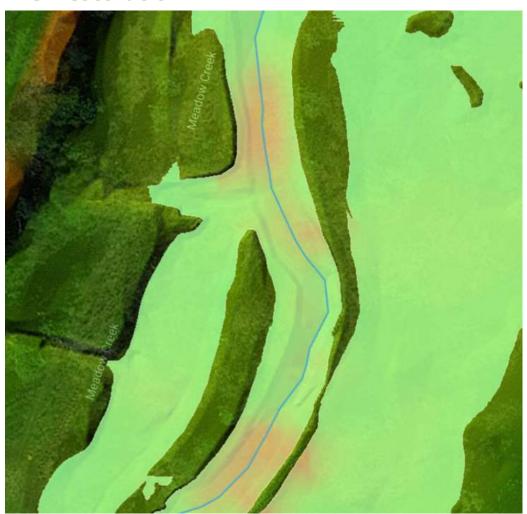
Pre-Restoration

Shear Comparison

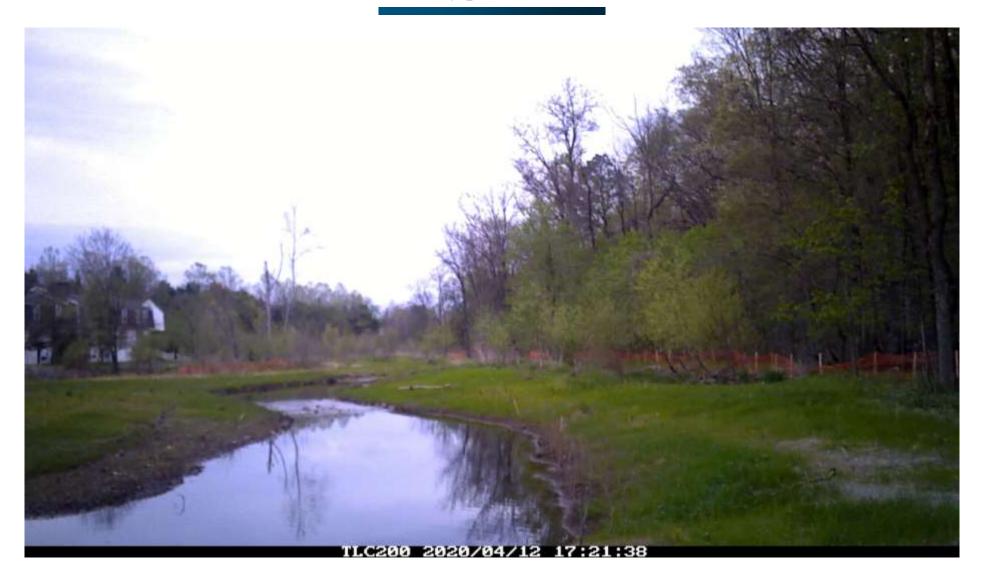
Sediment Transport Immediately post-construction

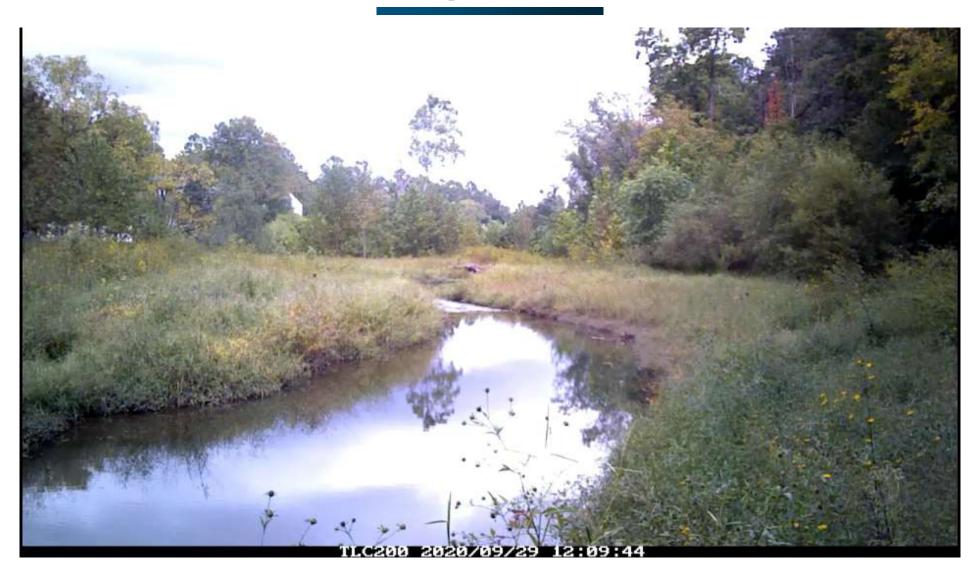
Sediment Transport 5 months post-construction

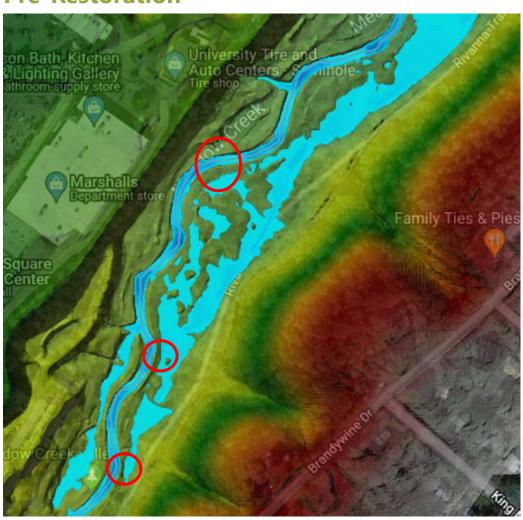
Pre-Restoration

Floodplain Connectivity

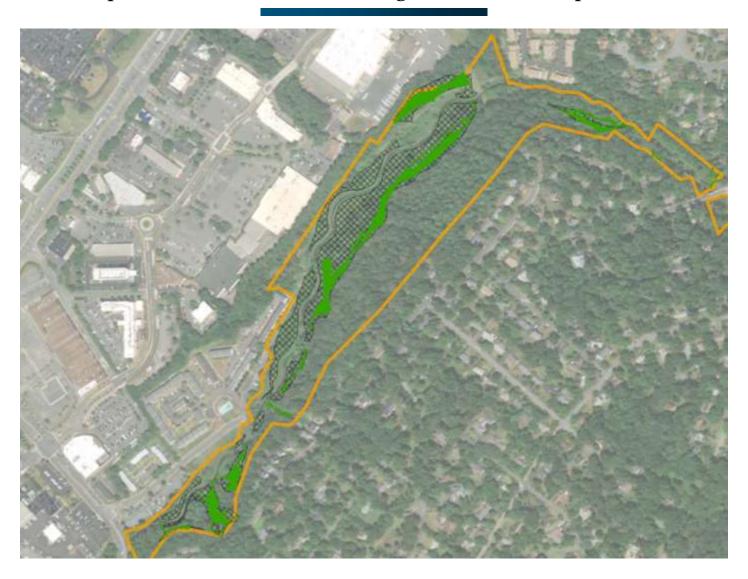
Increase to Restored Wetlands

(cross-hatch shows post-restoration wetlands and green hatch shows pre-restoration wetlands)

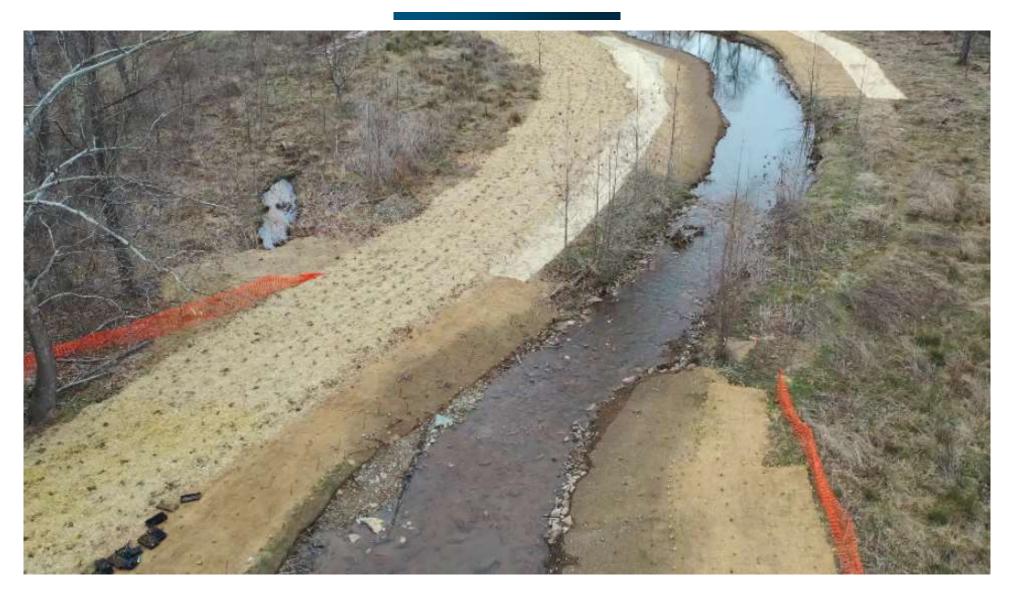
Immediate and Year 2 Post Repair - Drone
