Assessing stream water quality for a system affected by livestock production in northeast Mississippi

WATERSHEDS & WATER
QUALITY RESEARCH LAB

1st Stream Restoration Conference
August 2, 2022

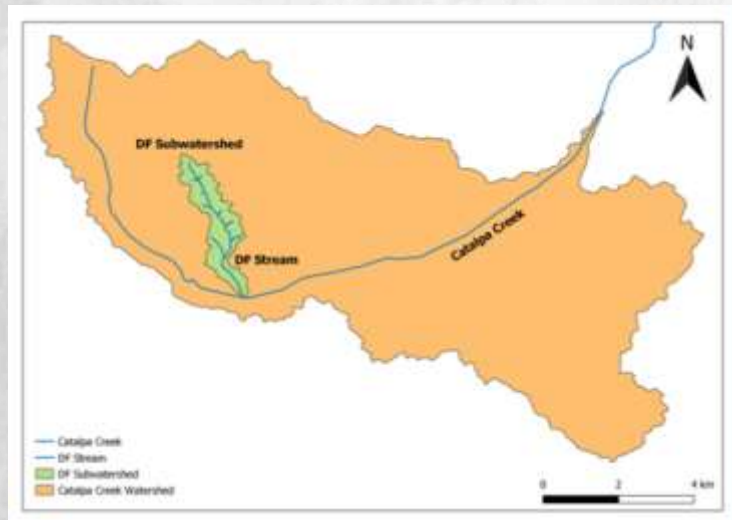
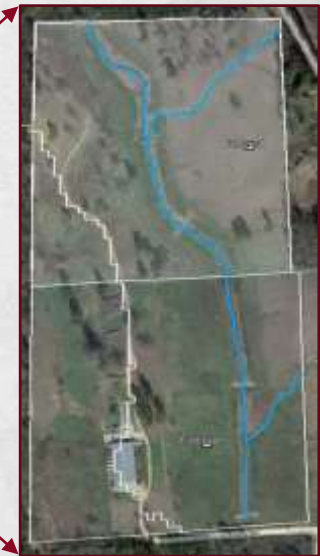
Study Area

- Sessums community NE – MS
- Sub-watershed headwater of Catalpa Creek
- Joey Bearden Dairy Research Center
- Designated Use: Fish & Wildlife
- Soils: 57% Type D (HSG)
- Land Use: Hay/Pasture
- Drainage Area: 0.25 km² (1.94 km²)
- Mainstream Length : 1.45 km (3.4 km)

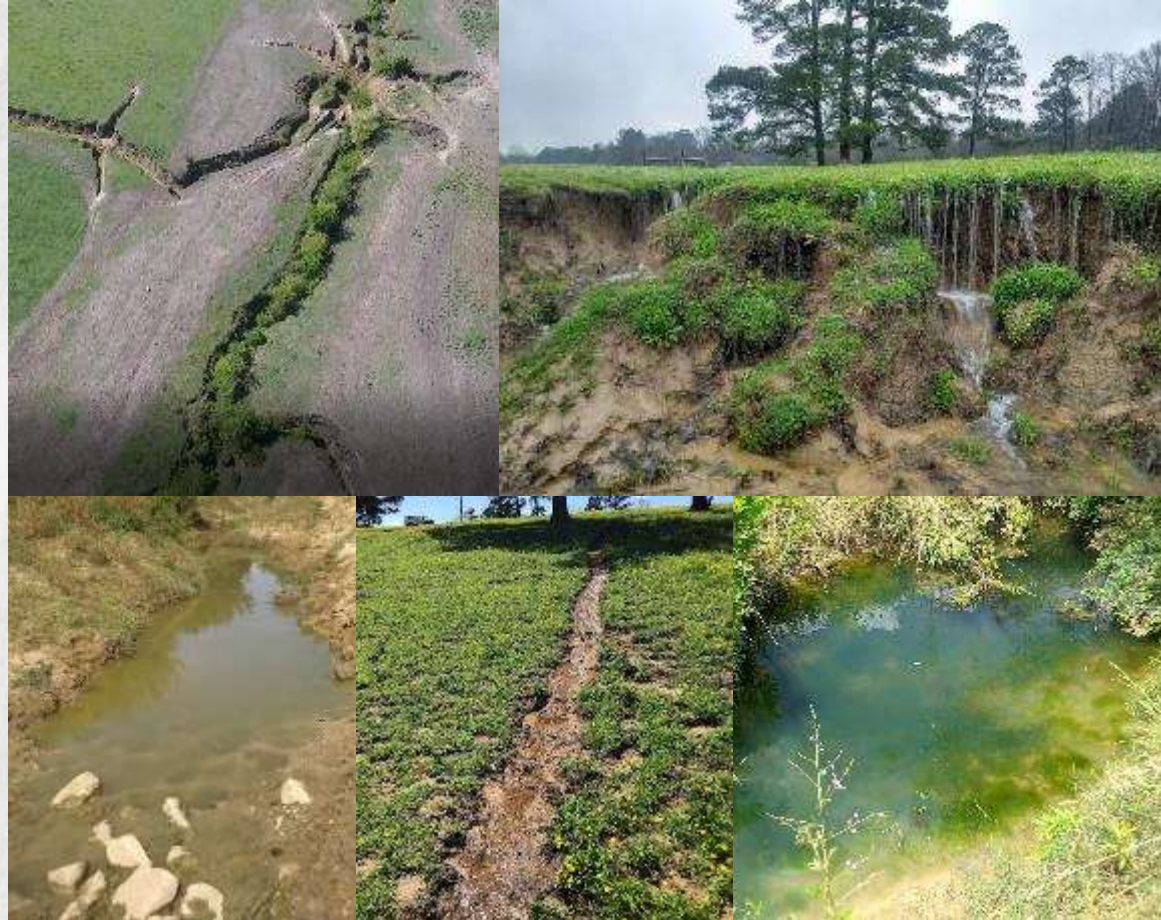
Study Area Issues

- Soil Compaction
- Reduced infiltration rates
- Runoff Volumes
- Sediment and Nutrients
- Low rates of DO
- Algae Bloom
- Streambank and bed erosion
- Upland, gully, rill erosion
- Concentrated flow

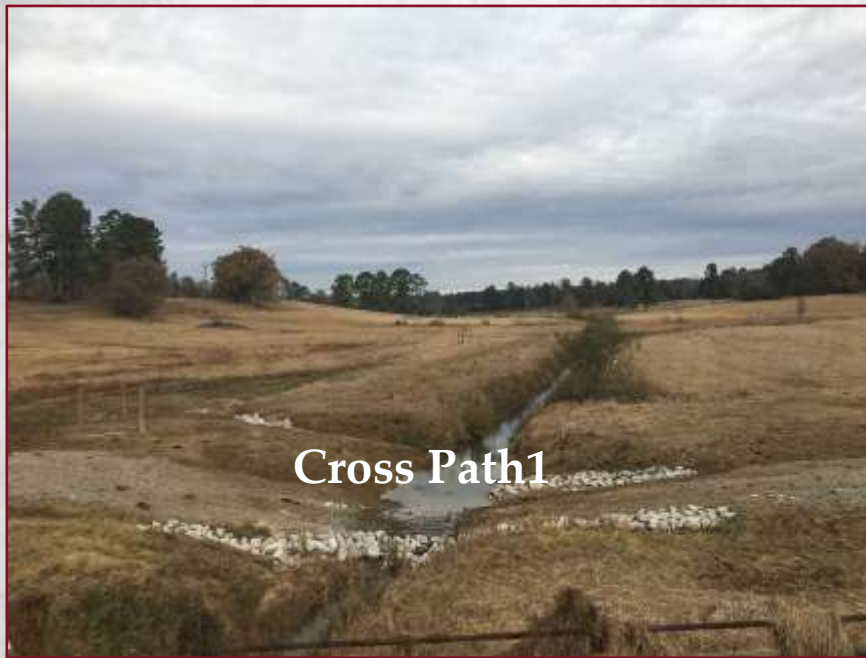
Pre-Implementation (July 2019 to March 2020)

No fenced stream
NRCS 381 - Stream Crossing

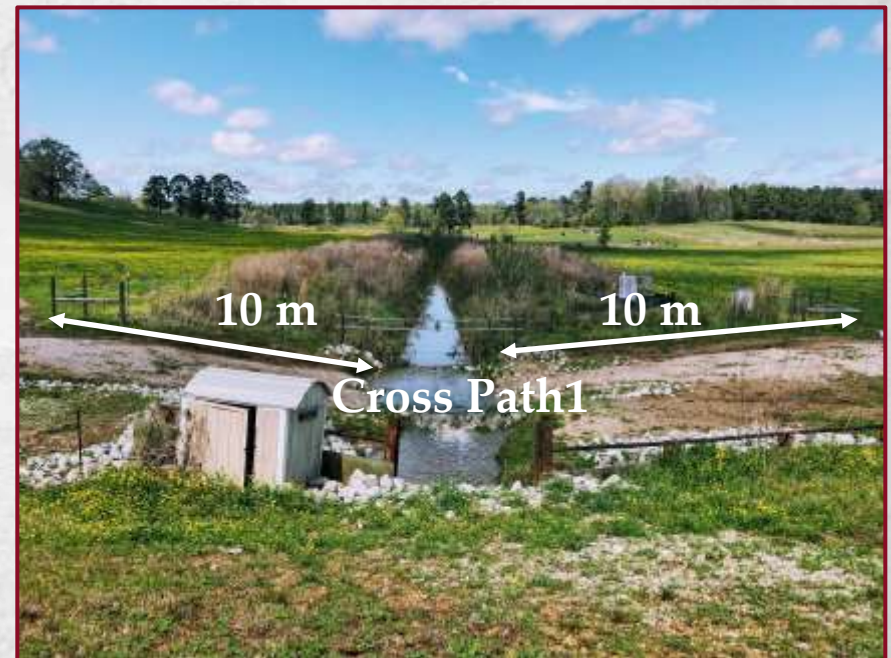
Post-Implementation (March 2021 to March 2022)

NRCS 381 - Stream Crossing
NRCS 382 - Fence (Animals Fenced out of the creek)
NRCS 391 - Riparian Forest Buffer

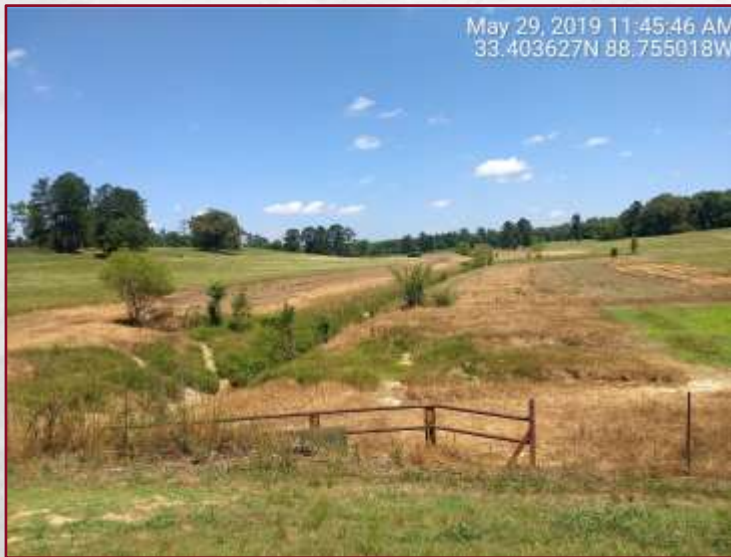
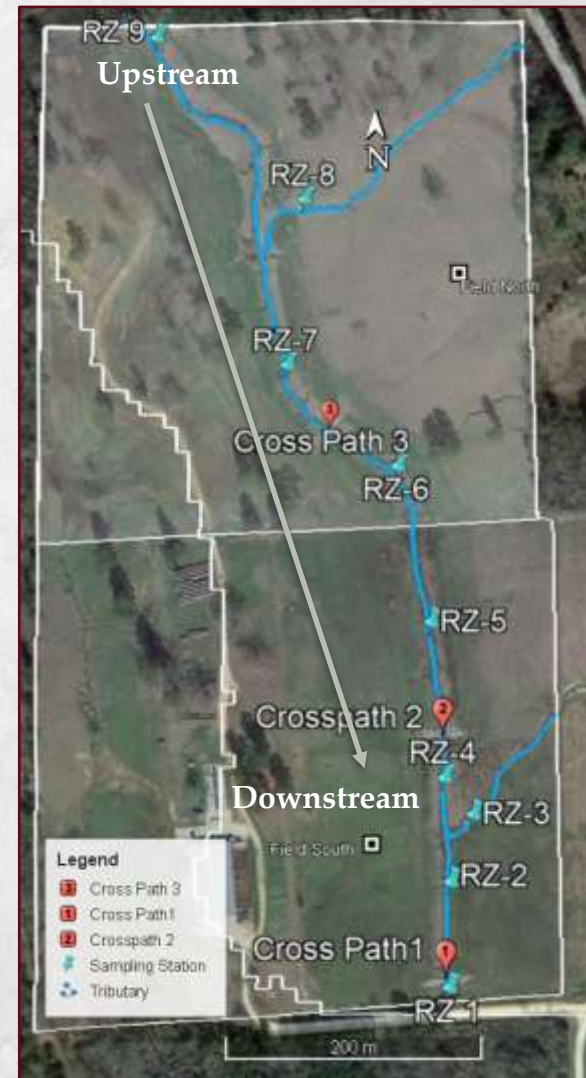
Sampling Stations Distribution

- 7 Monitoring Stations Mainstream
- 3 Cross paths: Before RZ 6, RZ 4, RZ 1
 - RZ 9 Upstream
 - RZ 1 Downstream
 - Fence closes upstream of CP1 & RZ1

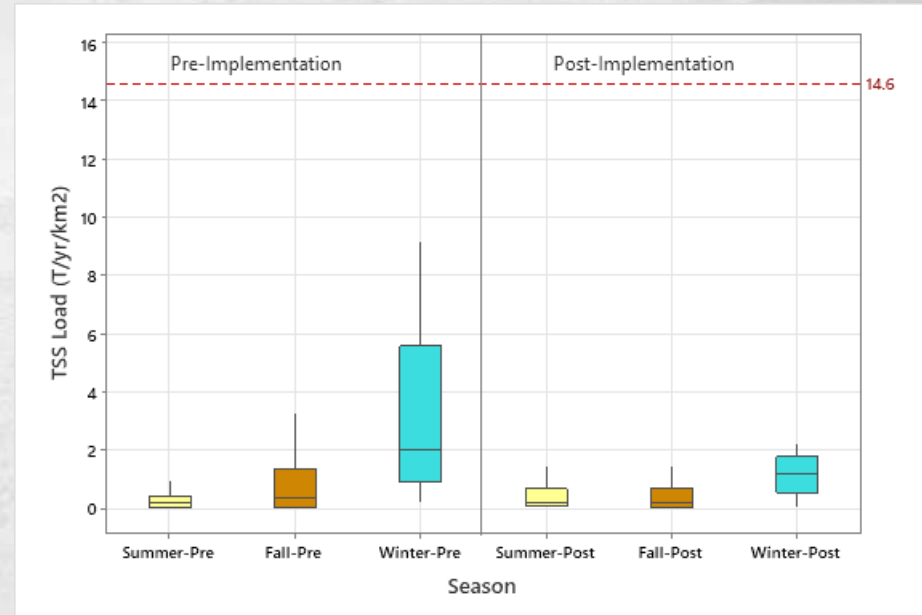
Concentration - Total Suspended Solids

--- TSS Load (Sediments TMDL Tibbee Creek)
Reference conditions, 1.5 Yr Recurrence interval, BKF

Yr 0= Pre-Implementation

Yr 2= Post-Implementation

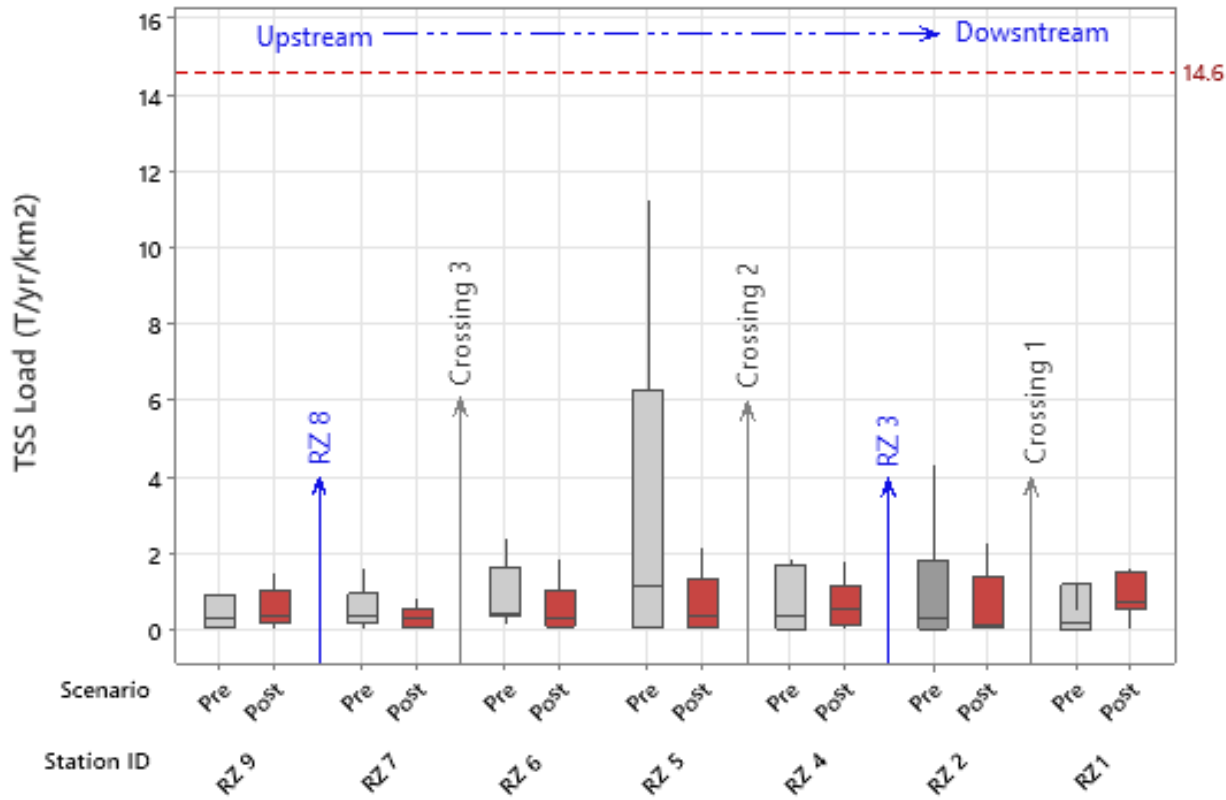
Spatial Variation TSS

Y0=Pre-Implementation Y2=Post-Implementation

----- TMDL Tibbee Creek - Minimum TMDL(14.6 T/Yr/Km²)

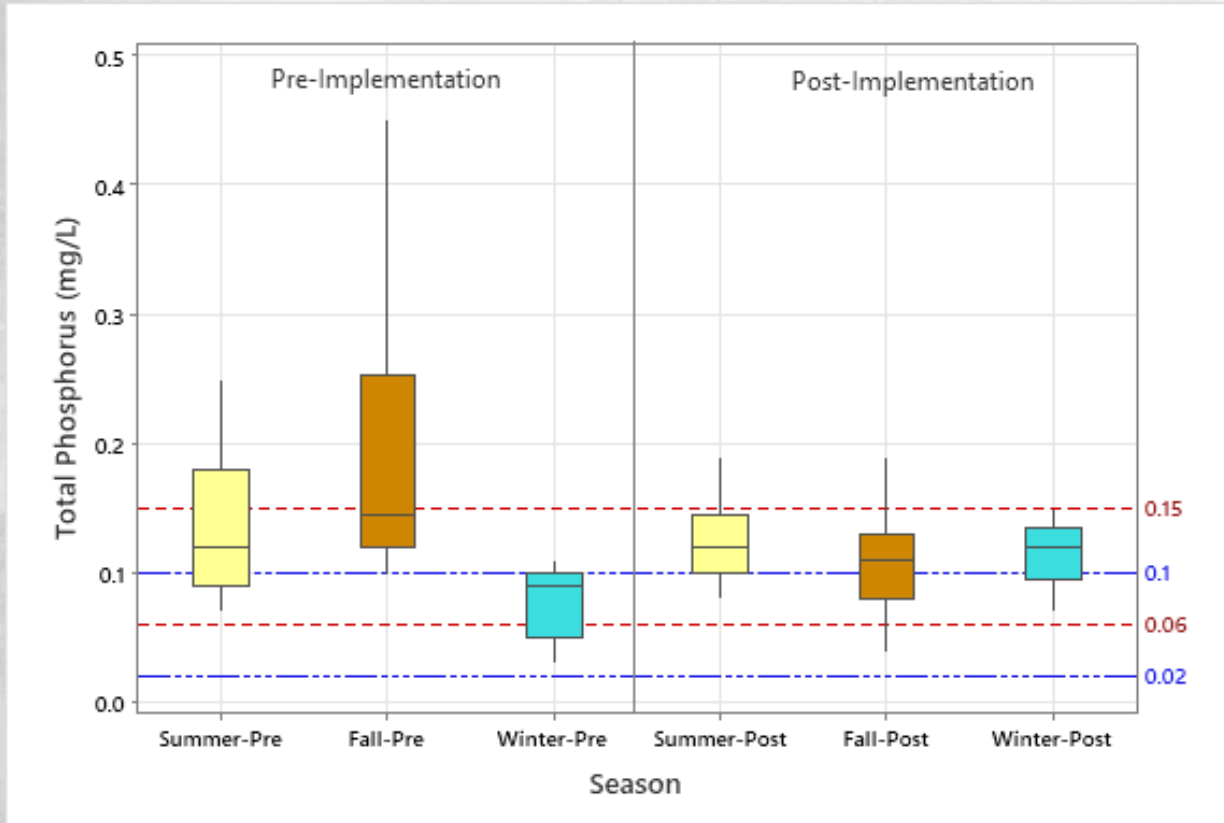
Temporal Variation Total Phosphorus

Yr 0=Pre-Implementation Yr 2=Post-Implementation

----- MDEQ 2014

----- EPA 2000

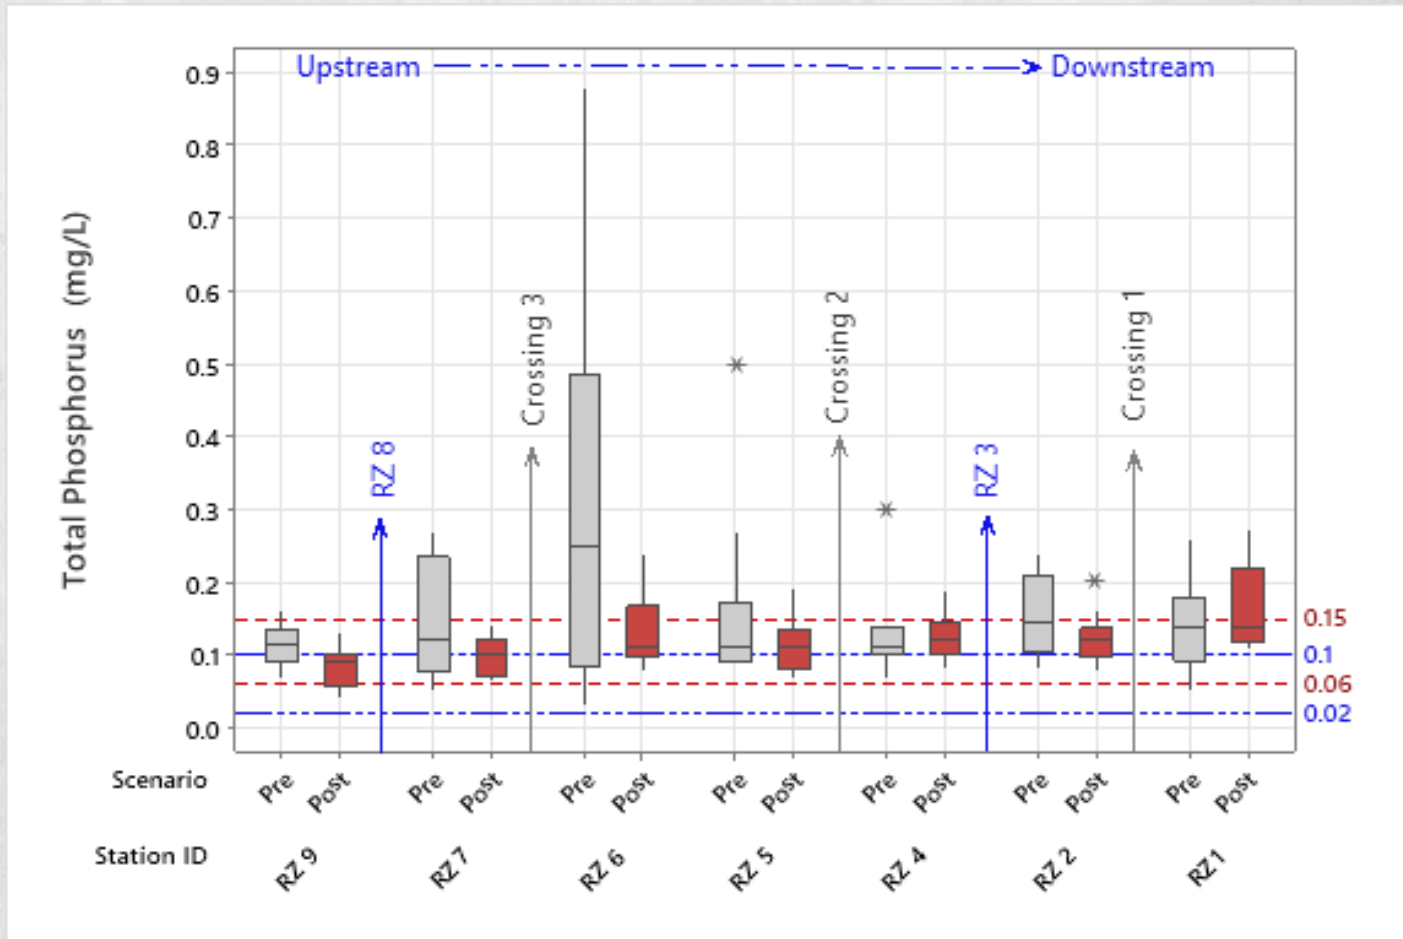
Spatial Variation Total Phosphorus

Y0=Pre-Implementation

Y2=Post-Implementation

--- MDEQ 2014

--- EPA 2000

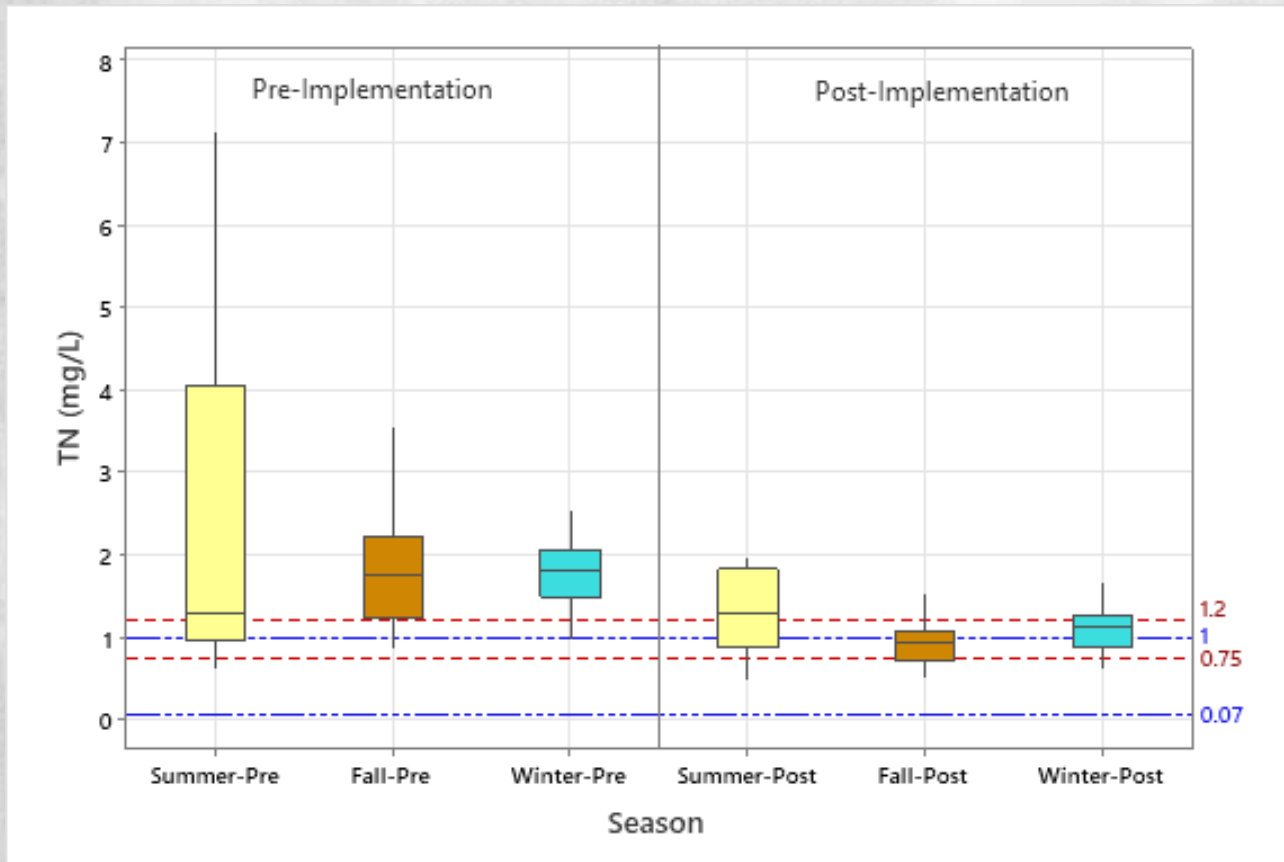
Temporal Variation Total Nitrogen

Y0 = Pre-Implementation

Yr 2 = Post-Implementation

--- MDEQ 2014

--- EPA 2000

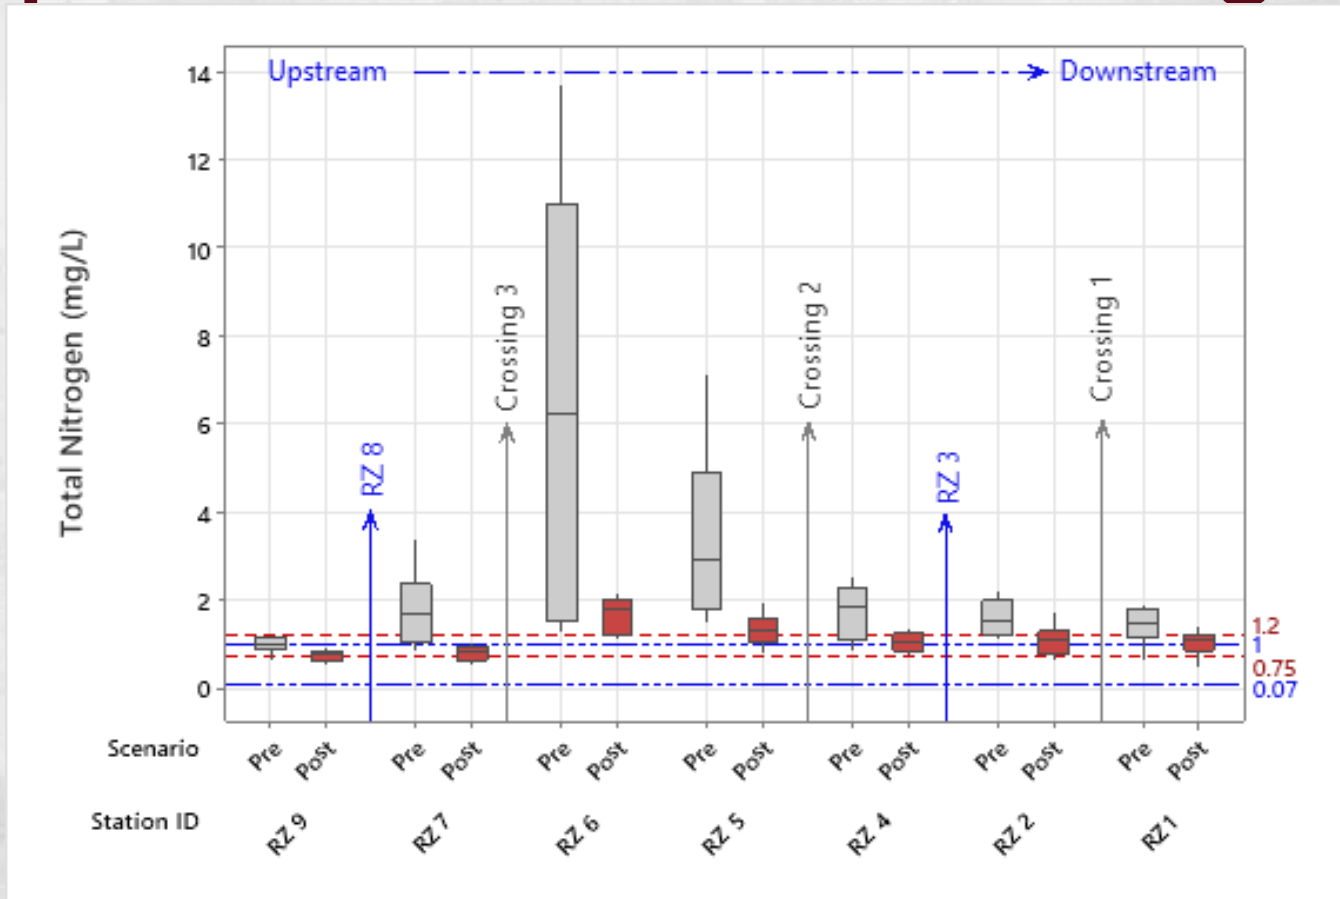
Spatial Variation Total Nitrogen

Y0= Pre-Implementation

Y2= Post-Implementation

--- MDEQ 2014

--- EPA 2000
