Implementing Prioritized Projects from a Watershed Plan on Picadome Golf Course in Lexington, KY

Session C Brad Anderson, PE, CPESC, LEED AP

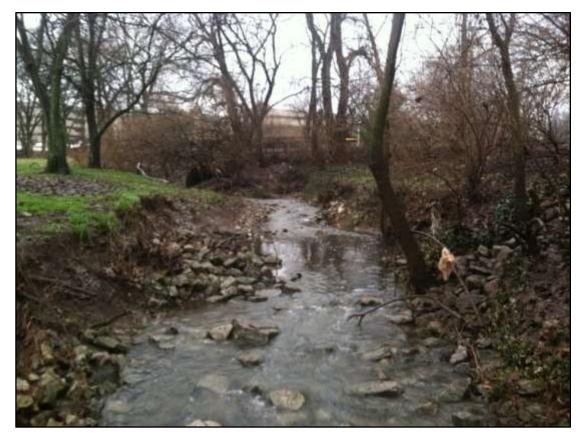
Upper reach was actively incising and laterally migrating.

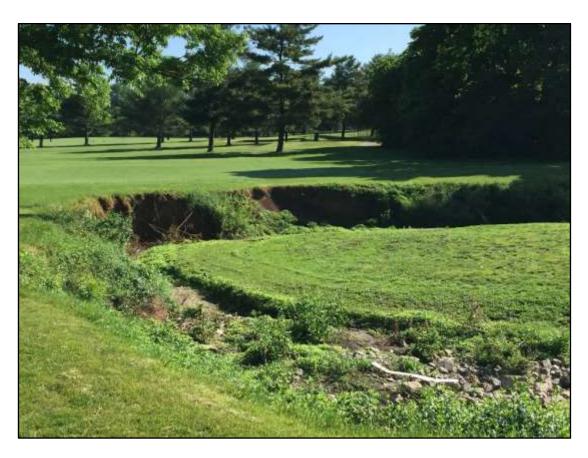
Middle reach contained a tight meander with a vertical eroding outer bank.

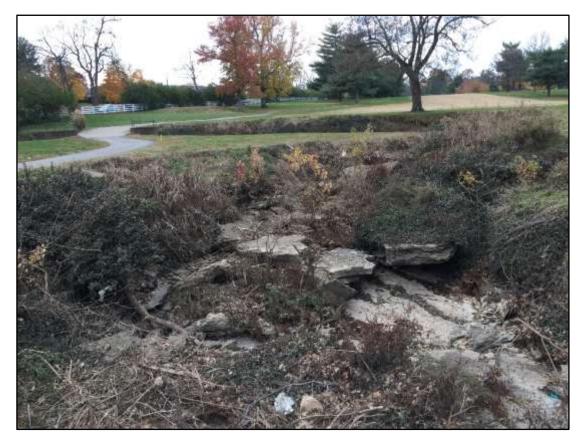
Lower reach was severely incised and had downcut to bedrock.

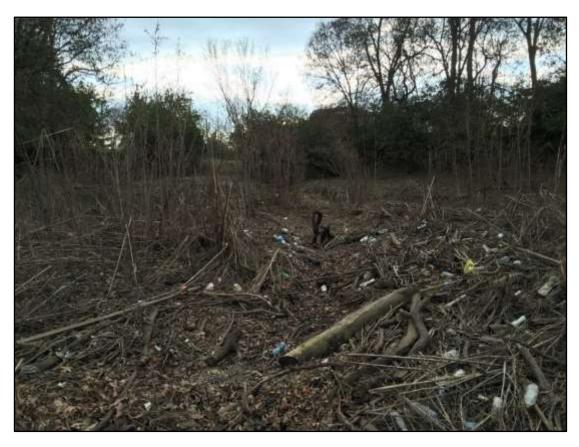
Sinkhole receives considerable amounts of trash and sediment.

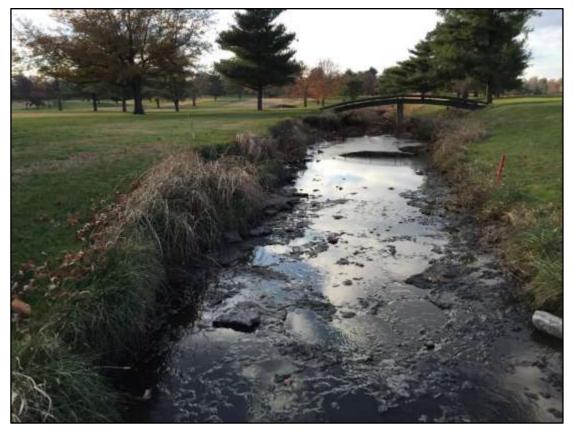
Upper reach of was overwidened, cut down to bedrock with eroding banks.

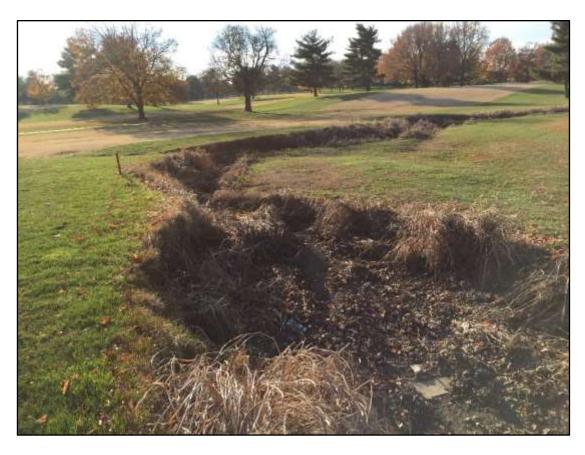
Middle reach was transitioning to narrower, more incised stream.

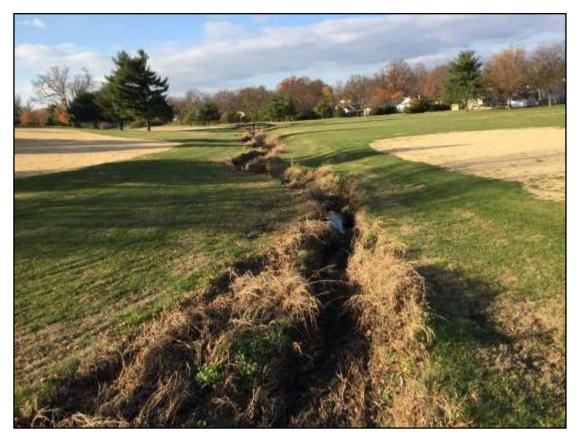
Lower reach was narrow and incised with eroding banks.

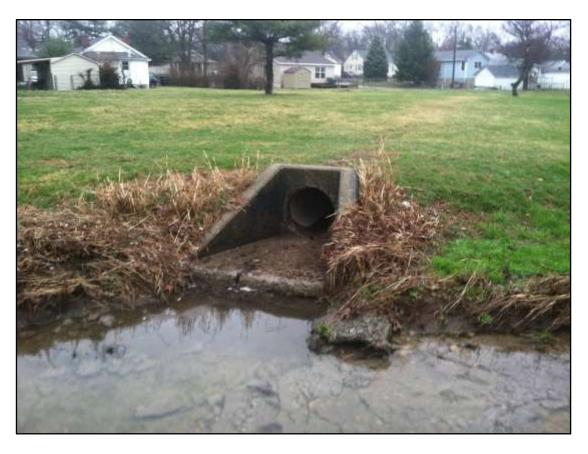
There were two stormwater outlets from adjacent neighborhood.
