**DESIGN, CONSTRUCTION AND MONITORING OF THE FIRE POND MITIGATION  
SITE: CONVERTING A POND TO A STREAM AND WETLAND COMPLEX**

**National Stream Restoration Conference ▪ August 1 – 3, 2022**

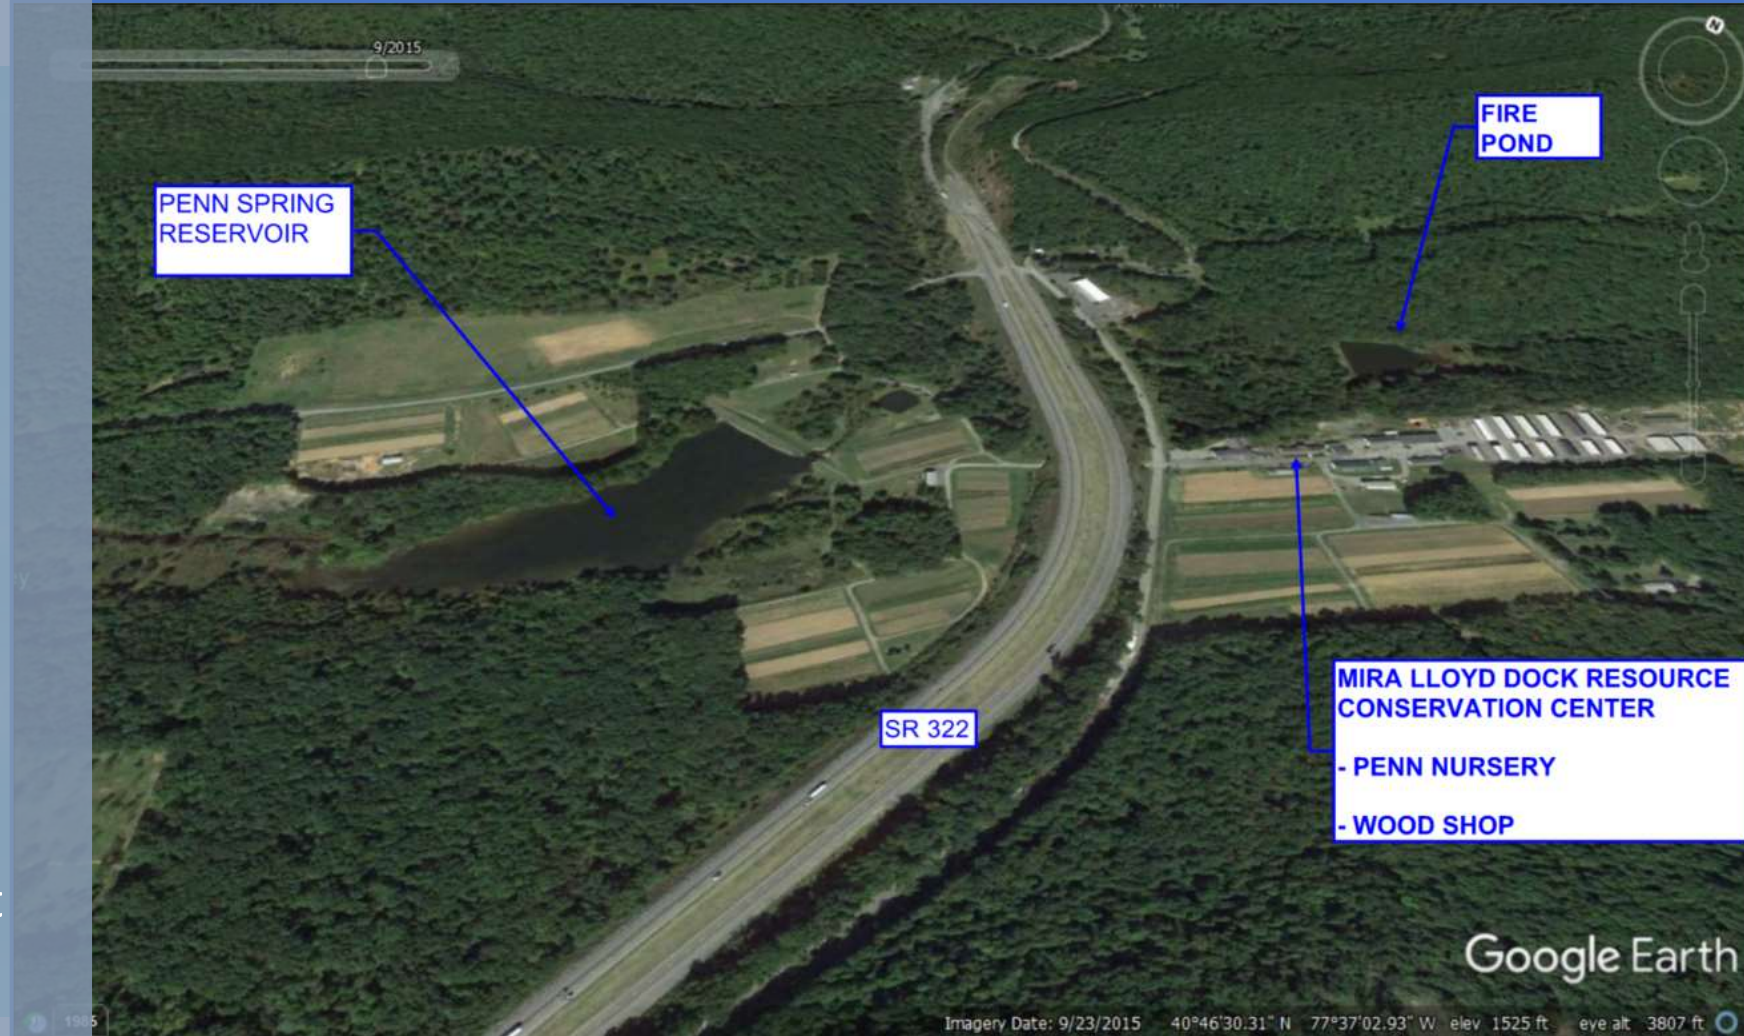
### Fire Pond = 1 acre (approx.)

- Emergency water source

### Penn Spring Res. = 10 acres

### Potter Run

- Class A Wild Trout Stream (Sport Fishery / Natural Reproduction)
- Brown and Brook Trout

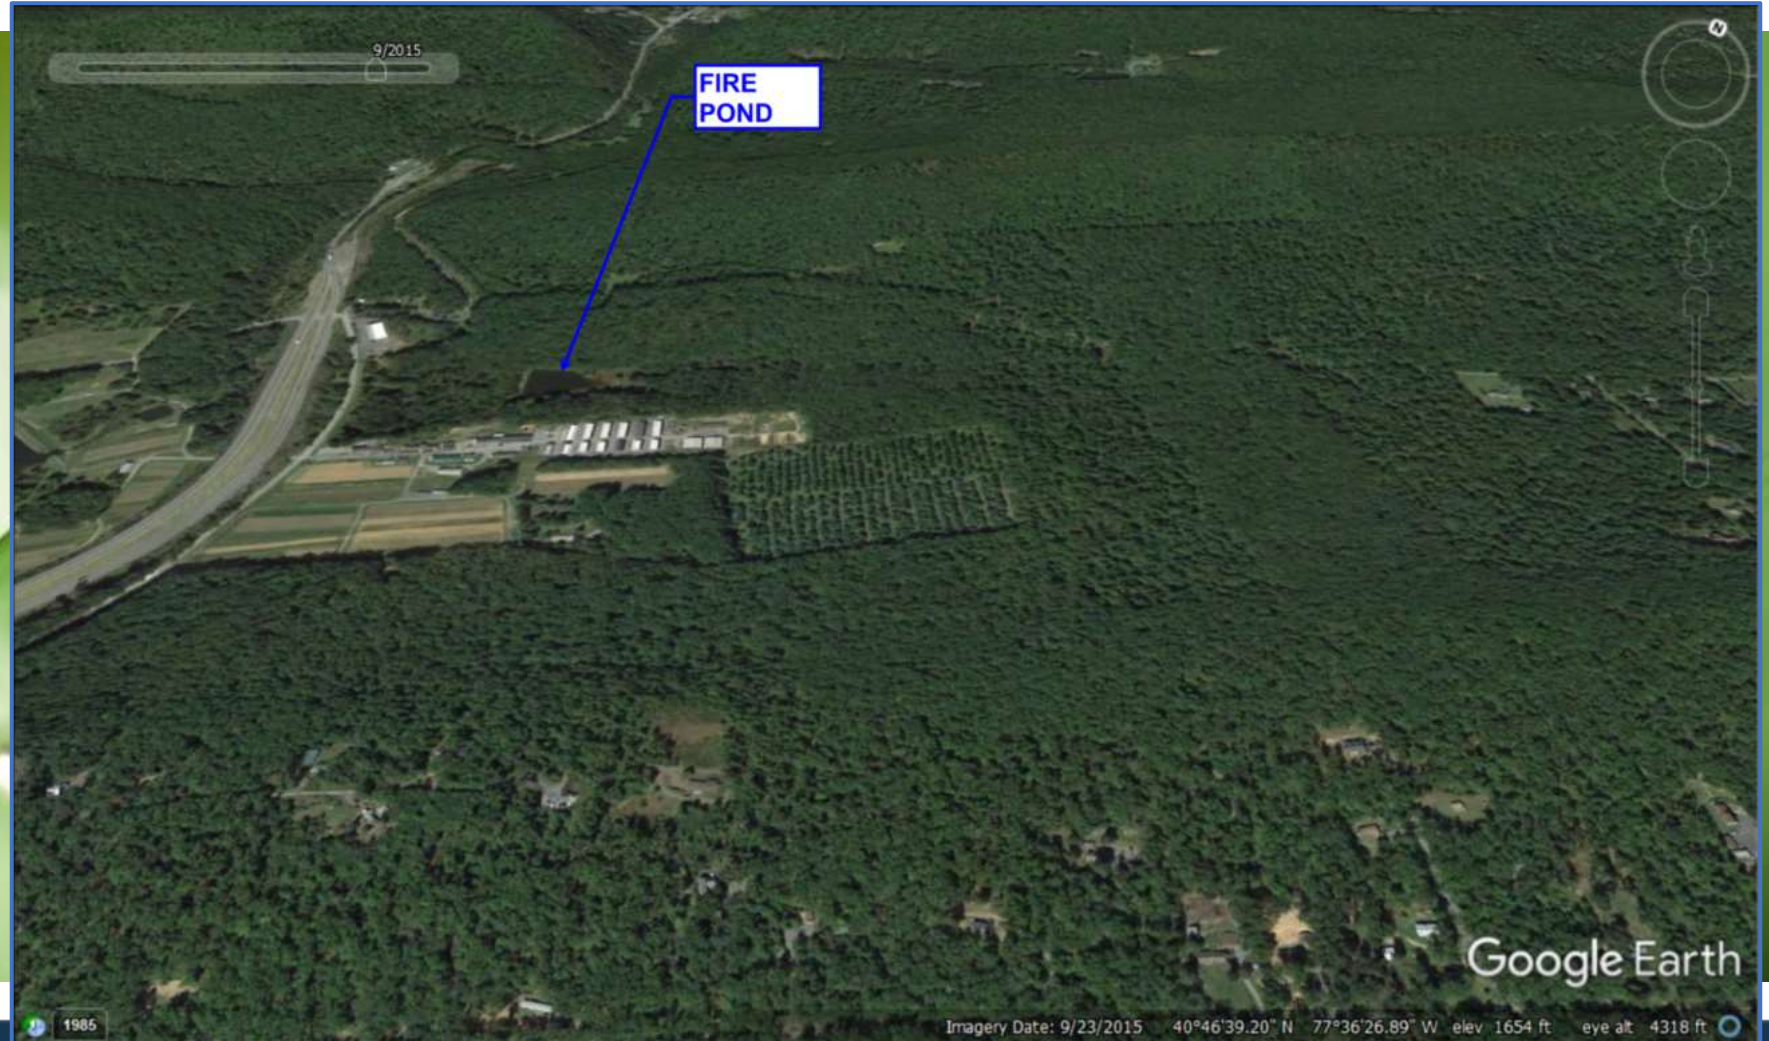
DA = 239 acres

Impervious = 3%

Row Crops = 8%

Forested = 89%

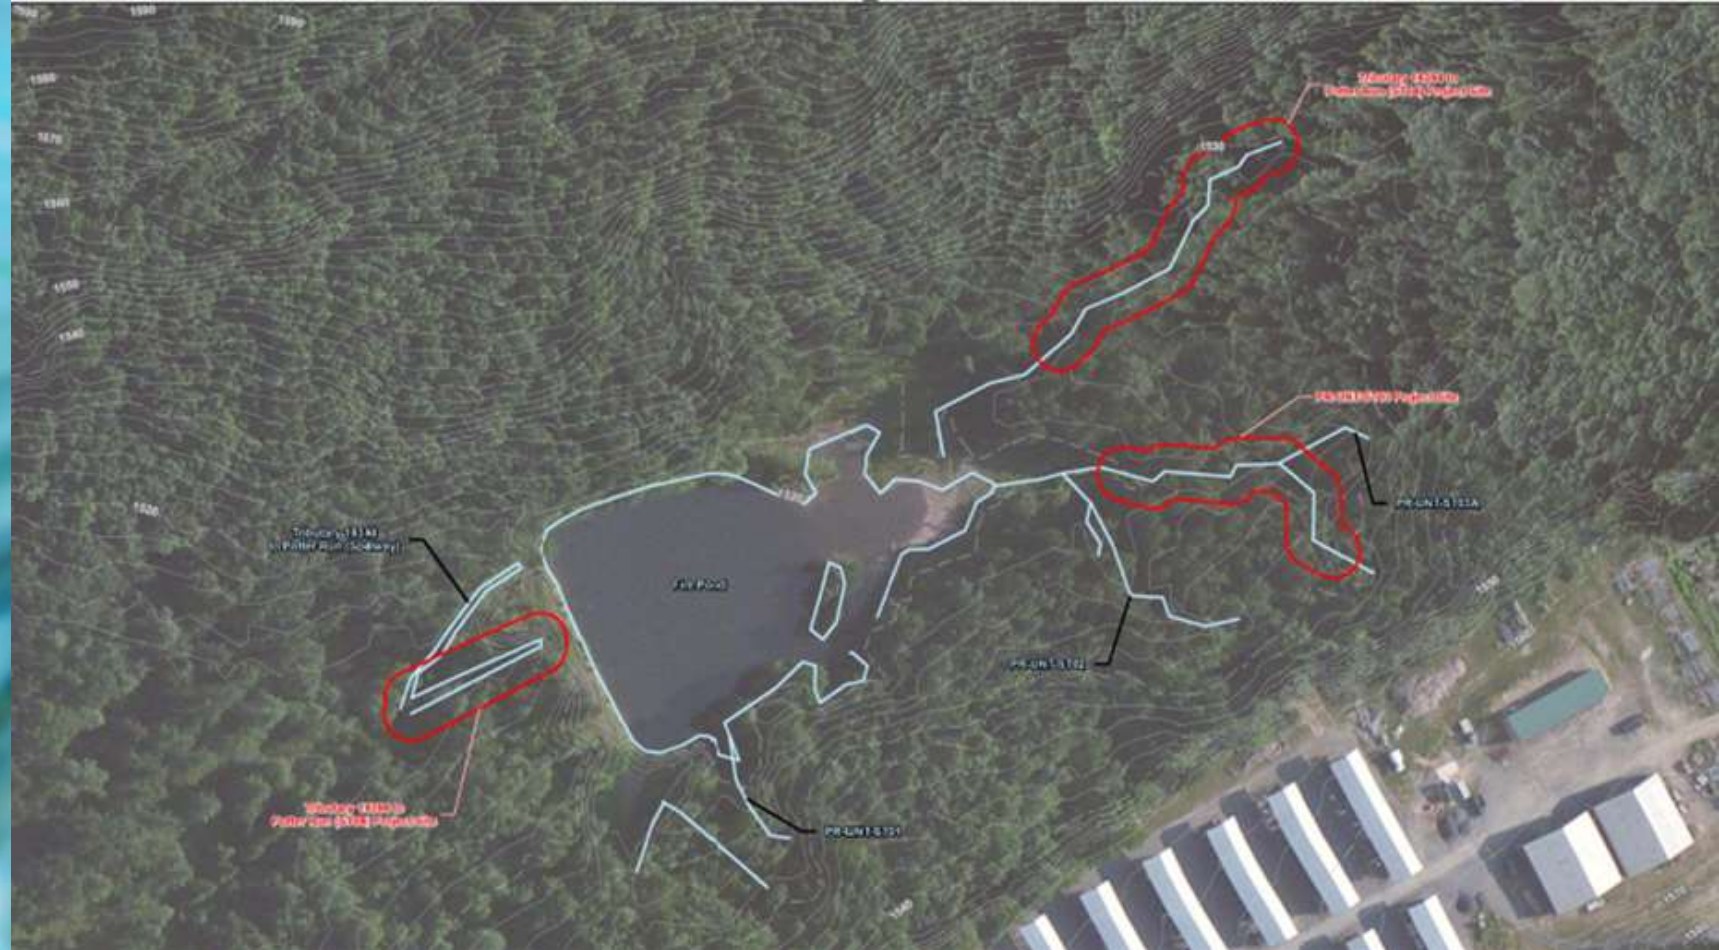
- Two Main Tributaries
  - Northern/Southern
- Main Outflow
  - Riser
- Spillway/High Water Outflow
- Spring House/Seep
- Southern Cove
- Northern Cove

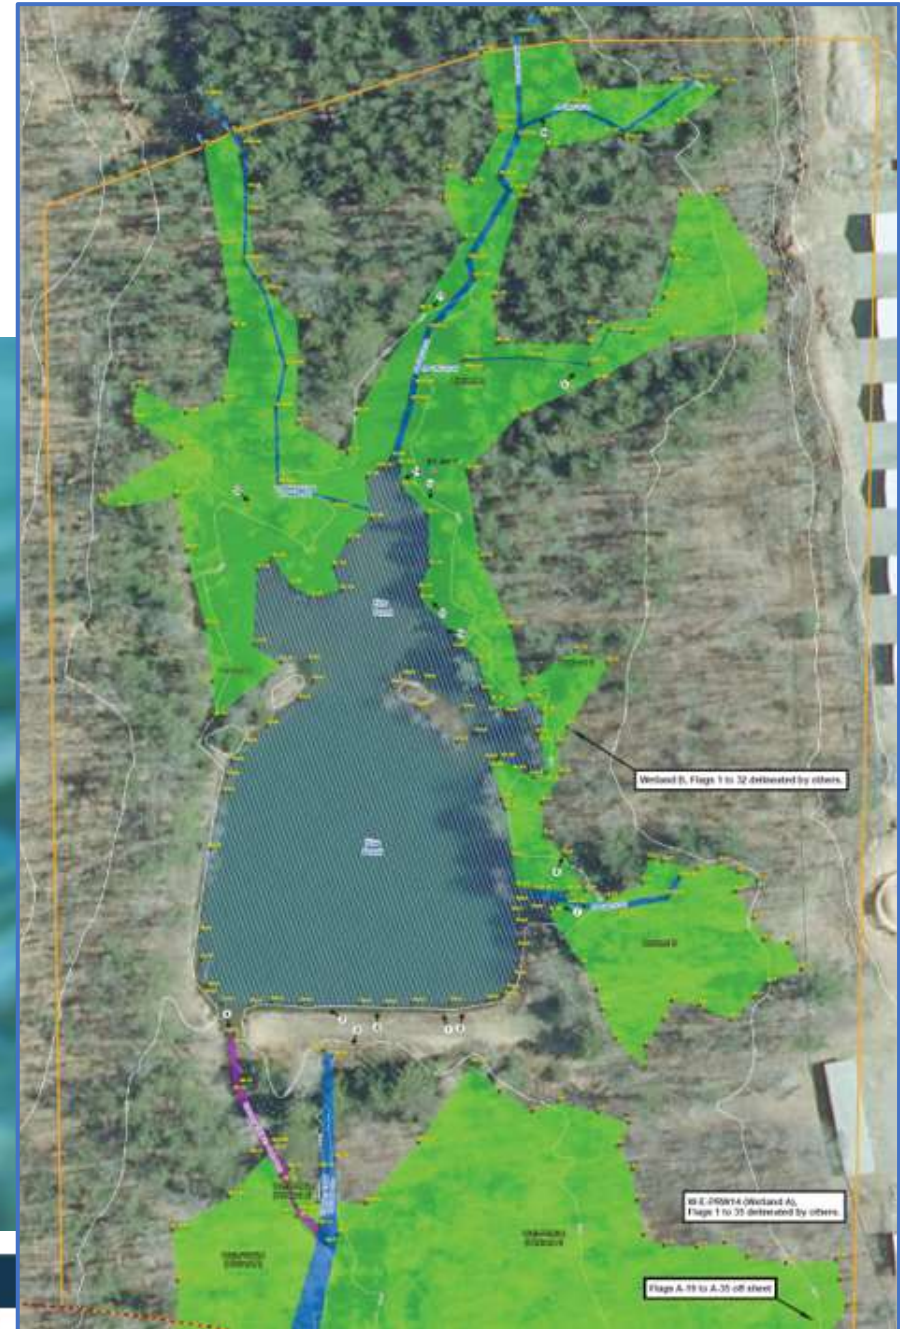
- Wetlands along pond
- Agency requirement
  - Maintain existing wetlands
- Design Implications

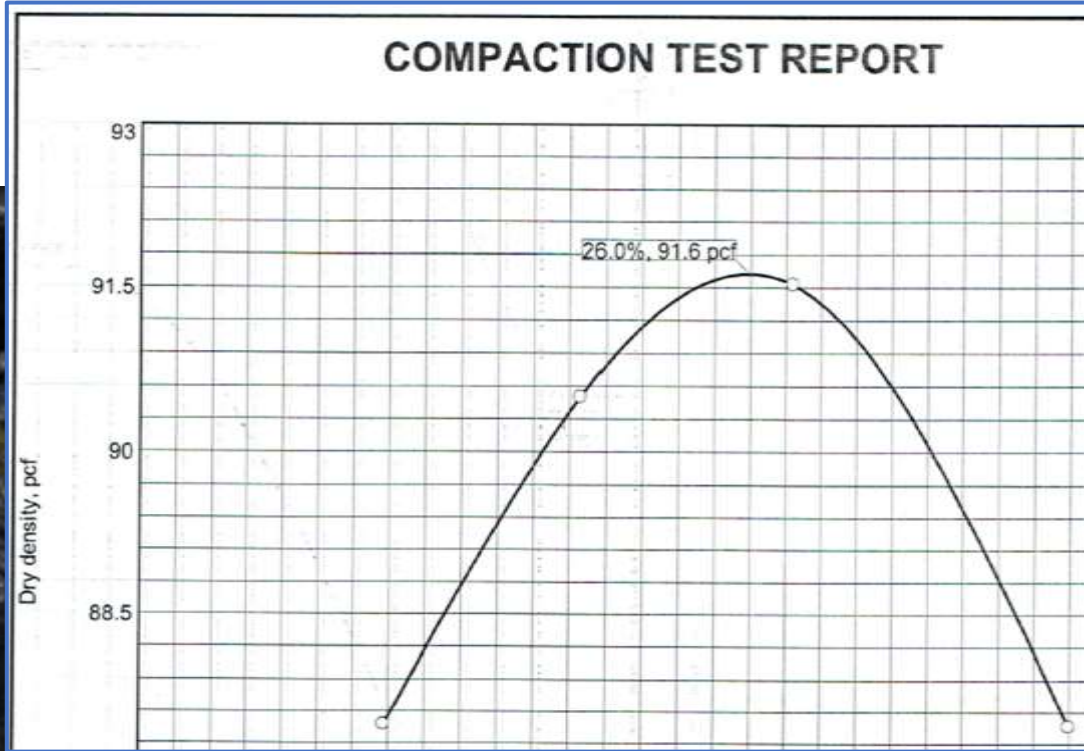
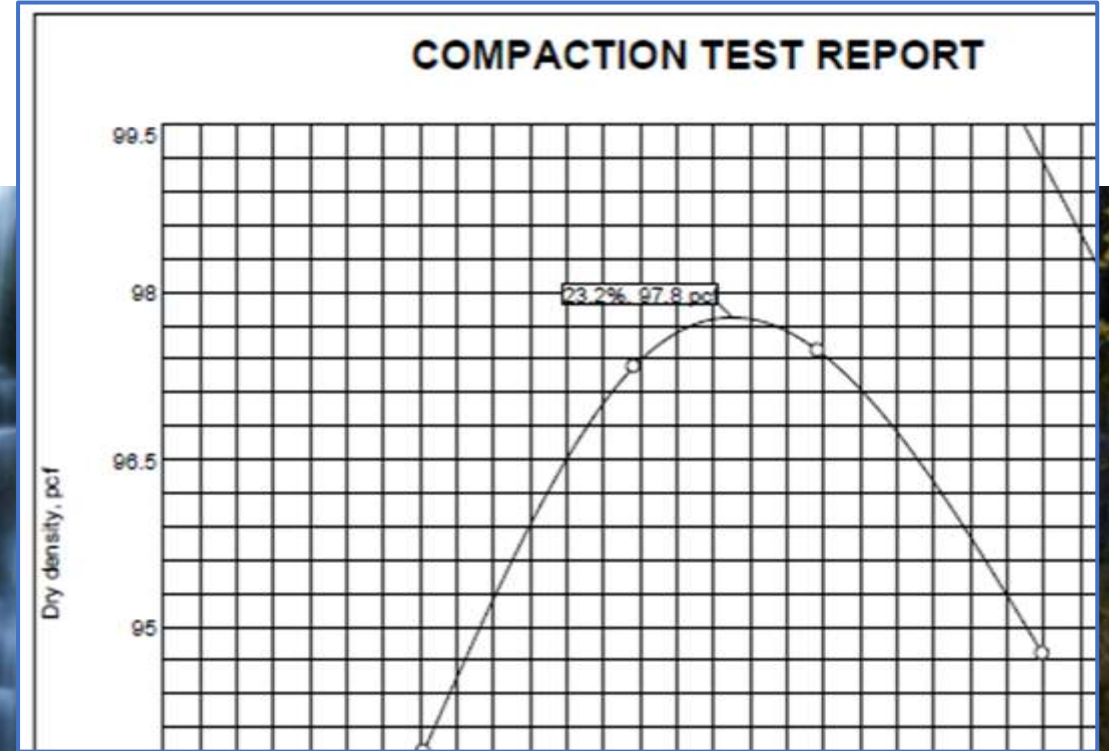
## Compaction Test Results

- 91.6 pcf
- 97.8 pcf

## Compaction Requirements

- 97%
- Top 3 feet = 100%

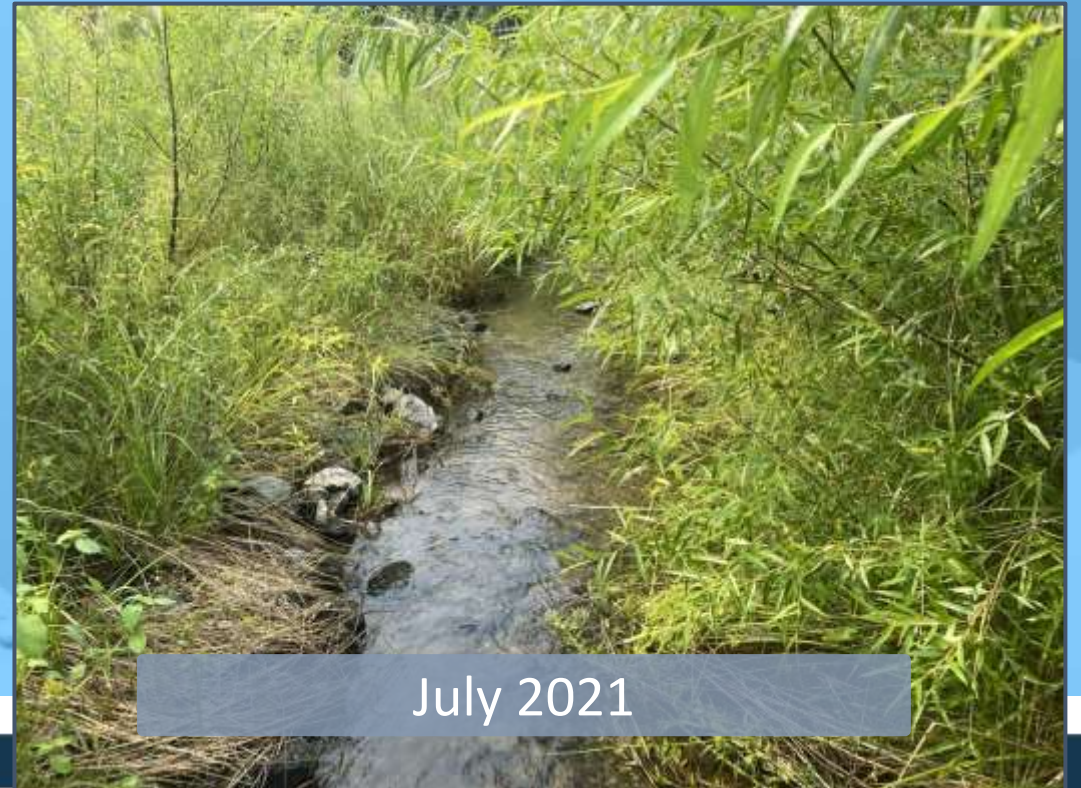
- Stable
- Functioning as designed/constructed
- Base flow
  - Intermittent (one event 2019/2020)
  - Perennial (both events 2021)
- Riparian zone well vegetated
- Macroinvertebrates
  - Caddisfly (3 taxa); Mayfly (1 taxa)
  - Pre-construction
    - Abundant
      - Caddisflies, mayflies, stoneflies and beetles
    - Common
      - Dragonflies and crayfish
- Fish observed throughout reach

- Invasive Species
  - Narrow-leaf cattail, Canada thistle, reed canary grass, Japanese stilt grass
  - Insignificant abundance
