Bioengineering Solution for Infrastructure Protection and Stream Stability in Blackwater Creek

National Stream Restoration Conference 2022

Emily Burgess

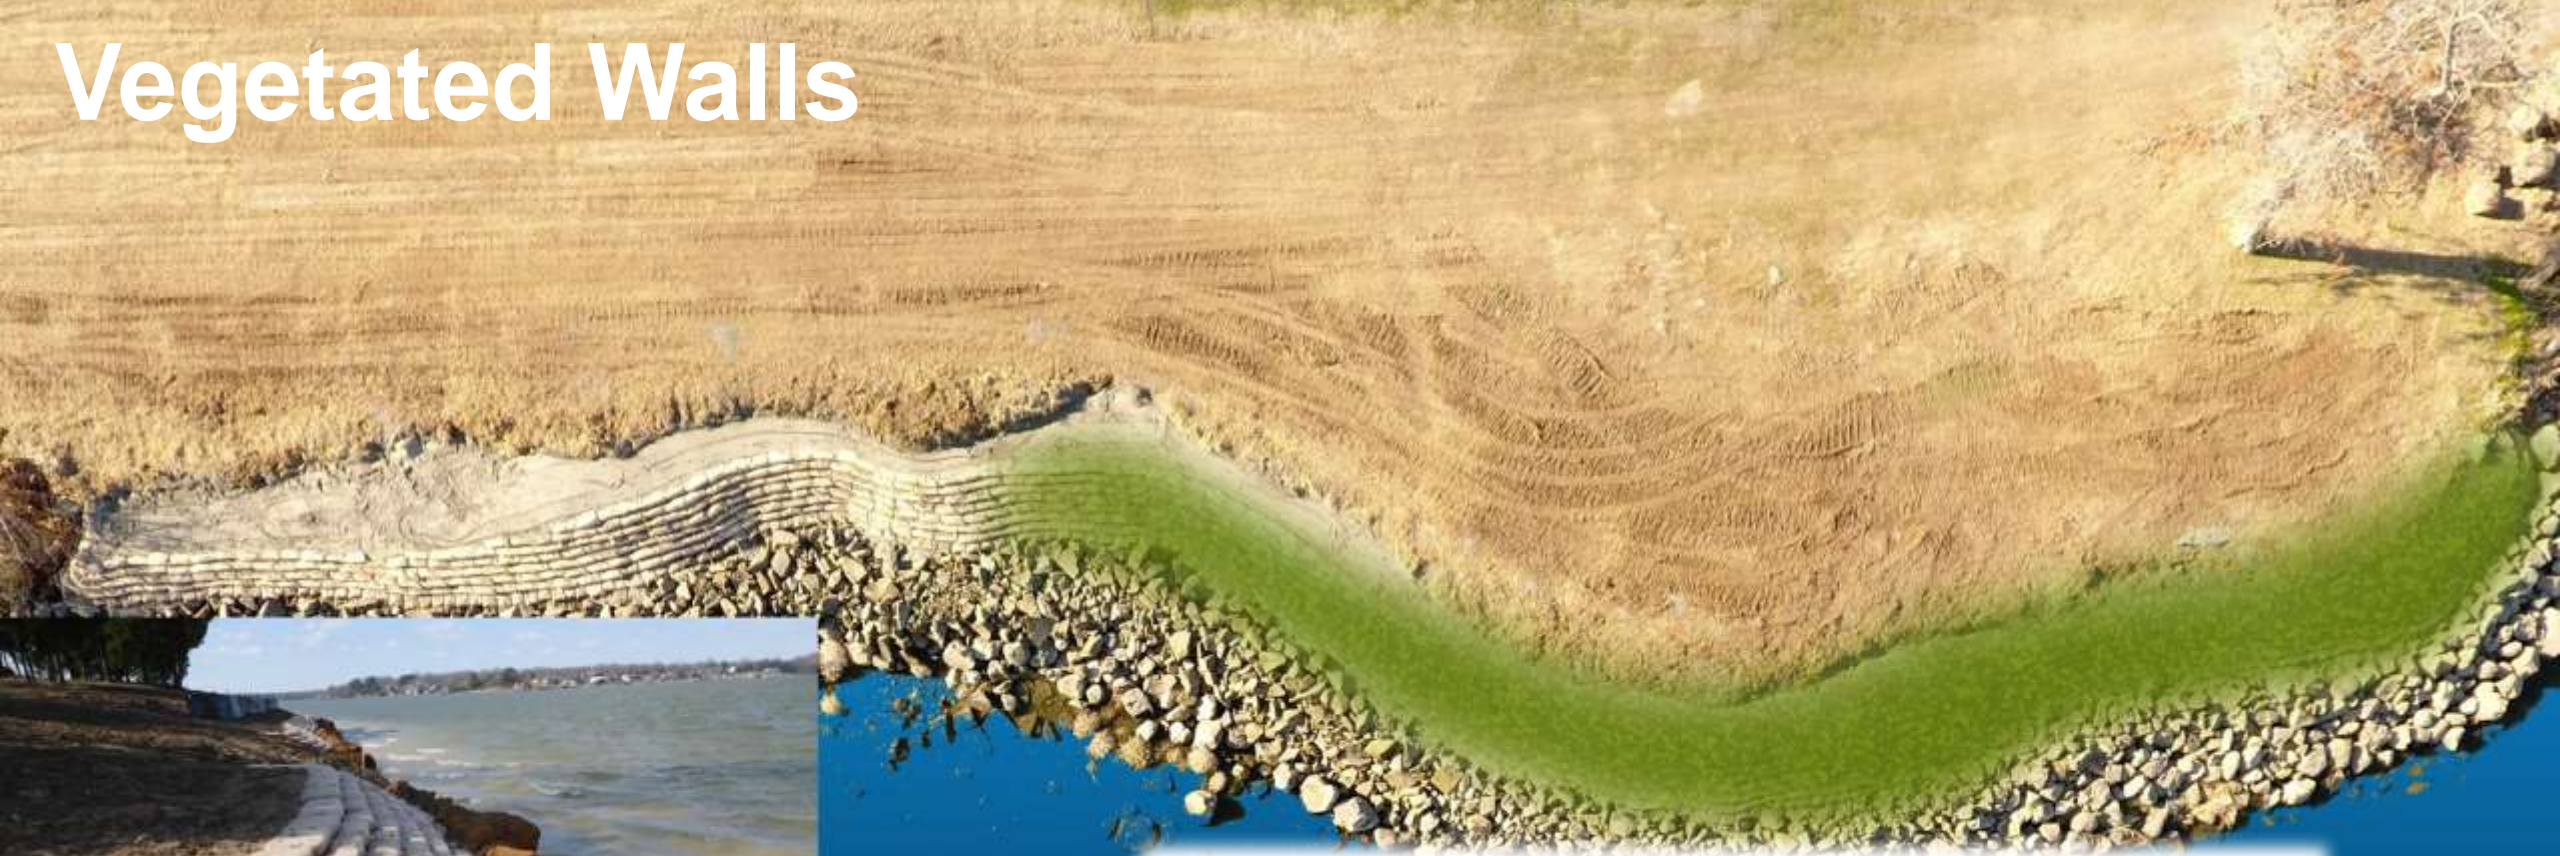
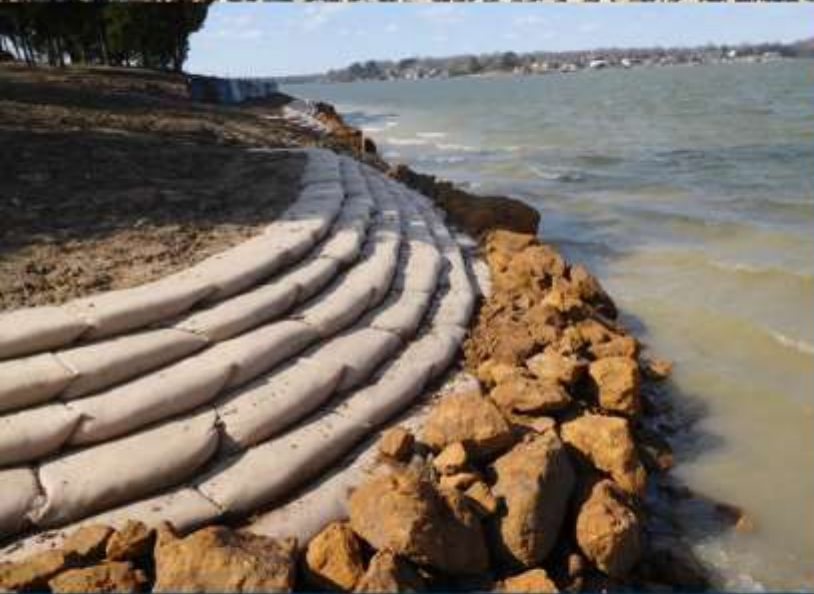
1 Envirolok Bag

Vegetated Walls
