Field of Dreams Watershed & Water Trail

Stream Restoration, the Iowa DNR River Restoration Toolbox and a Vision for Change!

*Judith E. Joyce, PWS
Principal & Senior Geomorphologist*

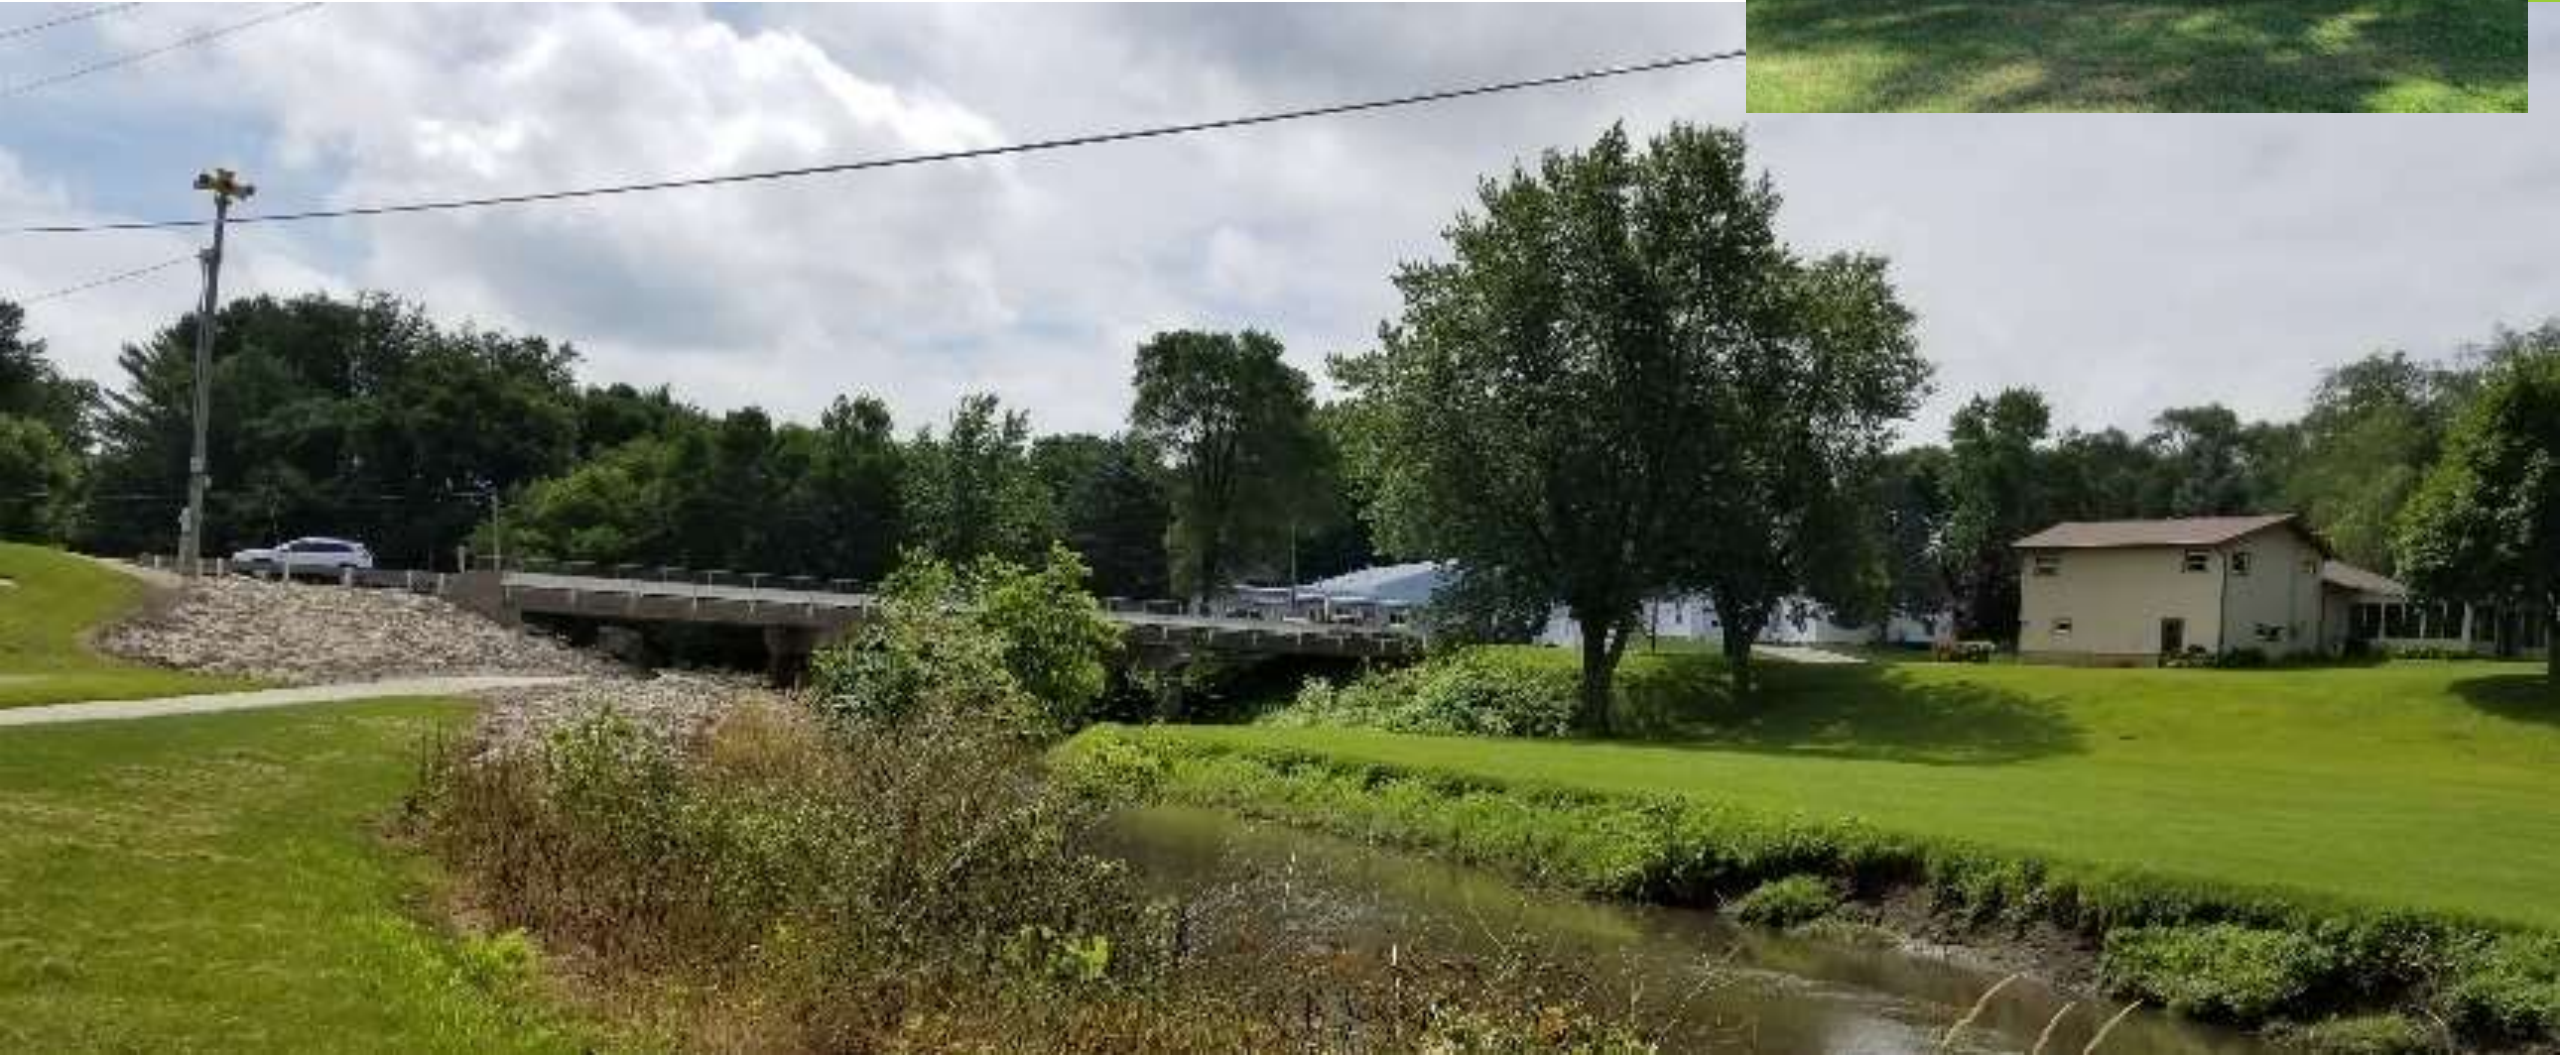
Bear Creek – Ignored!

Shallow-rooted turf near stream edge susceptible to bank collapse

Steep rip-rap bank

Turf grass

Bike path

Overwidened channel causing uniformly slow moving water (lack of habitat), and deposition of sediment.

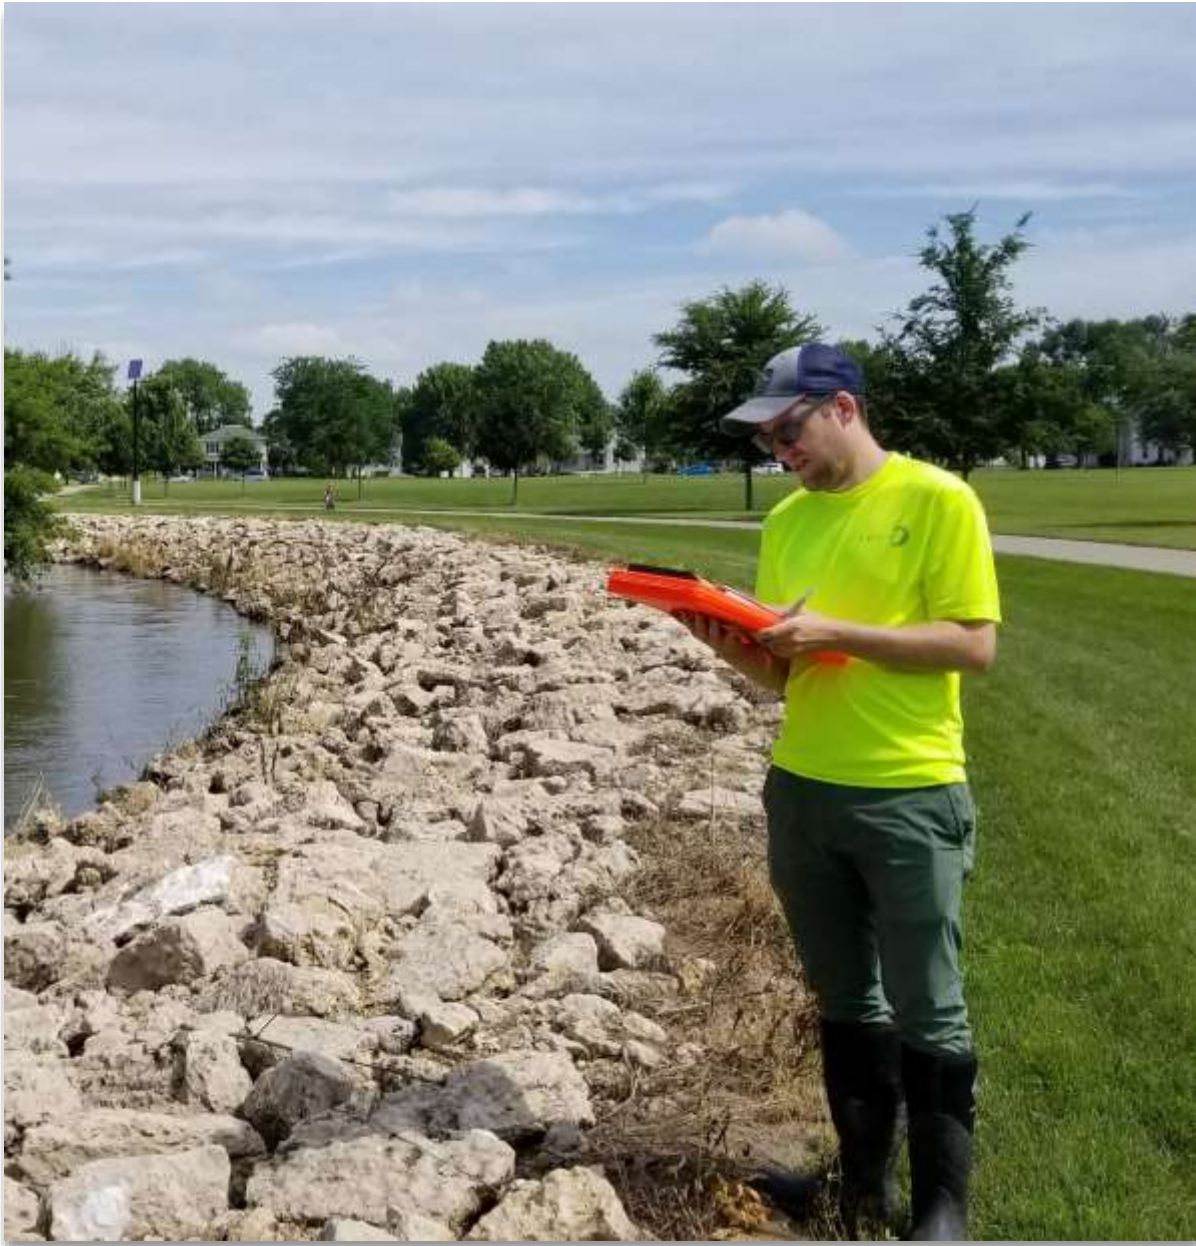
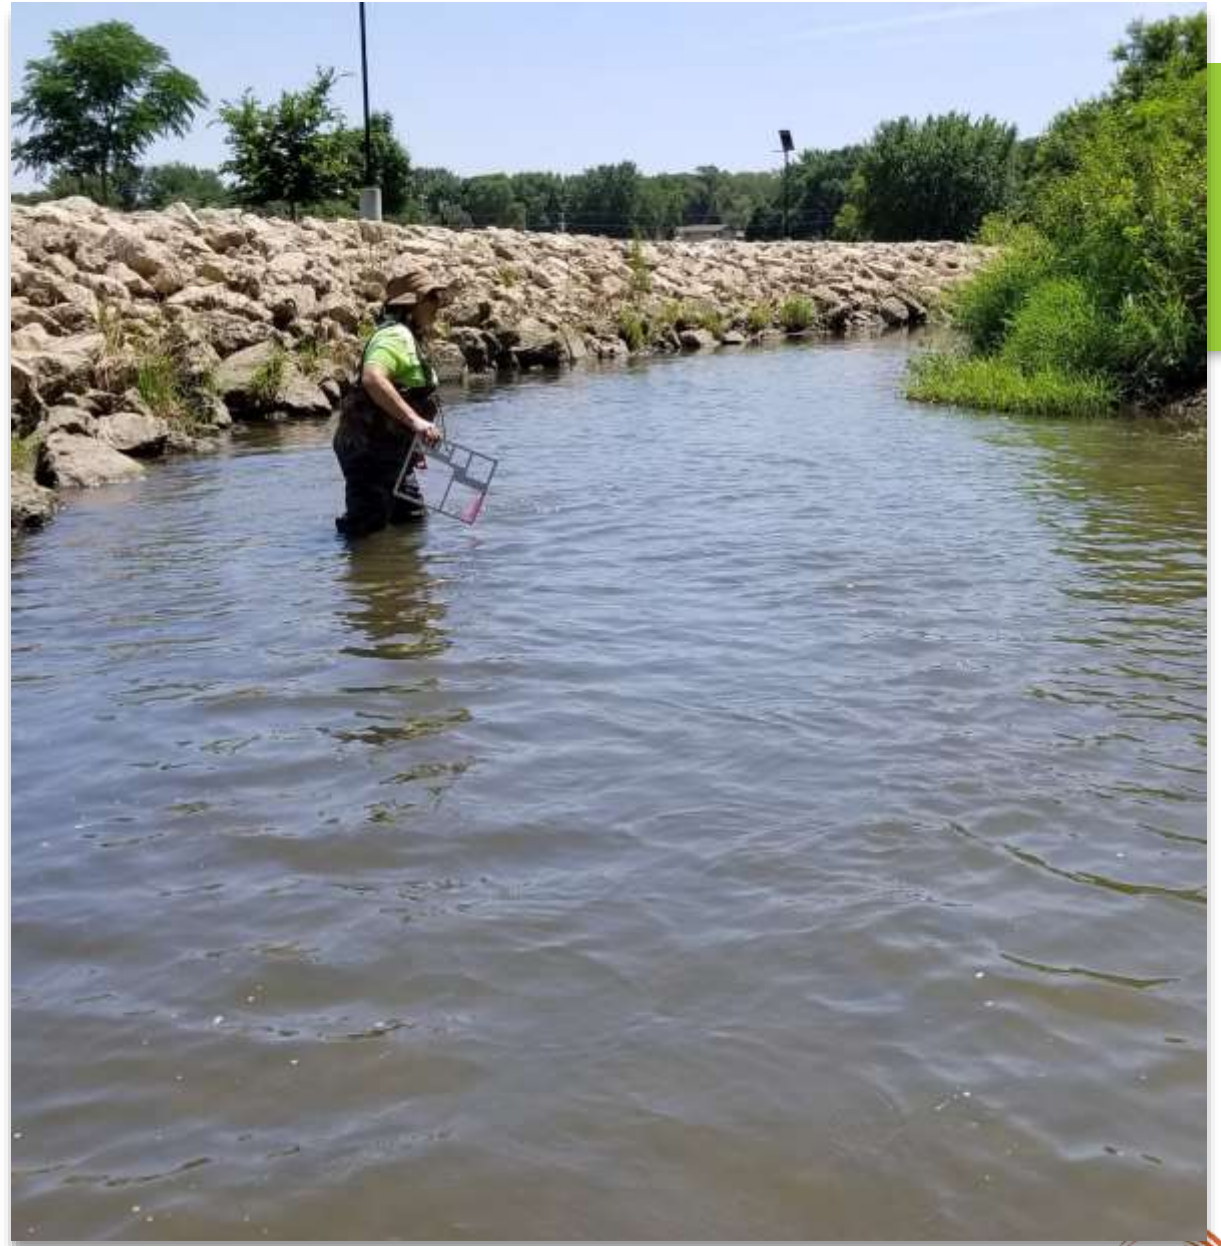
Before

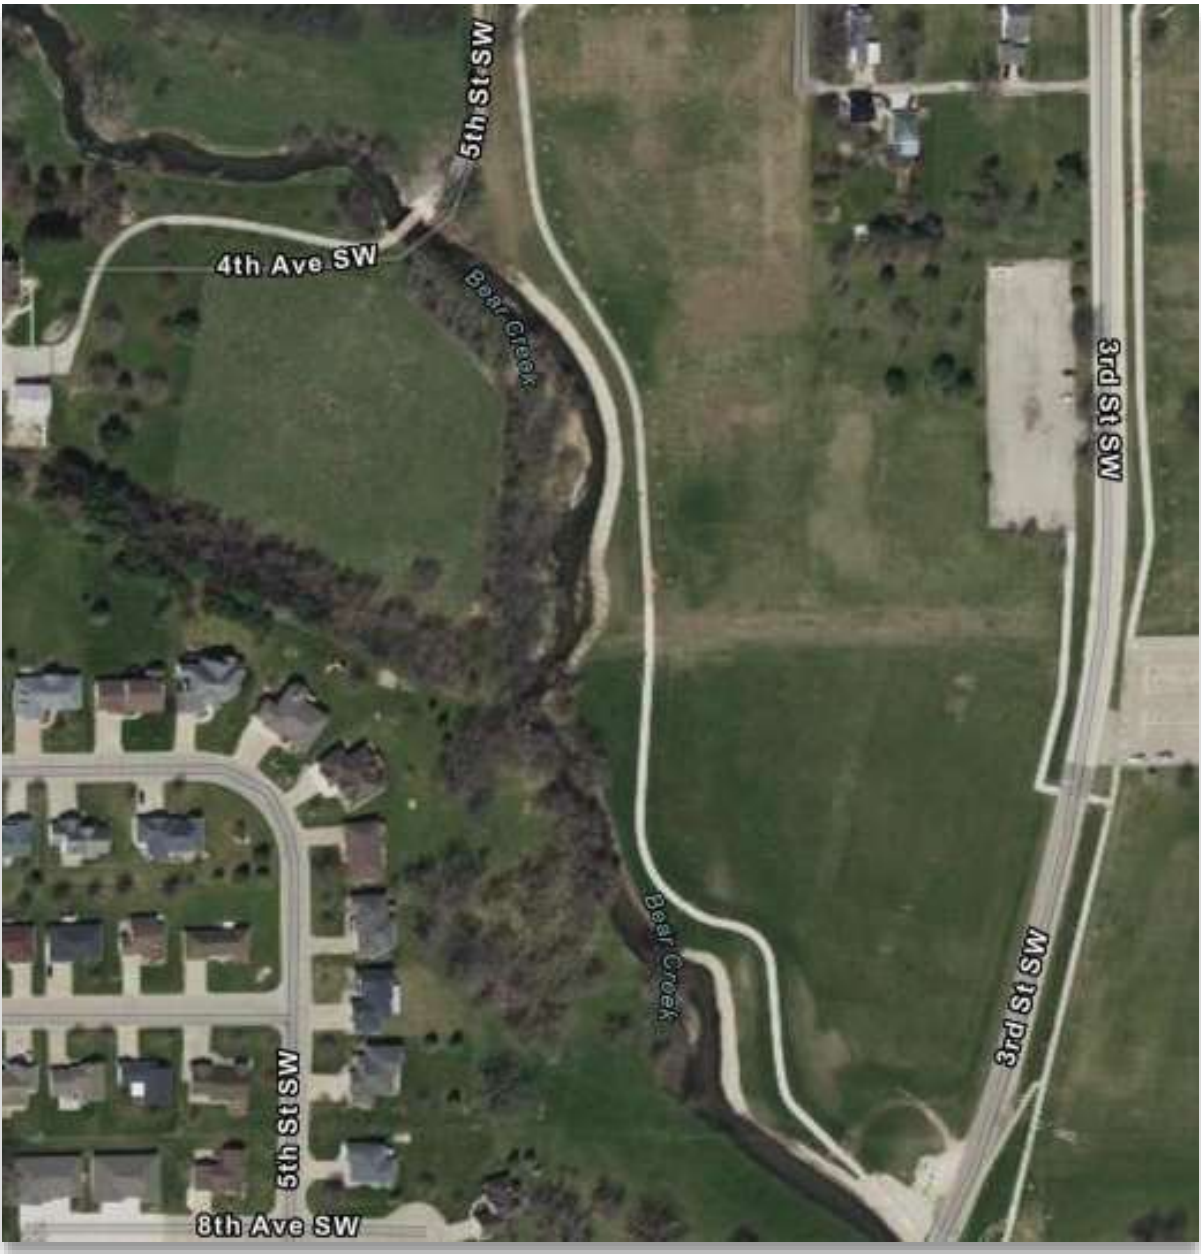
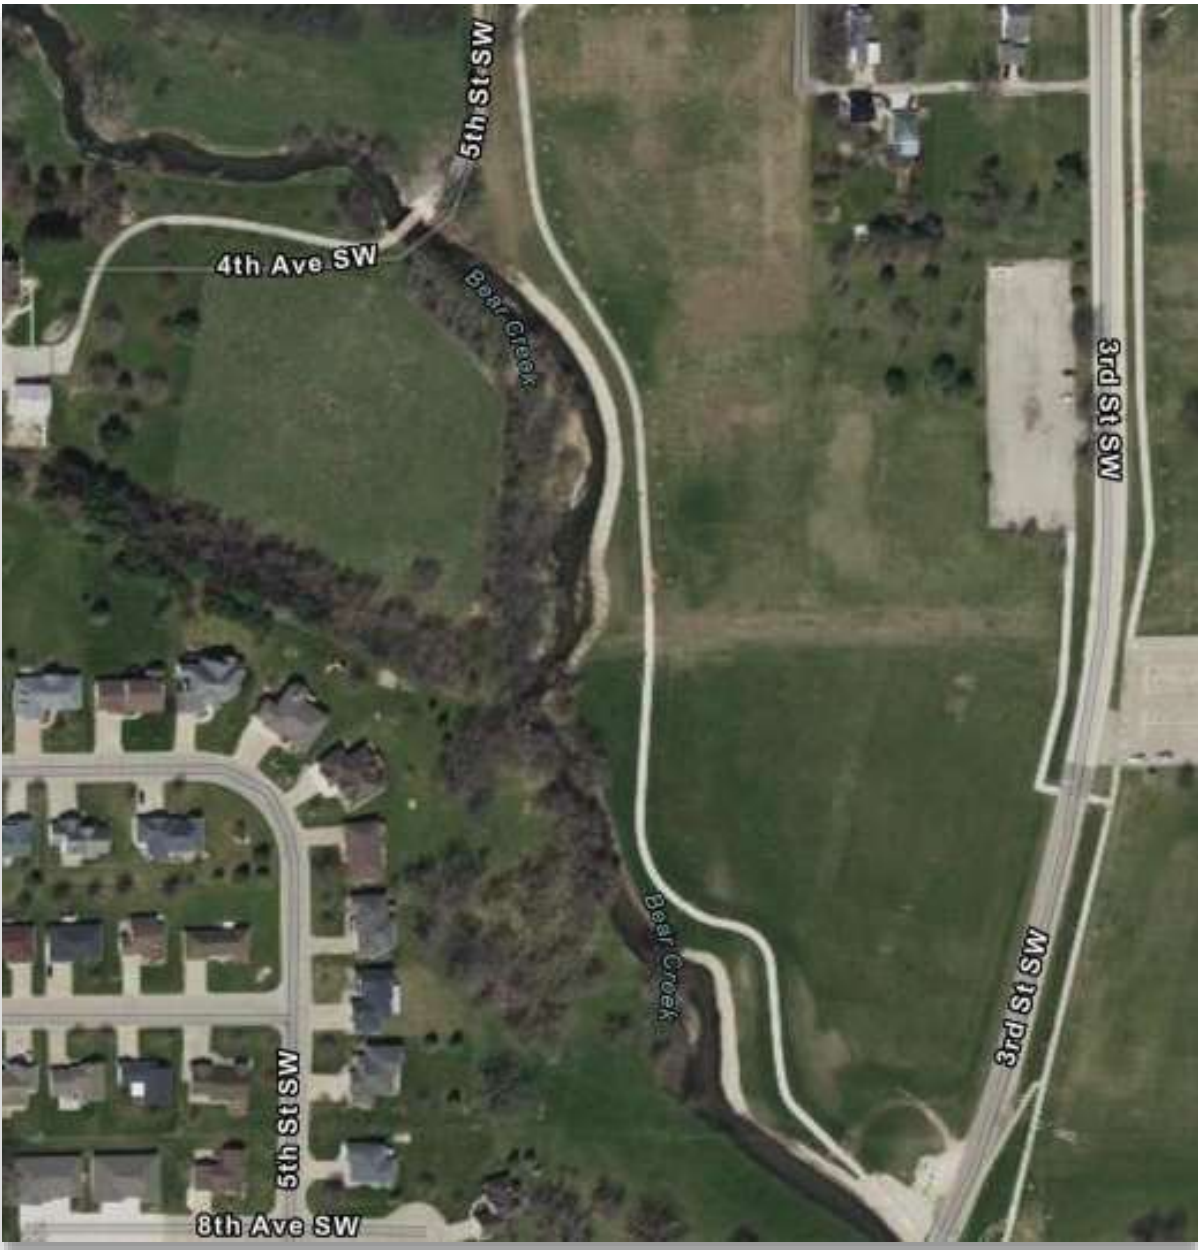
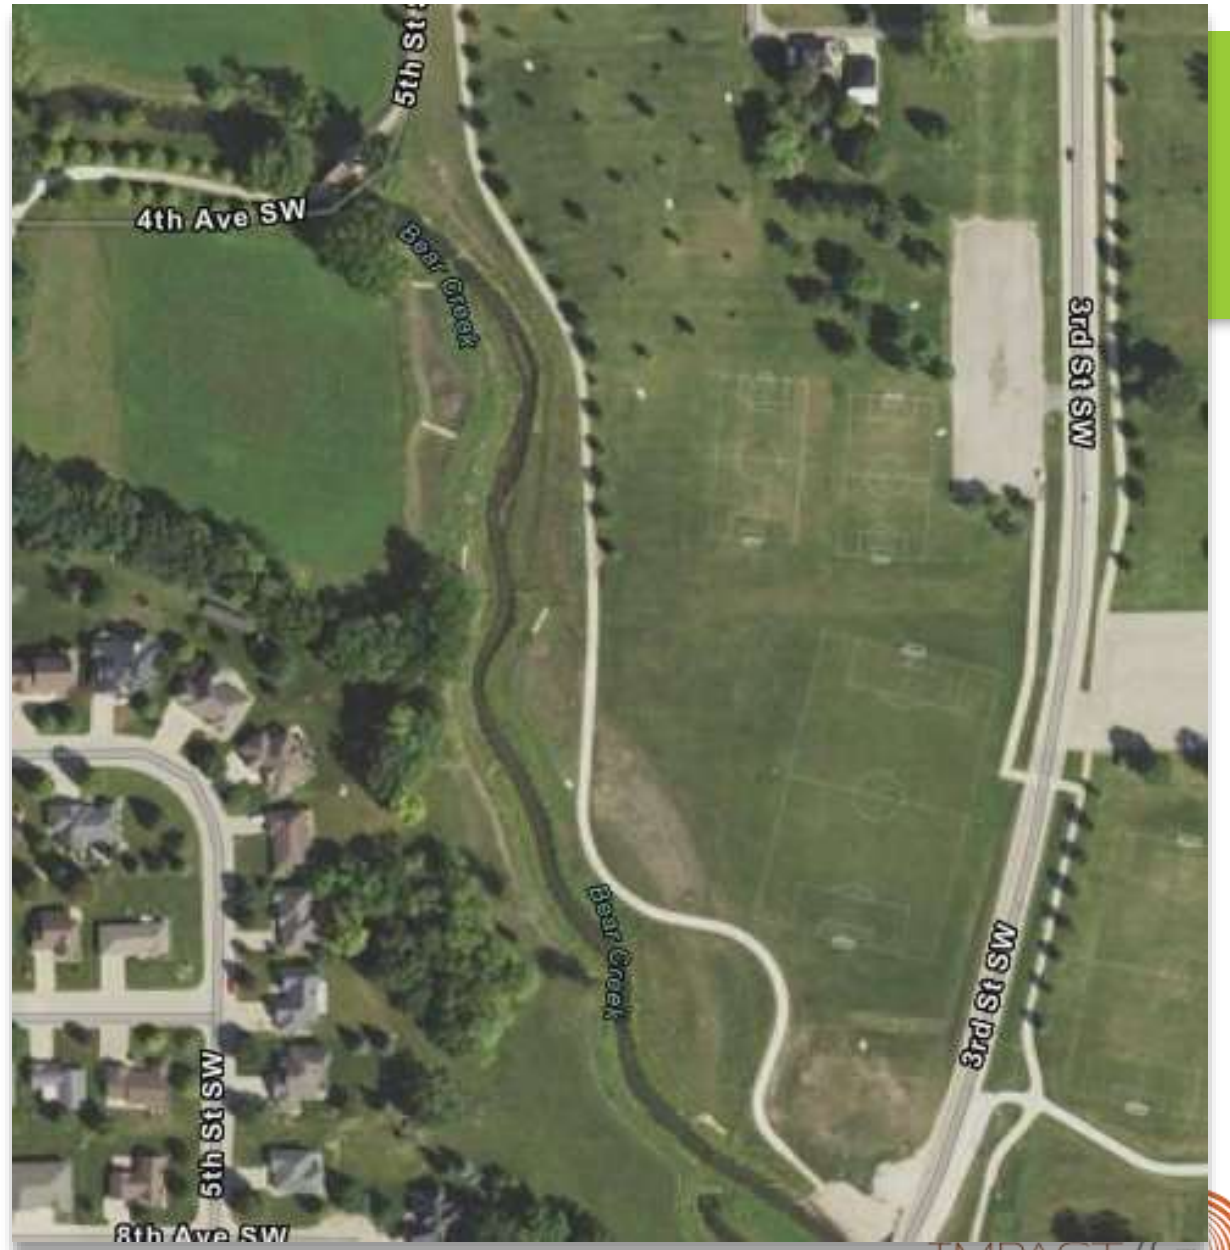
After

Native trees, grasses, and forbs provide excellent habitat for pollinators, birds, and mammals. Their deep roots help hold the streambank in place

Native vegetation near bike path to increase connectivity with nature

Bankfull benches help dissipate energy during normal high-water events

Bike trail moved to create additional floodplain area and flood storage

Shallow oxbow

Rootwads help armor the streambank and deflect flows away from the bank, helping to protect infrastructure, like the bike trail. They also provide excellent habitat for fish and other aquatic life

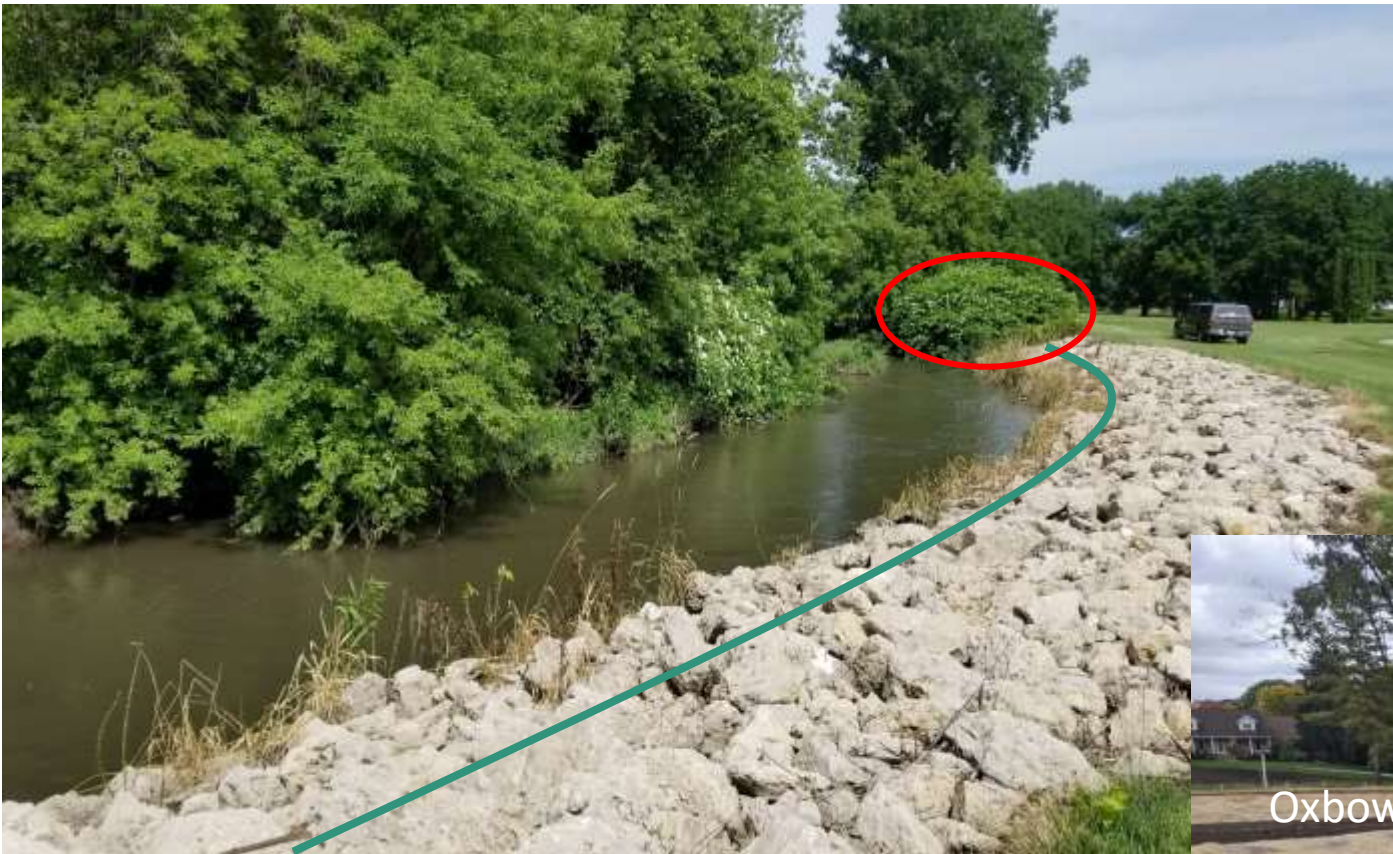
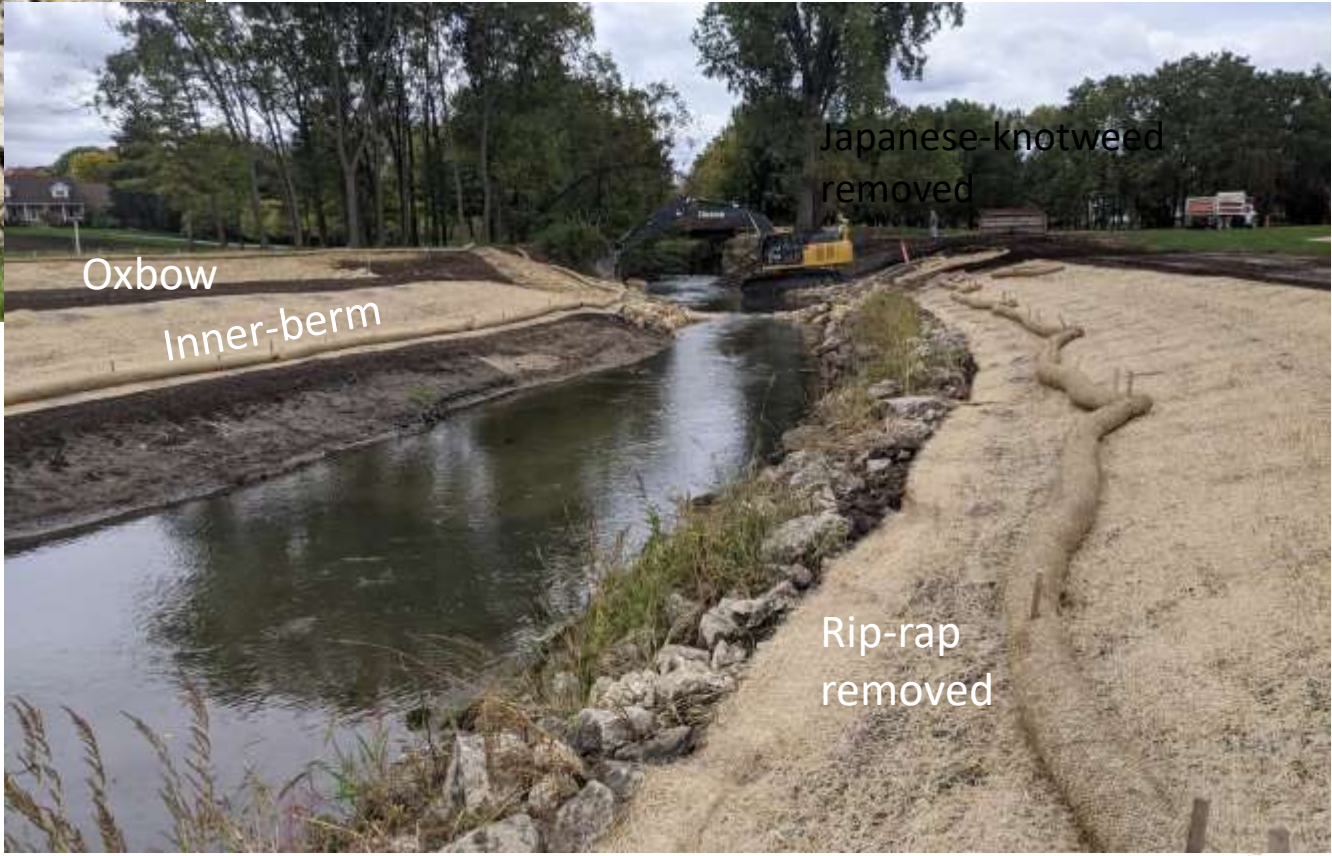
Oxbow
Inner-berm

Japanese-knotweed
removed

Rip-rap
removed
