# Engineered Riffles on Portage Creek, MI

Design, Post Construction Monitoring, and Lessons  
Learned

Janeen McDermott, PE

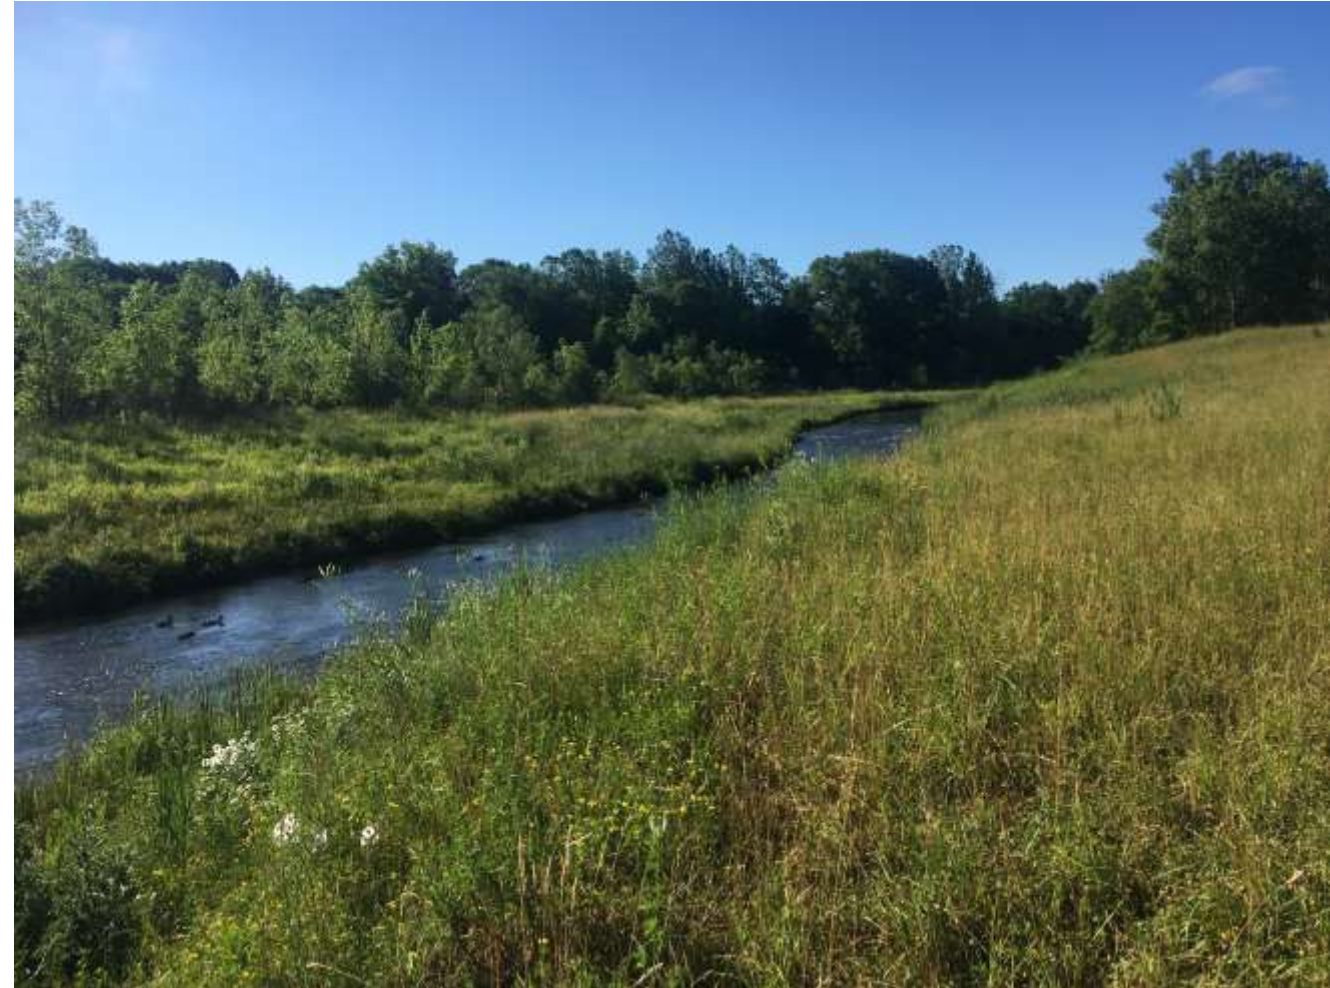
- Required by the State permit
- 5 years of post-construction monitoring
- Field visit 2-3 times each year primarily looking at vegetation establishment, bank erosion, and channel stability
- Through this program, targeted bank erosion was observed at multiple riffle locations

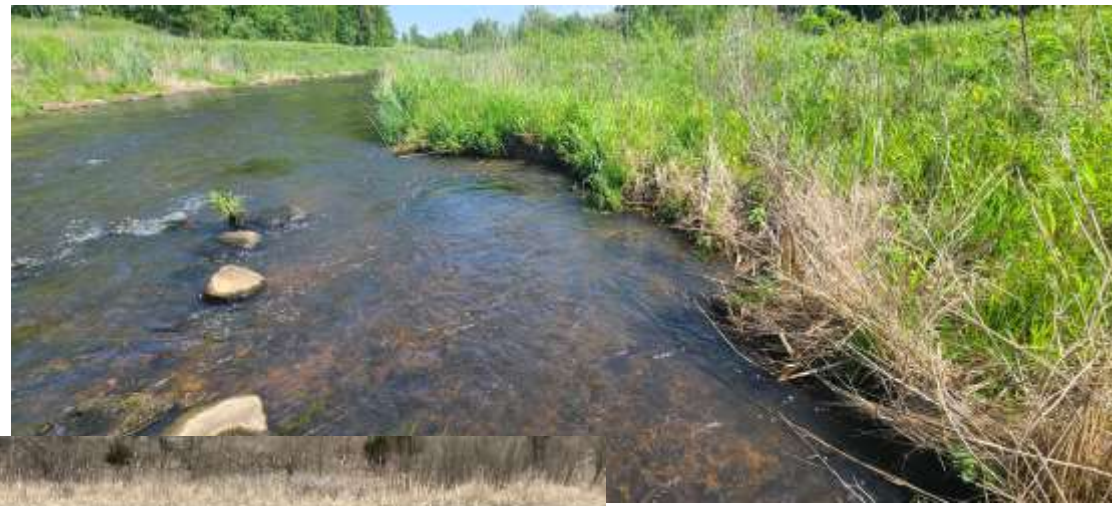
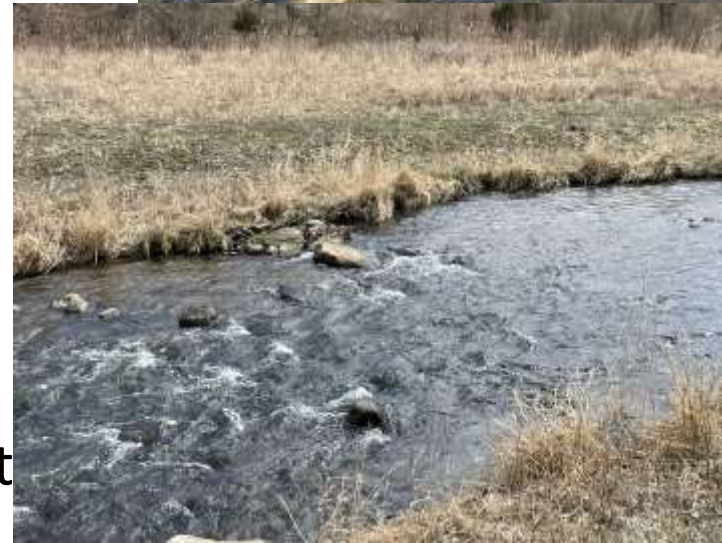
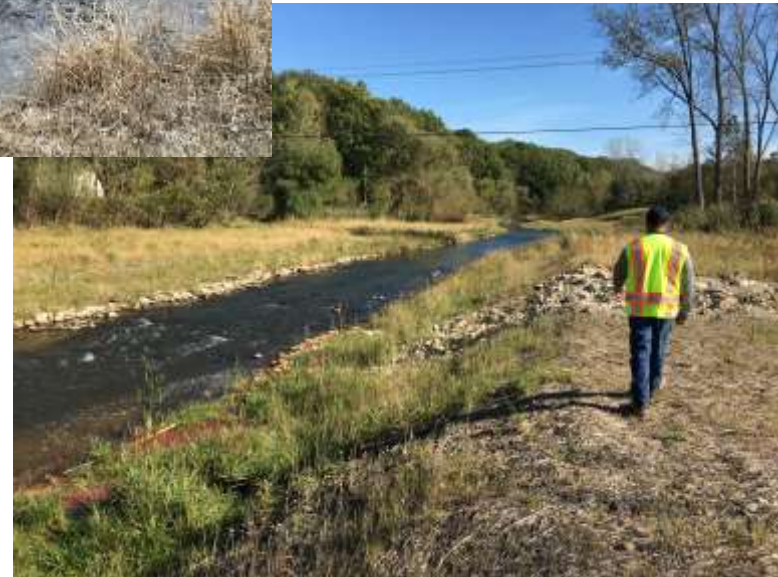
- Riffles 1, 2, and 3 have noted the most pronounced bank erosion between the embedded rock vanes.
- Riffle 4 has largely remained the same throughout the monitoring period.
- Bank erosion has been a slow process with small increases from year to year.
- Embedded rock vanes appear to be working to direct flow back toward the main channel.
- Aquatic habitat diversity with pool riffle system, undercut banks, and large wood structures has improved water quality and habitat as shown by fish survey data.

- When flow was introduced to channel some erosion of channel banks occurred – where not repaired those initial bank erosions have progressed in successive years.
  - Stabilize stream banks at riffles prior to introducing flow and/or be sure to re-establish designed banks at time of final restoration
- Details matter!
