## Instream Structures in the Mid-Atlantic United States:

An Investigation of the Design, Project, and Watershed Factors that Affect Structure Success

Presented by: Benjamin Smith () Stantec Ben.Smith@Stantec.com

National Stream Restoration Conference 2022 August 2, 2022

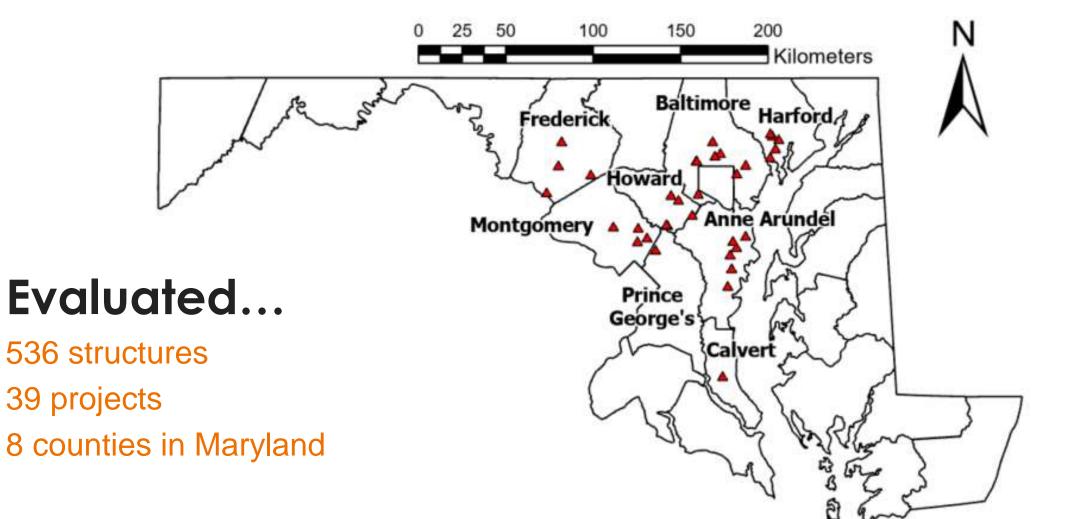
# Structure assessment performance in the field

An overall structure score was determined by summing all subcategory scores.

0	1	2	3
	% remaining	0- 25%	25- 50%	50- 75%	75- 100%
Stability	material movement	significant	moderate	slight	none
	unintended bank erosion/ bed scour	significant	moderate	slight	none
Sediment	unintended aggradation	significant	moderate	slight	none
		0	3	6	
Function	serving intended purpose	no	partially	yes

0	1	2	3
	% remaining	0- 25%	25- 50%	50- 75%	75- 100%
Stability	material movement	significant	moderate	slight	none
	unintended bank erosion/ bed scour	significant	moderate	slight	none
Sediment	unintended aggradation	significant	moderate	slight	none
		0	3	6	
Function	serving intended purpose	no	partially	yes

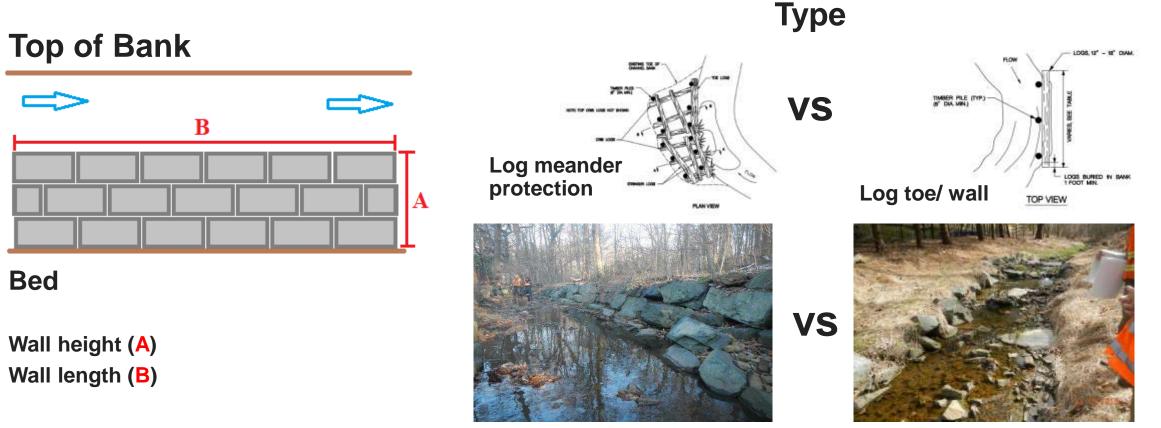
# Bank protection structure-scale predictors related to...

Imbricated rock wall

**Rock toe**

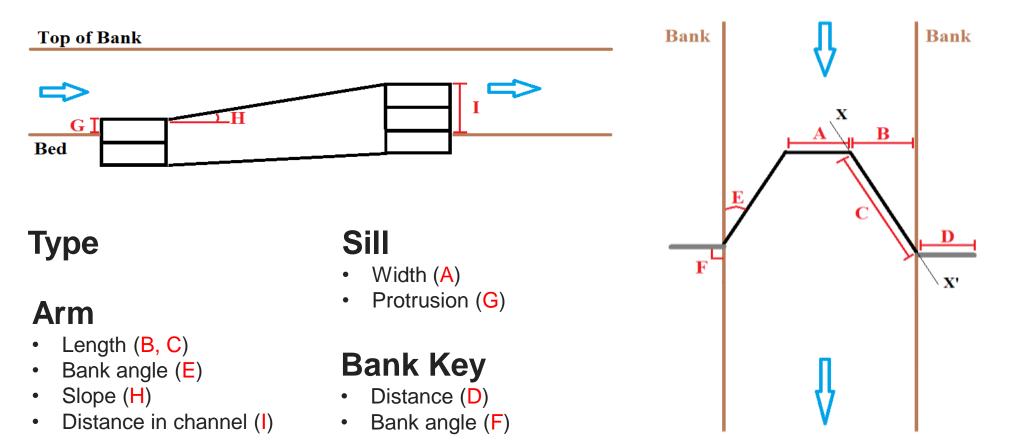
# Full span vane structure-scale variables relate to...

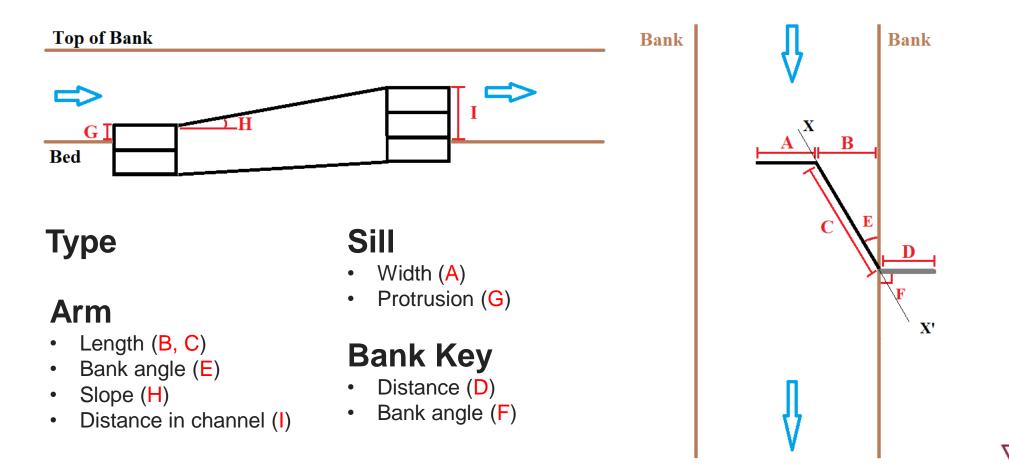
# Partial span vane structure-scale variables are almost the same as full span vanes

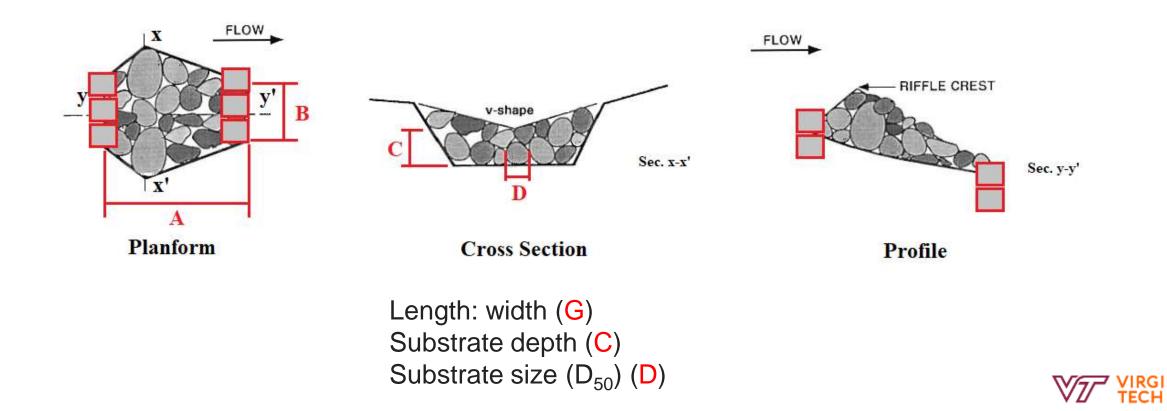
# Constructed riffle structure-scale predictors relate to the dimensions and substrate

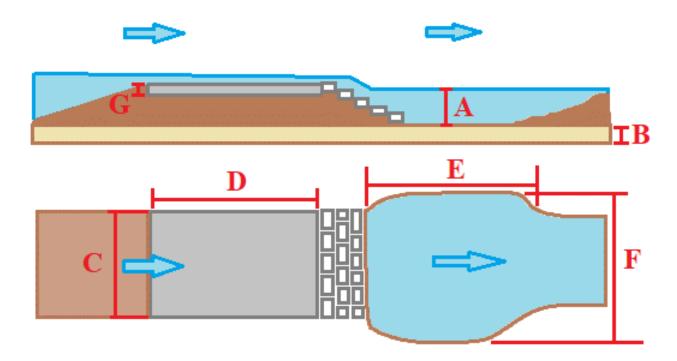
# RSC structure-scale predictors relate to properties of the weir and pool

#### Weir

- Length: width (D:C)
- Slope
- Substrate size  $(D_{50})$
- Substrate thickness (G)

### Pool

- Length: width (E:F)
- Depth (A)
- Perimeter

### Infiltration Media Thickness (B)

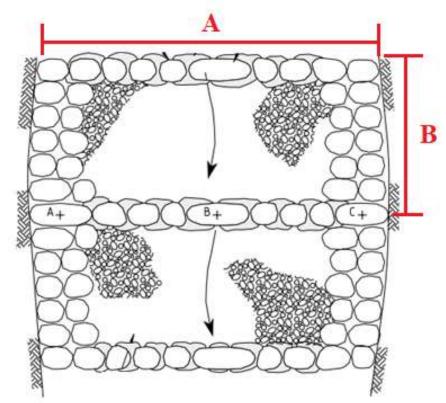
# Step pool structure-scale variables relate to the system, sill, and pool

### System-wide

- Number of step-pools
- Total length
- Average step-pool slope
- Ratio of mean steepness

### Sill width (A)

### Pool

- Depth (C)
- Length: width (B:A)
- Substrate depth
- Substrate size (D<sub>50</sub>)
- Perimeter

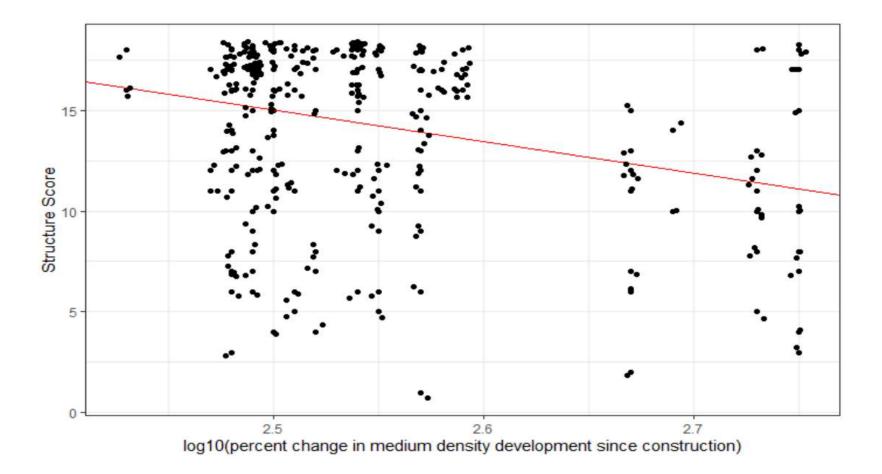
## Increased watershed urbanization is correlated to decreased structure performance

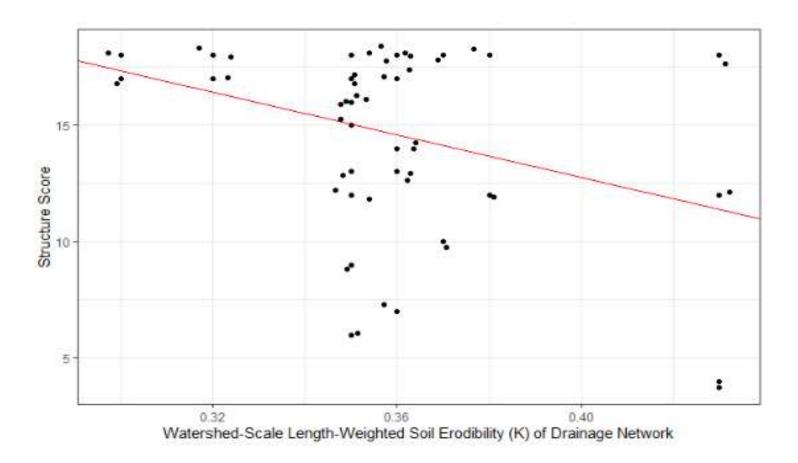
## Log structure performance is negatively correlated to drainage network streambank erodibility

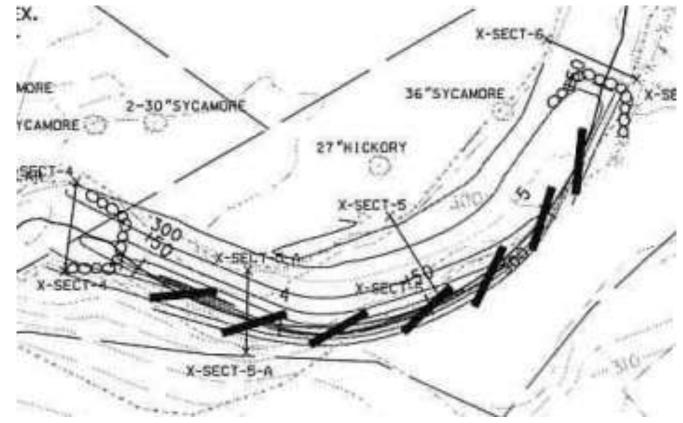
## Restoration activities have a protective effect on nearby structures

#### **Rock bank protection**

- Project length (+)\*
- Structure density (+)\*

#### Log partial span vanes

- Proximity to other structures (+)
- \* 90% of variability explained by project

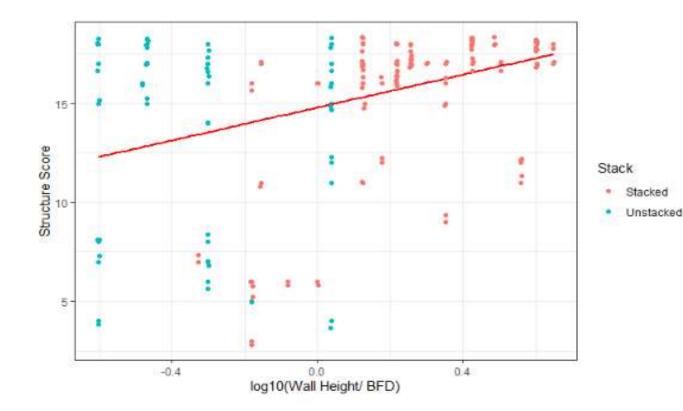
## Rock bank protection performance was positively correlated to wall height

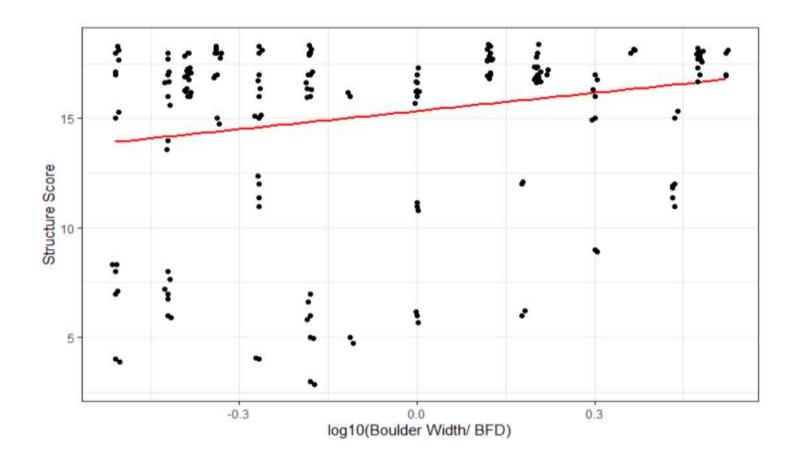
# Rock bank protection performance was positively correlated to boulder size

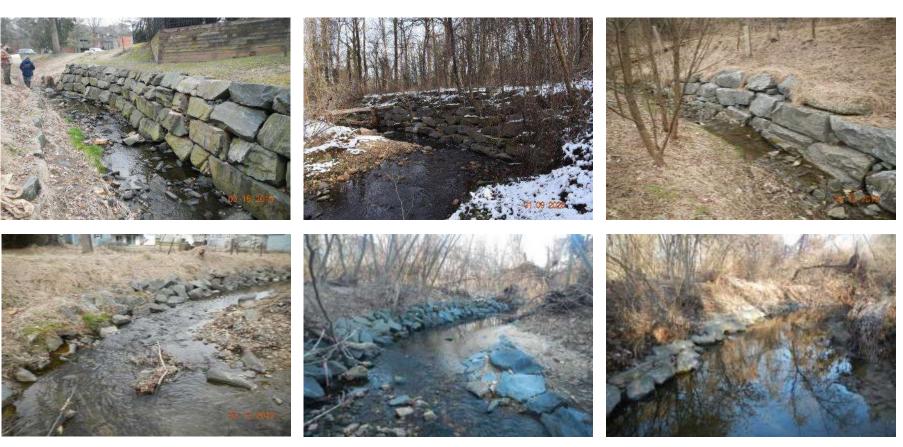
## Stacked bank protection performed better than unstacked bank protection

Stacked

**Unstacked**

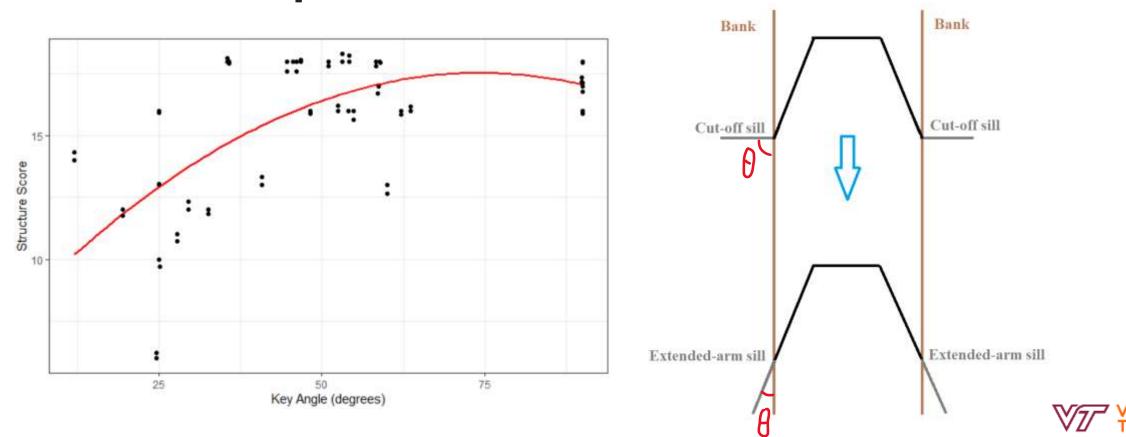
## Full span vane key angles between 35 and 90 degrees correlated with increased performance

- Imbricated rock walls are more stable and provide a greater degree of bank protection than rock toe.
- Vanes should be constructed with bank keys to prevent flanking, ideally angled between 35 and 90 degrees.
- The stability of constructed riffles can be enhanced significantly using downstream grade control.

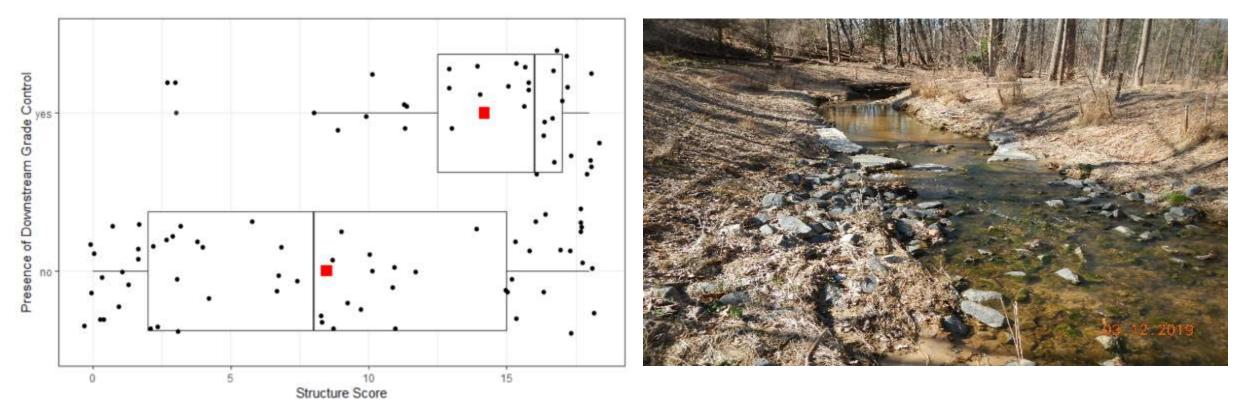
## Structure score is positively correlated to downstream grade control for constructed riffles

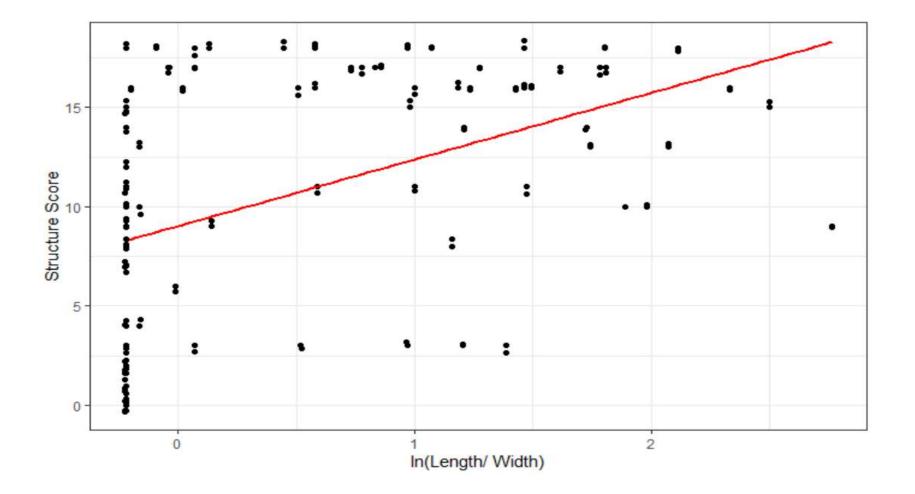
# Constructed riffle scores were positively correlated to the L:W and substrate depth

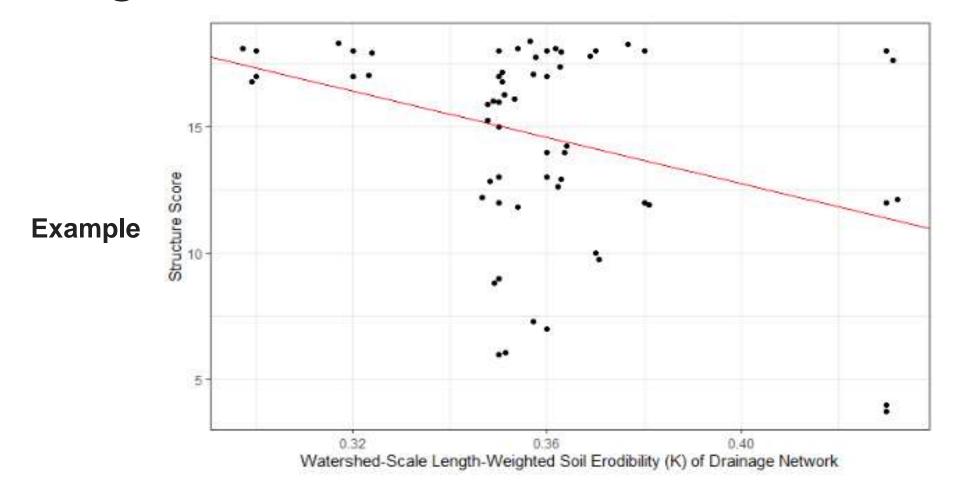
# Structures performed well over a range of conditions
