Subgrade Structures in Restoration Design

Presented by:
Grant Ginn, PE, Senior Principal/River Engineer

National Stream Restoration Conference 2022
August 2, 2022

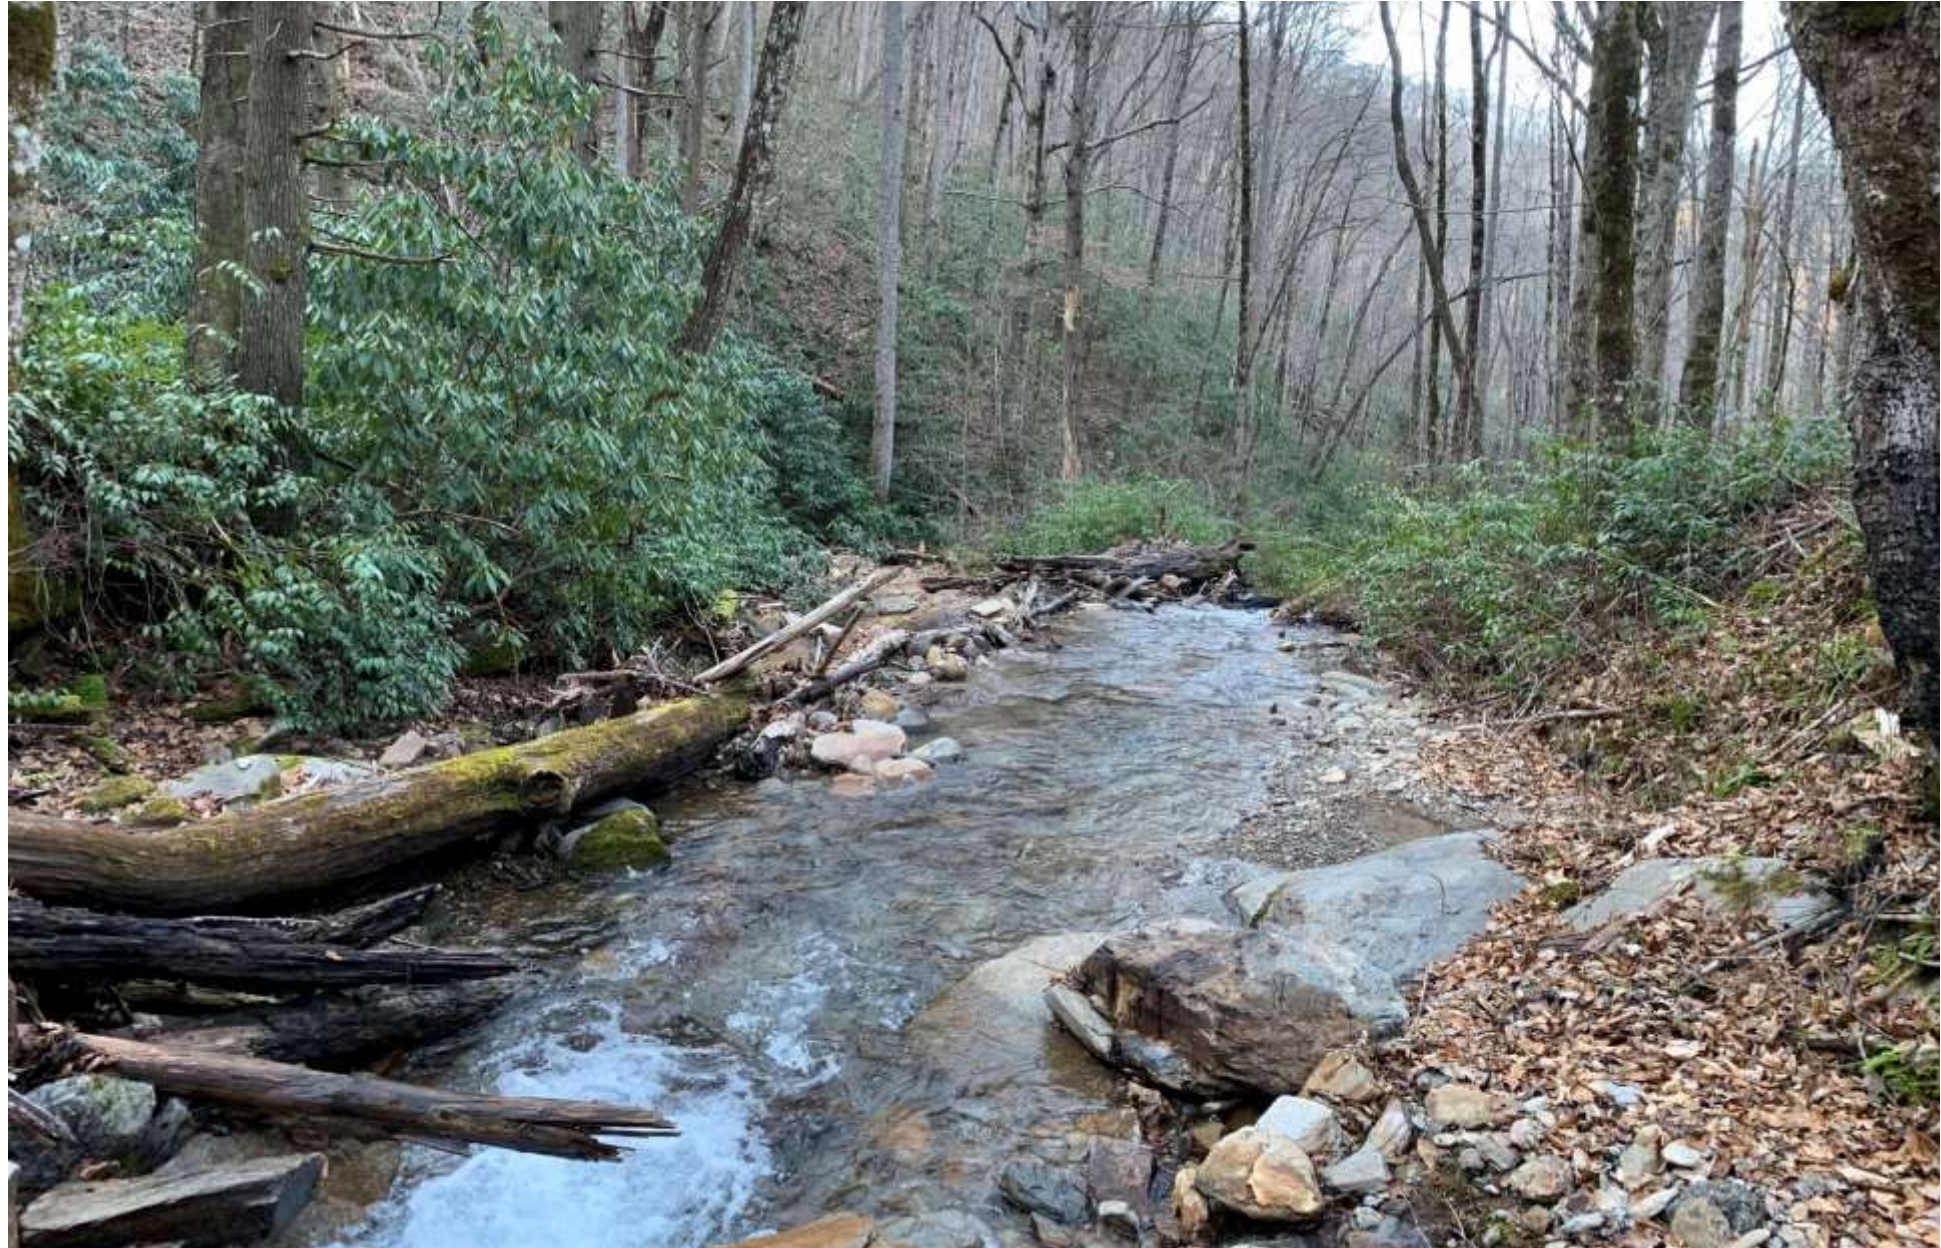
Wesser Creek

- Tributary to Nantahala River
- Top of old downed tree and limbs formed a debris jam
- Riffle has aggraded above the debris and grade drops through jam

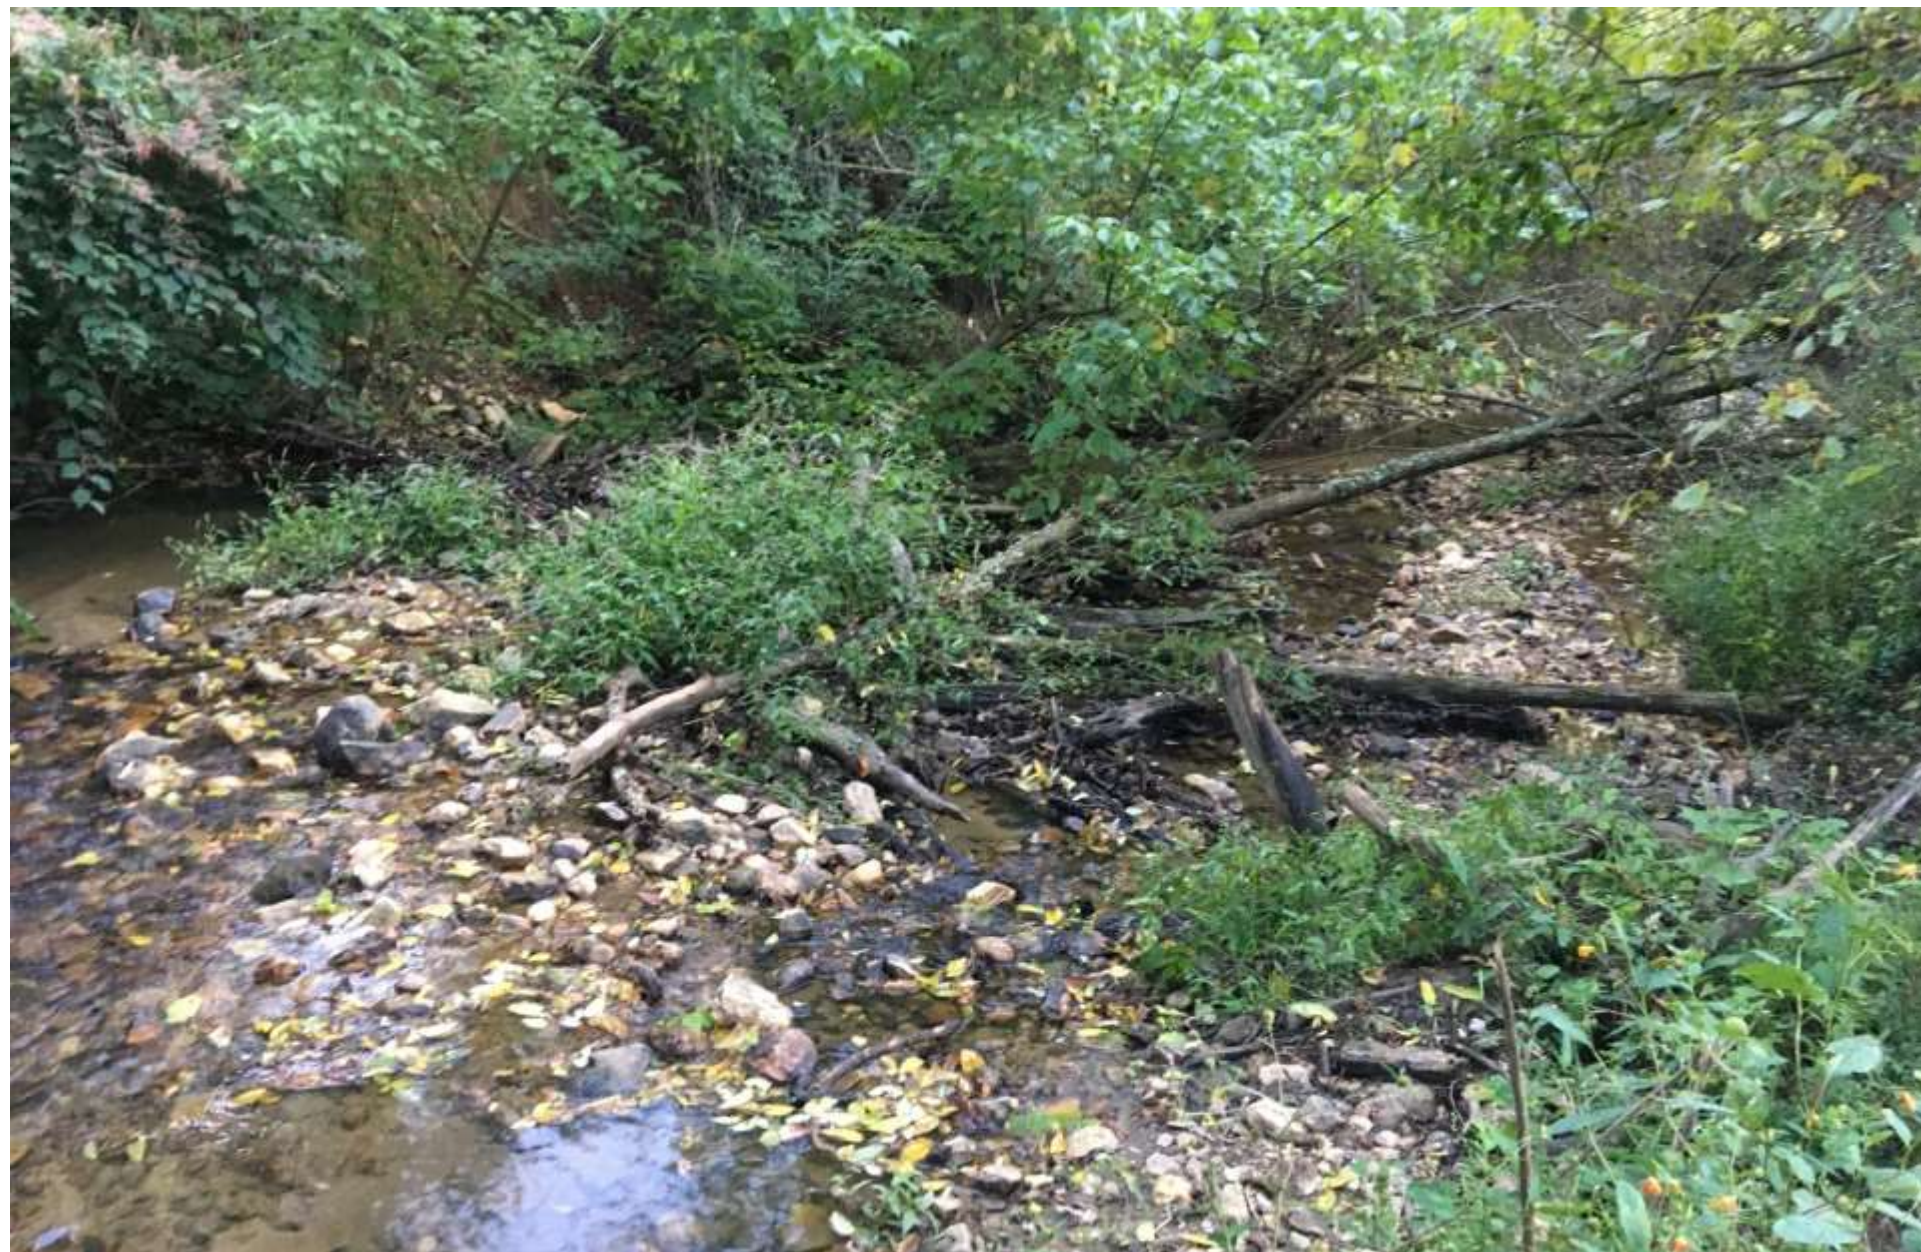
Gabriel Creek

- Small creek near Mars Hill College
- Debris jam at least five years old
- Mostly composed of small limbs which are trapping cobble and sediment

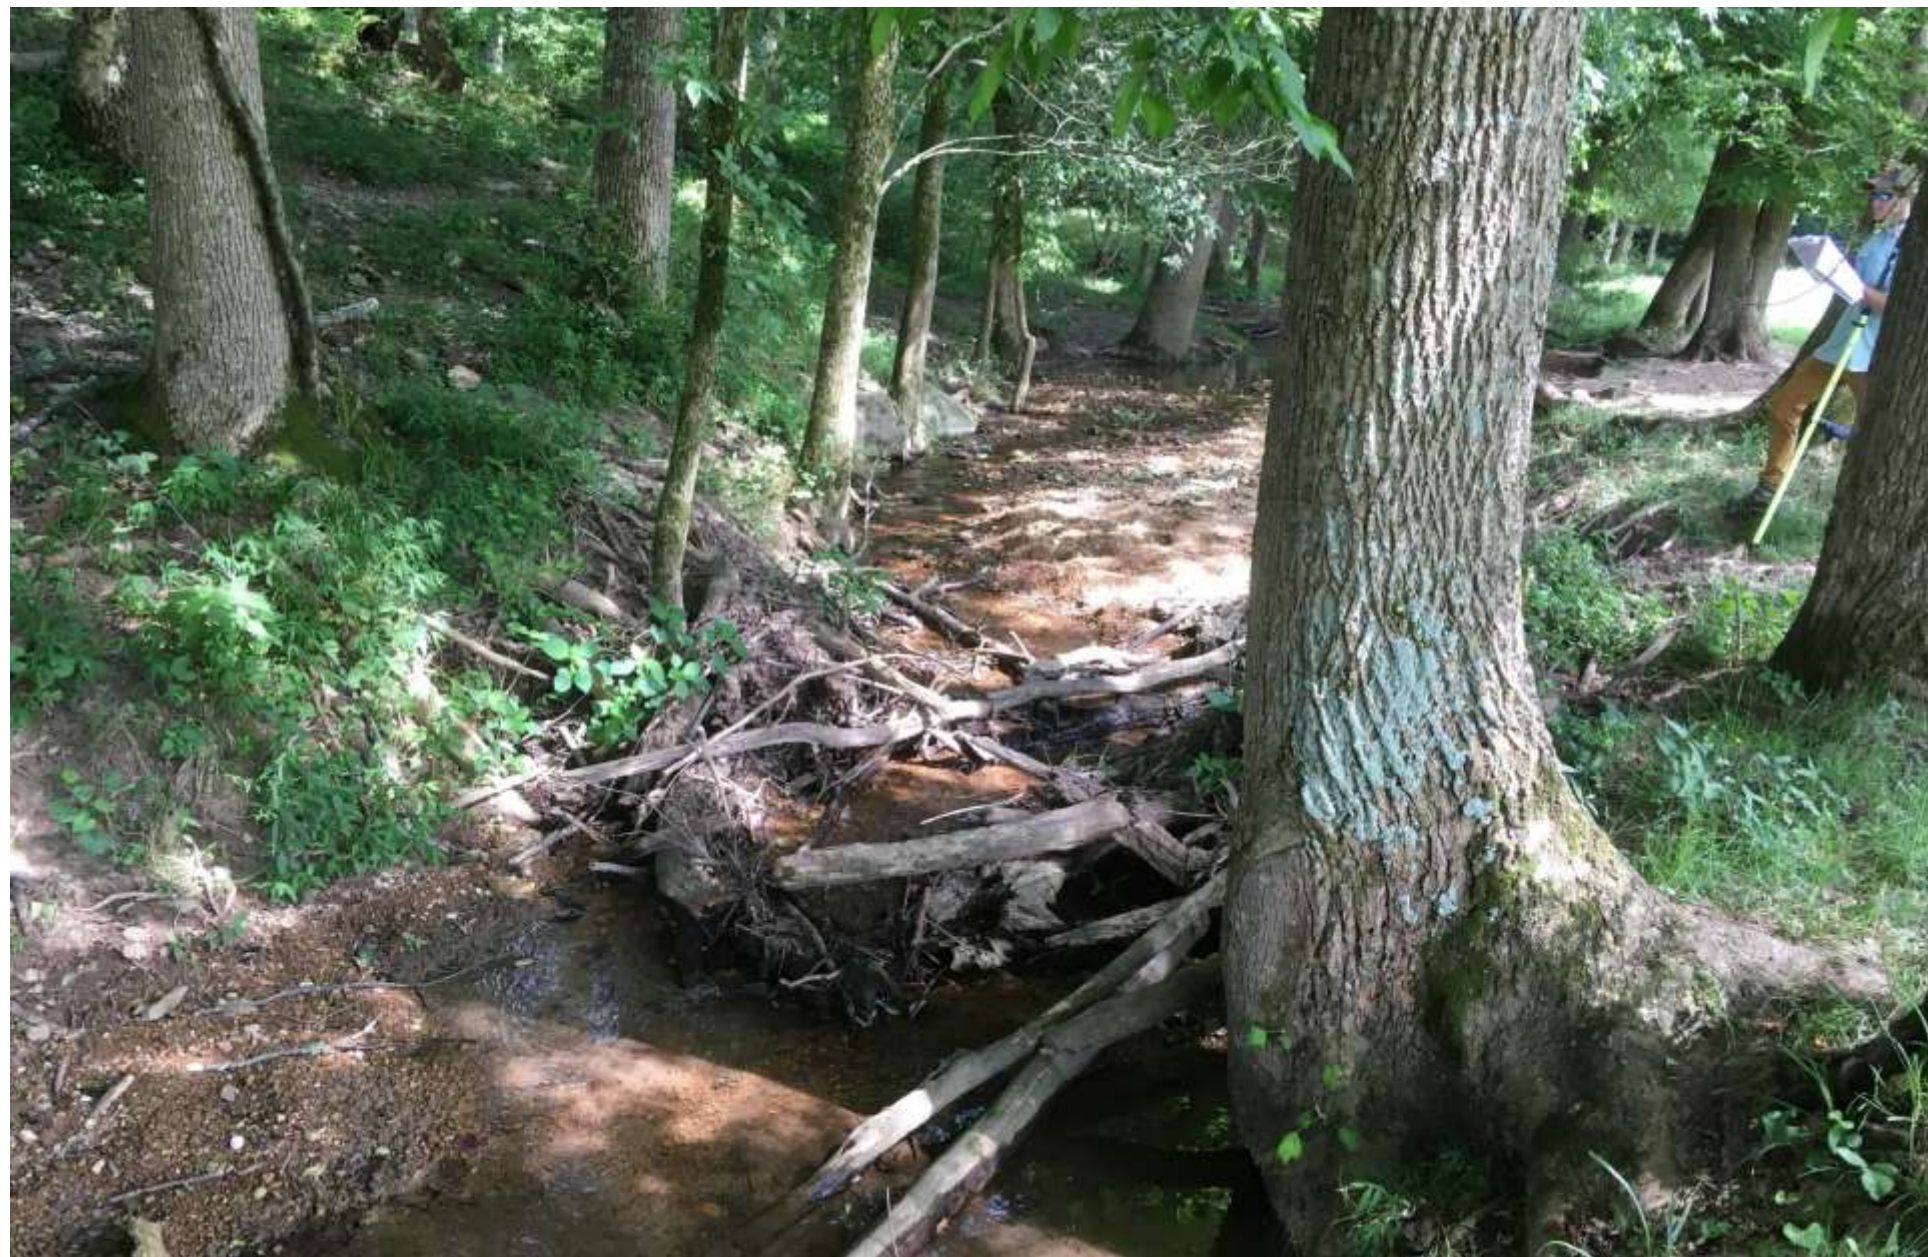
Pickett Branch

- Debris jam formed in incised stream
- Trapped sediment has restored bed profile upstream of debris jam
- Bedload is gravel and sand

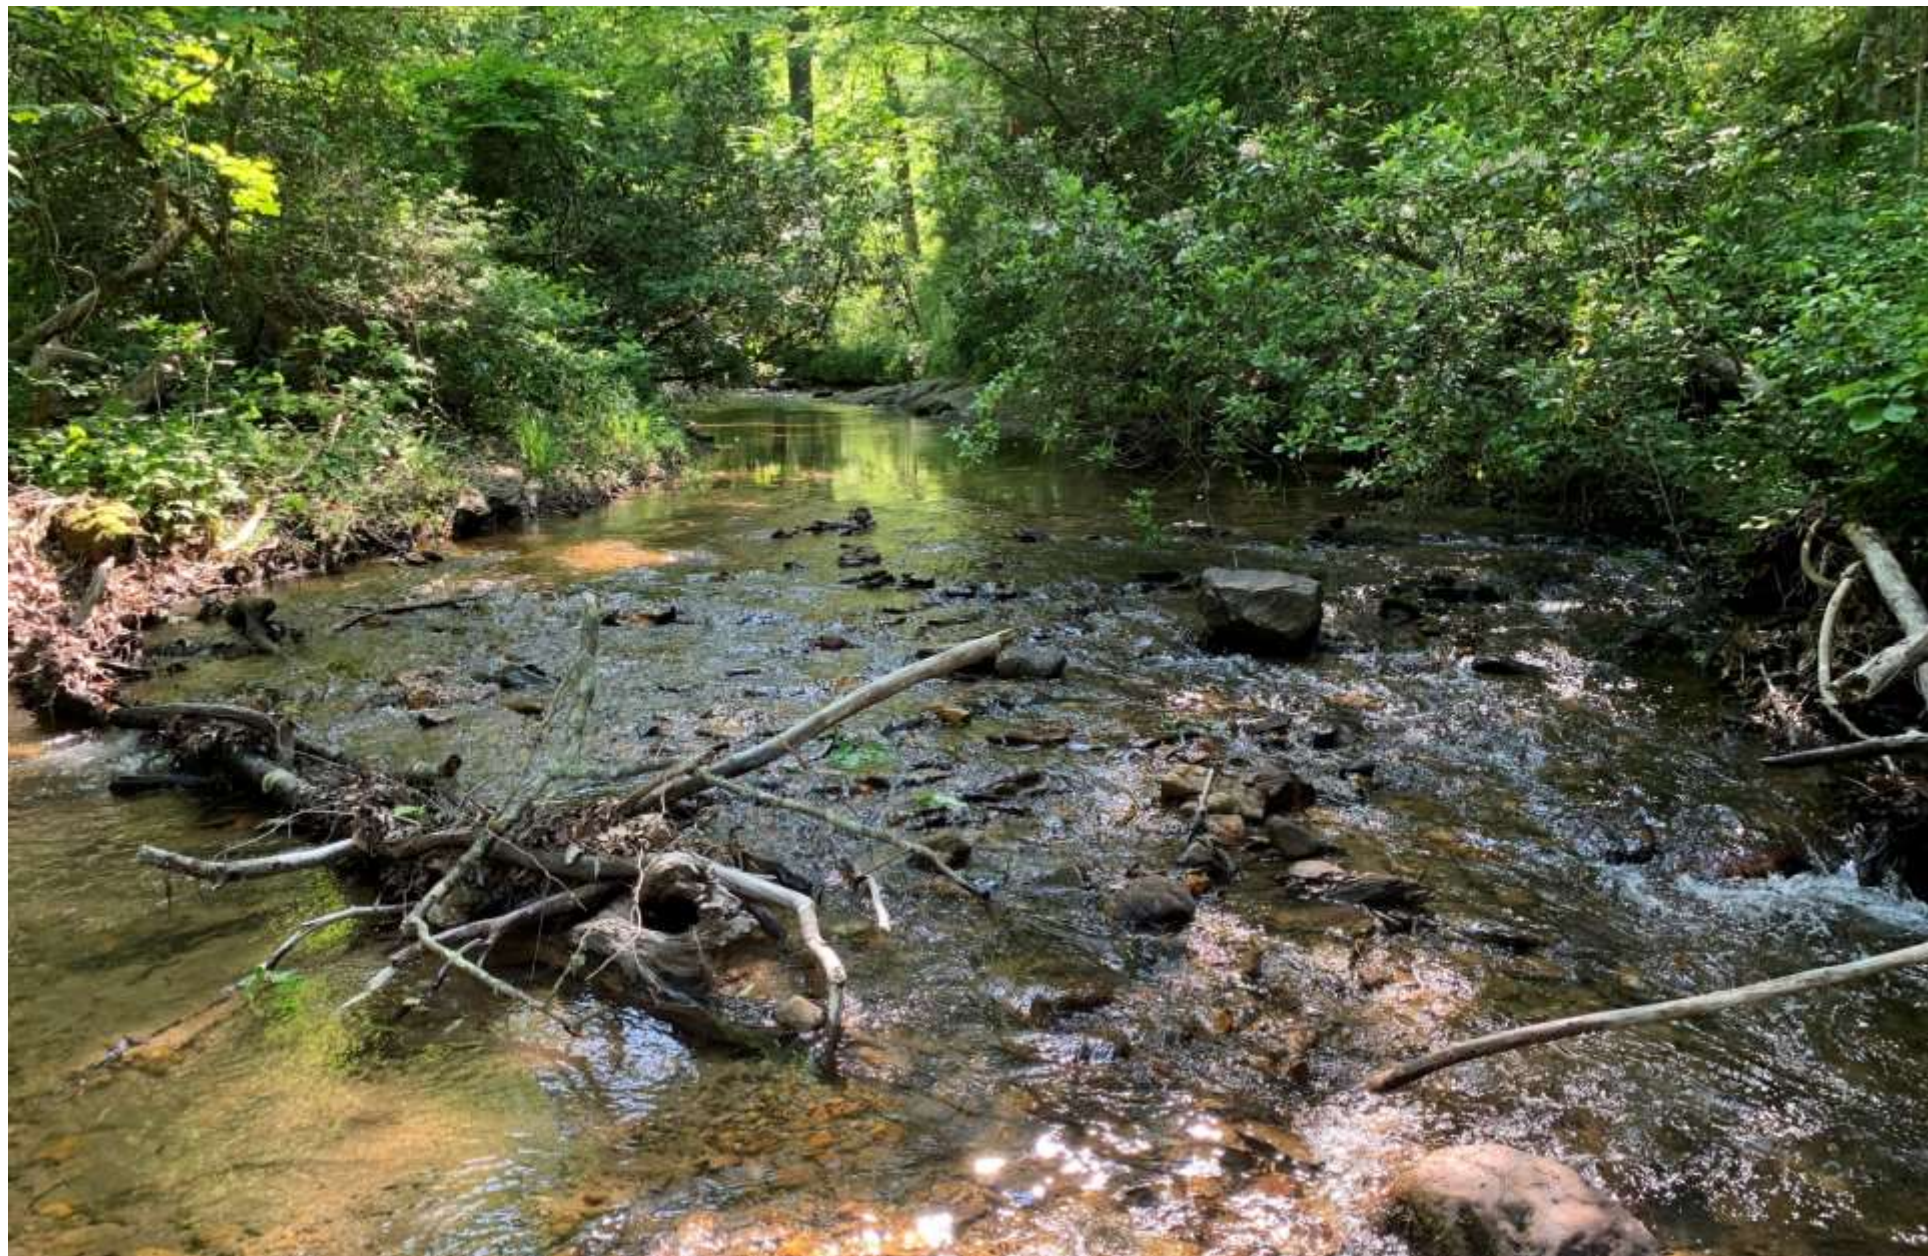
Bent Creek

- Small limbs embedded across channel trapping additional small limbs
- Only a small amount of debris, but still affecting the profile
- Multiple profile facets

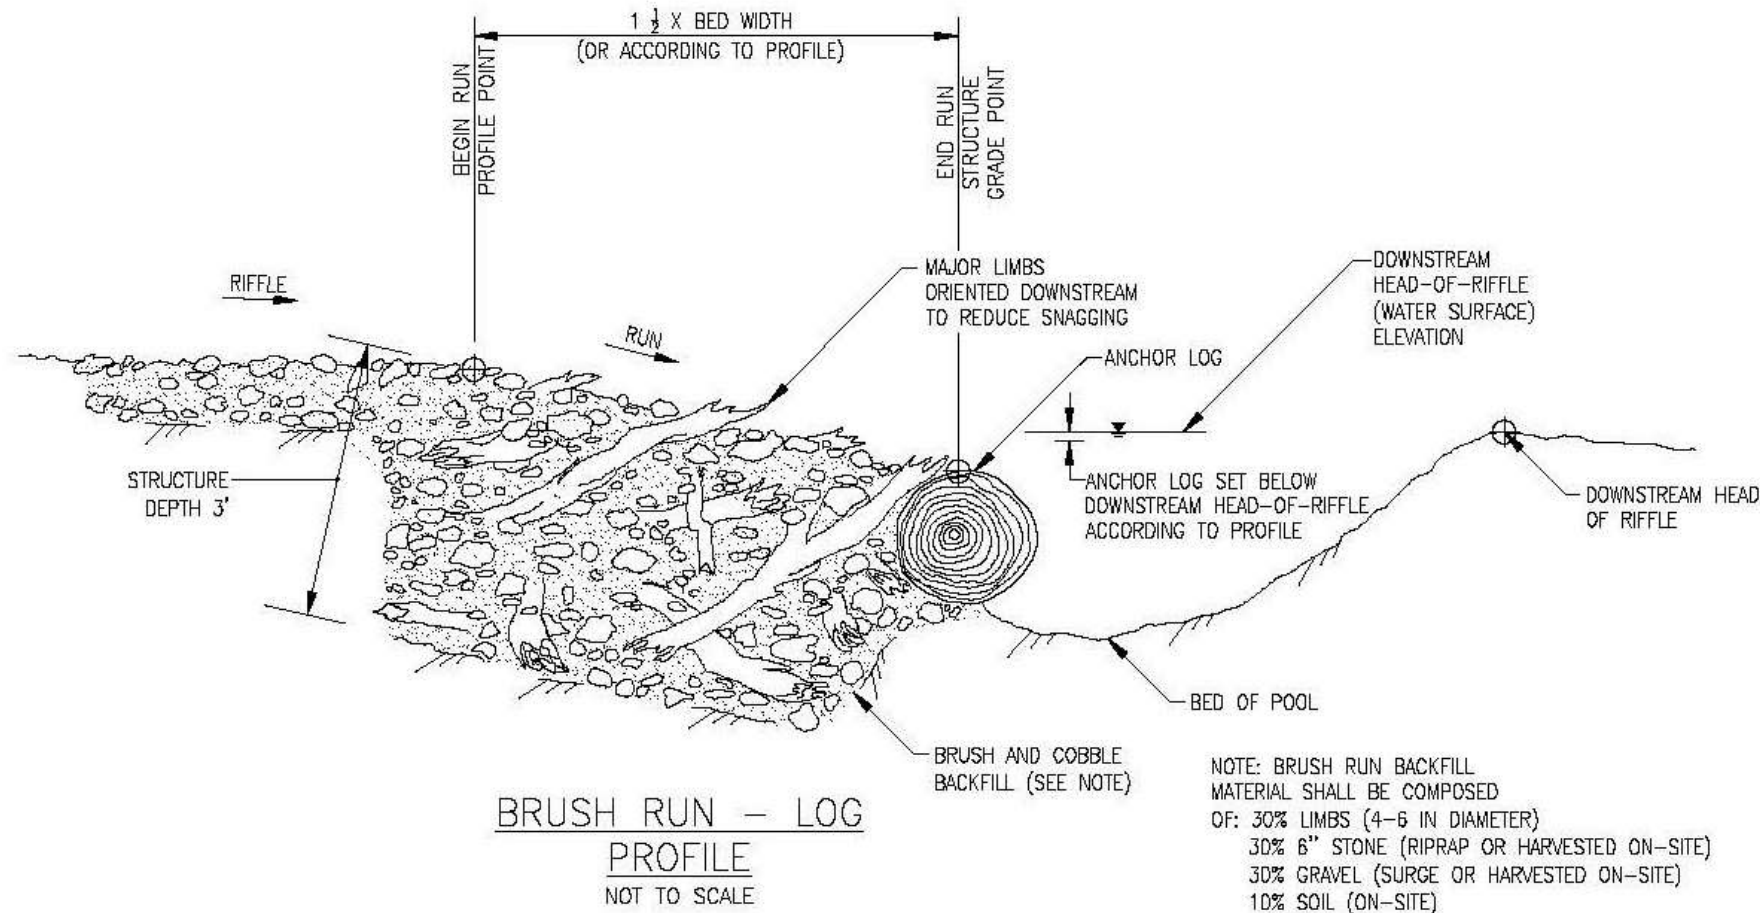
Brush-run Detail

- Reduces abrupt drop of grade control structures
- Increased roughness
- Simplifies construction
- Can reduce requirement for imported boulders and logs
- Makes better use of onsite material
- Provides long term transition to natural conditions

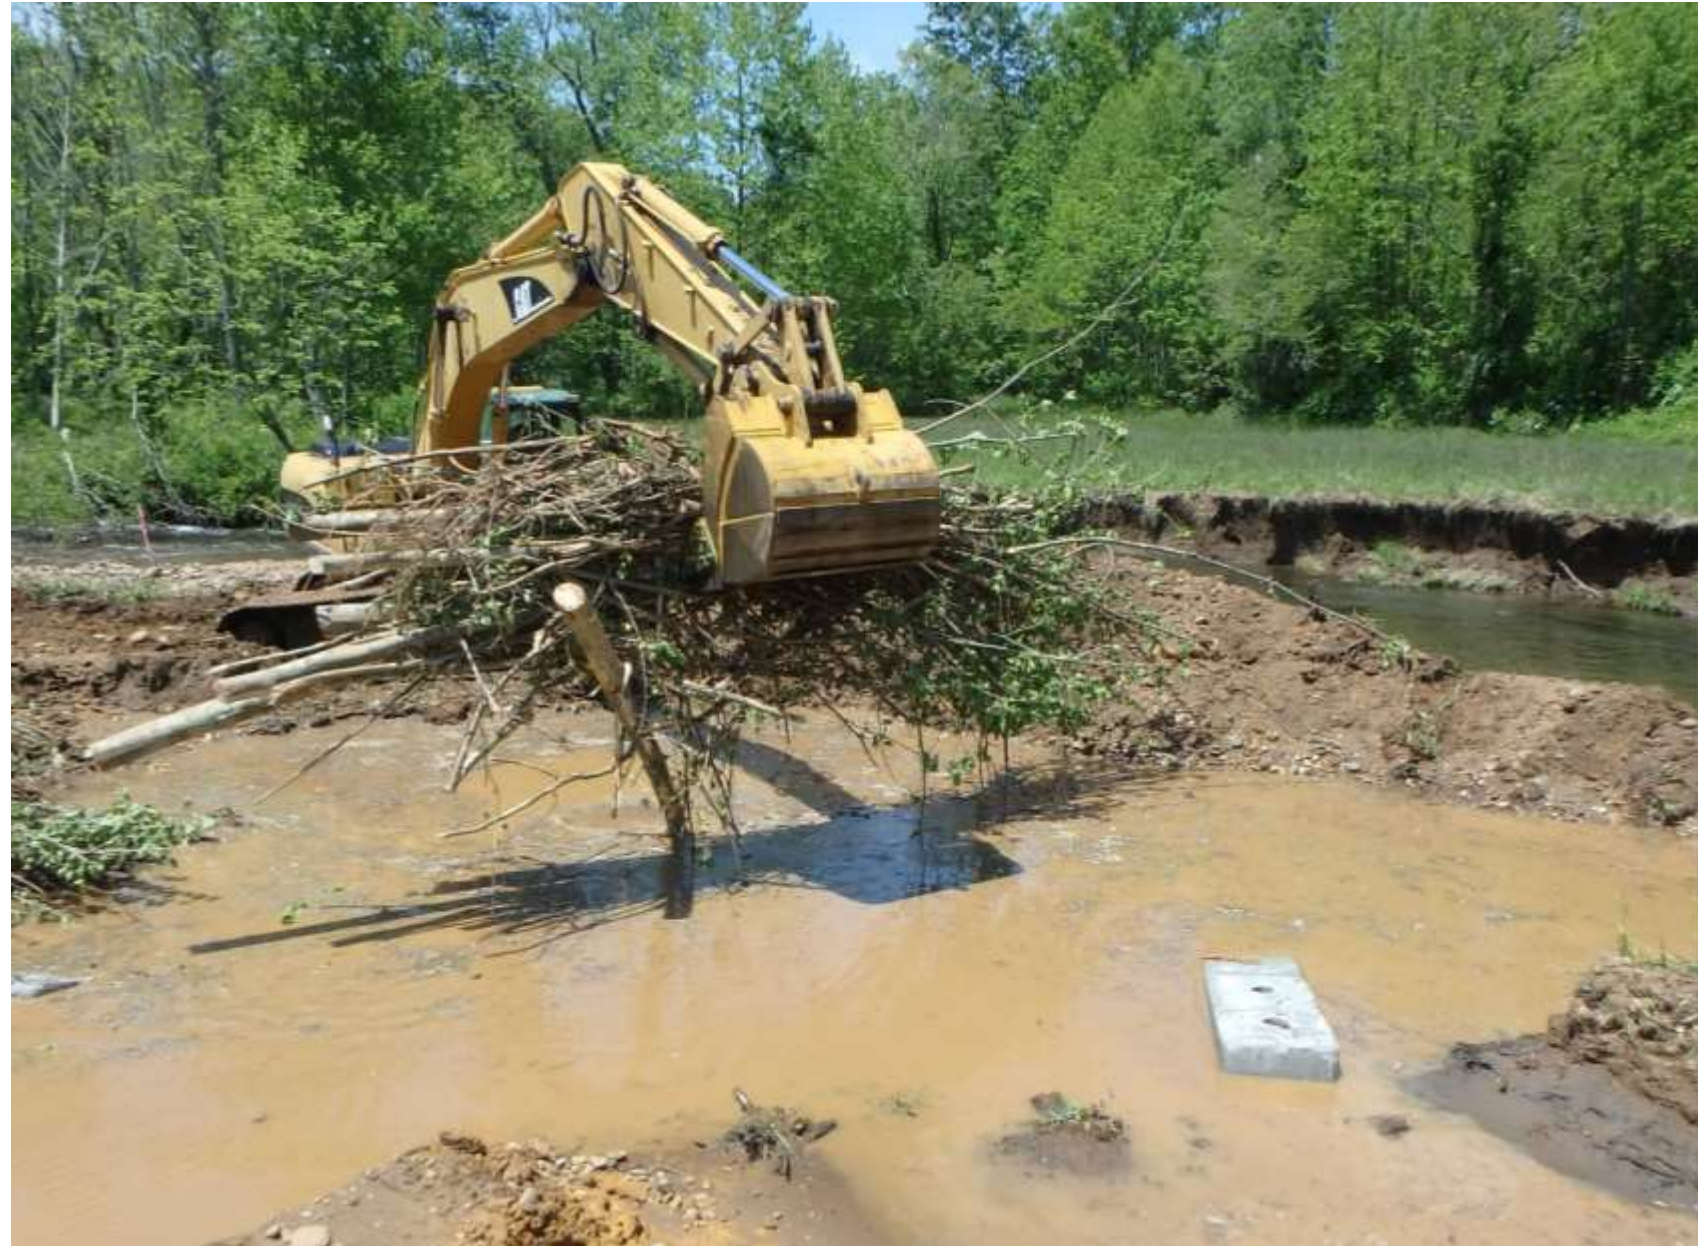
Cartoogechaye Creek

- Construction: June 2017
- First structure built with flow isolated from main river
- Limbs and brush installed by excavating bed and sinking brush with native cobble
- Site Stats:
 - DA = 38 sq. mi.
 - $Q_{BKF} = 970$ cfs
 - $W_{BKF} = 67$ ft
 - $S_{AVG} = 0.5\%$
 - W/D = 21

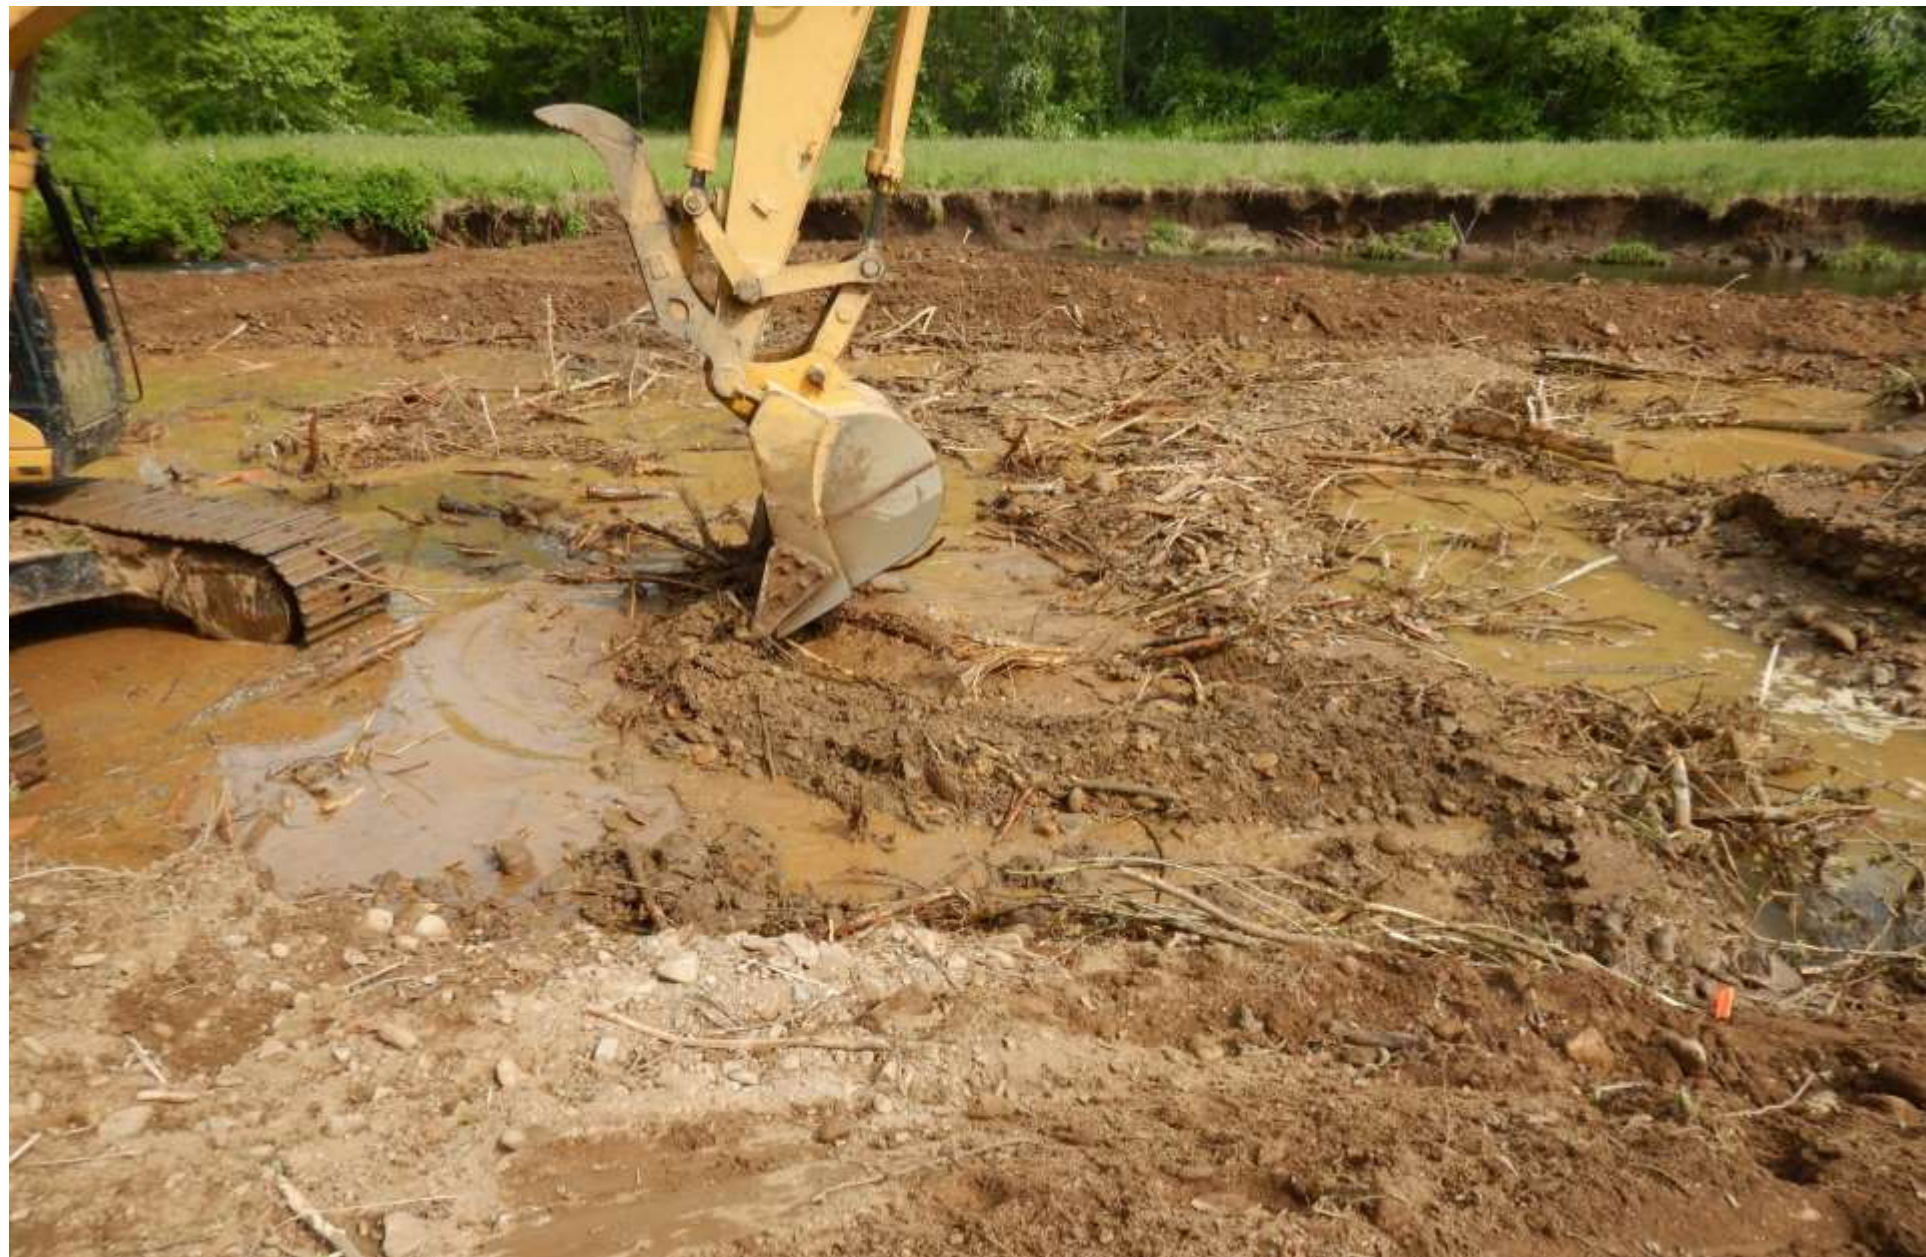
Cartoogechaye Creek

- June 2017
- Material buried in rows across the channel bed
- Approximately 20% to 30% of backfill consisted of limbs and brush

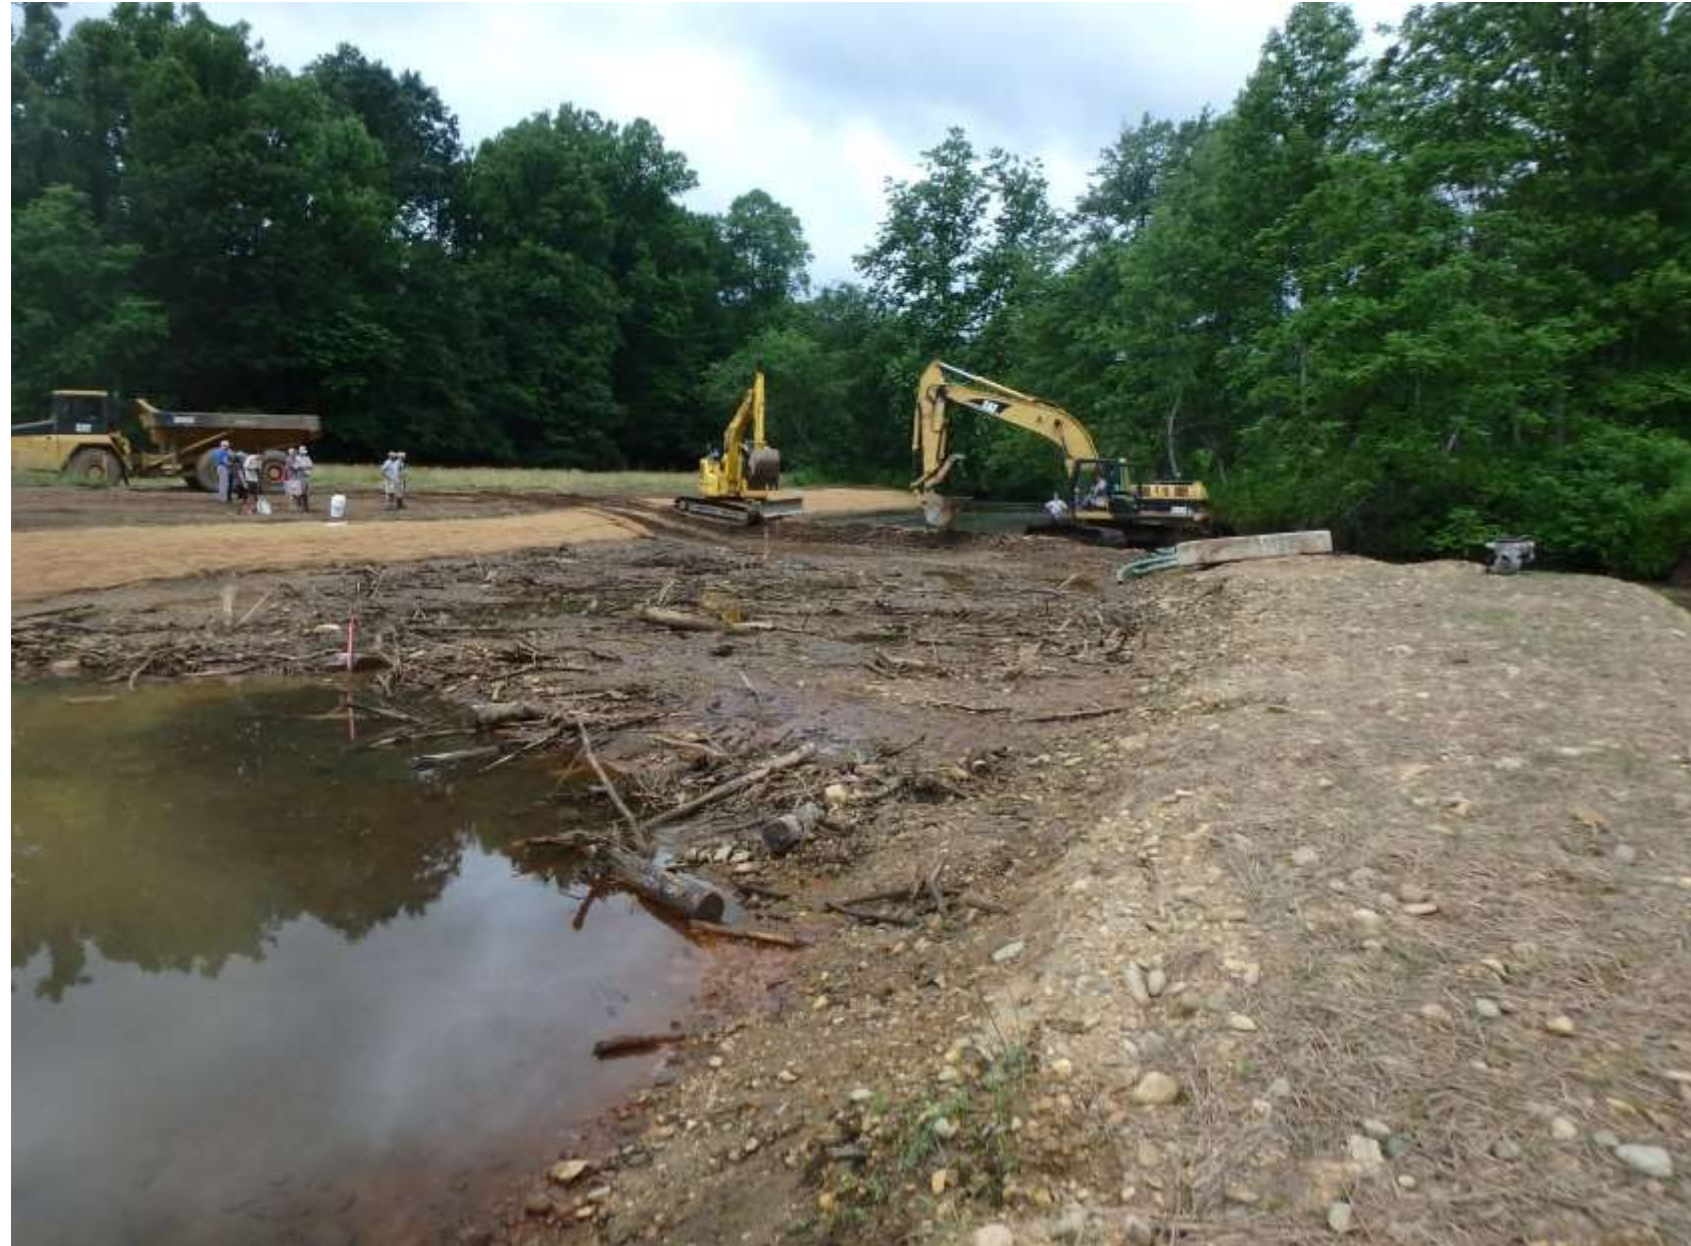
Cartoogechaye Creek

- June 2017
- Completed structure prior to release of flow
- Anchor logs placed at downstream end below grade
- Downstream 'V' shape and cross slope to thalweg intended to centralize faster current

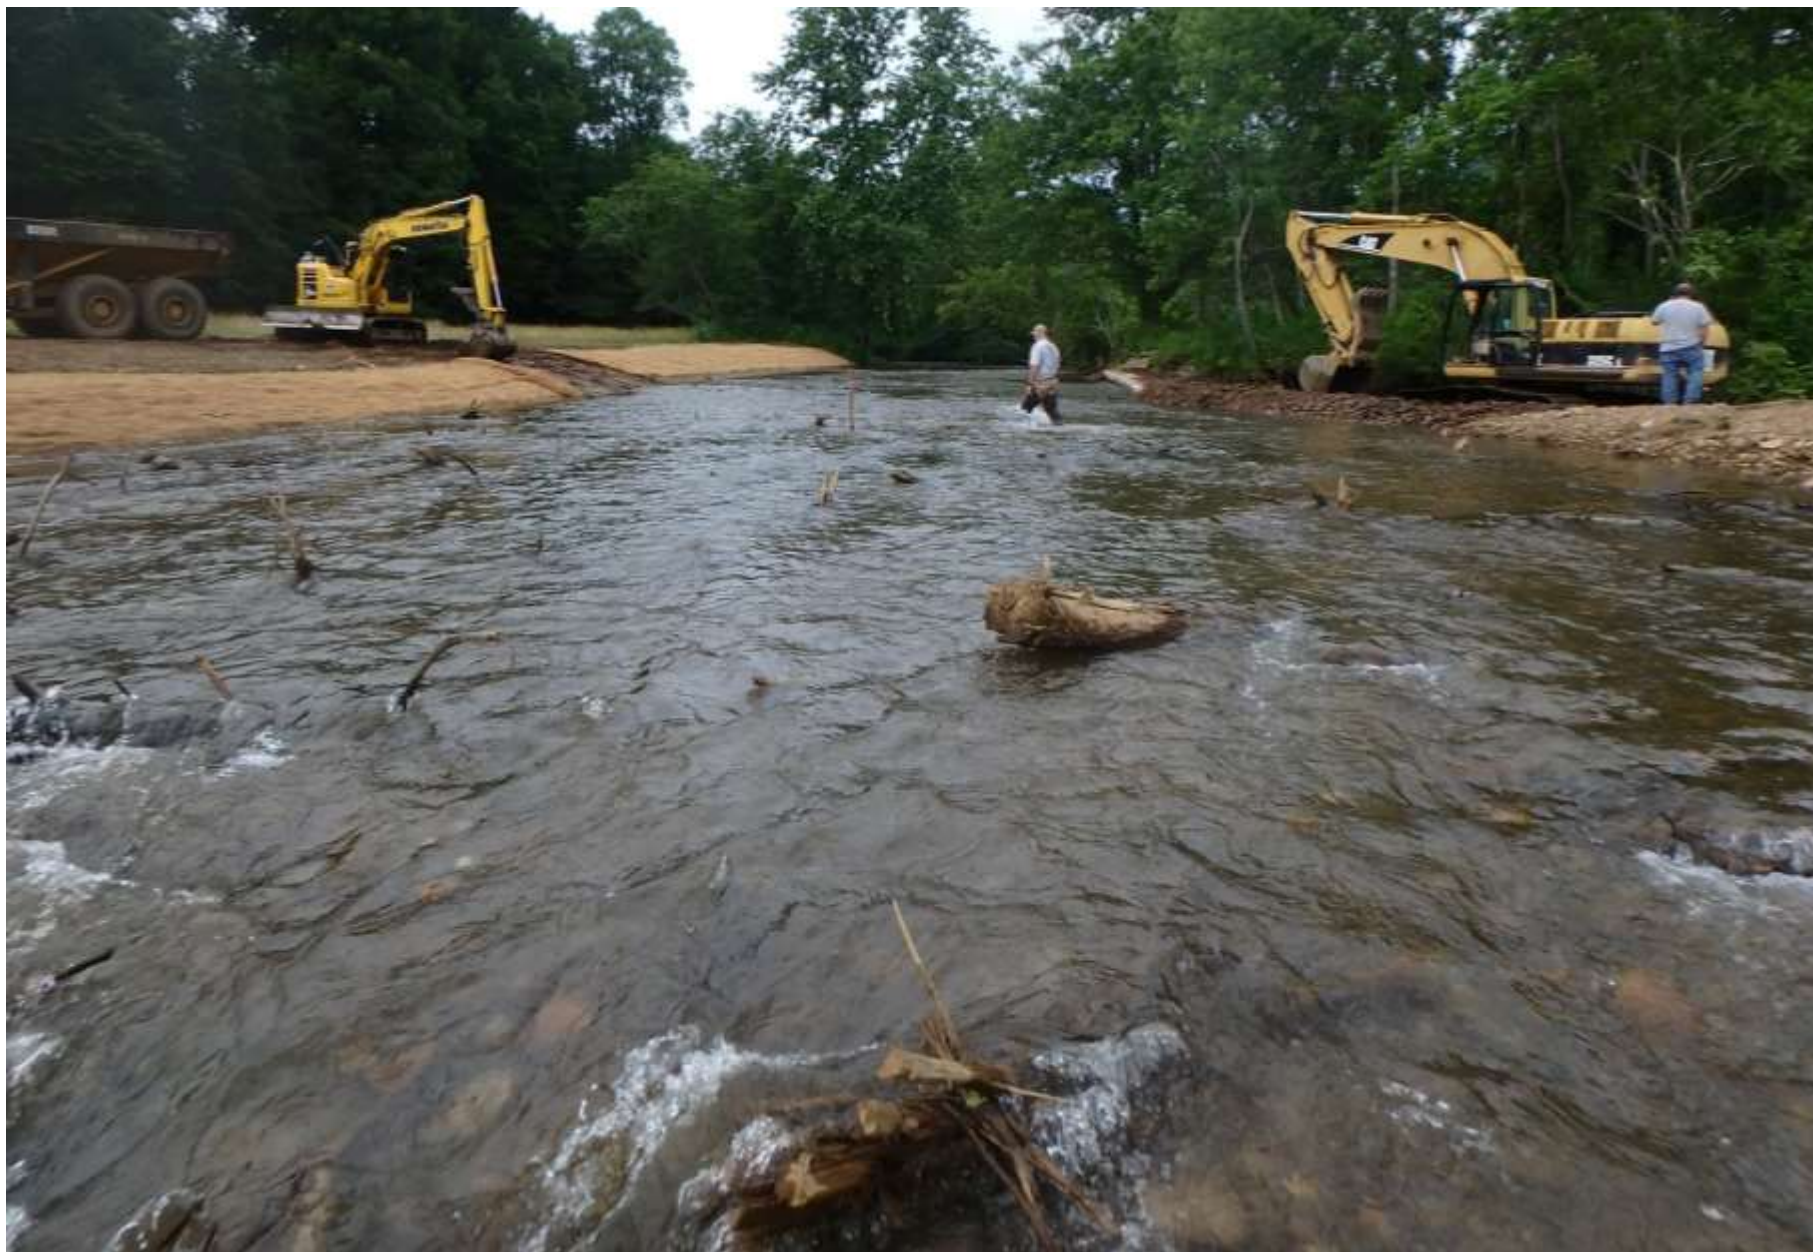
Cartoogechaye Creek

- June 2017
- Immediately following connection of flow
- Downstream steeper facet in foreground
- Slightly flatter facet through the structure
- Flatter riffle facet upstream of structure

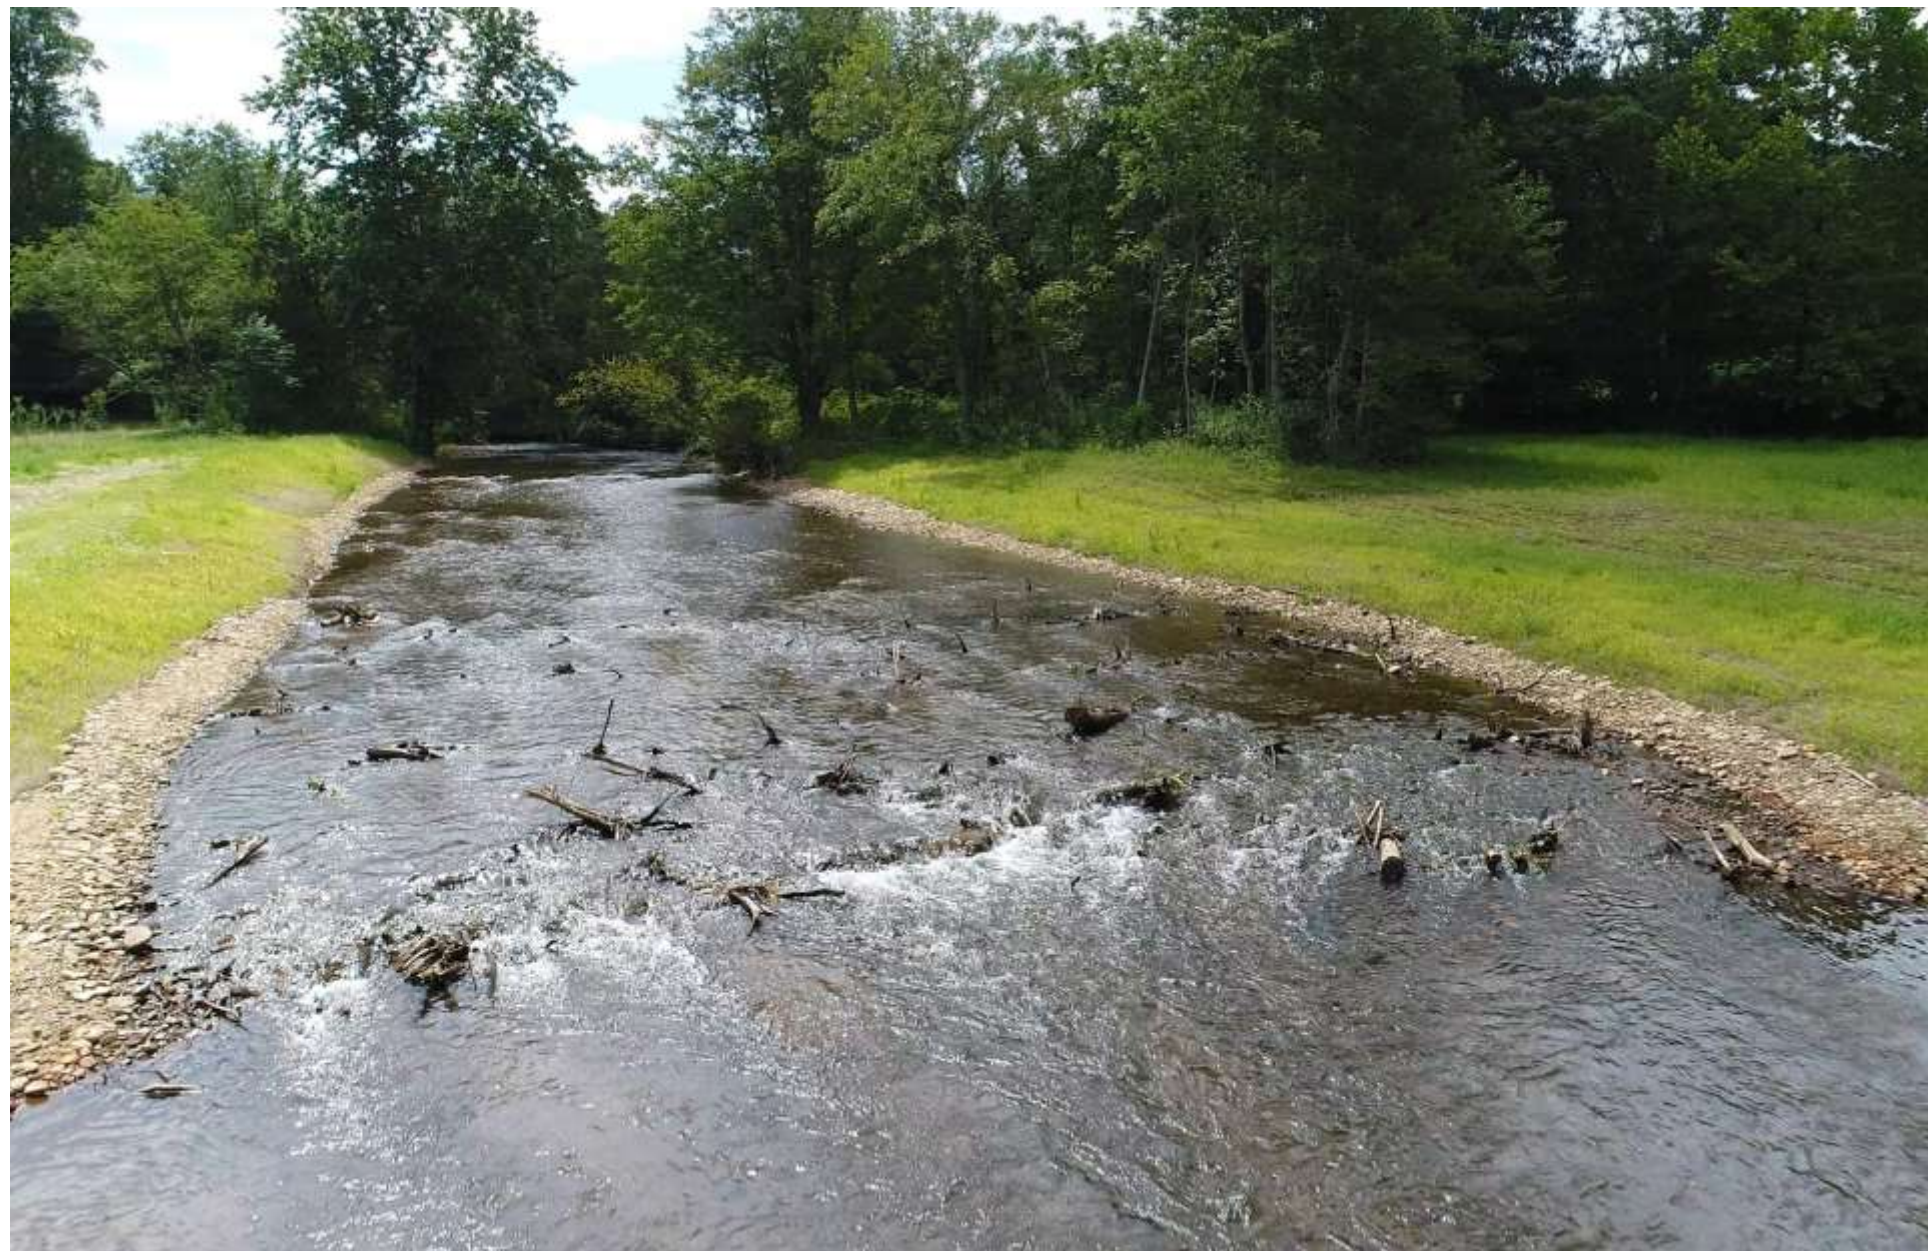
Cartoogechaye Creek

- June 2017
- After completion of construction
- Bed slope increases from riffle through structure
