Subgrade Structures in Restoration Design

Presented by:
Grant Ginn, PE, Senior Principal/River Engineer

National Stream Restoration Conference 2022
August 2, 2022

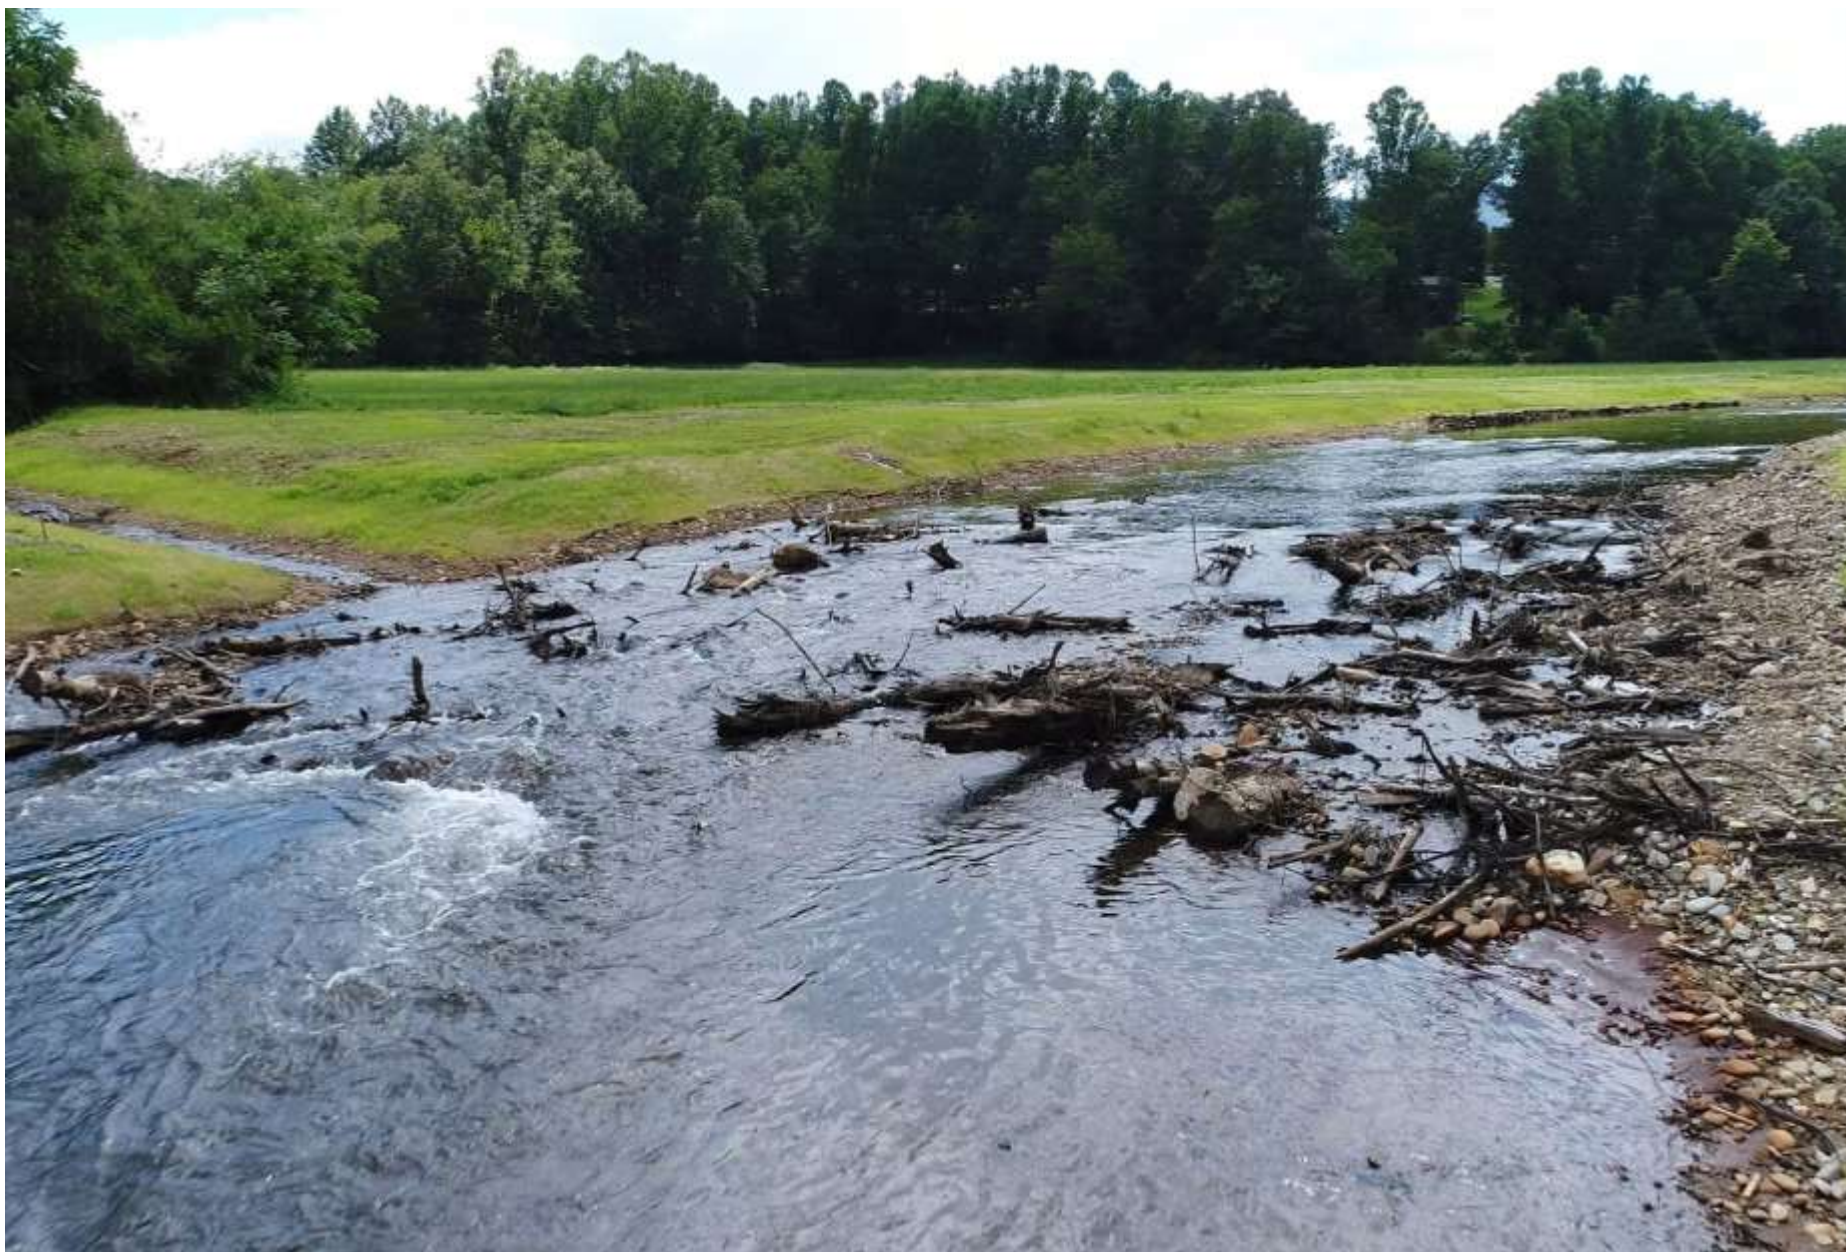
Cartoogechaye Creek

- July 2017
- Furthest structure at downstream end of project reach
- Larger drop through this last structure
- Three facet slopes:
 - Downstream facet
 - Main structure facet
 - Upstream riffle facet

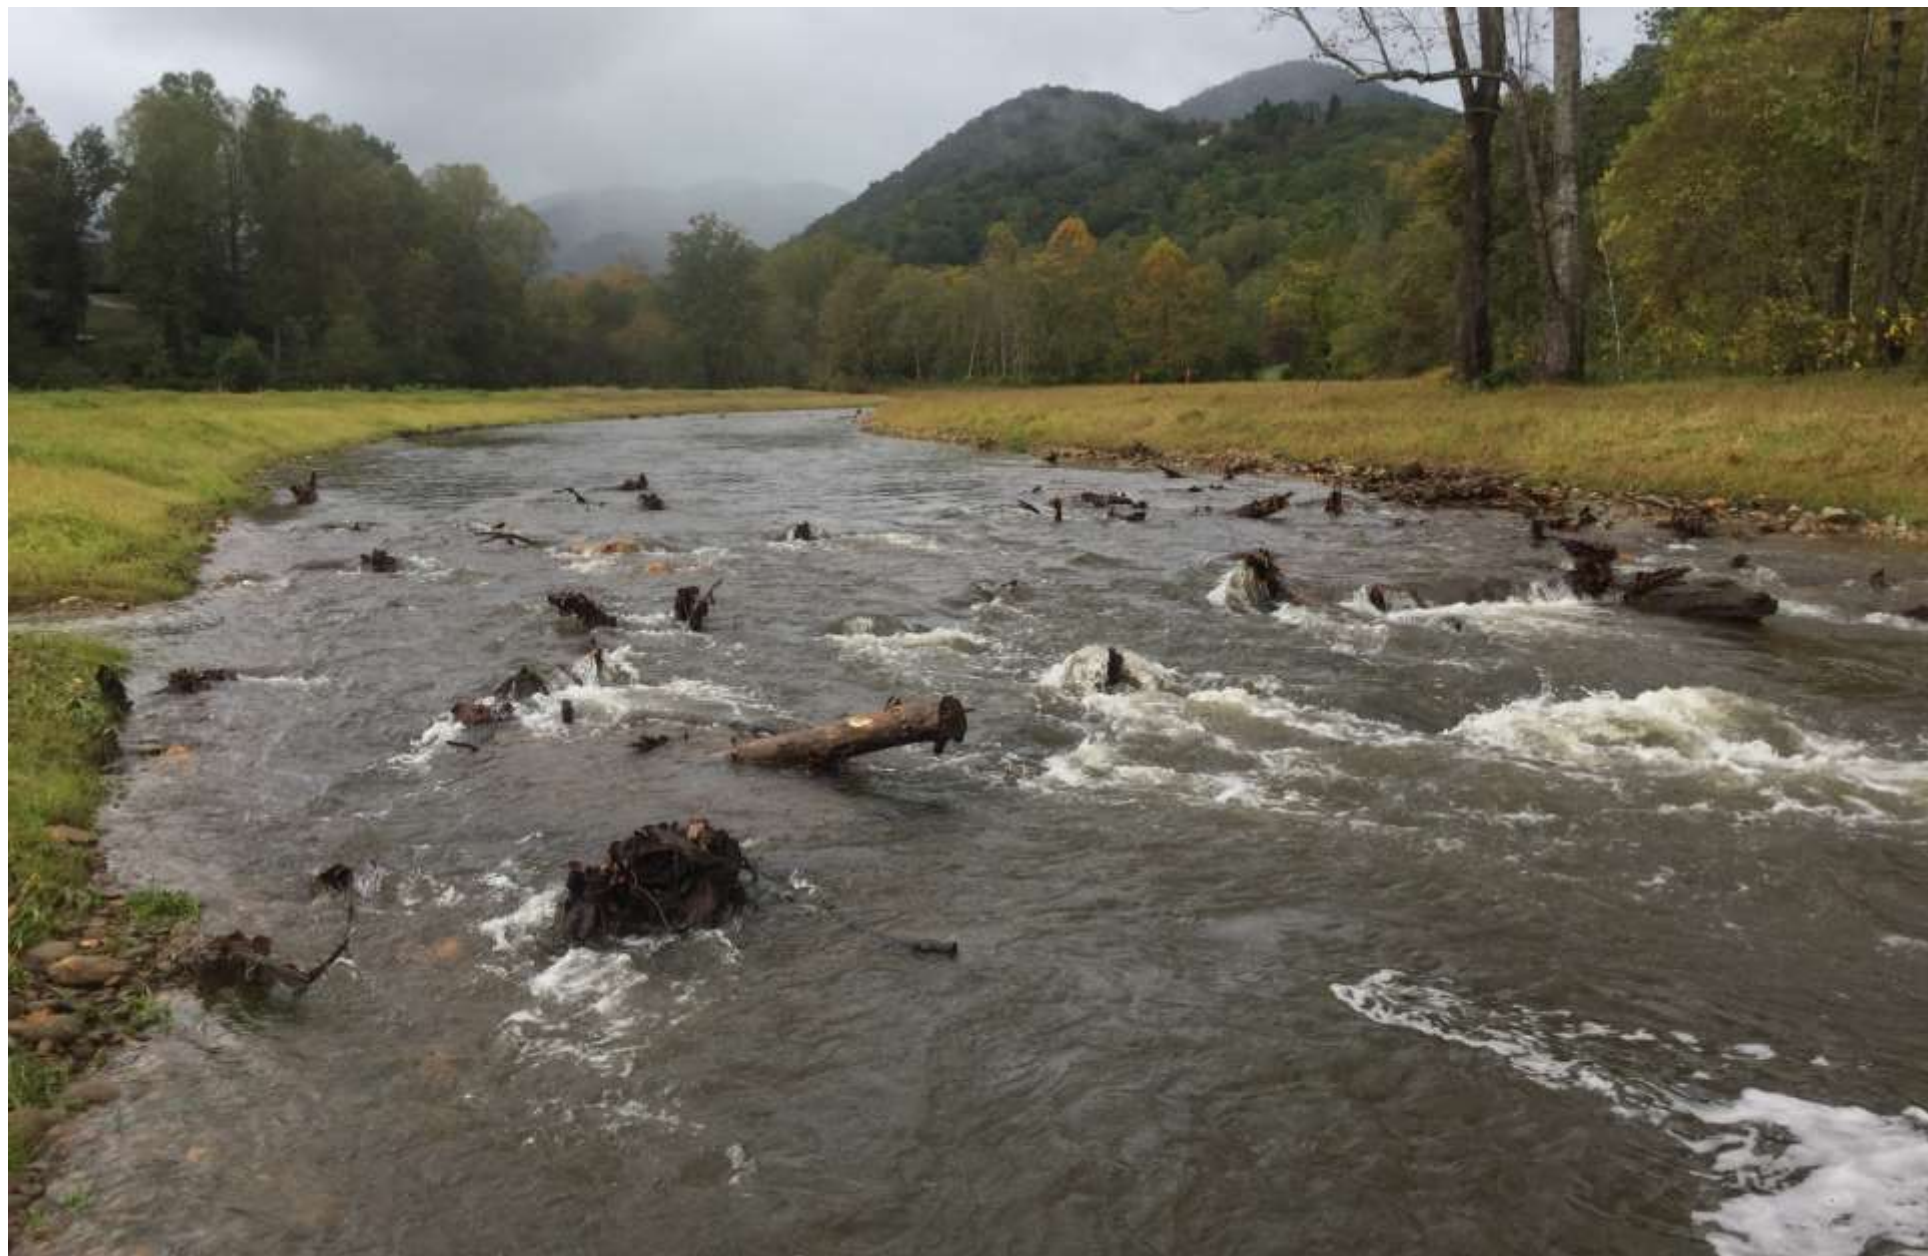
Cartoogechaye Creek

- Oct 2017
- Following bankfull event in the fall

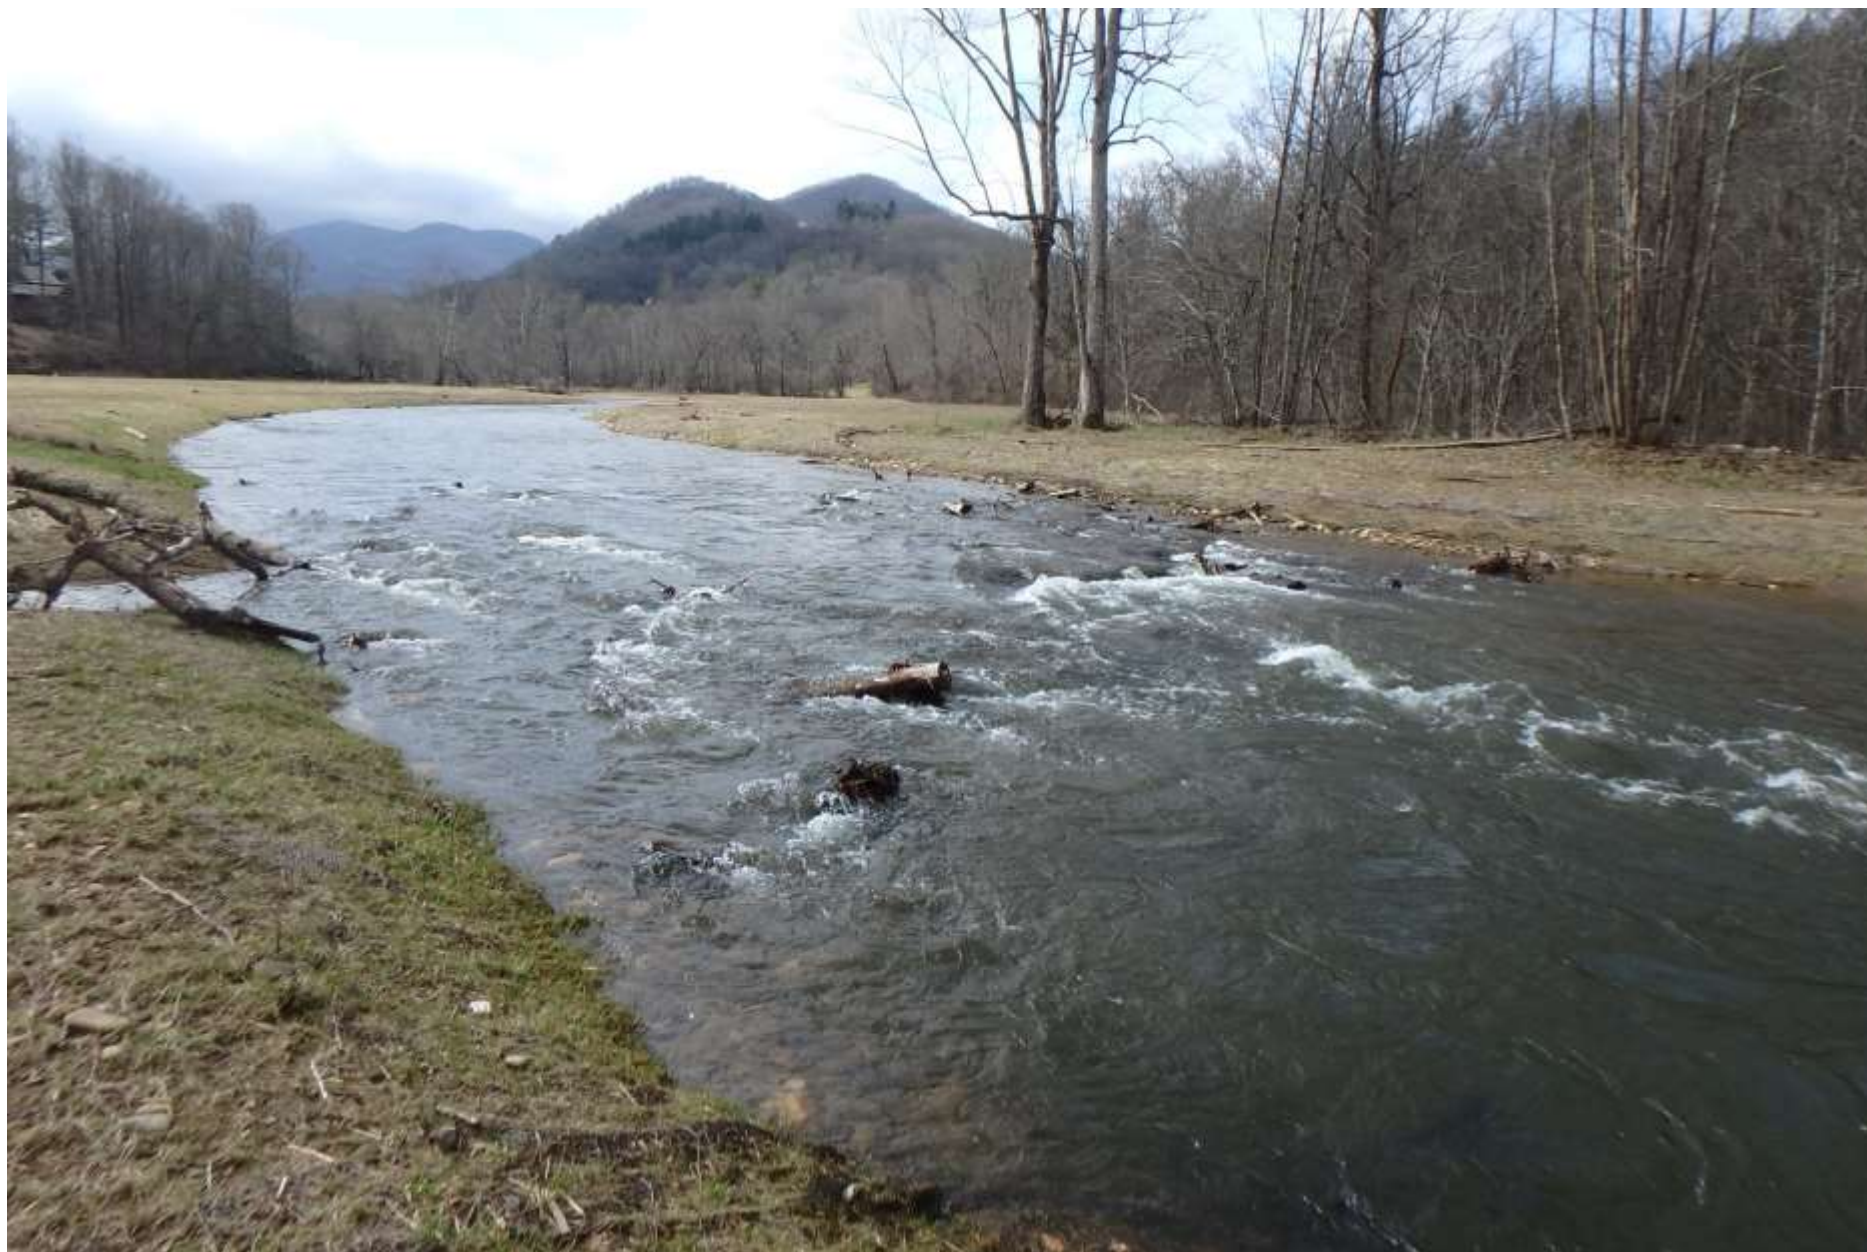
Cartoogechaye Creek

- February 2018
- Several bankfull and greater events during the winter of 2017-2018
- High baseflow following overbank flow
- Centralized faster current
- Banks intact despite limited protection

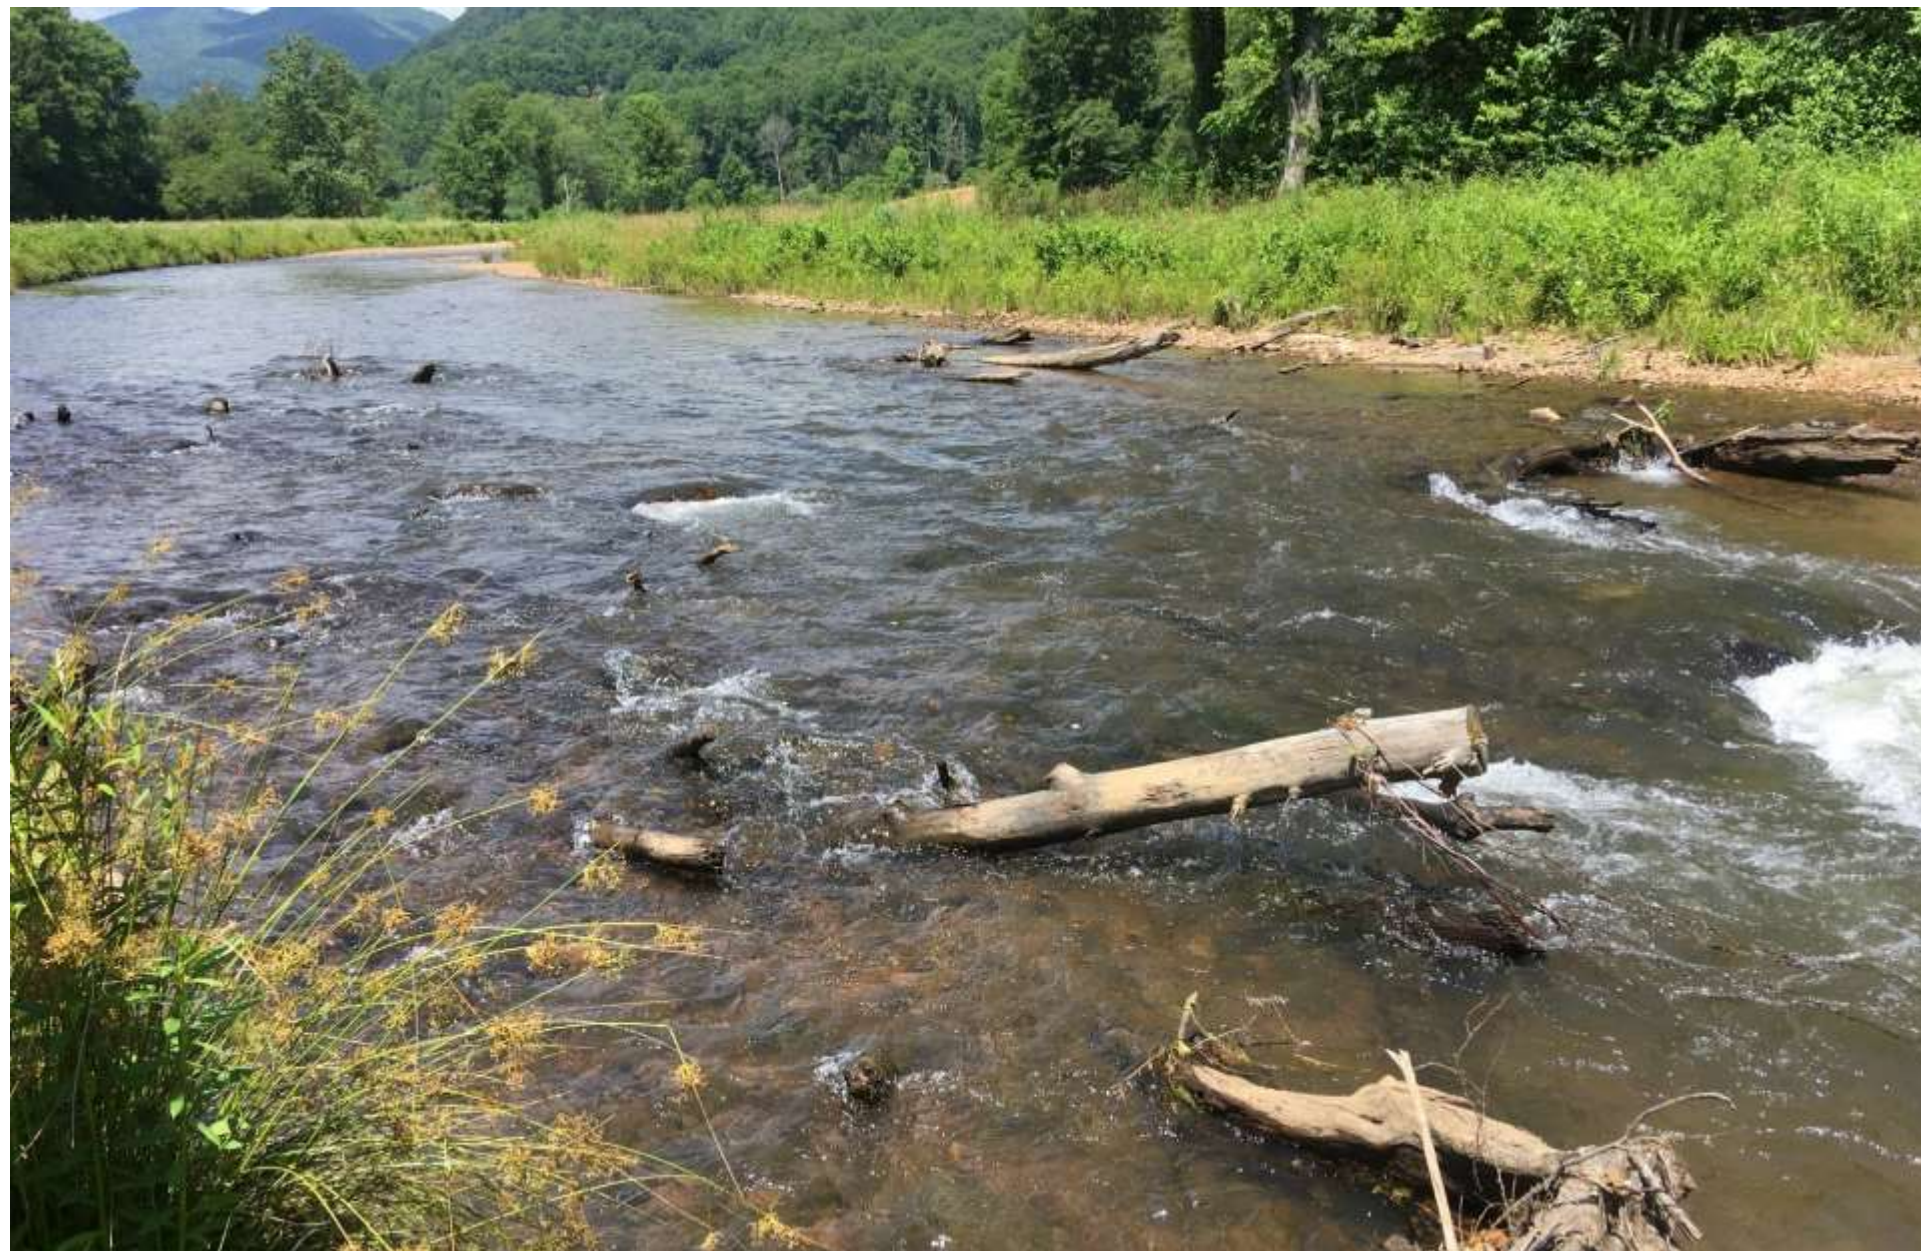
Cartoogechaye Creek

- July 2020
- Three years after completion

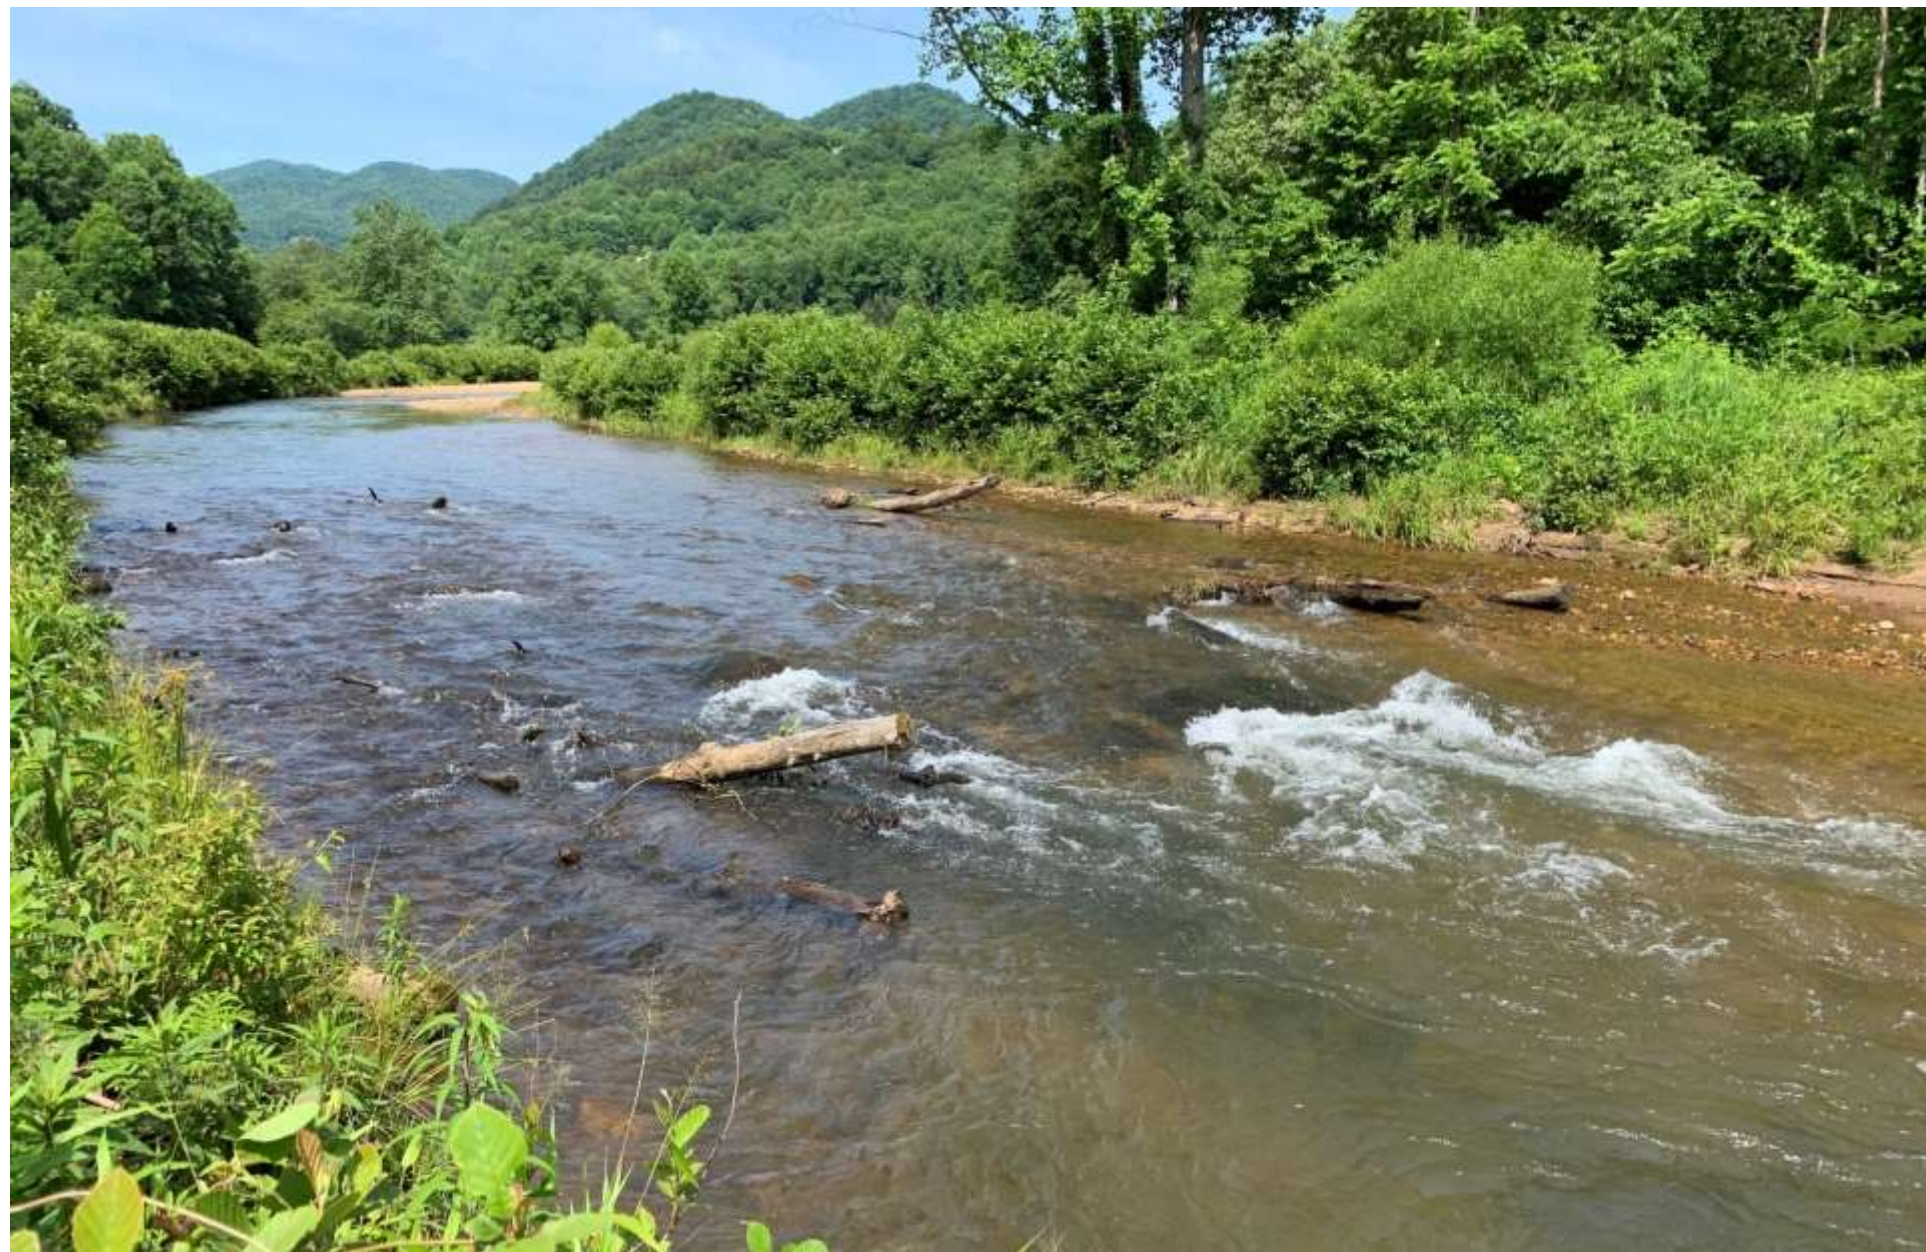
Cartoogechaye Creek

- June 2022
- Five years after completion
- Incoming sediment reducing facet expression
- Structure naturalizing and becoming part of the river

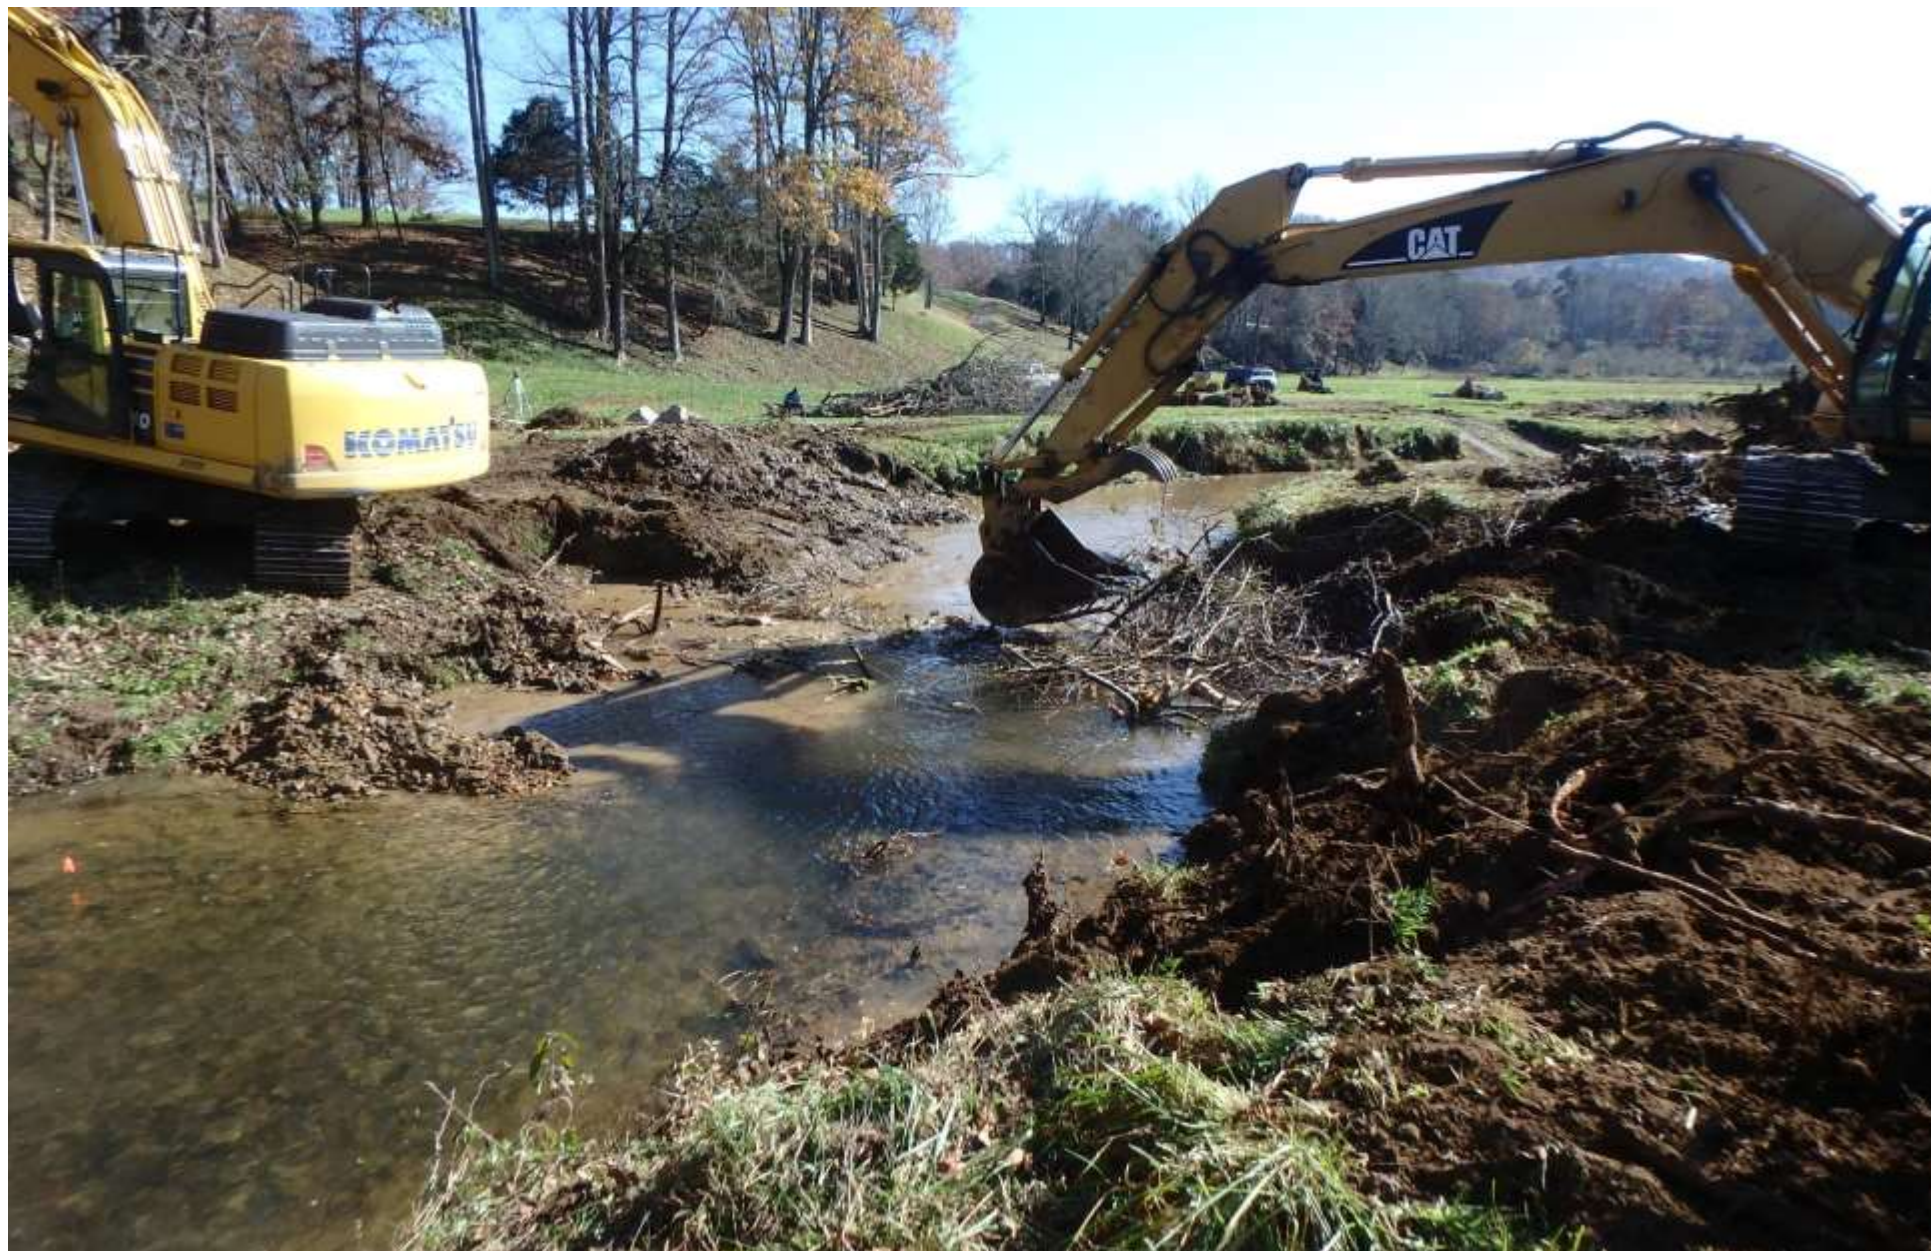
Peachtree Creek

- Construction:
November 2017
- Two track-hoes working from each bank
- Site Stats:
 - DA = 17 sq. mi.
 - $W_{BKF} = 36$ ft
 - $S_{AVG} = 0.5\%$
 - W/D = 19

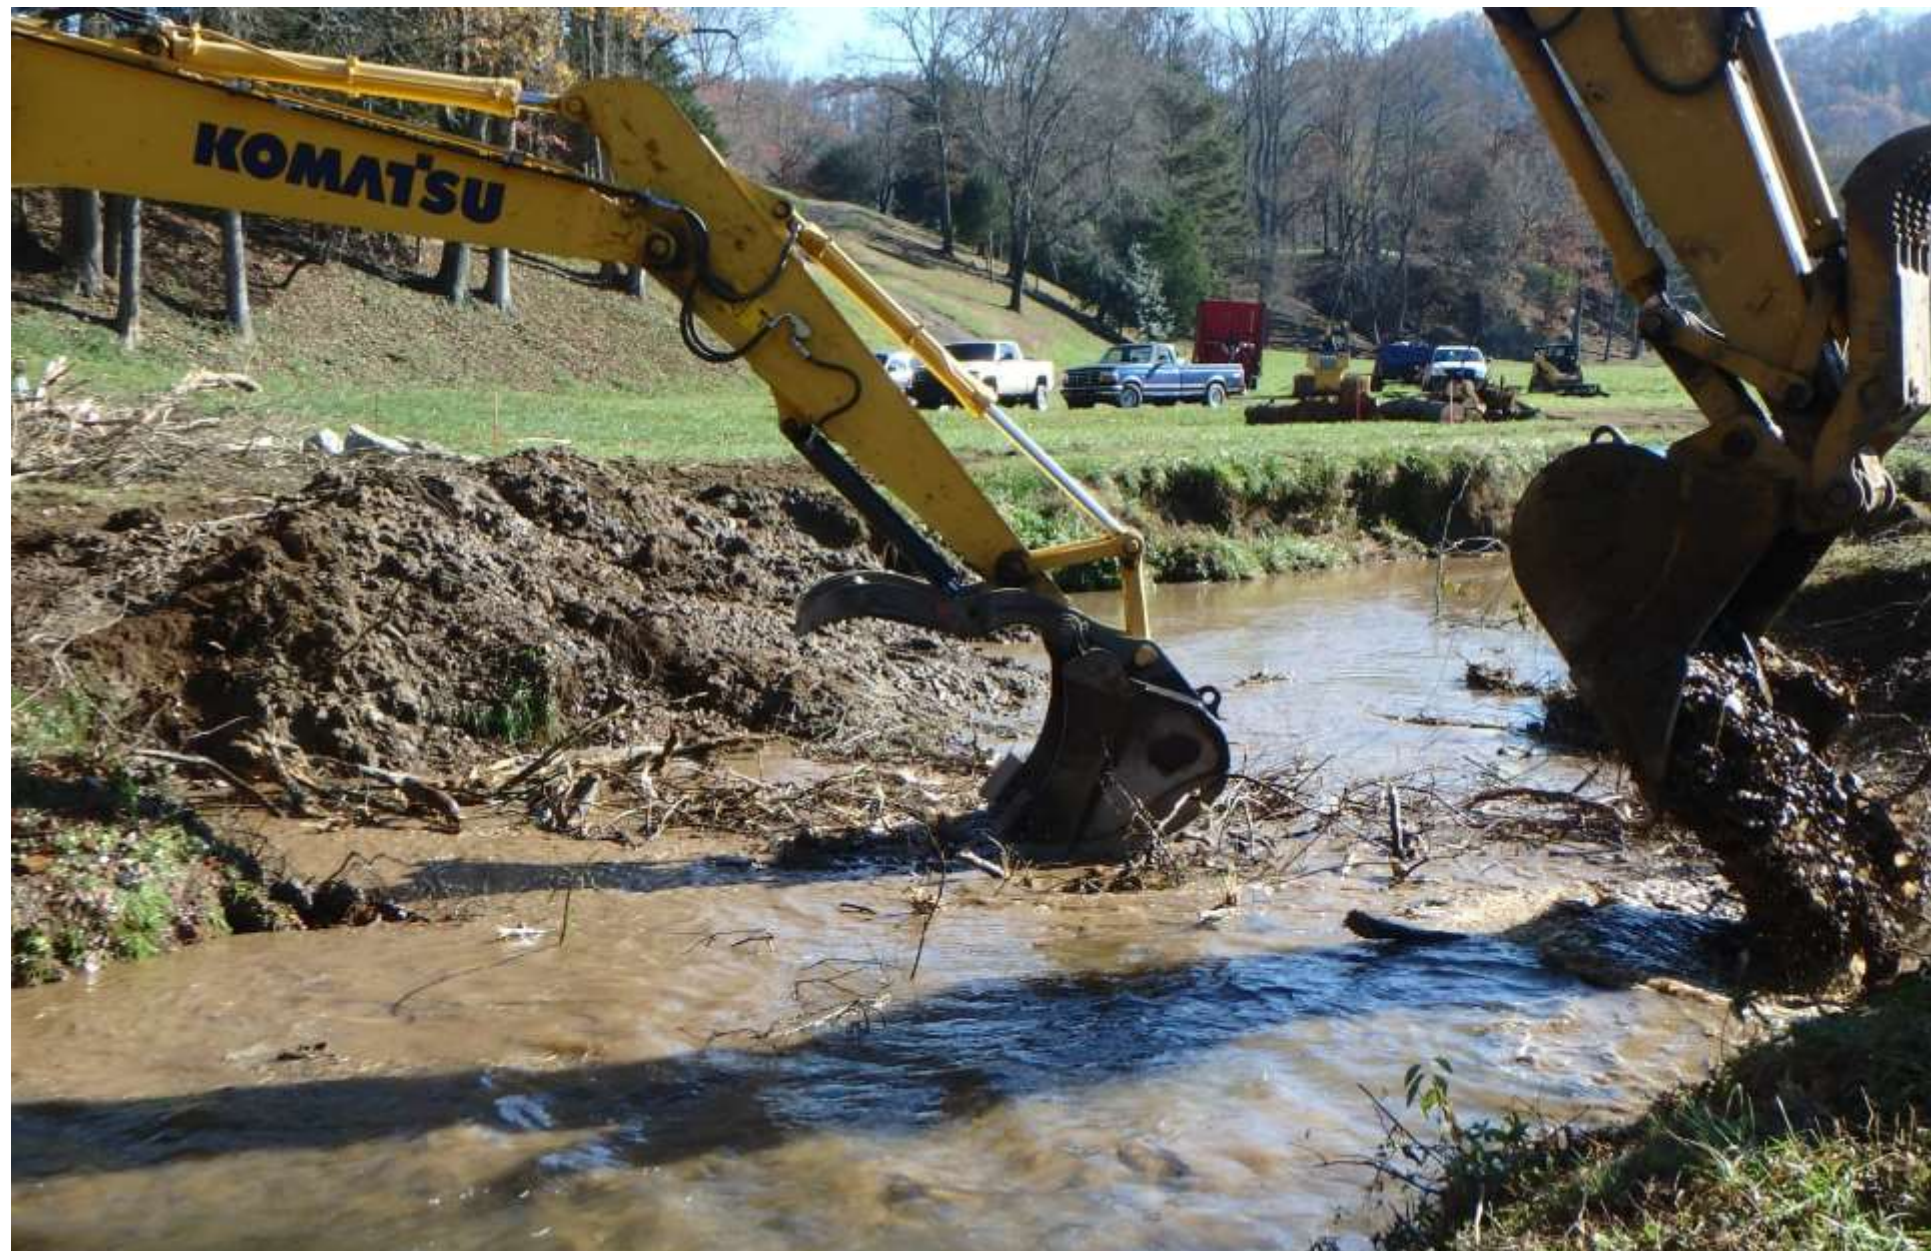
Peachtree Creek

- November 2017
- Installed material extended underneath proposed bank
- Brush fill weighted down with native bed material
- Brush component approximately 20% to 30%

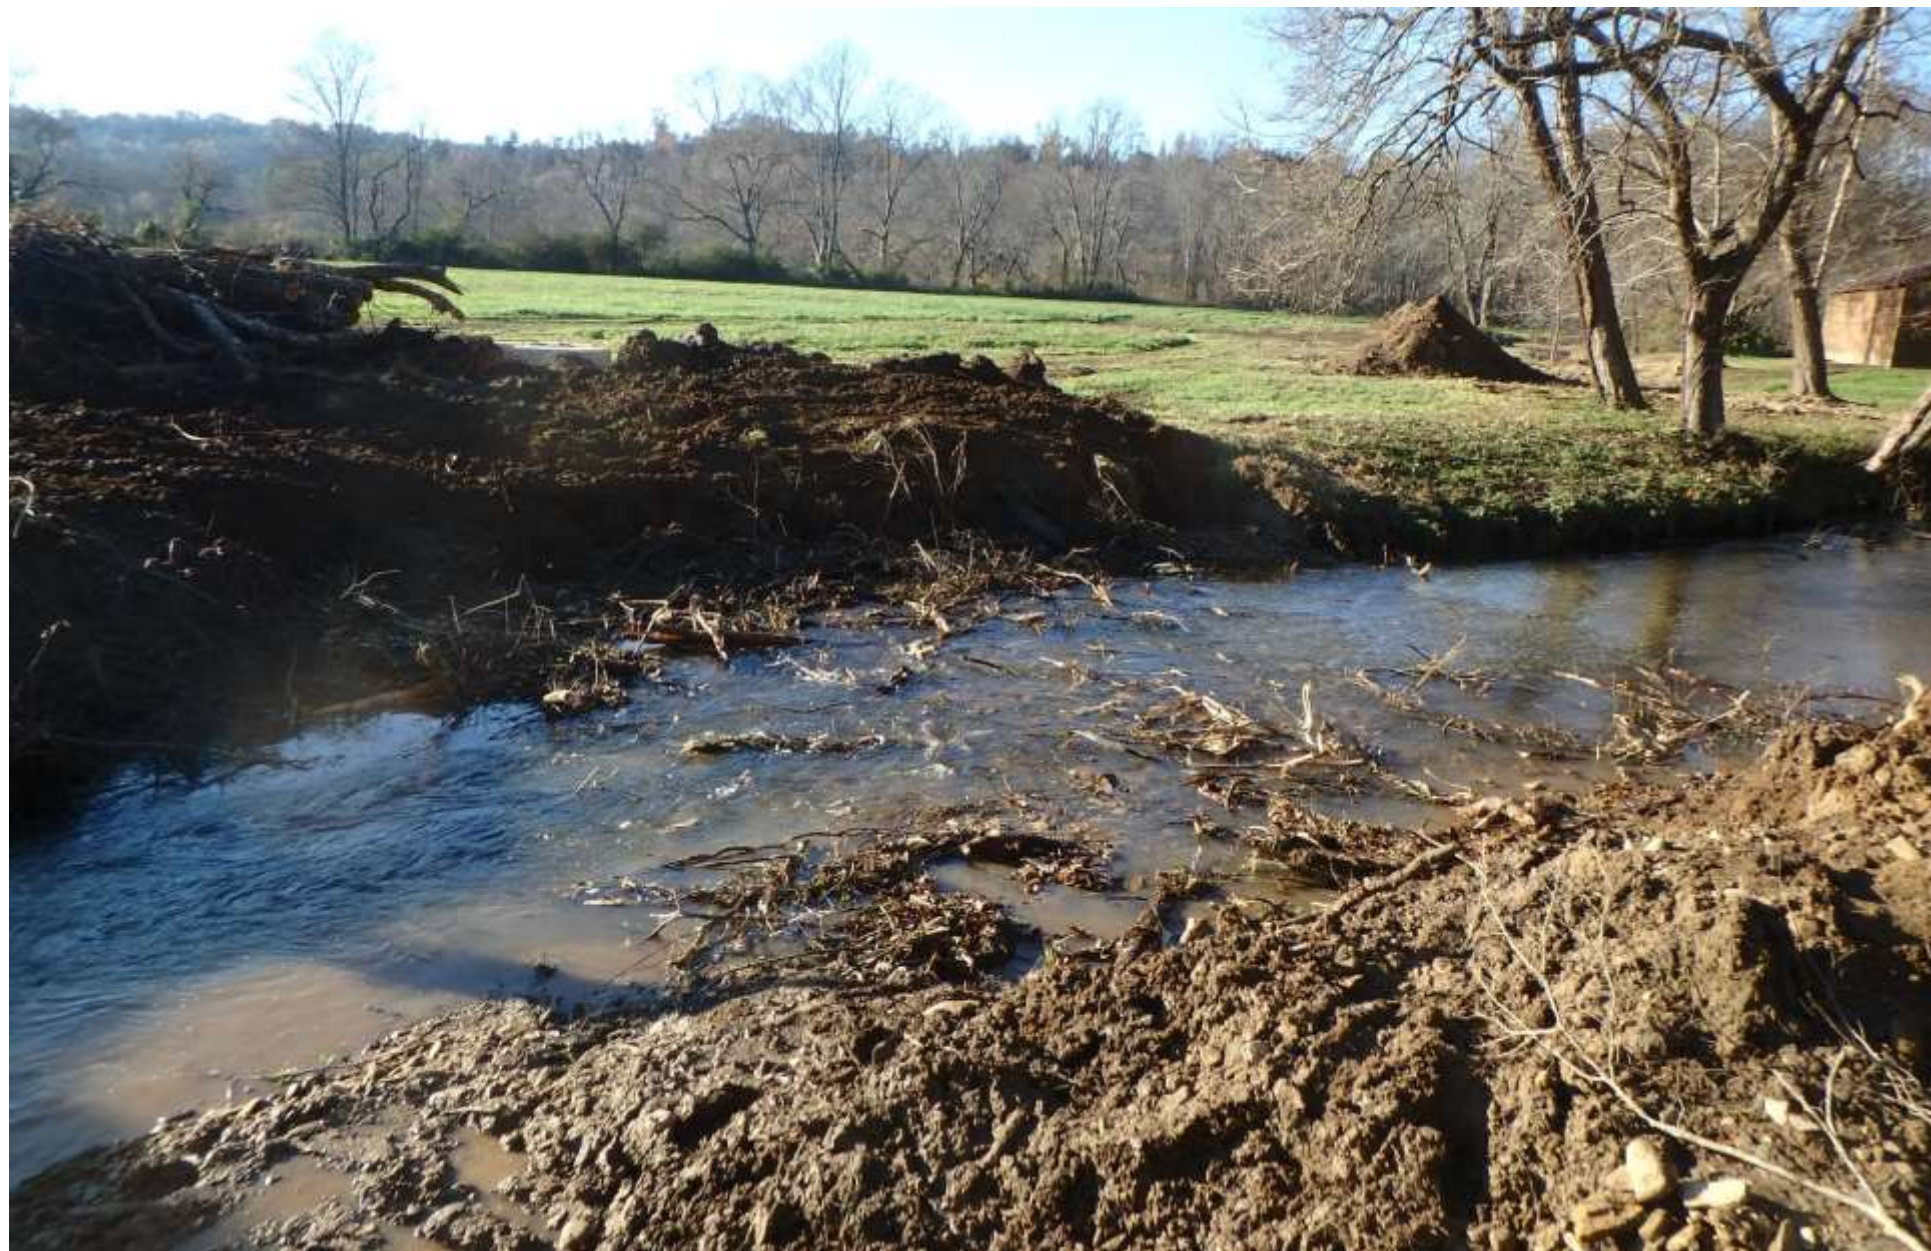
Peachtree Creek

- November 2017
- Bed material mix installed
- Prior to reconstruction of banks
- Brush component in this structure is mostly smaller diameter

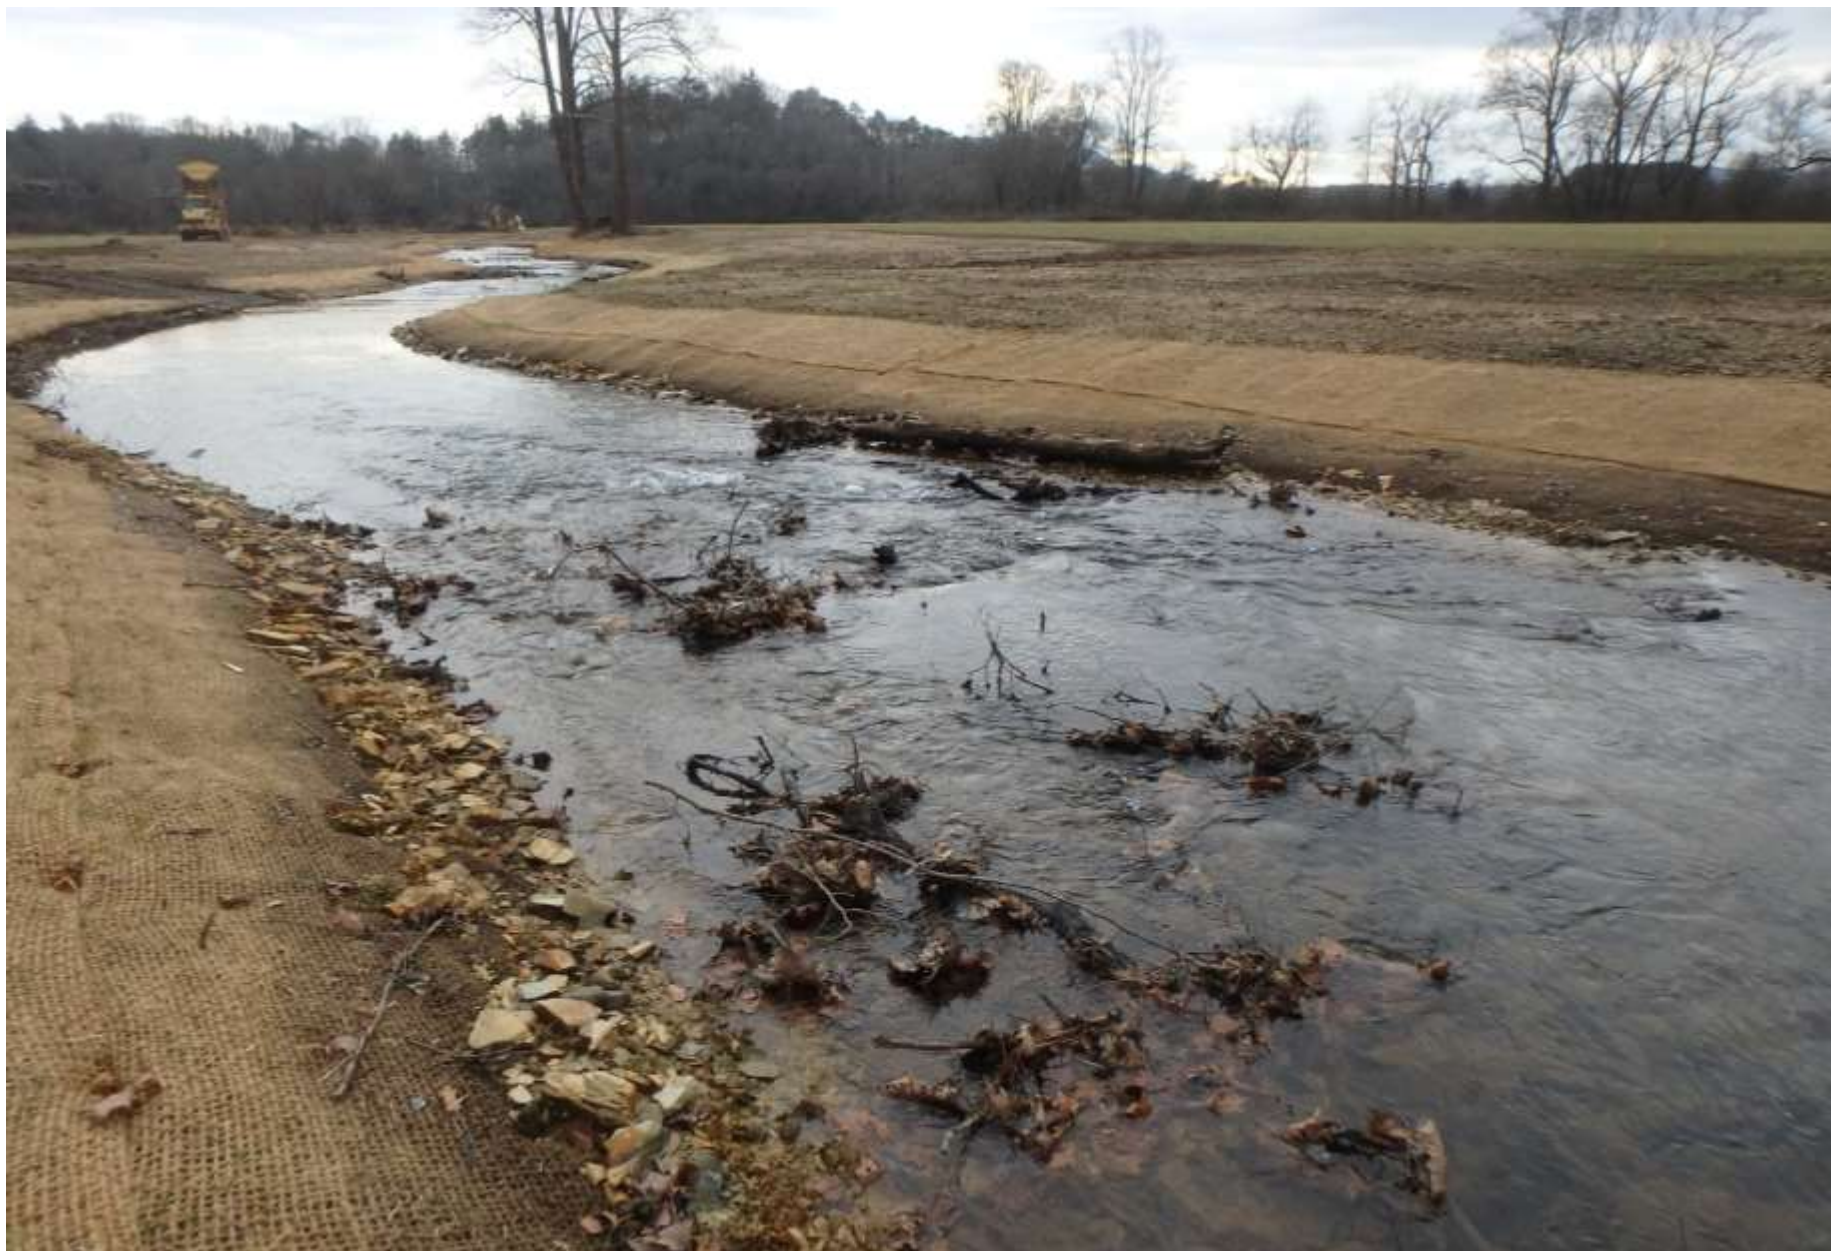
Peachtree Creek

- February 2018
- Lower central thalweg position helping to collect and centralize flow vectors
- Downstream steeper facet with second facet through the structure
- Banks protected with a coir wrap
