Subgrade Structures in Restoration Design

Presented by:
Grant Ginn, PE, Senior Principal/River Engineer

National Stream Restoration Conference 2022
August 2, 2022

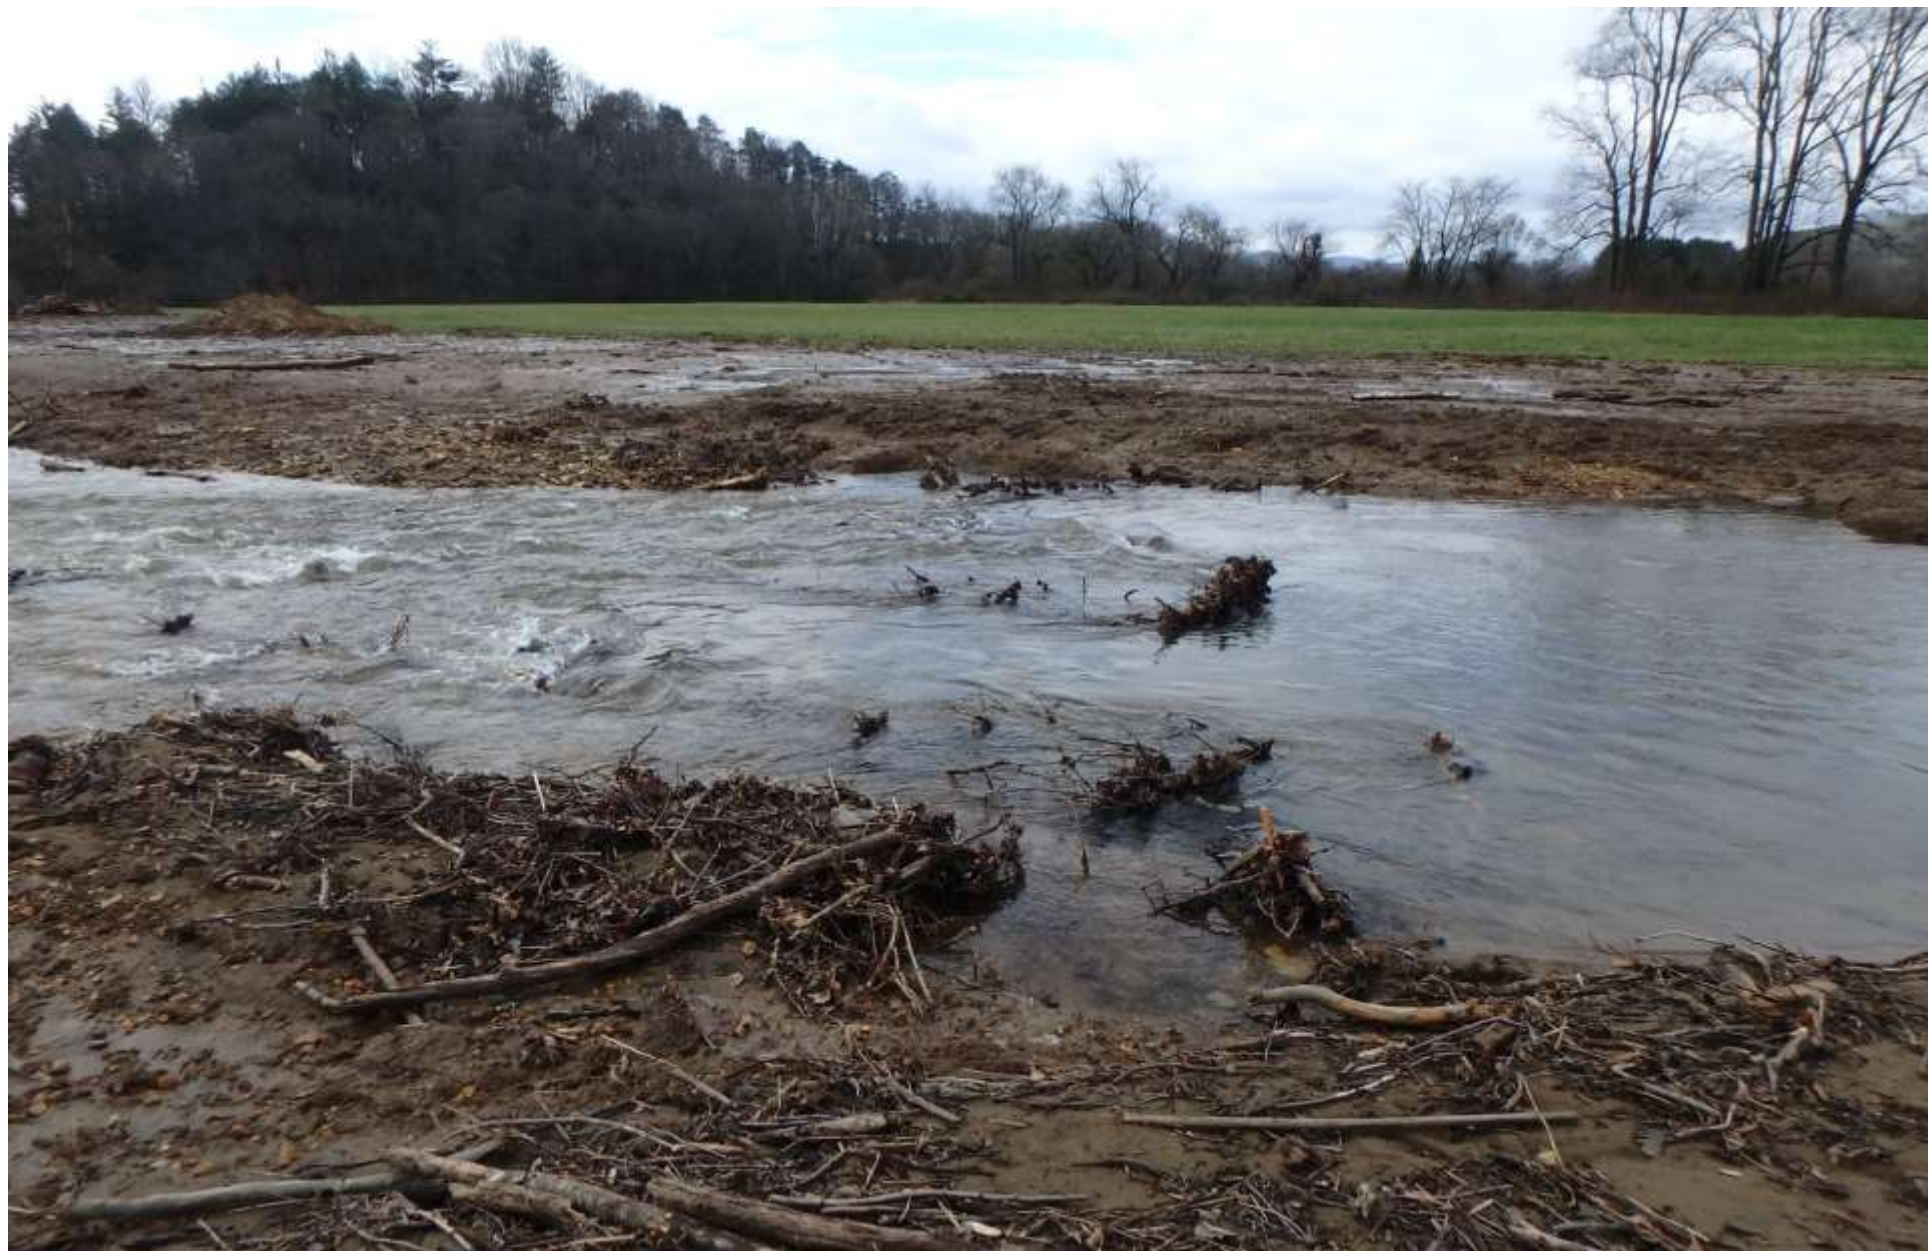
Peachtree Creek

- February 2018
- Following overbank storm during construction
- Structure was complete but bank protection matting had not yet been installed
- Structure held well with only minor bank erosion

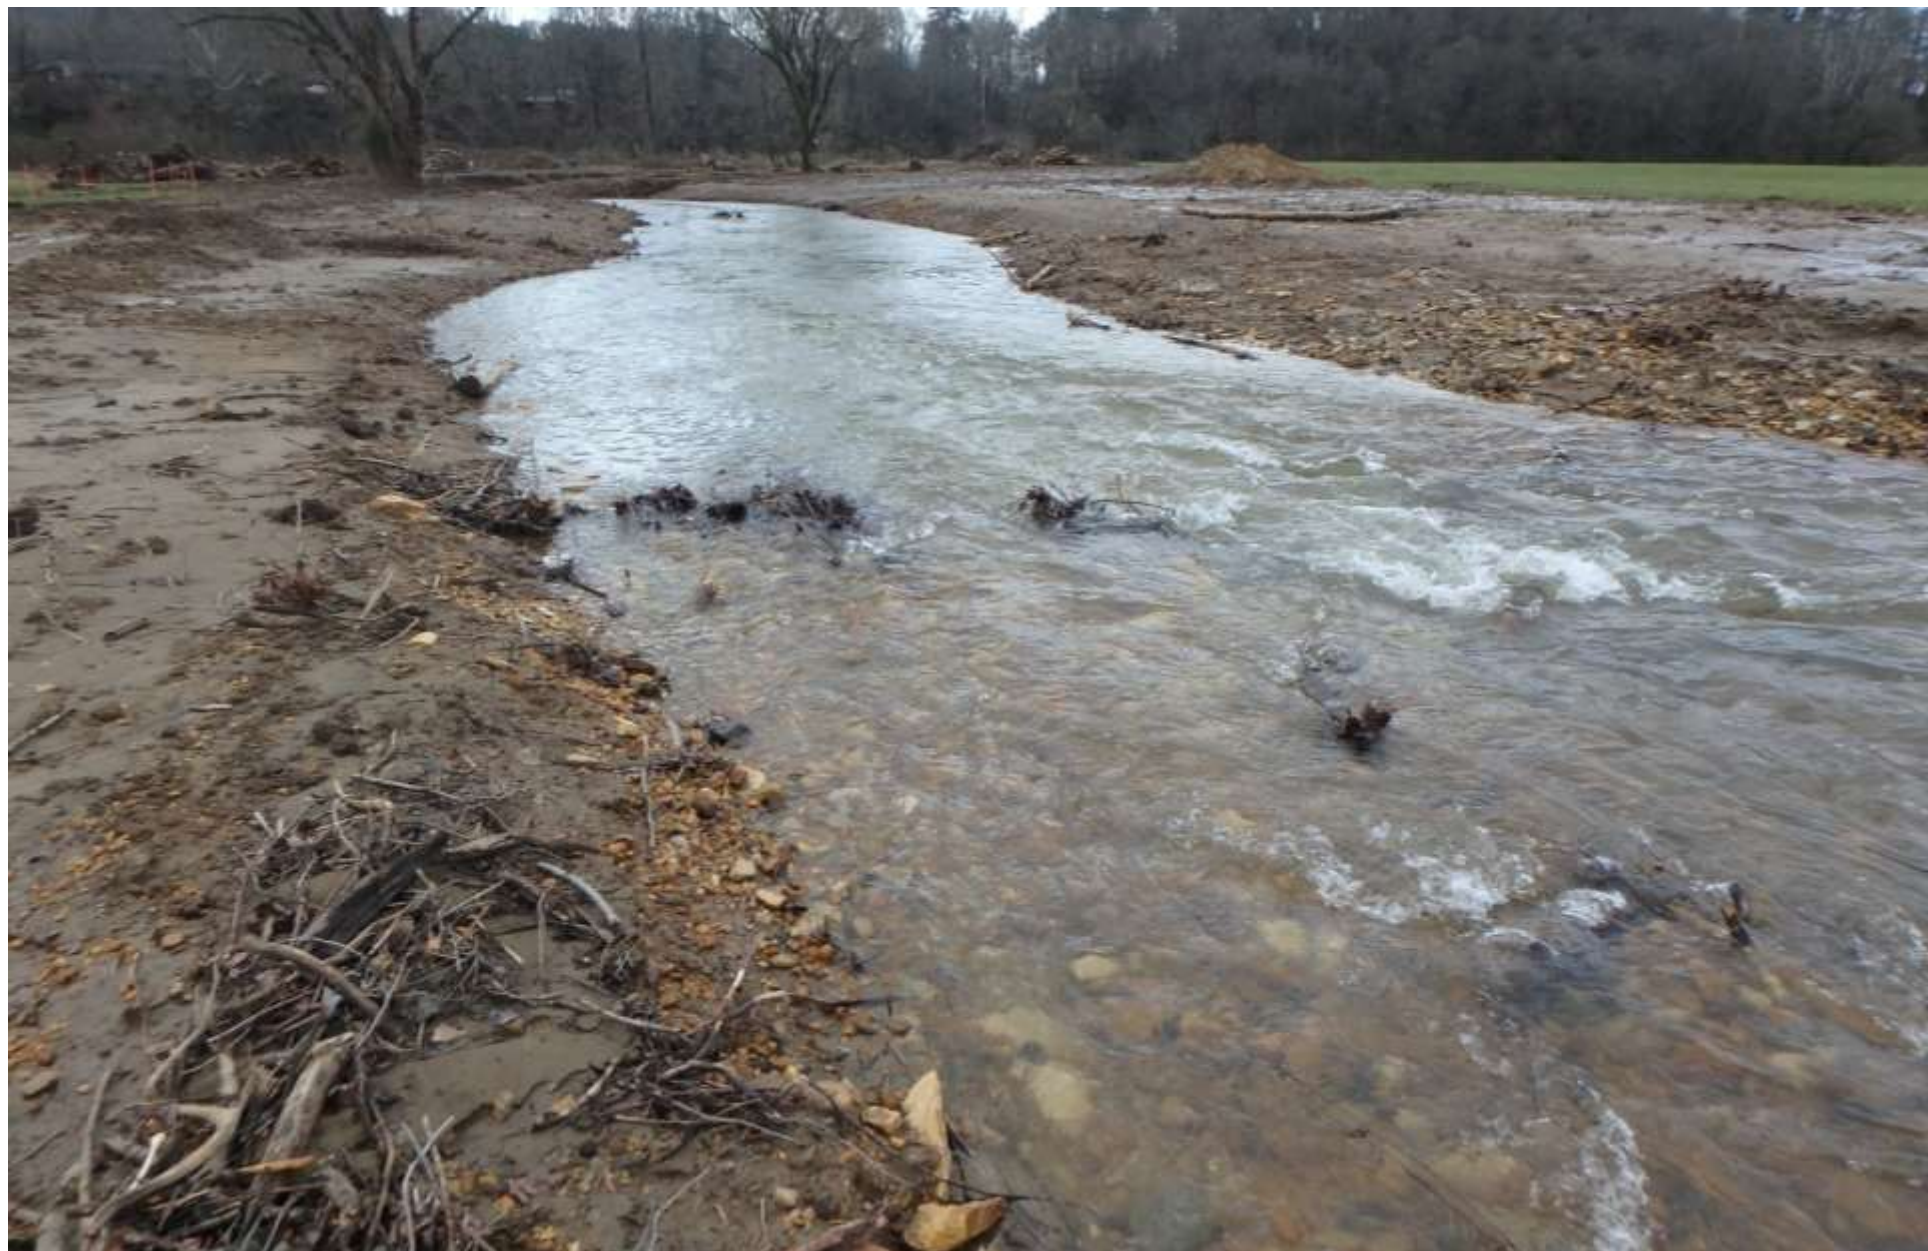
Peachtree Creek

- February 2018
- Same structure looking downstream
- No erosion on left bank, even some deposition
- Prompted reconsideration of bank protection method

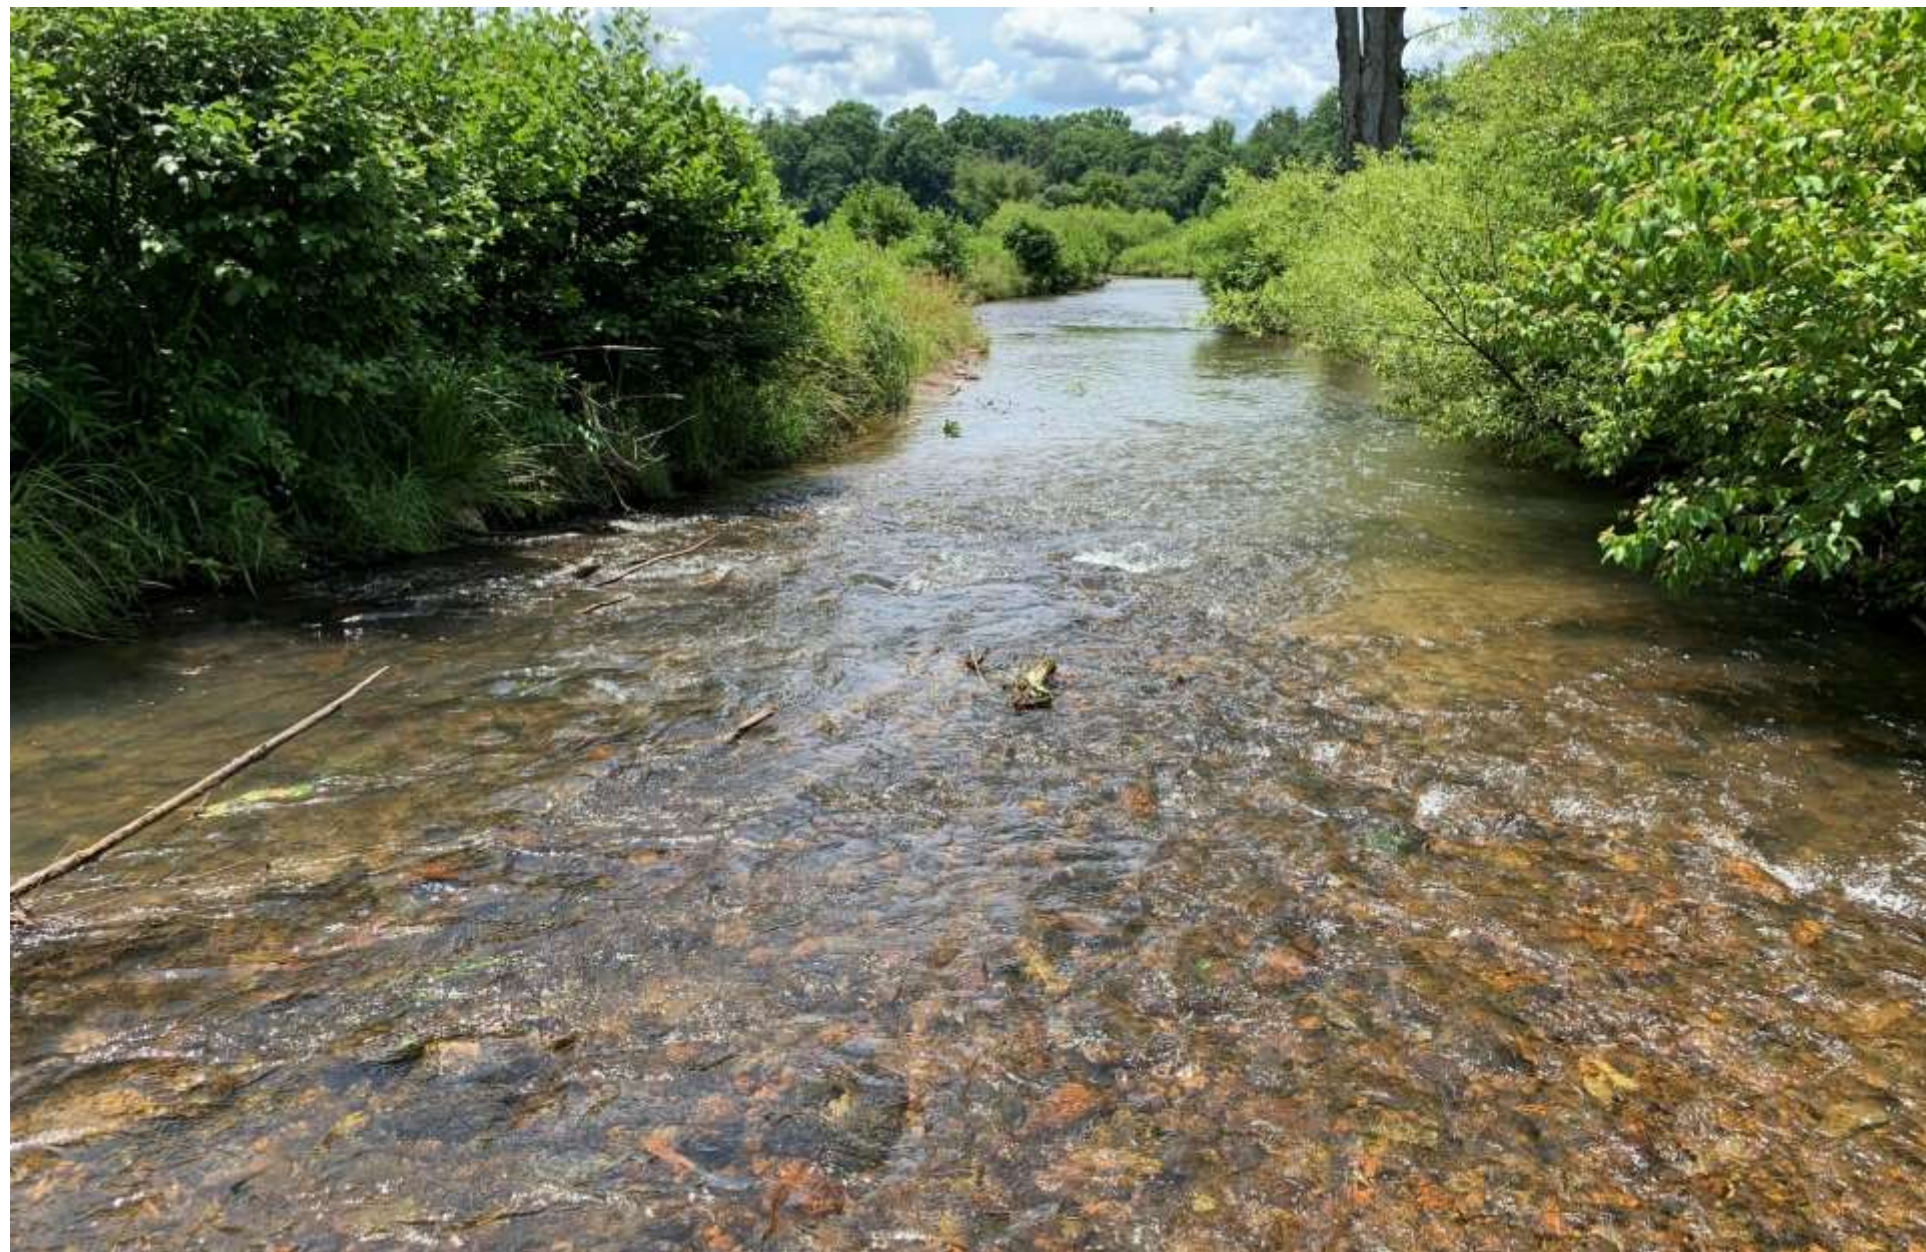
Peachtree Creek

- June 2022
- 4.5 years after completion
- Incoming sediment has buried some of the structures at the upstream end of the site

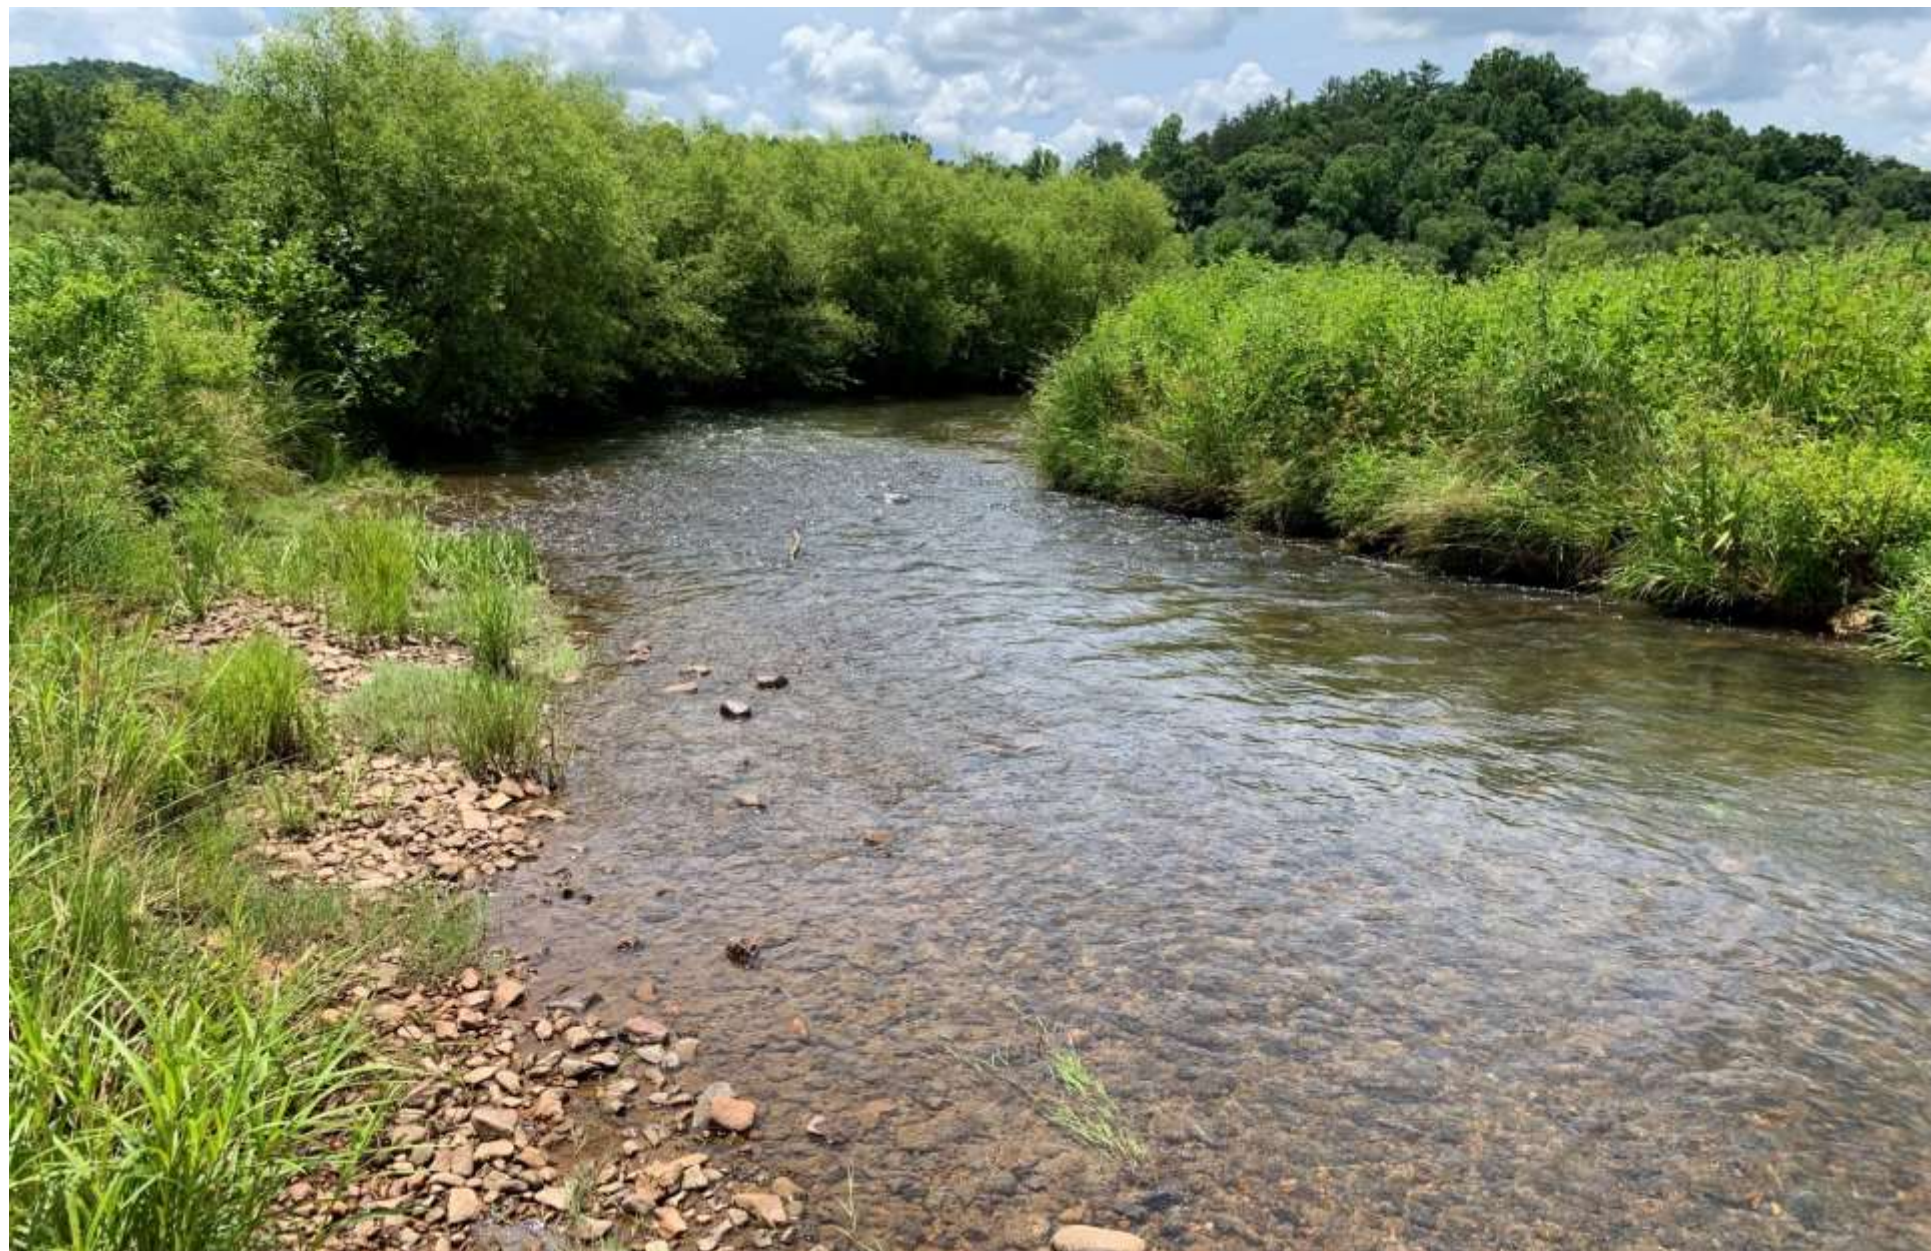
Peachtree Creek

- June 2022
- Another structure covered in bed material
- Bed facets still present

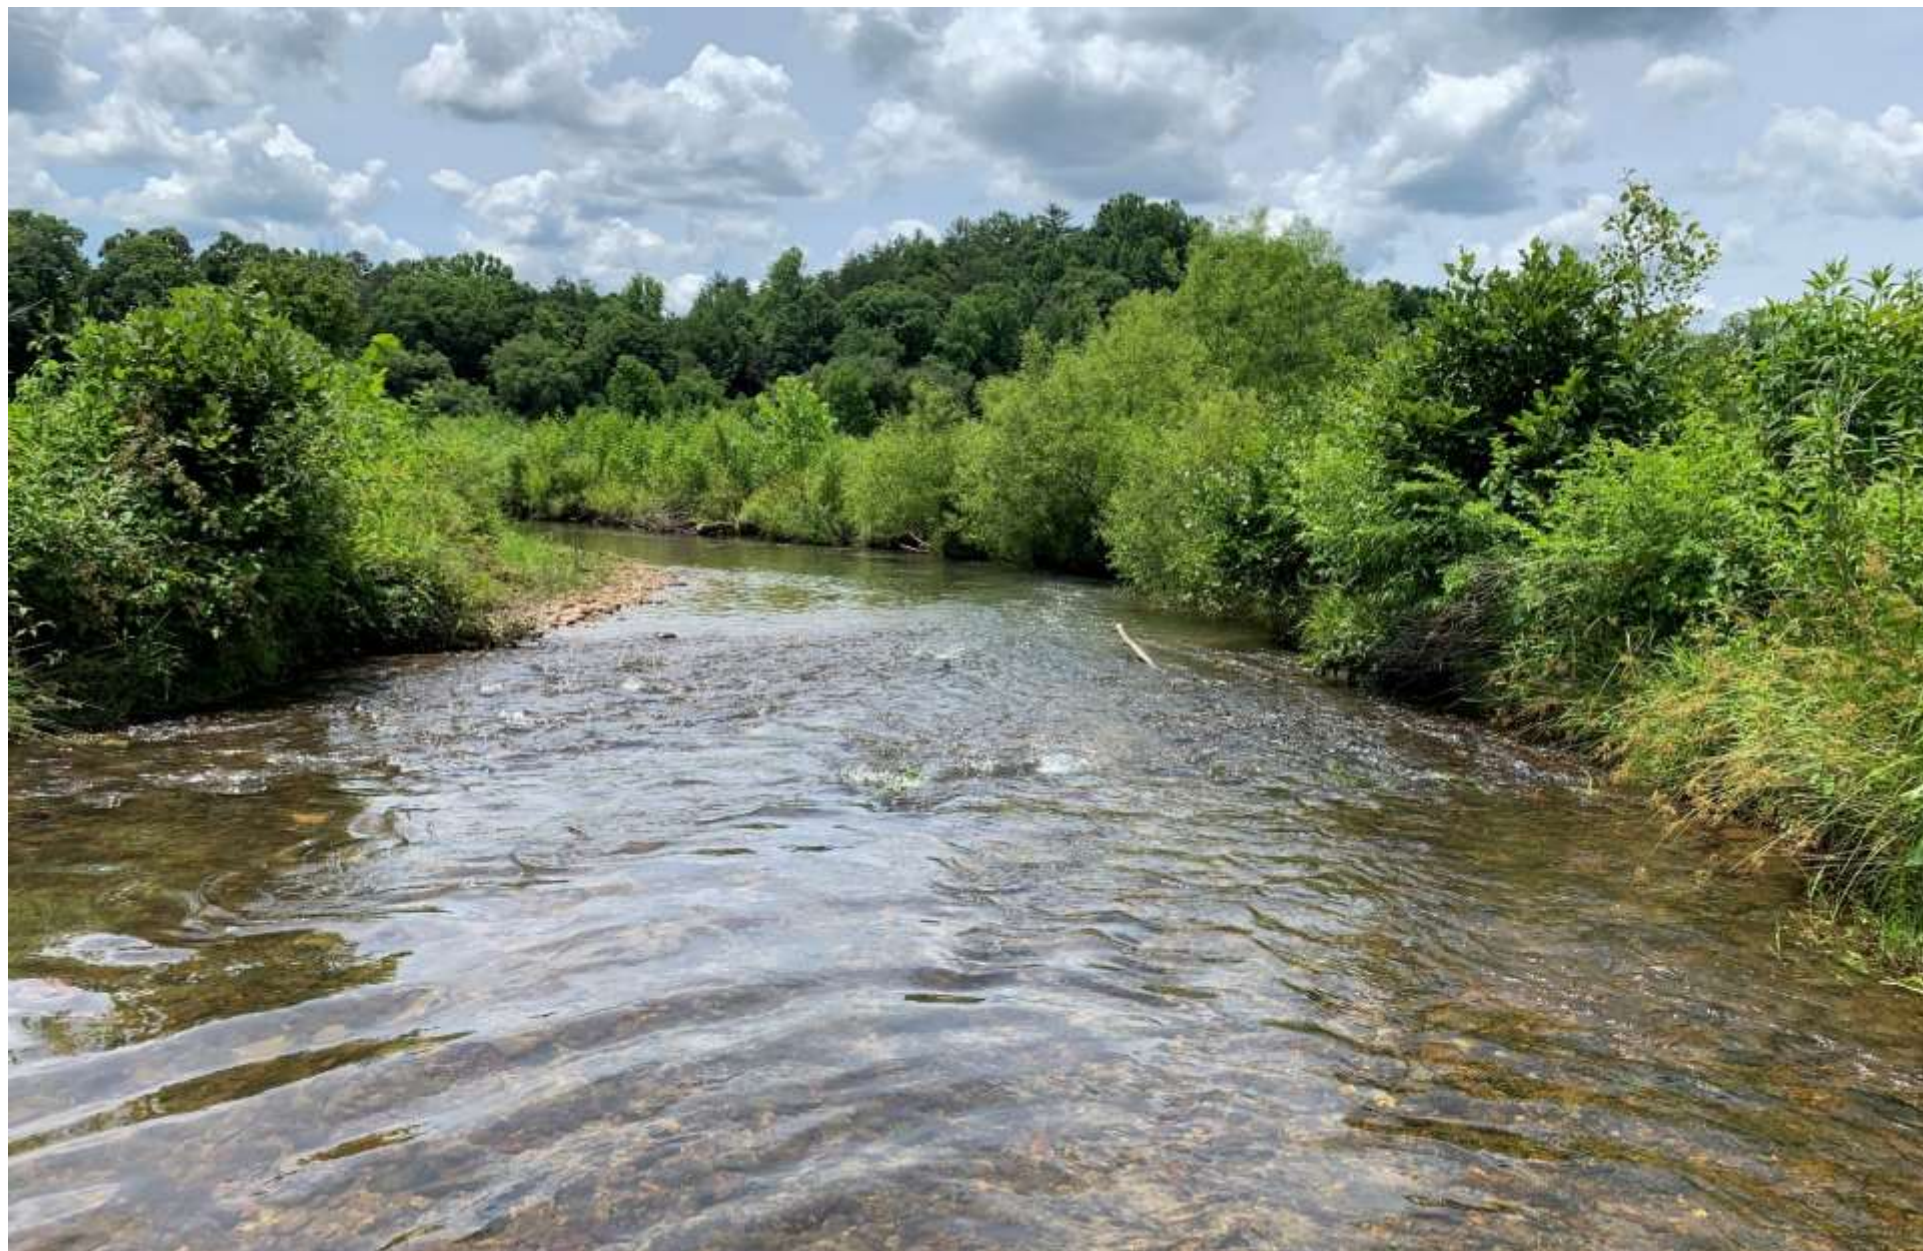
Peachtree Creek

- June 2022
- Another structure covered in bed material
- Structure is still influencing the collection and centralizing of flow vectors
- Naturalized bed form

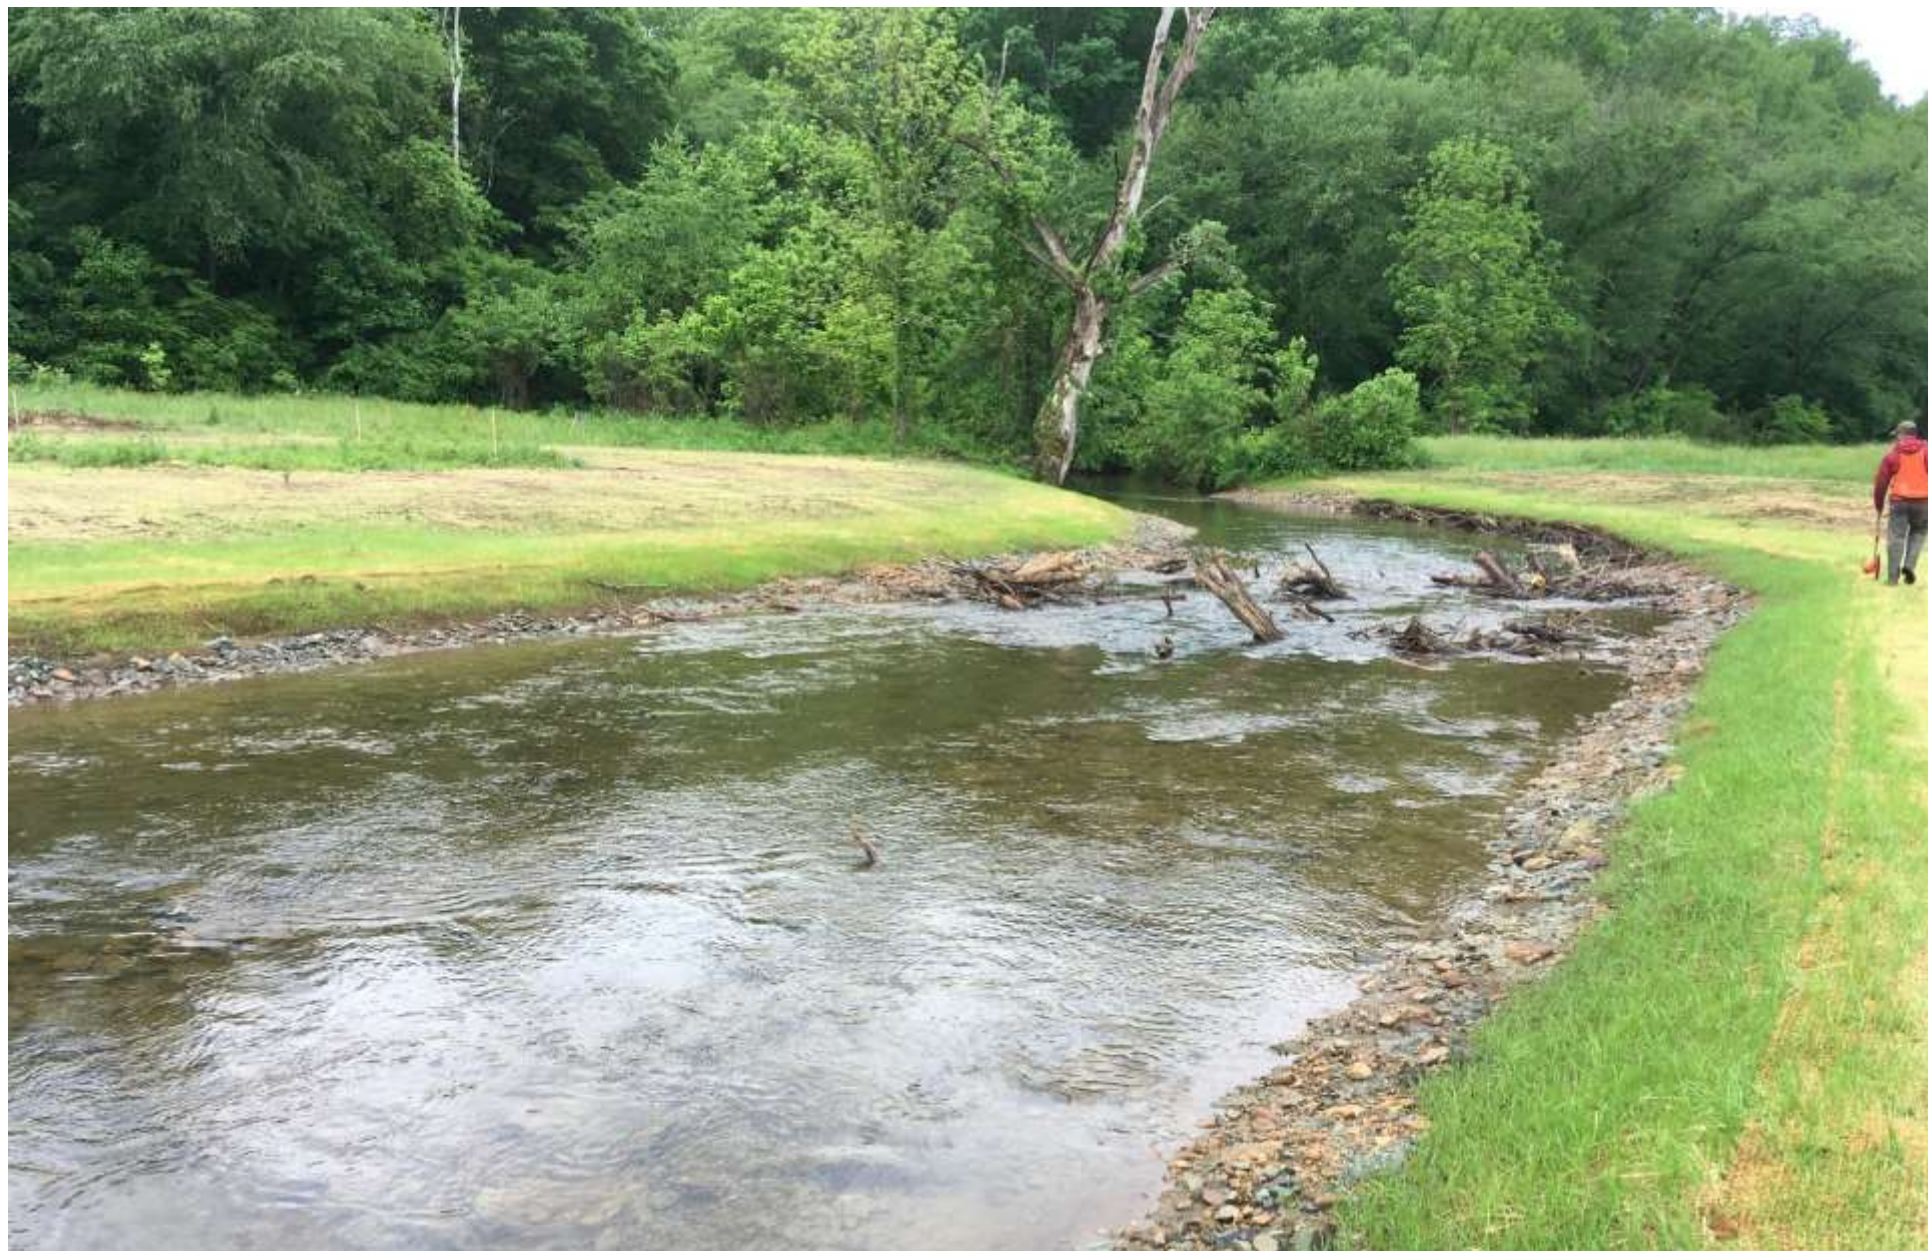
Peachtree Creek

- February 2018
- Structure at downstream end of site following construction
- Larger material included in composition

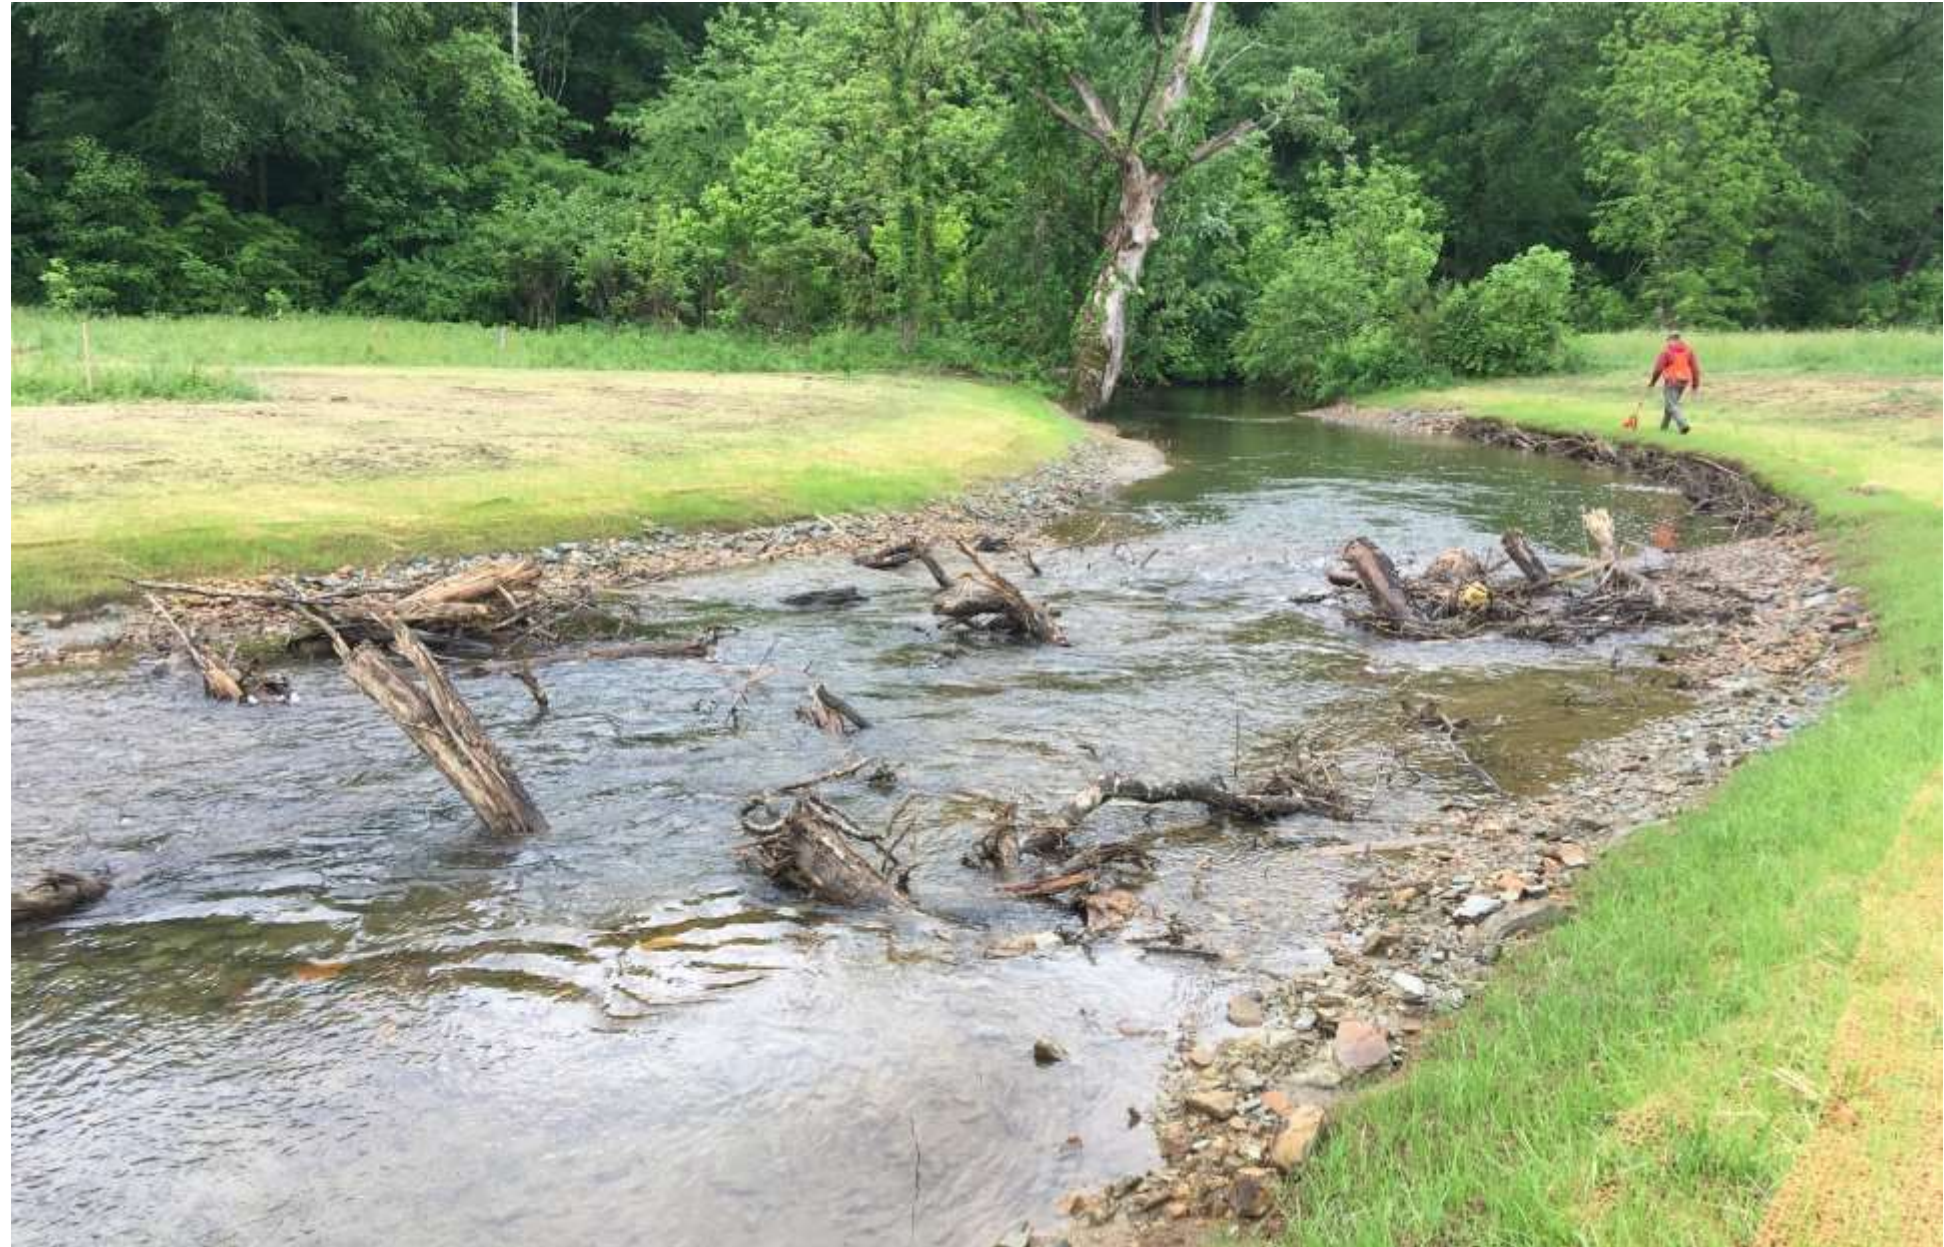
Peachtree Creek

- February 2018
- Closer view of same structure
- Large protruding pieces were cut down to water surface after this photo

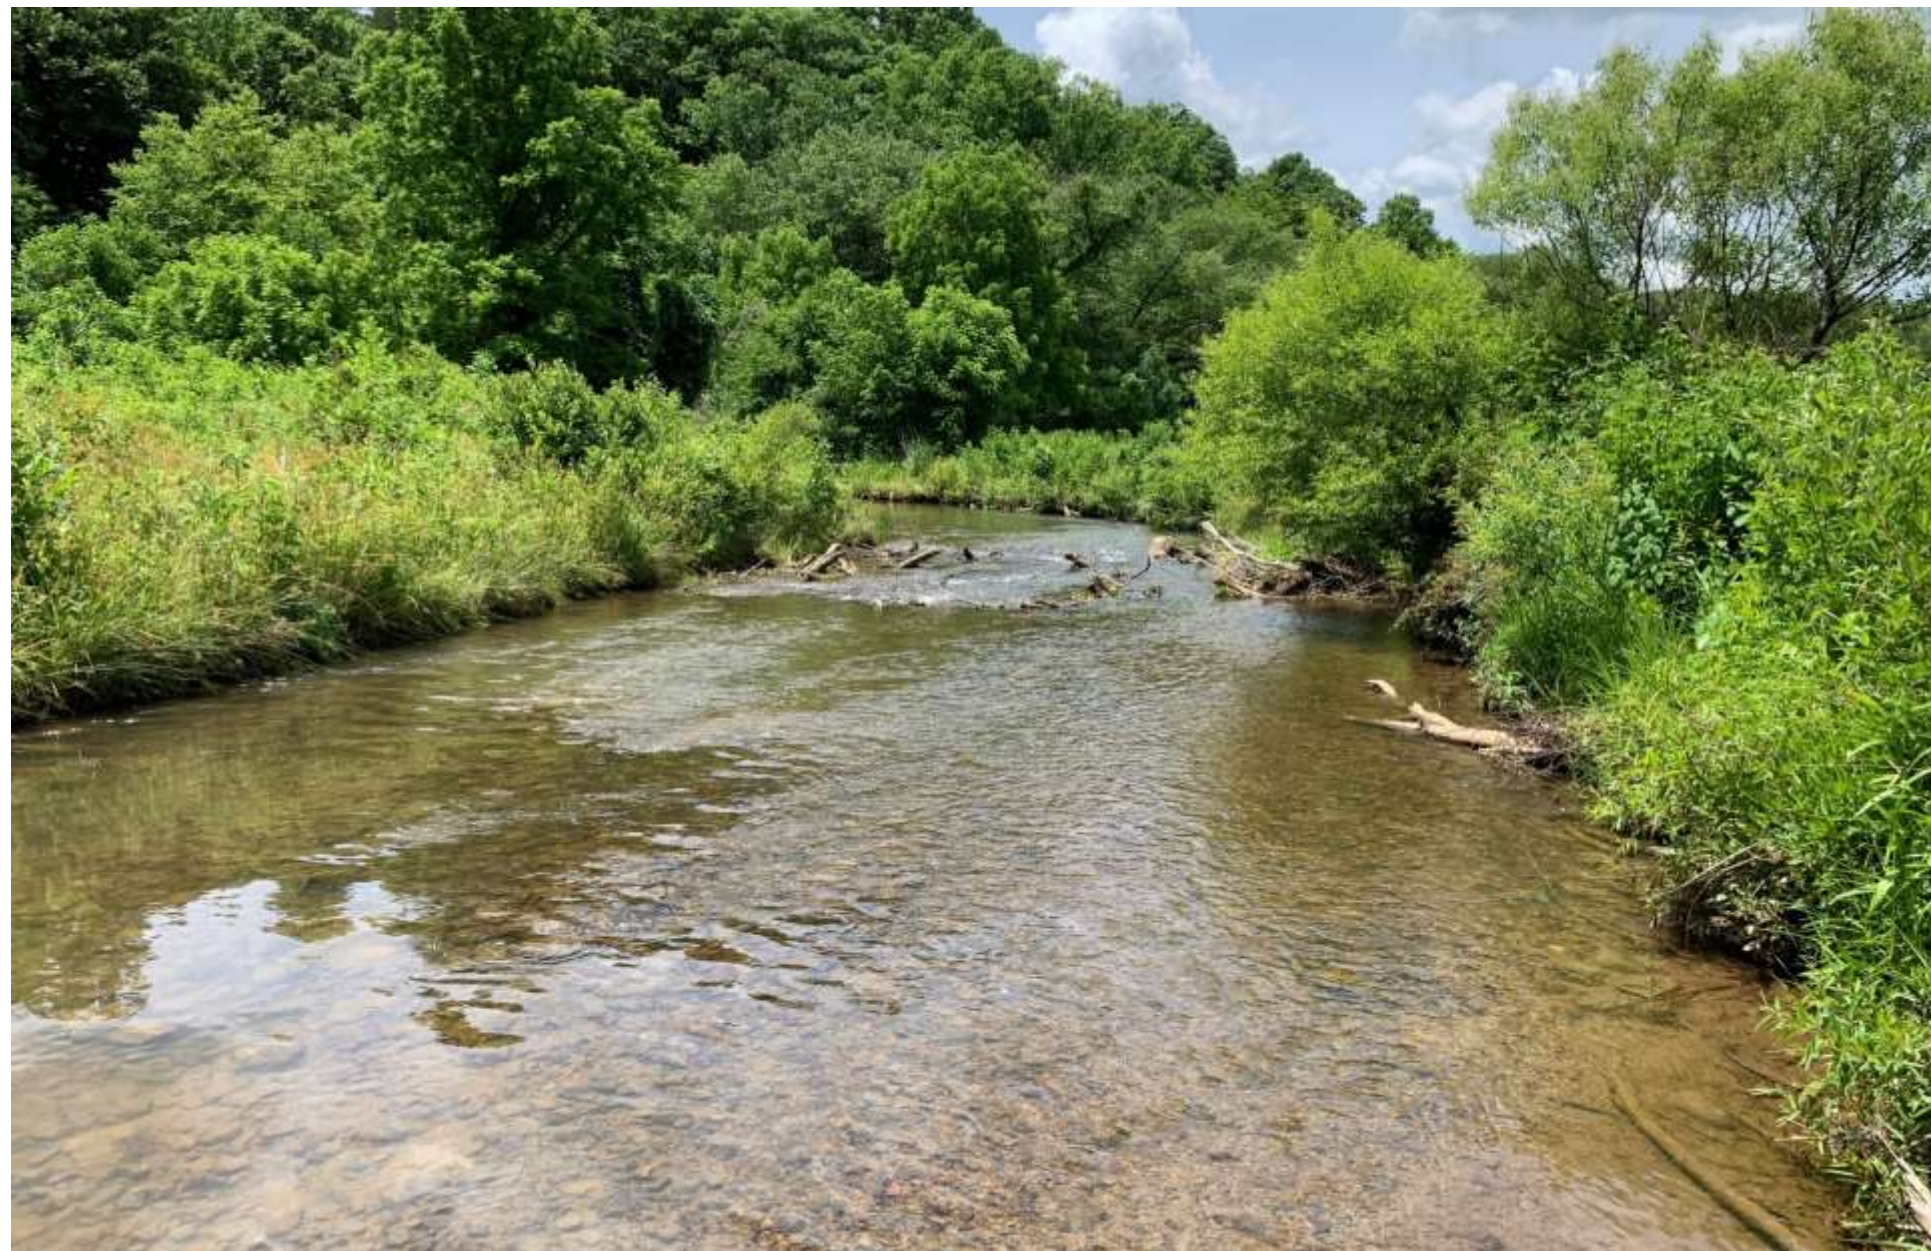
Peachtree Creek

- June 2022
- Same structure 4.5 years later

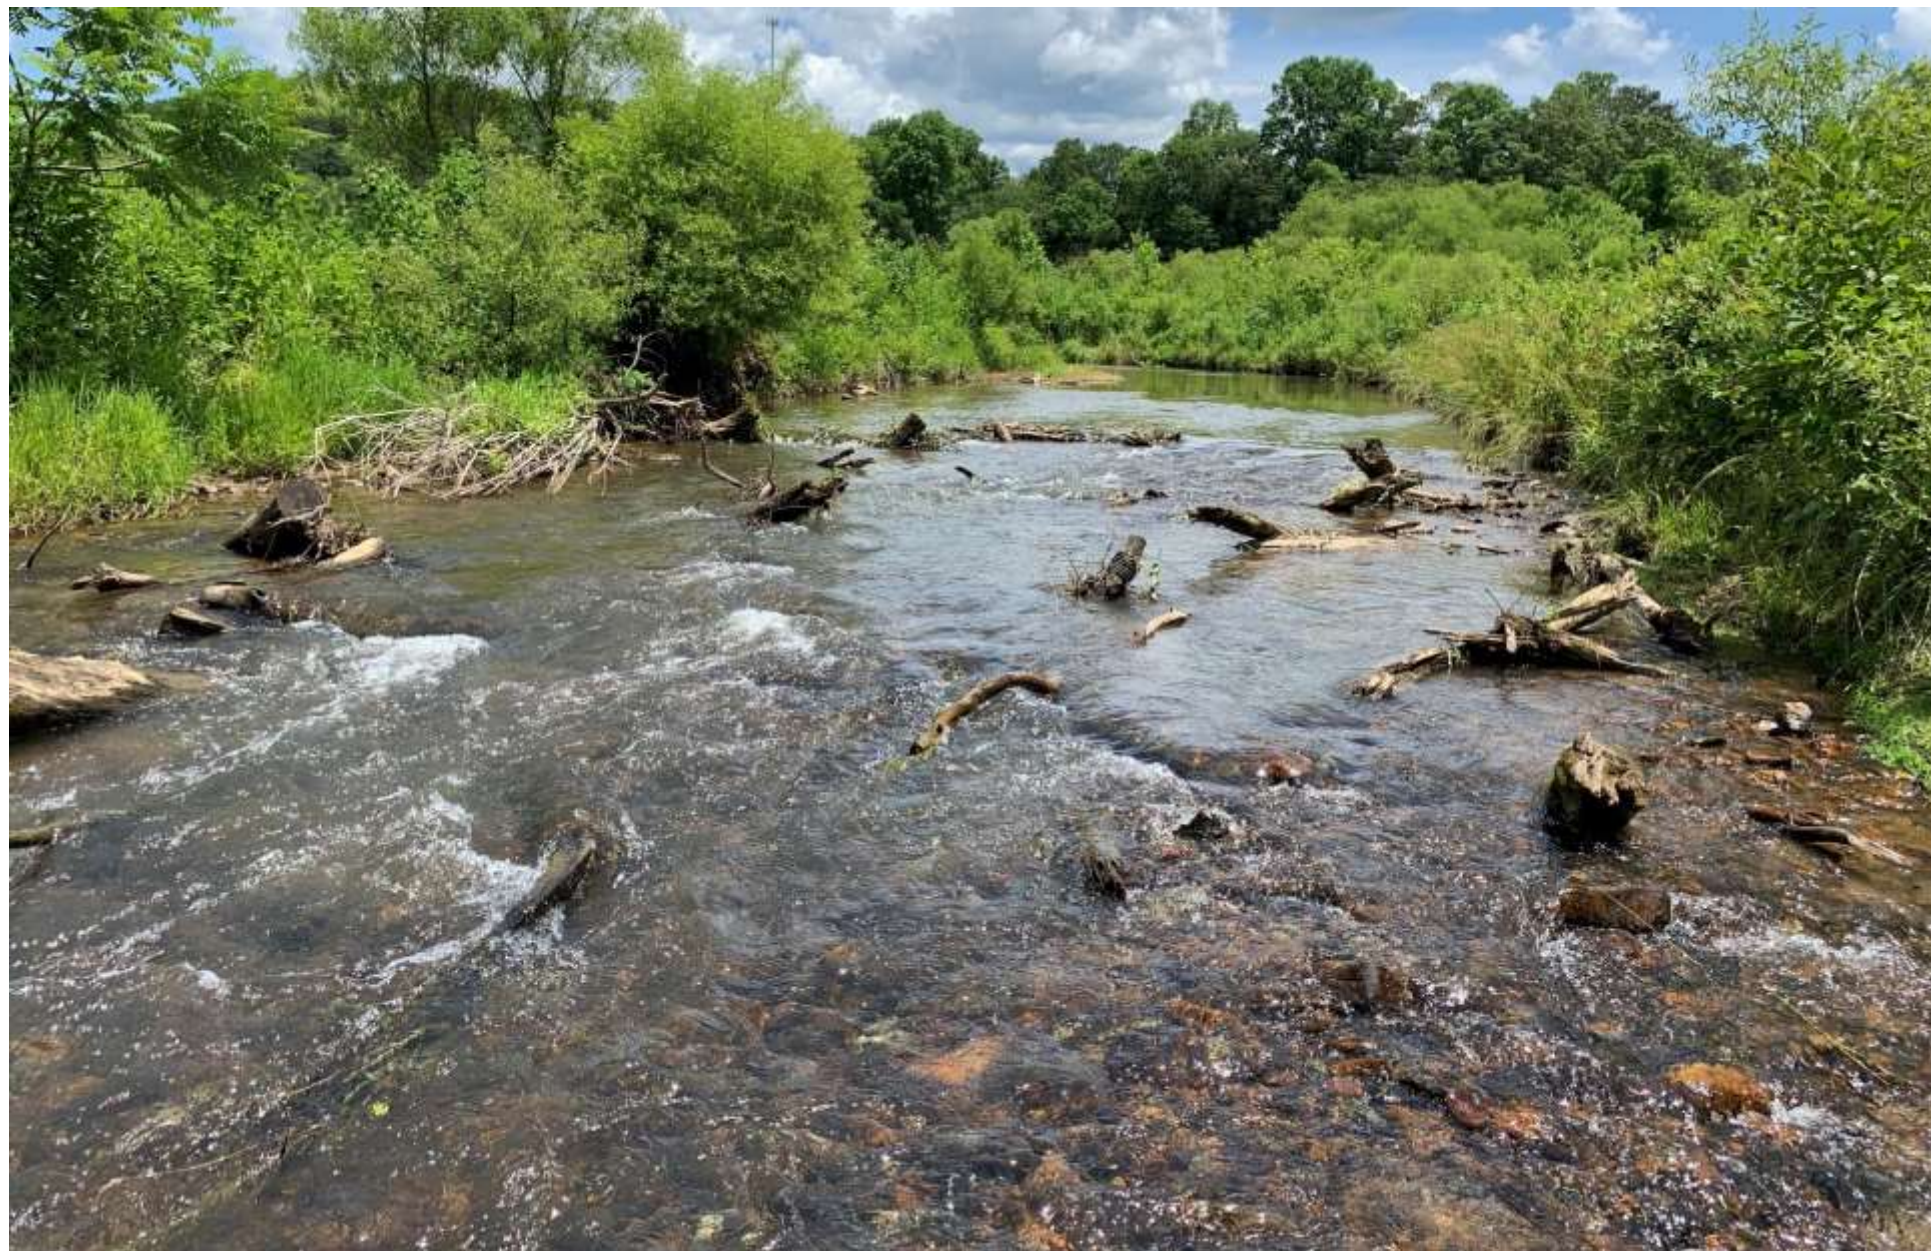
Peachtree Creek

- June 2022
- 4.5 years after completion
- Structure is still very pronounced
- All three facets still expressed
- Faster central flow and slower flow near the banks
