Subgrade Structures in Restoration Design

Presented by:
Grant Ginn, PE, Senior Principal/River Engineer

National Stream Restoration Conference 2022
August 2, 2022

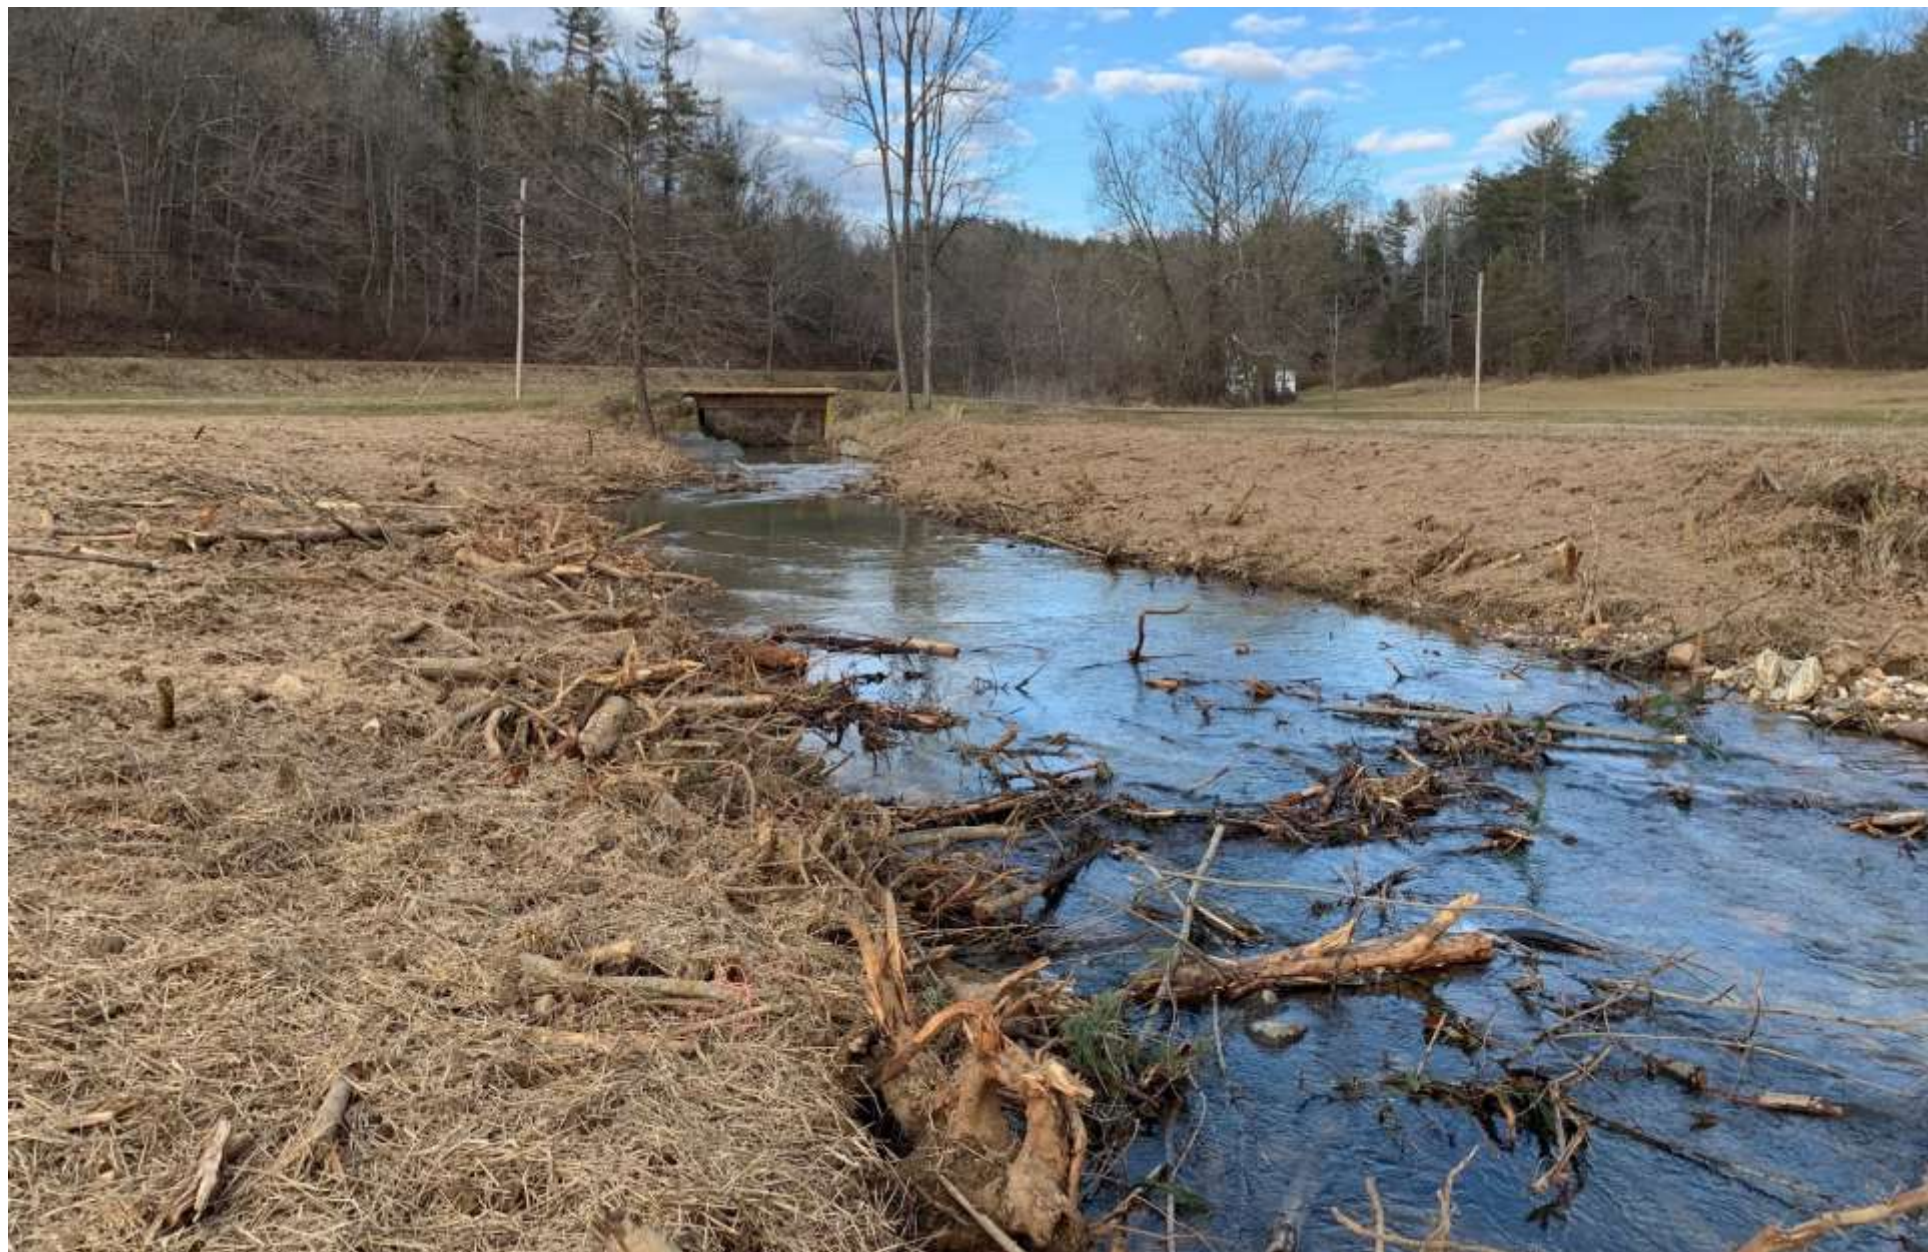
Paint Fork Creek

- Const: Jan 2021
- Site Stats:
 - DA = 14 sq. mi.
 - $W_{BKF} = 28$ ft
 - $S_{AVG} = 0.3\%$
 - W/D = 17
- Brush pack material carried to top of bank and to the back of the bench
- No coir matting bank protection

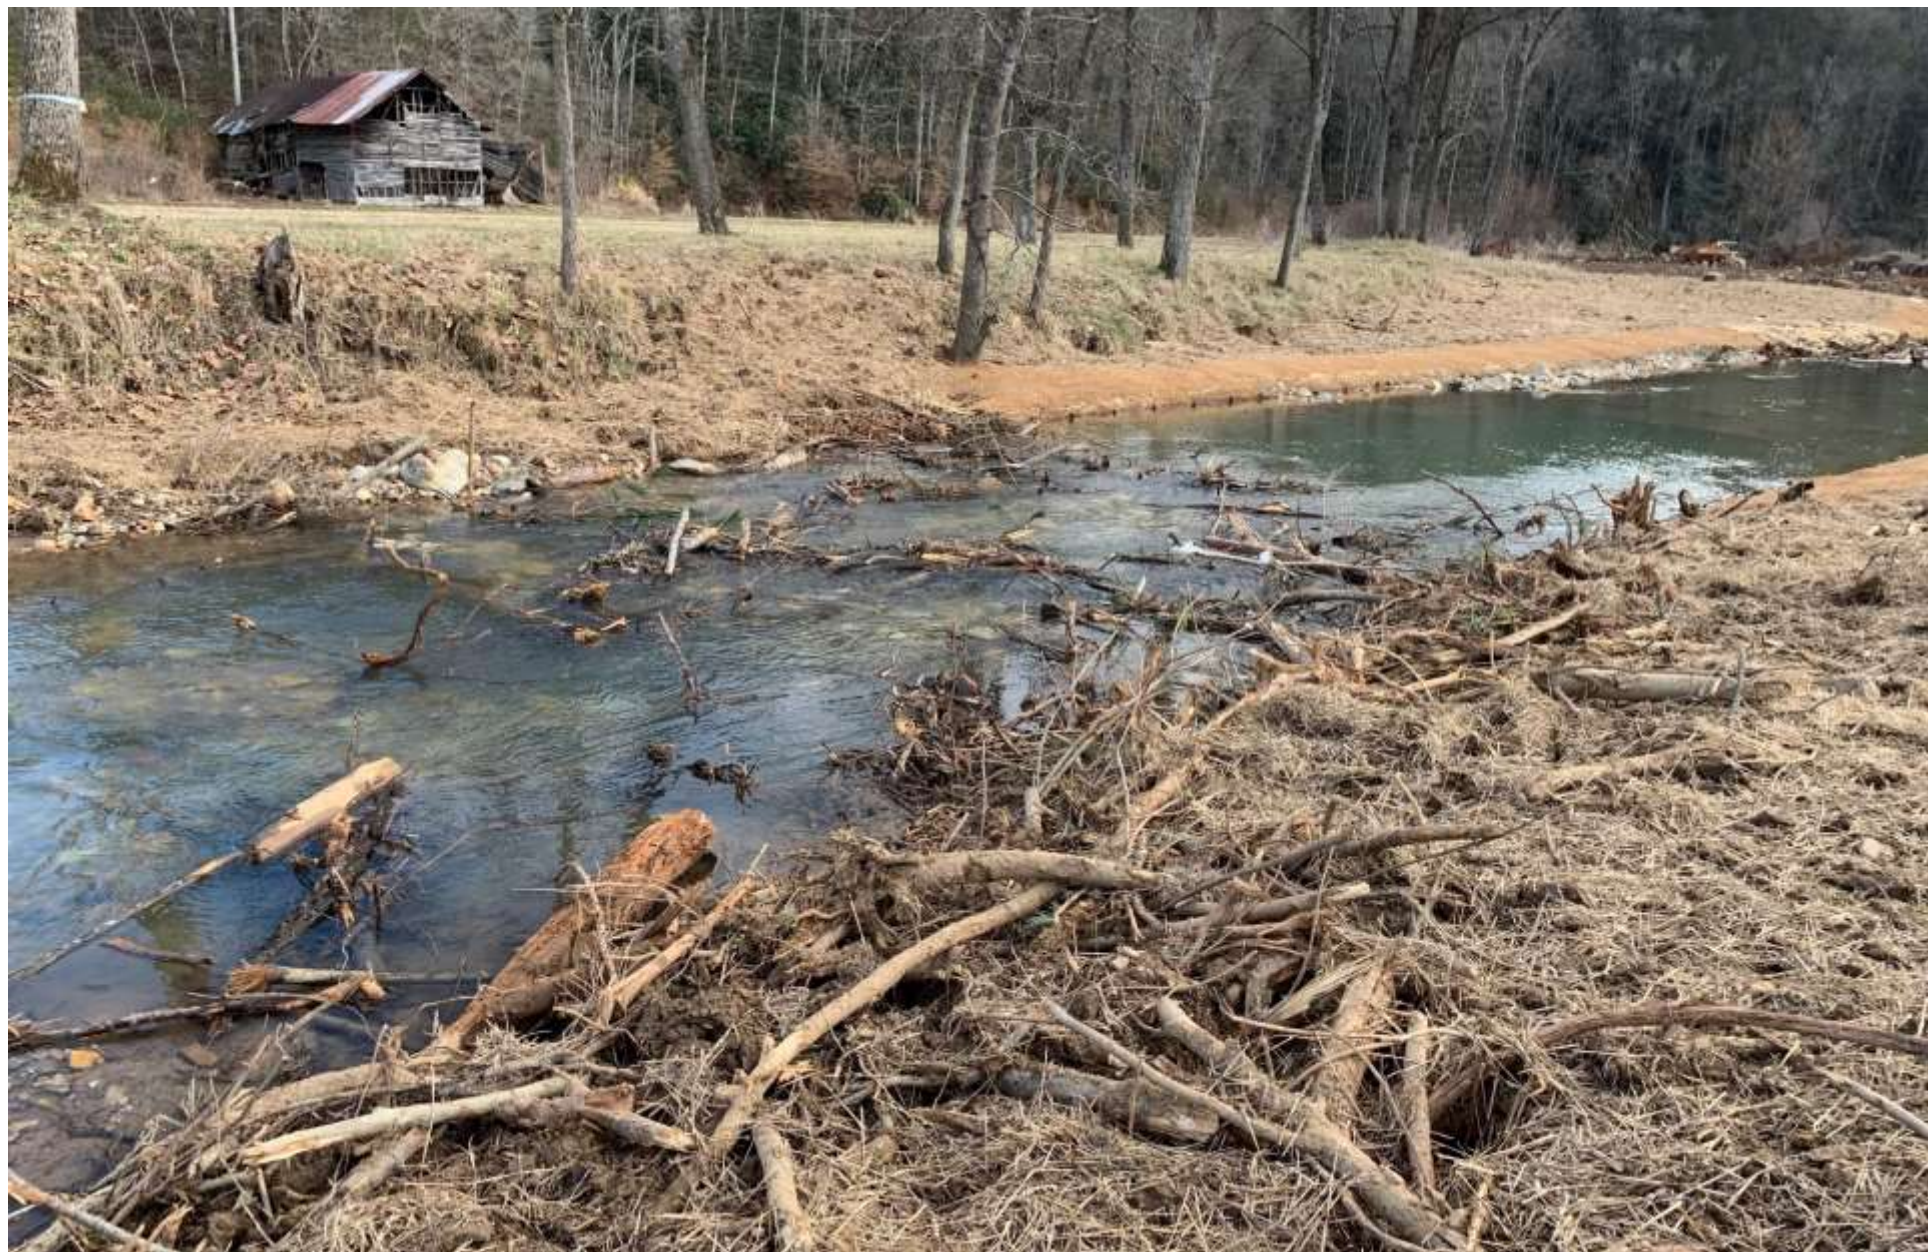
Paint Fork Creek

- February 2021
- Brush pack material installed to the back of the bench
- Coir matting bank protection downstream of structure

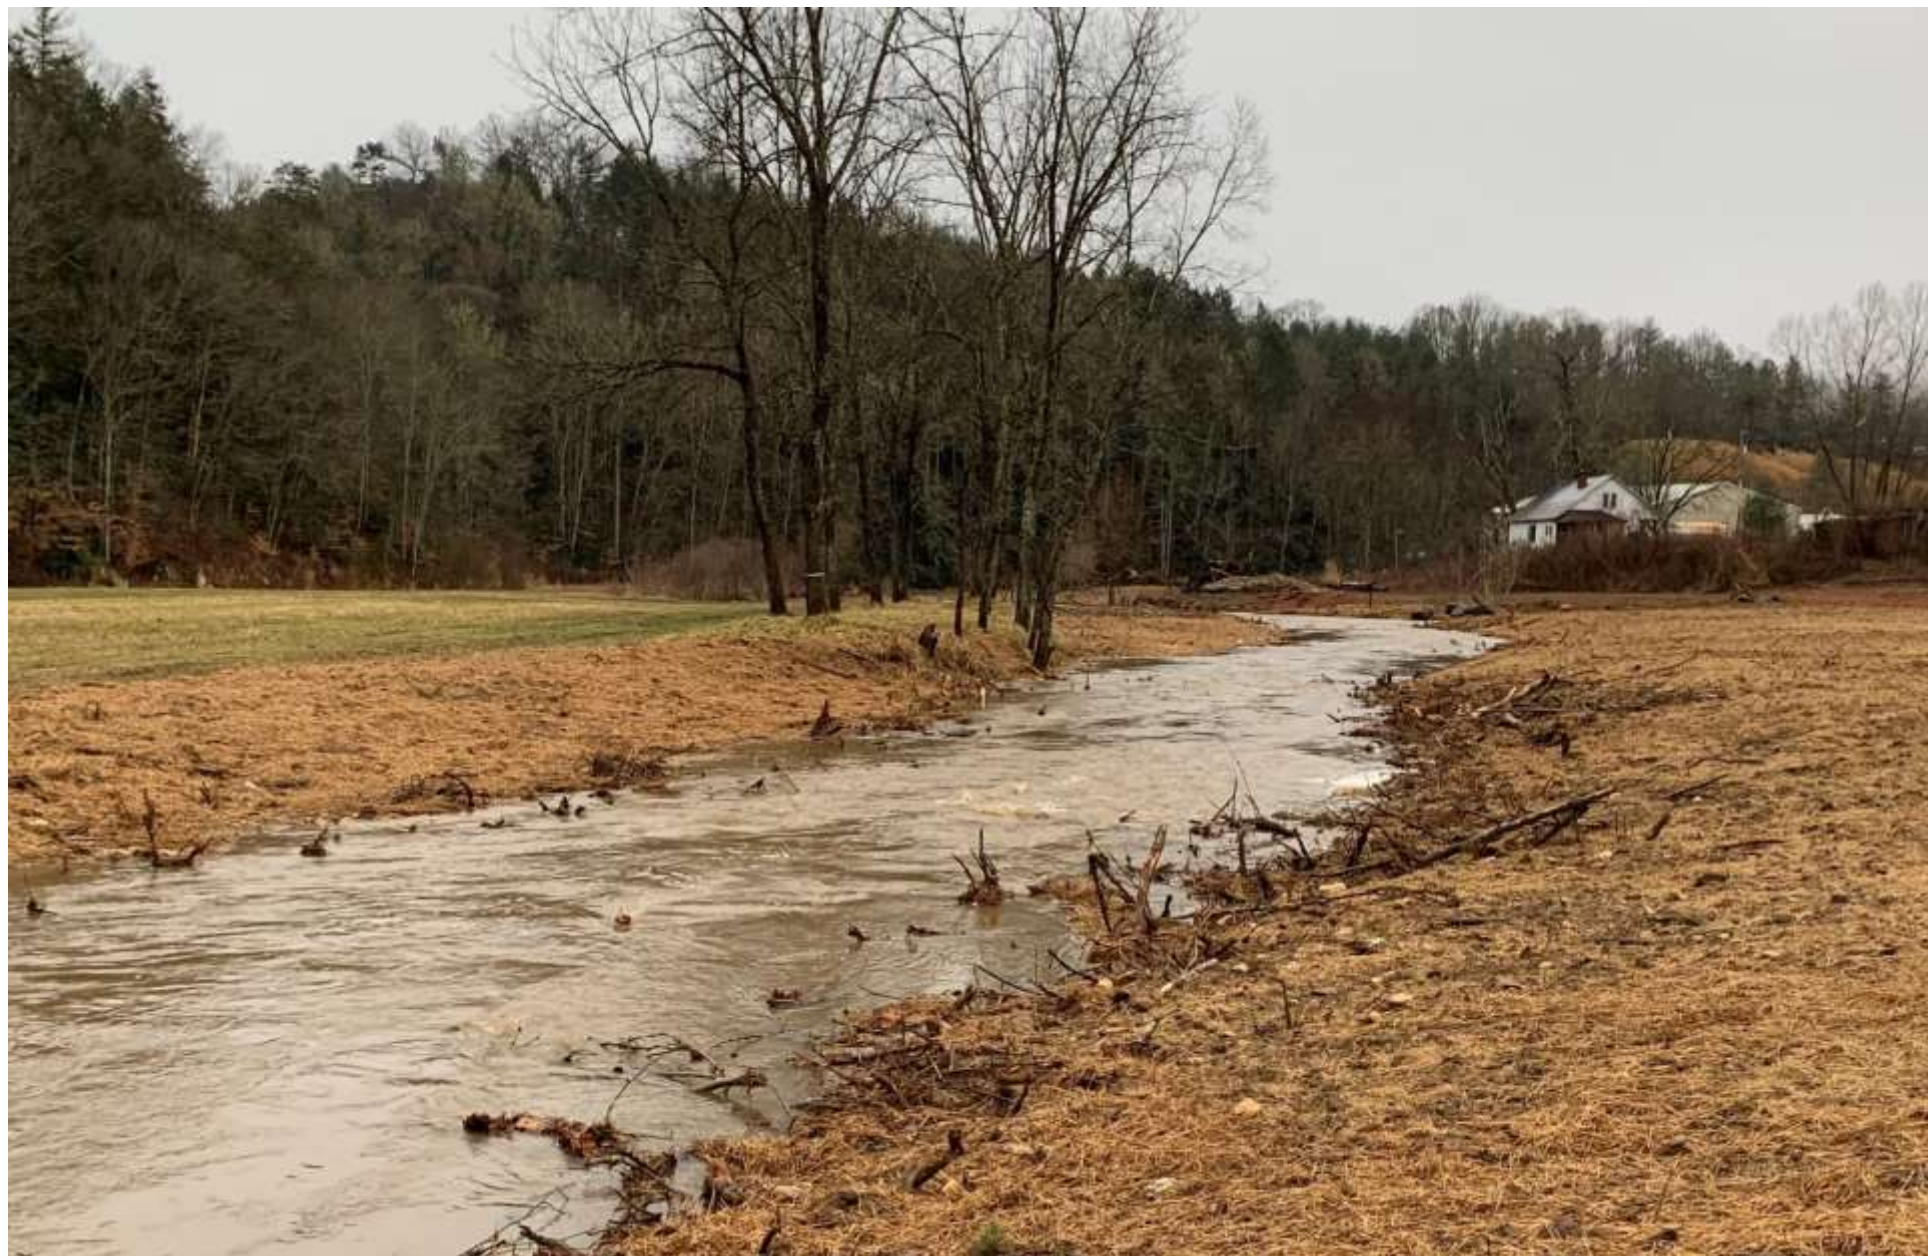
Paint Fork Creek

- February 2021
- Over-bankfull event during construction
- Faster central flow
- Slower flow along the rough bank margin

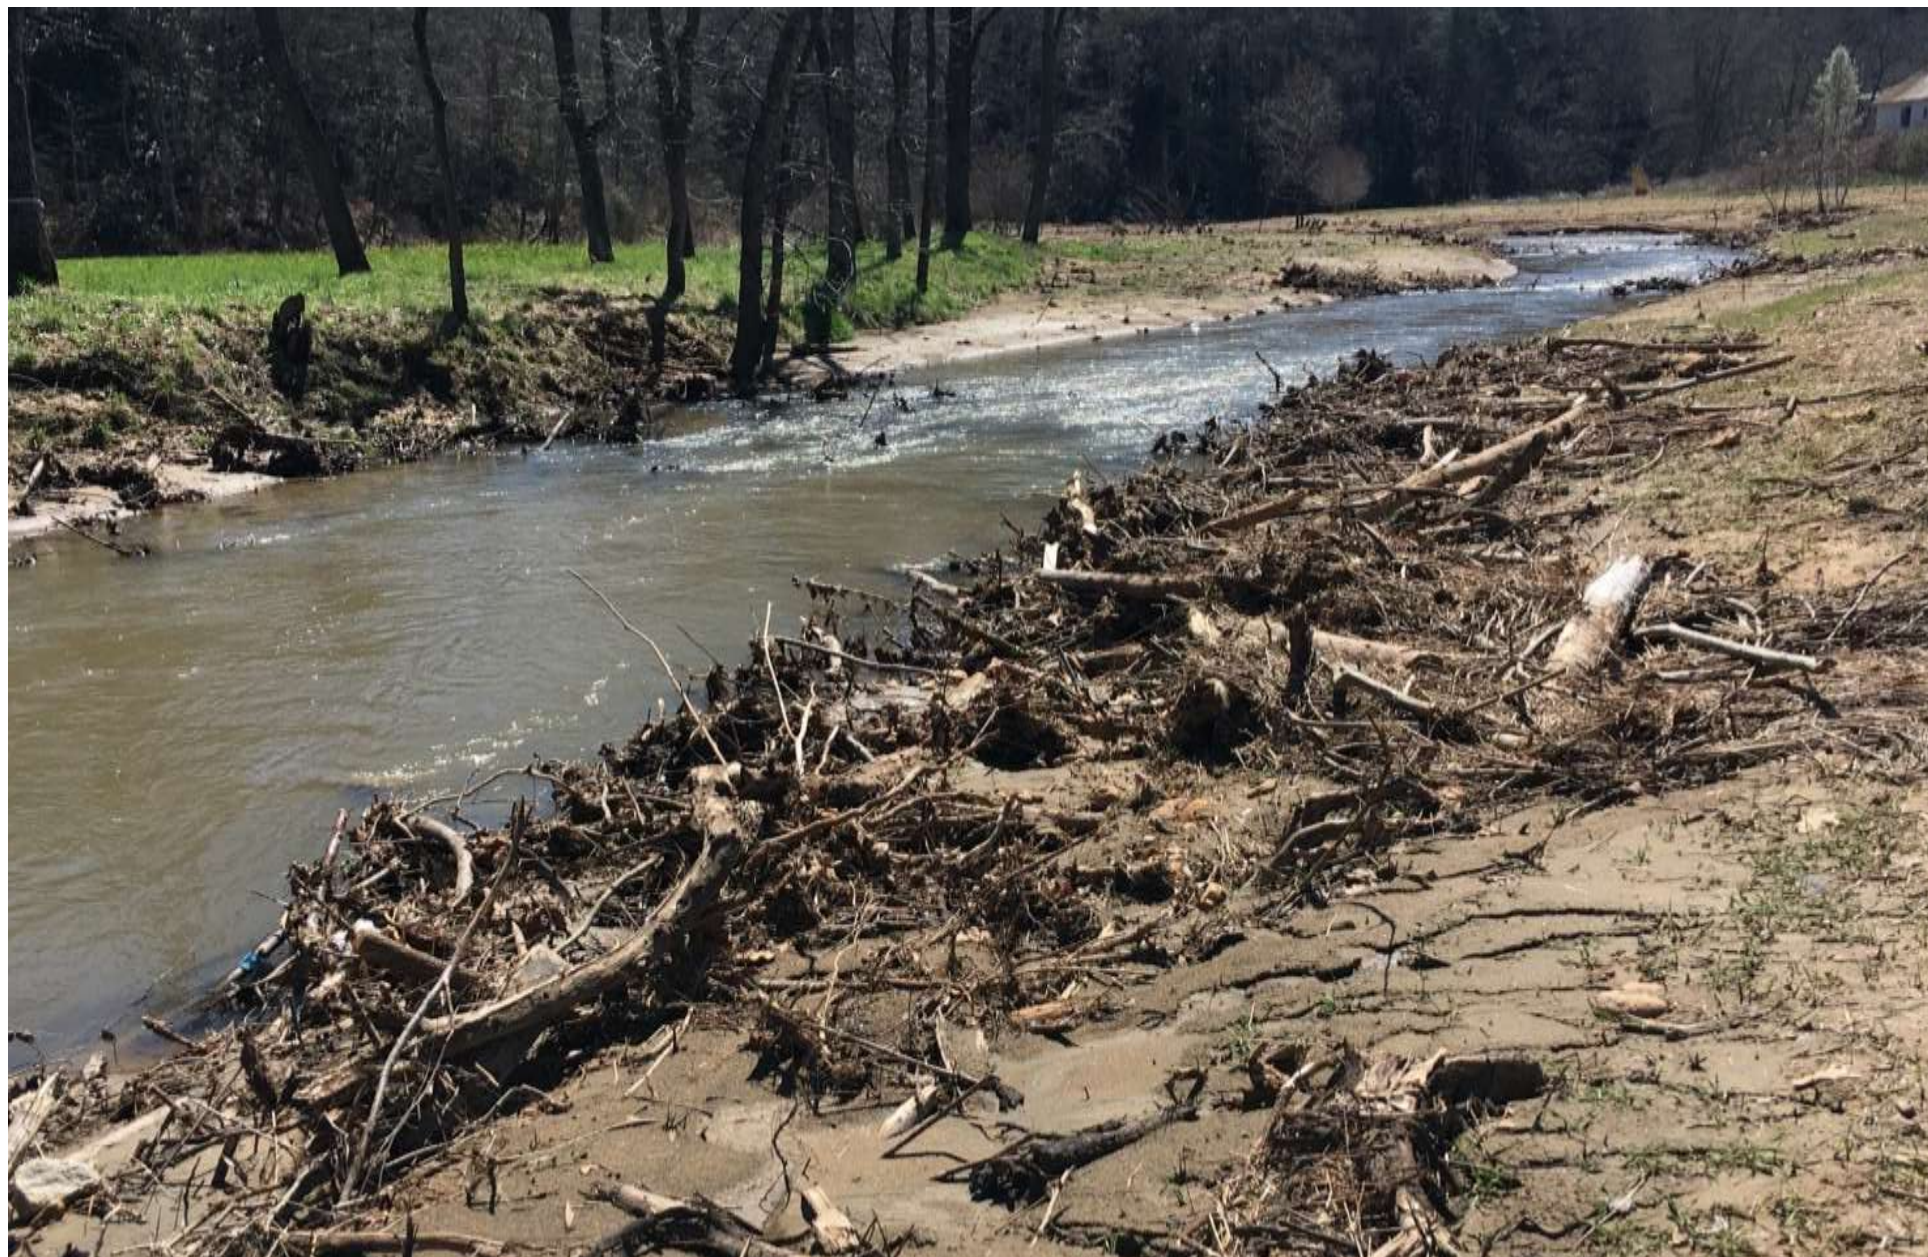
Paint Fork Creek

- March 2021
- Following over-bank event
- Deposition in the brush-packed bank material

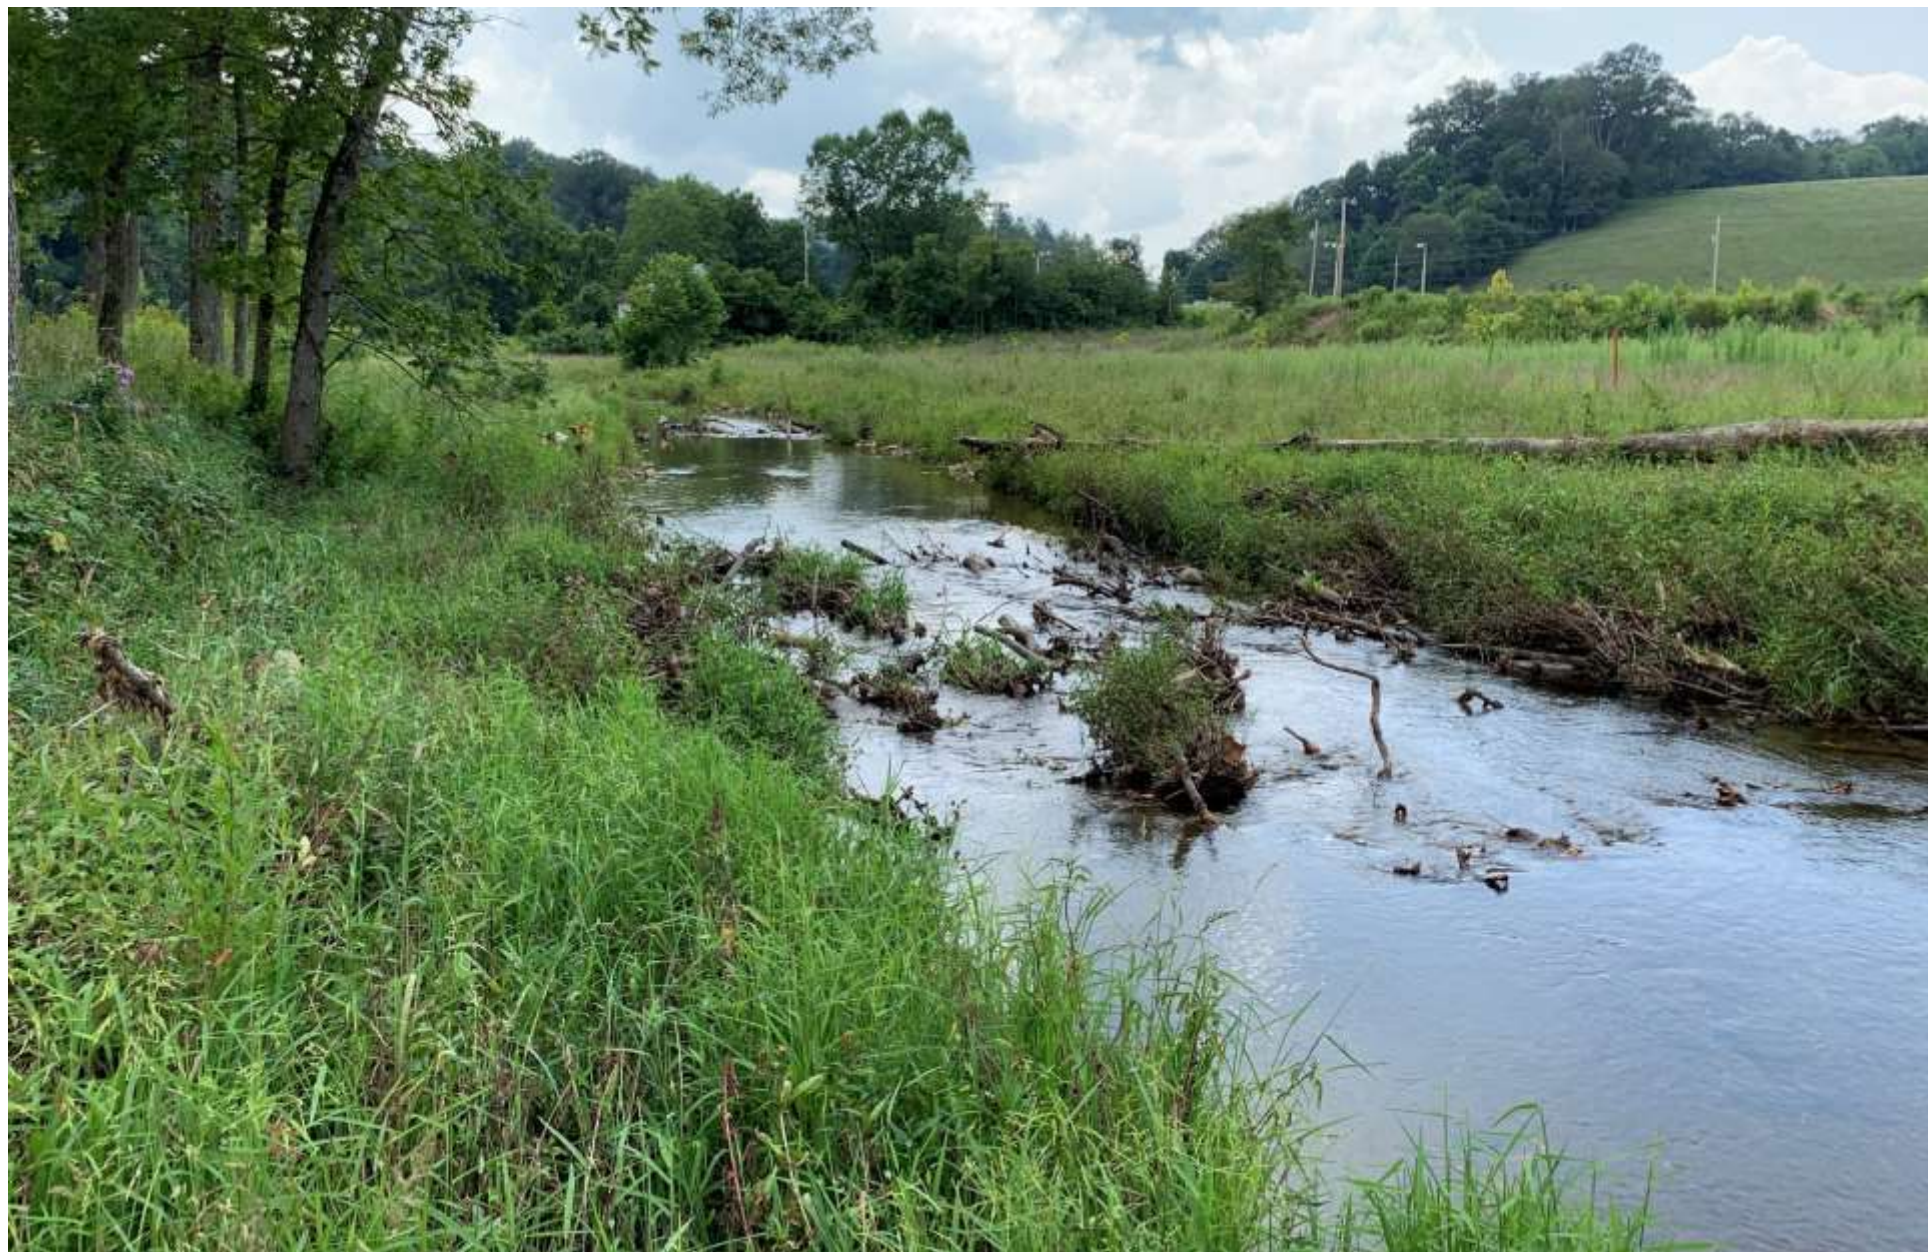
Paint Fork Creek

- August 2021
- Later the same year
- Following Hurricane Fred

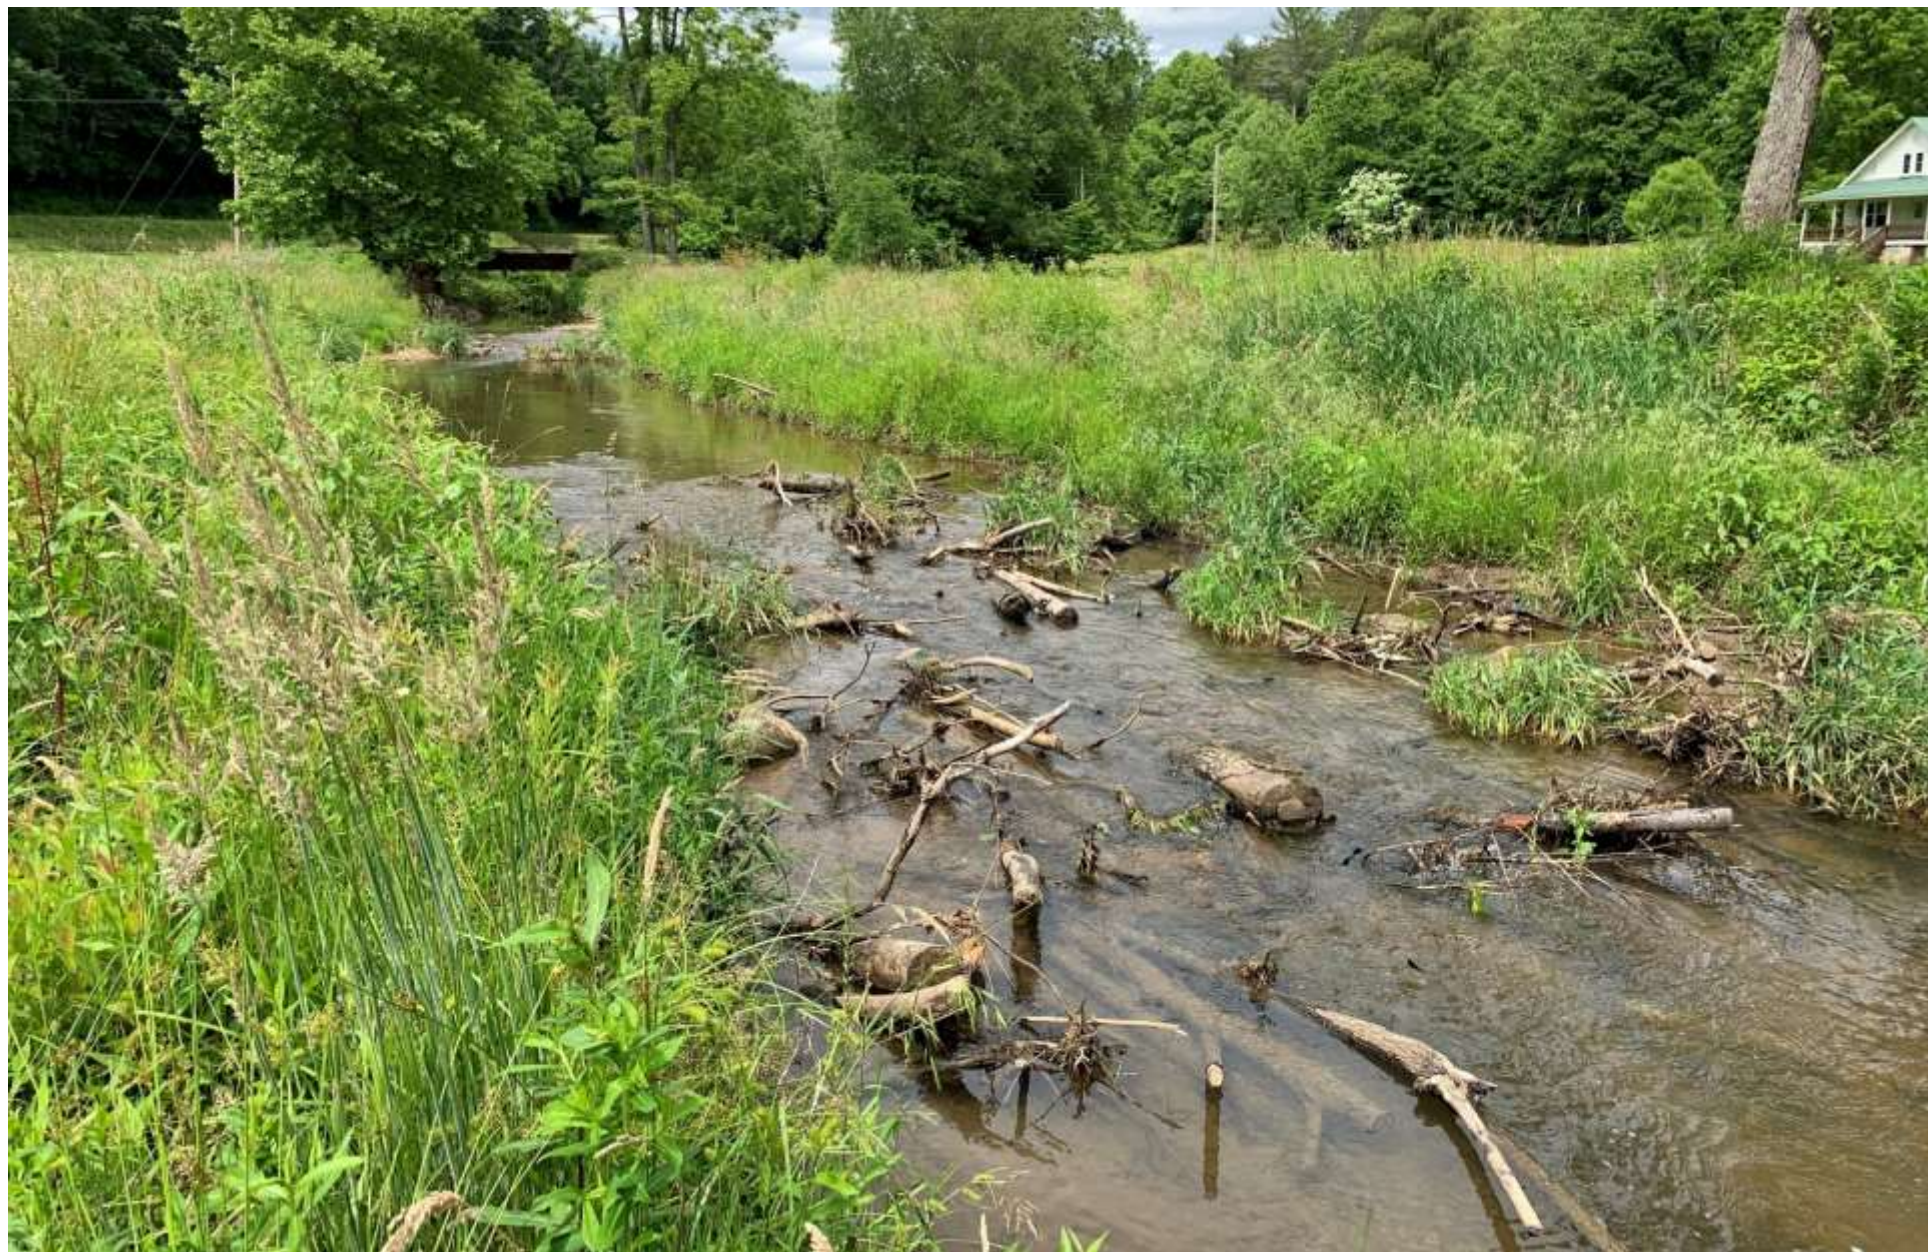
Paint Fork Creek

- June 2022
- Facing upstream
- Fully vegetated banks

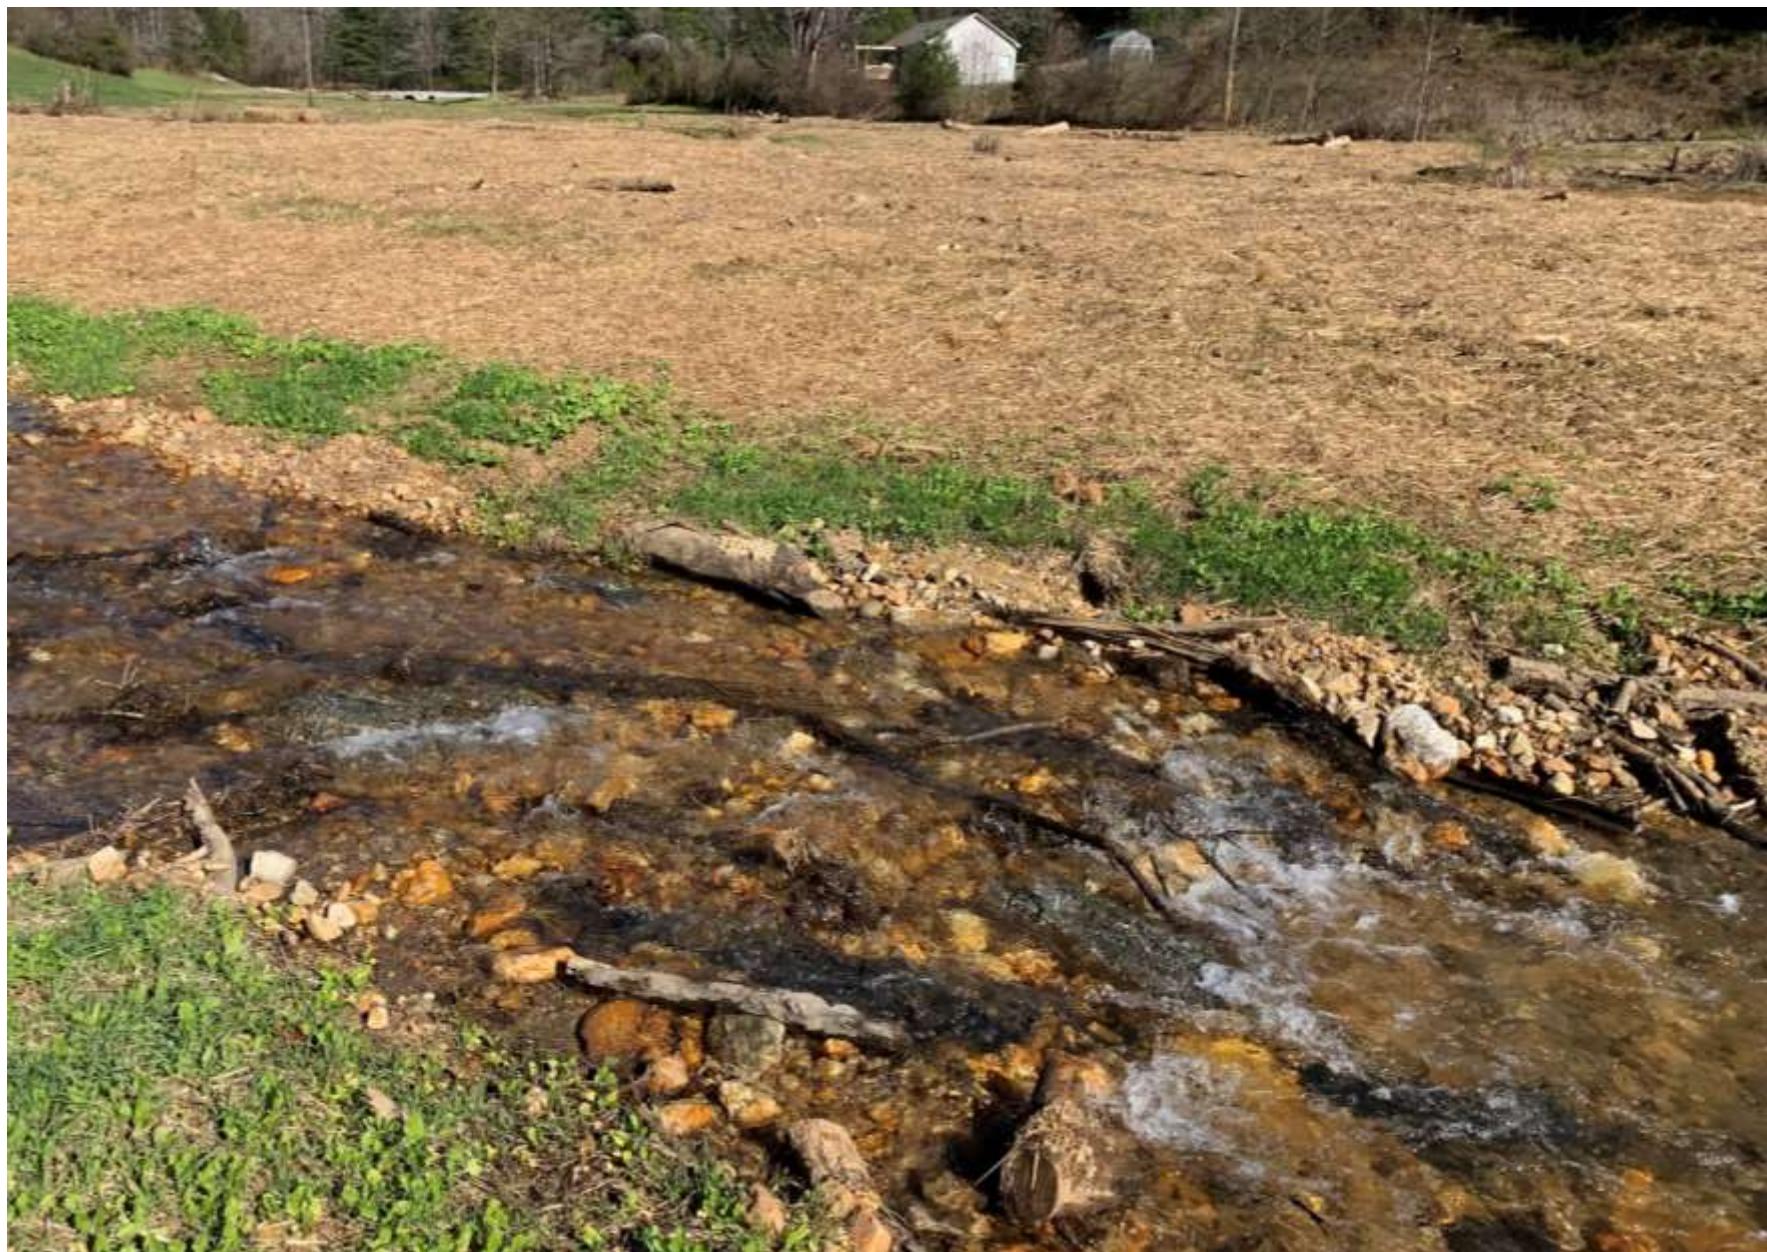
Seniard Creek

- Construction November 2020
- Site Stats:
 - DA = 1.3 sq. mi.
 - $W_{BKF} = 17.5$ ft
 - $S_{AVG} = 2\%$
 - W/D = 16
- Constructed over 3000 ft. of main channel
- Constructed 48 structures
- This structure fails two years later

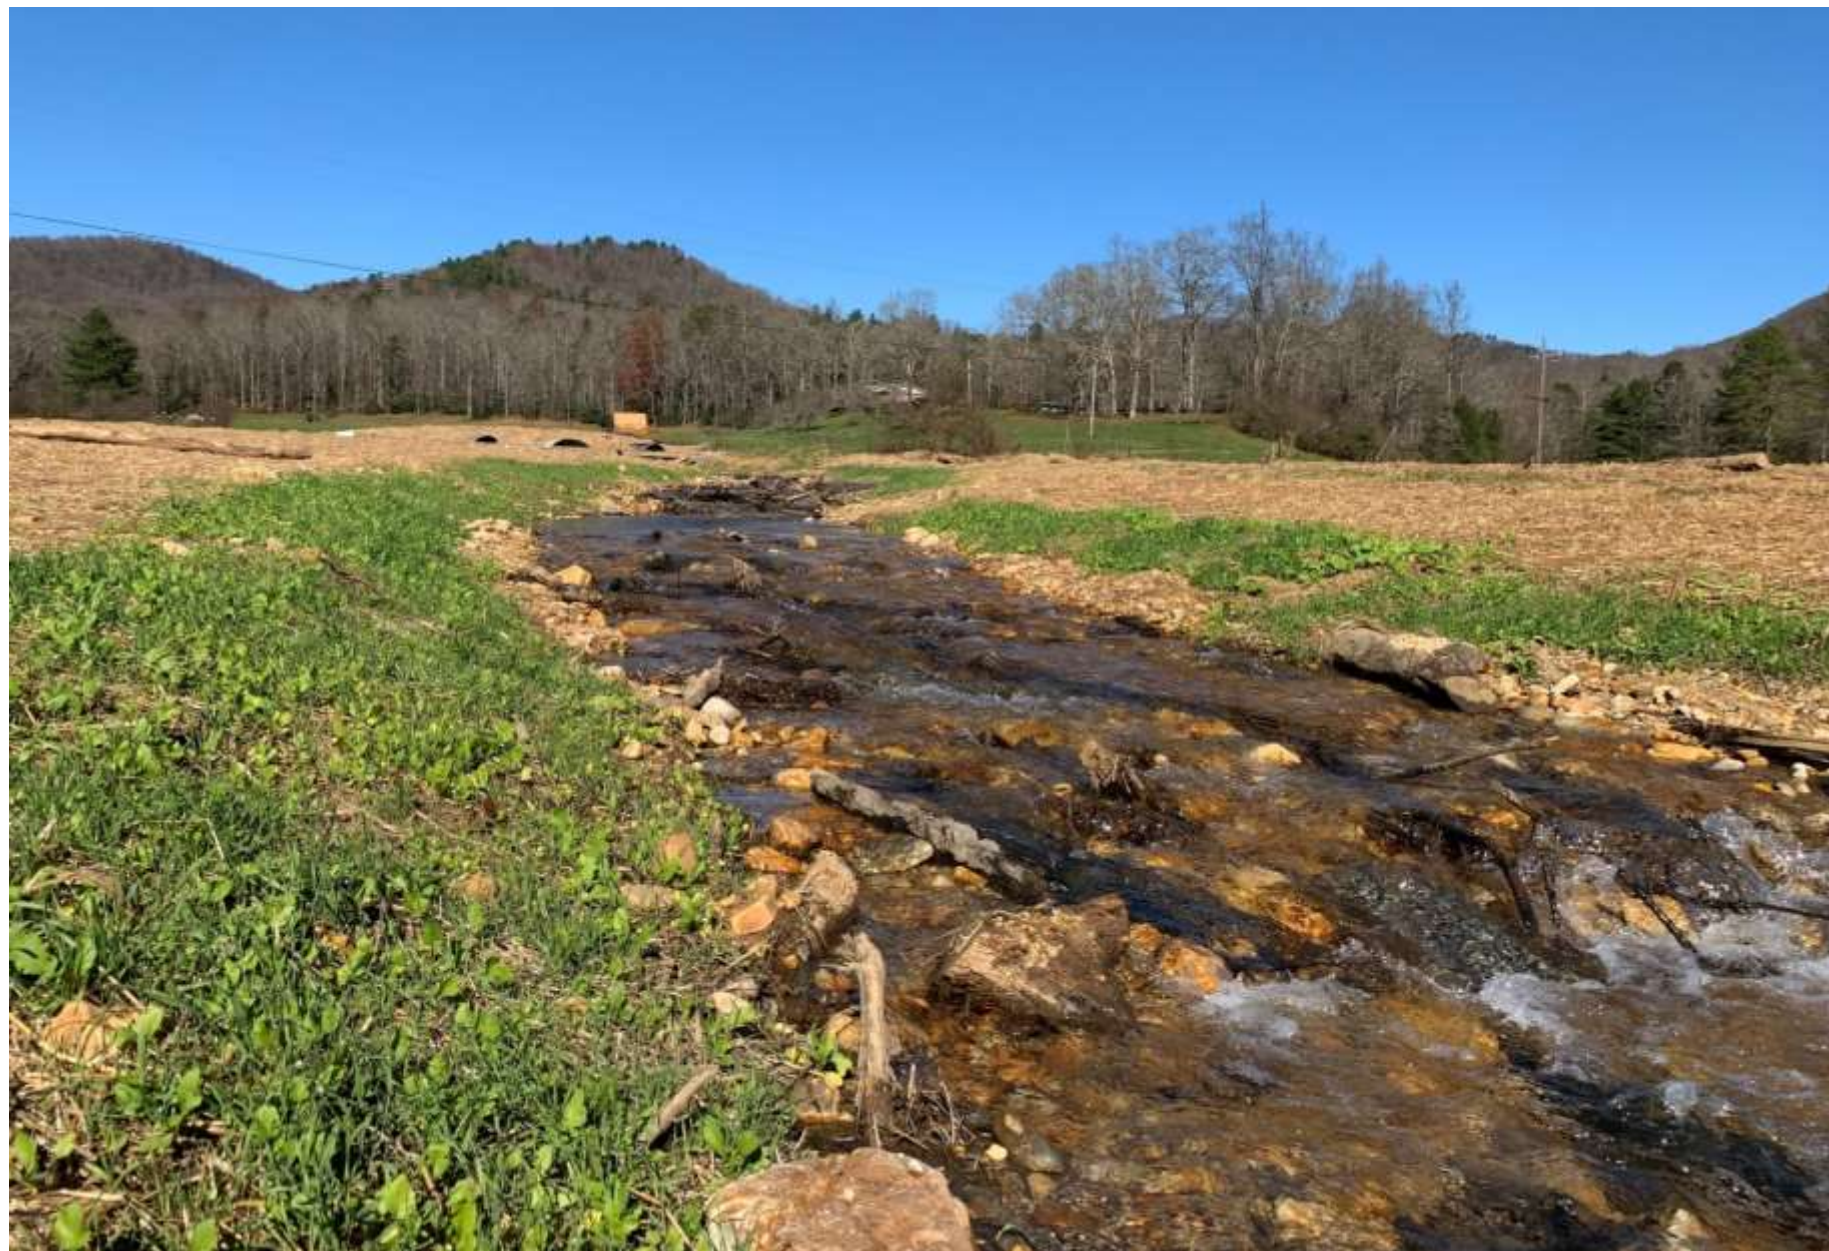
Seniard Creek

- November 2020
- Logs were placed parallel to flow
- Logs were too long to allow proper embedding
- Logs oriented with the flow accelerate velocity and promote sediment movement

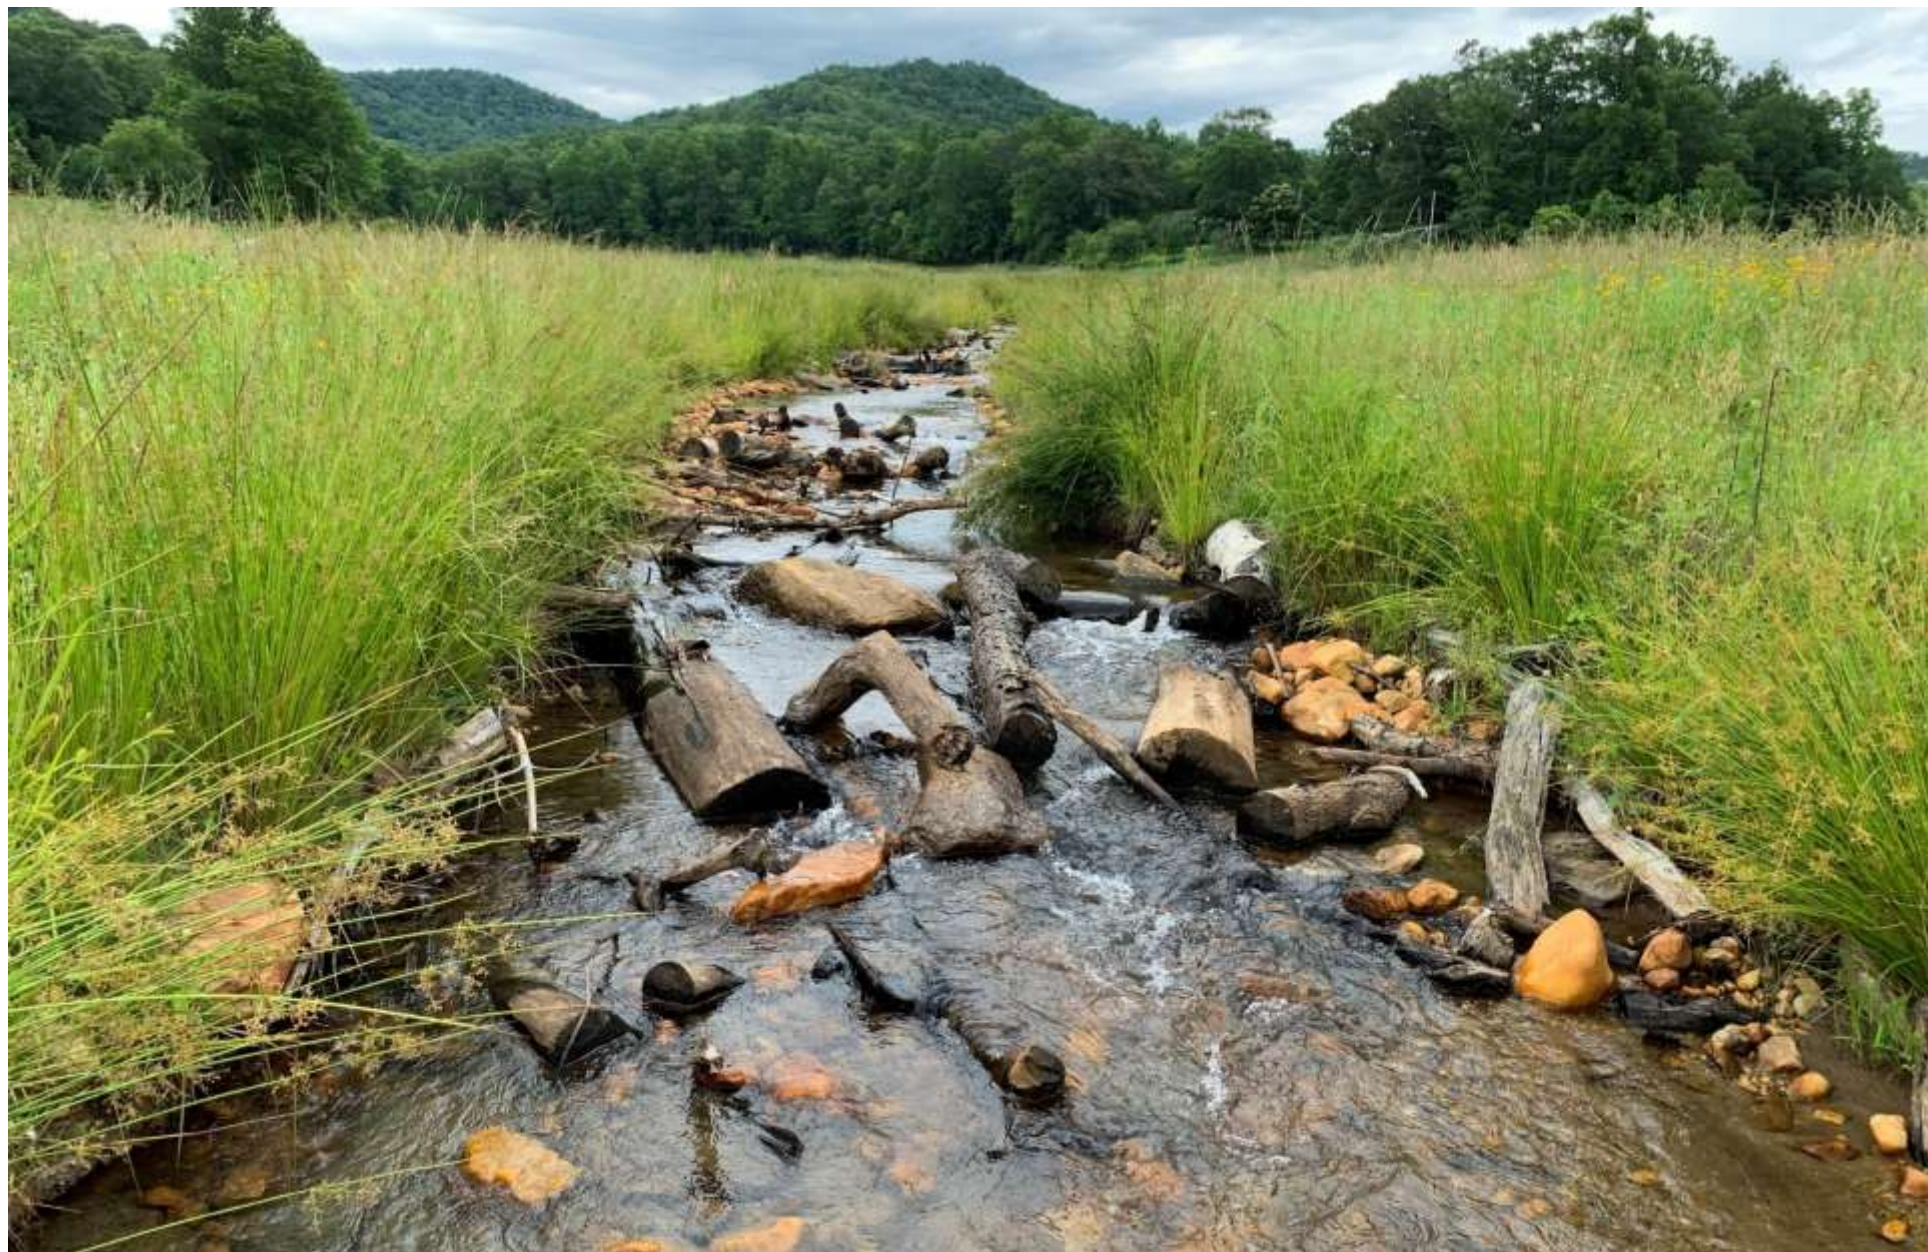
Seniard Creek

- June 2022
- Two years after construction
