Subgrade Structures in Restoration Design

Presented by:
Grant Ginn, PE, Senior Principal/River Engineer

National Stream Restoration Conference 2022
August 2, 2022

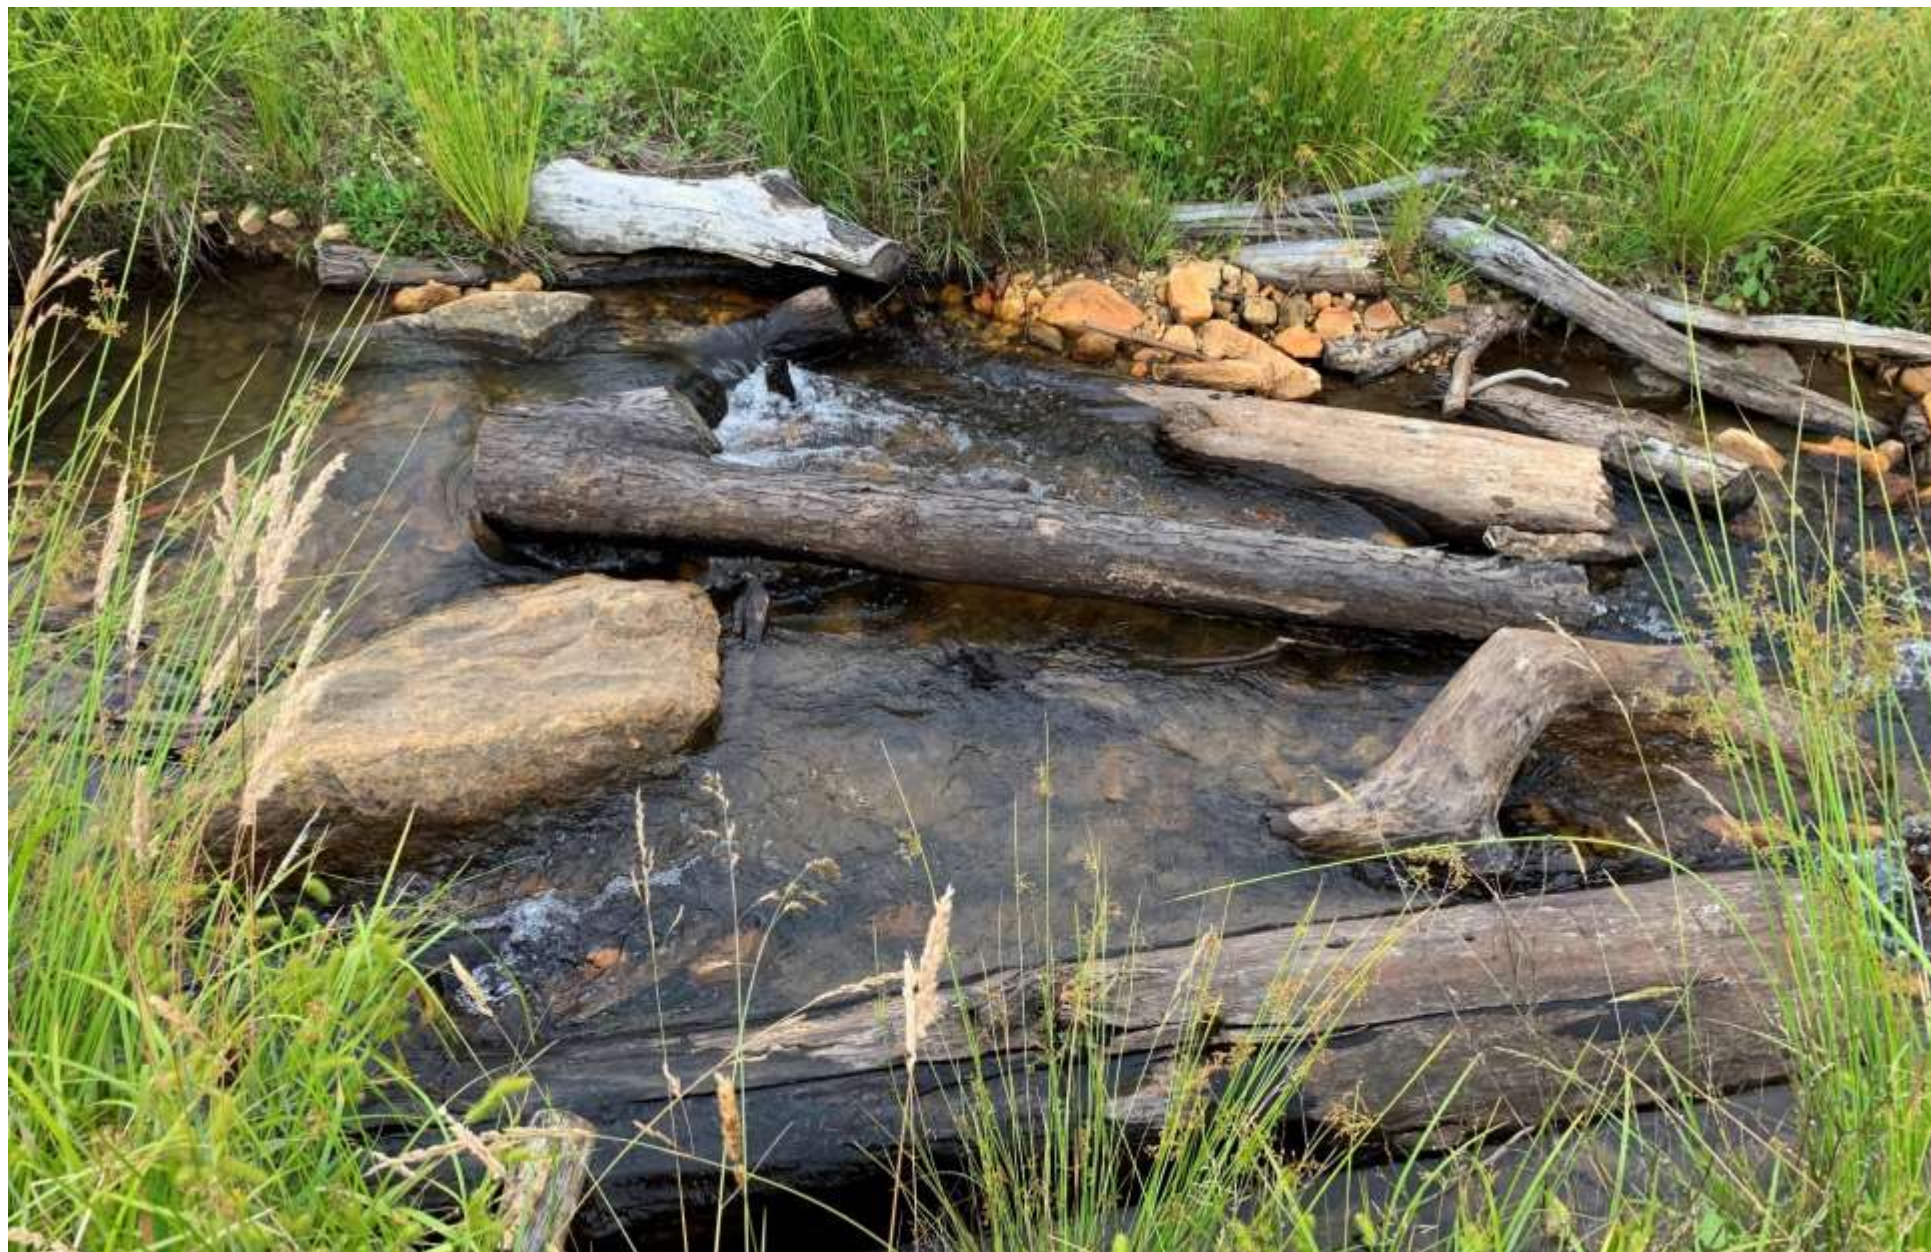
Seniard Creek

- June 2022
- Bed material moved out of structure
- Parallel logs create chutes that accelerate flow
- Logs are not trapping bed material

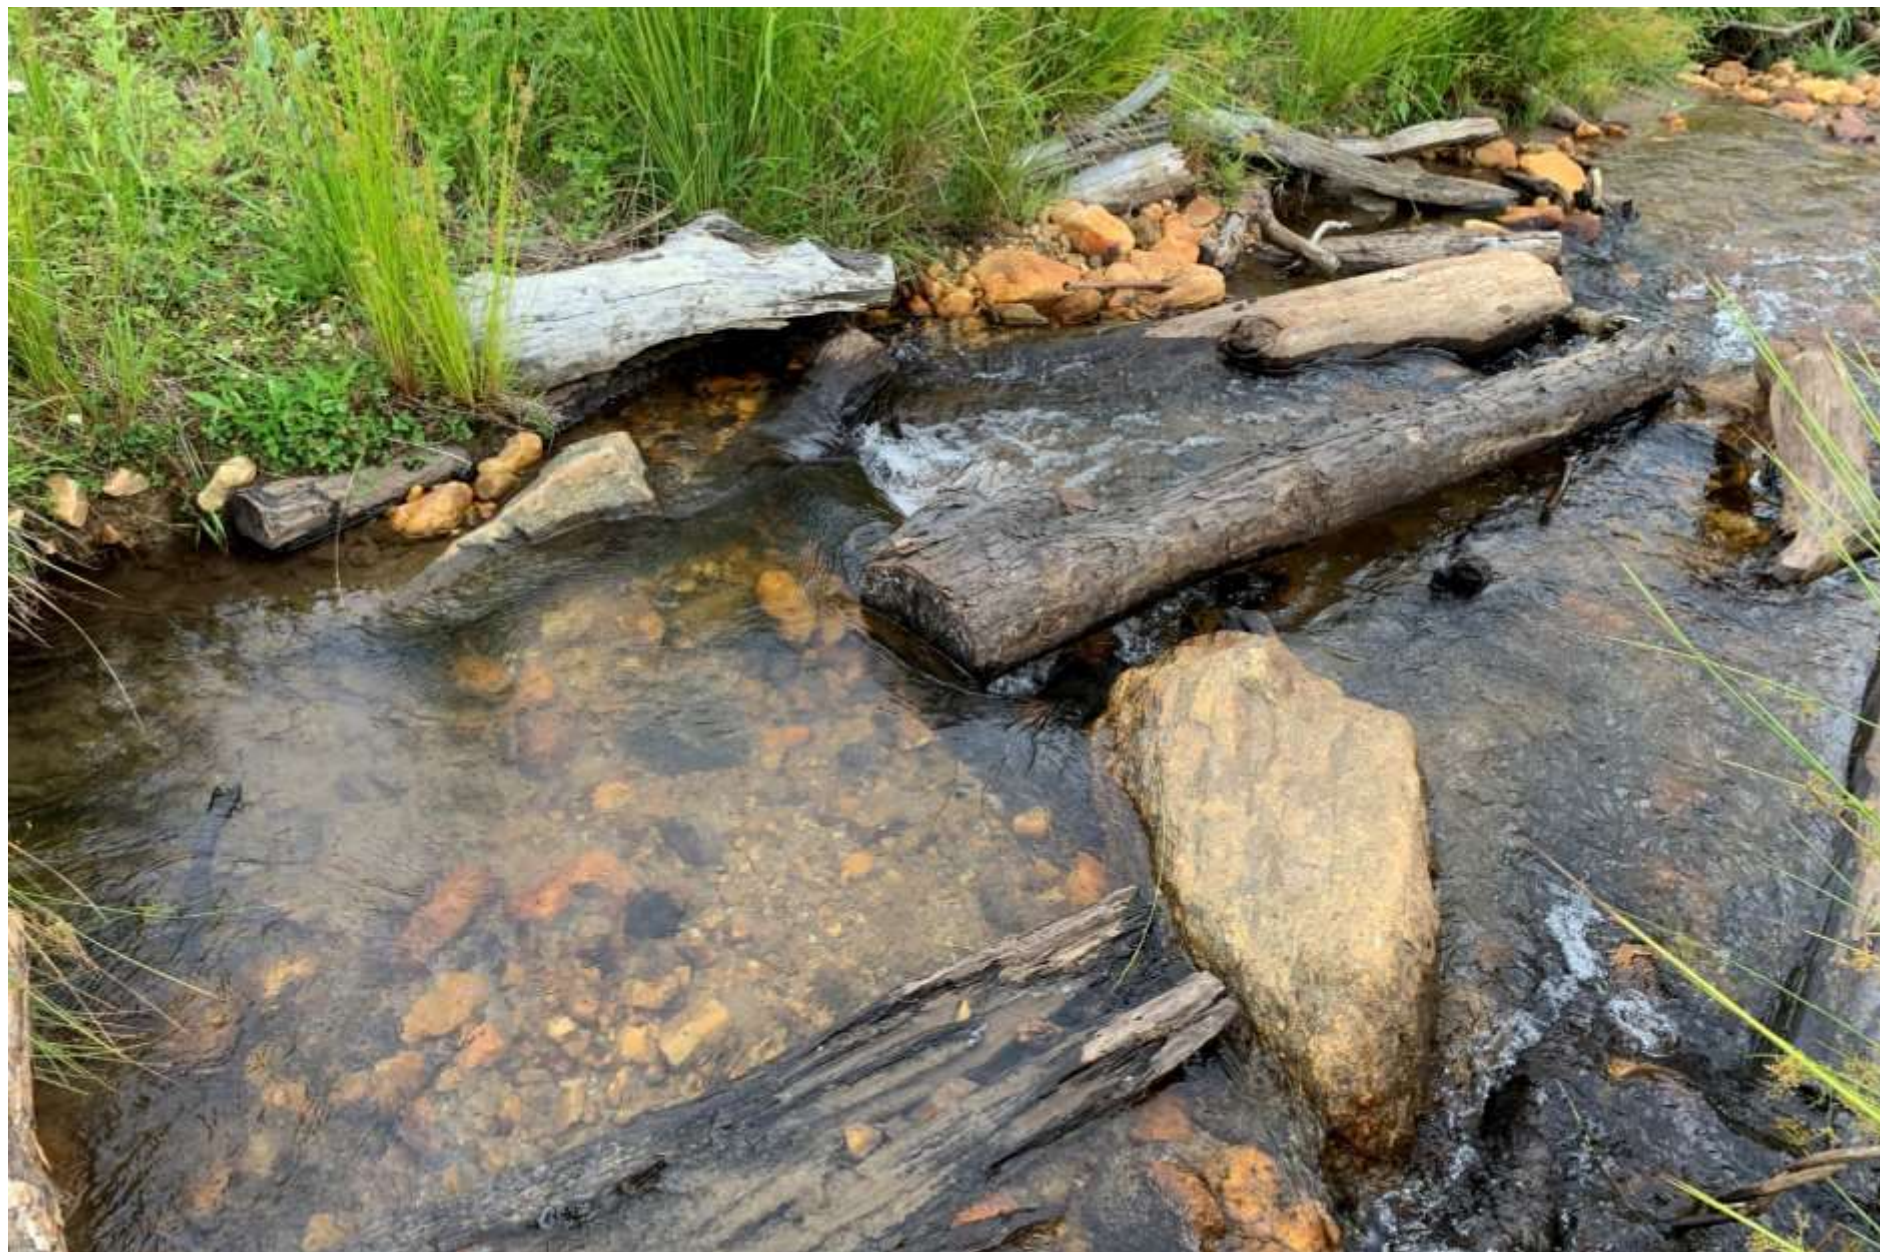
Seniard Creek

- June 2022
- Bank remains stable despite structure failure
- Scour along bank has exposed buried woody material that is adding roughness
- Dislodged logs adding to flow complexity
- Failed structures potentially offer a source of large wood recruitment

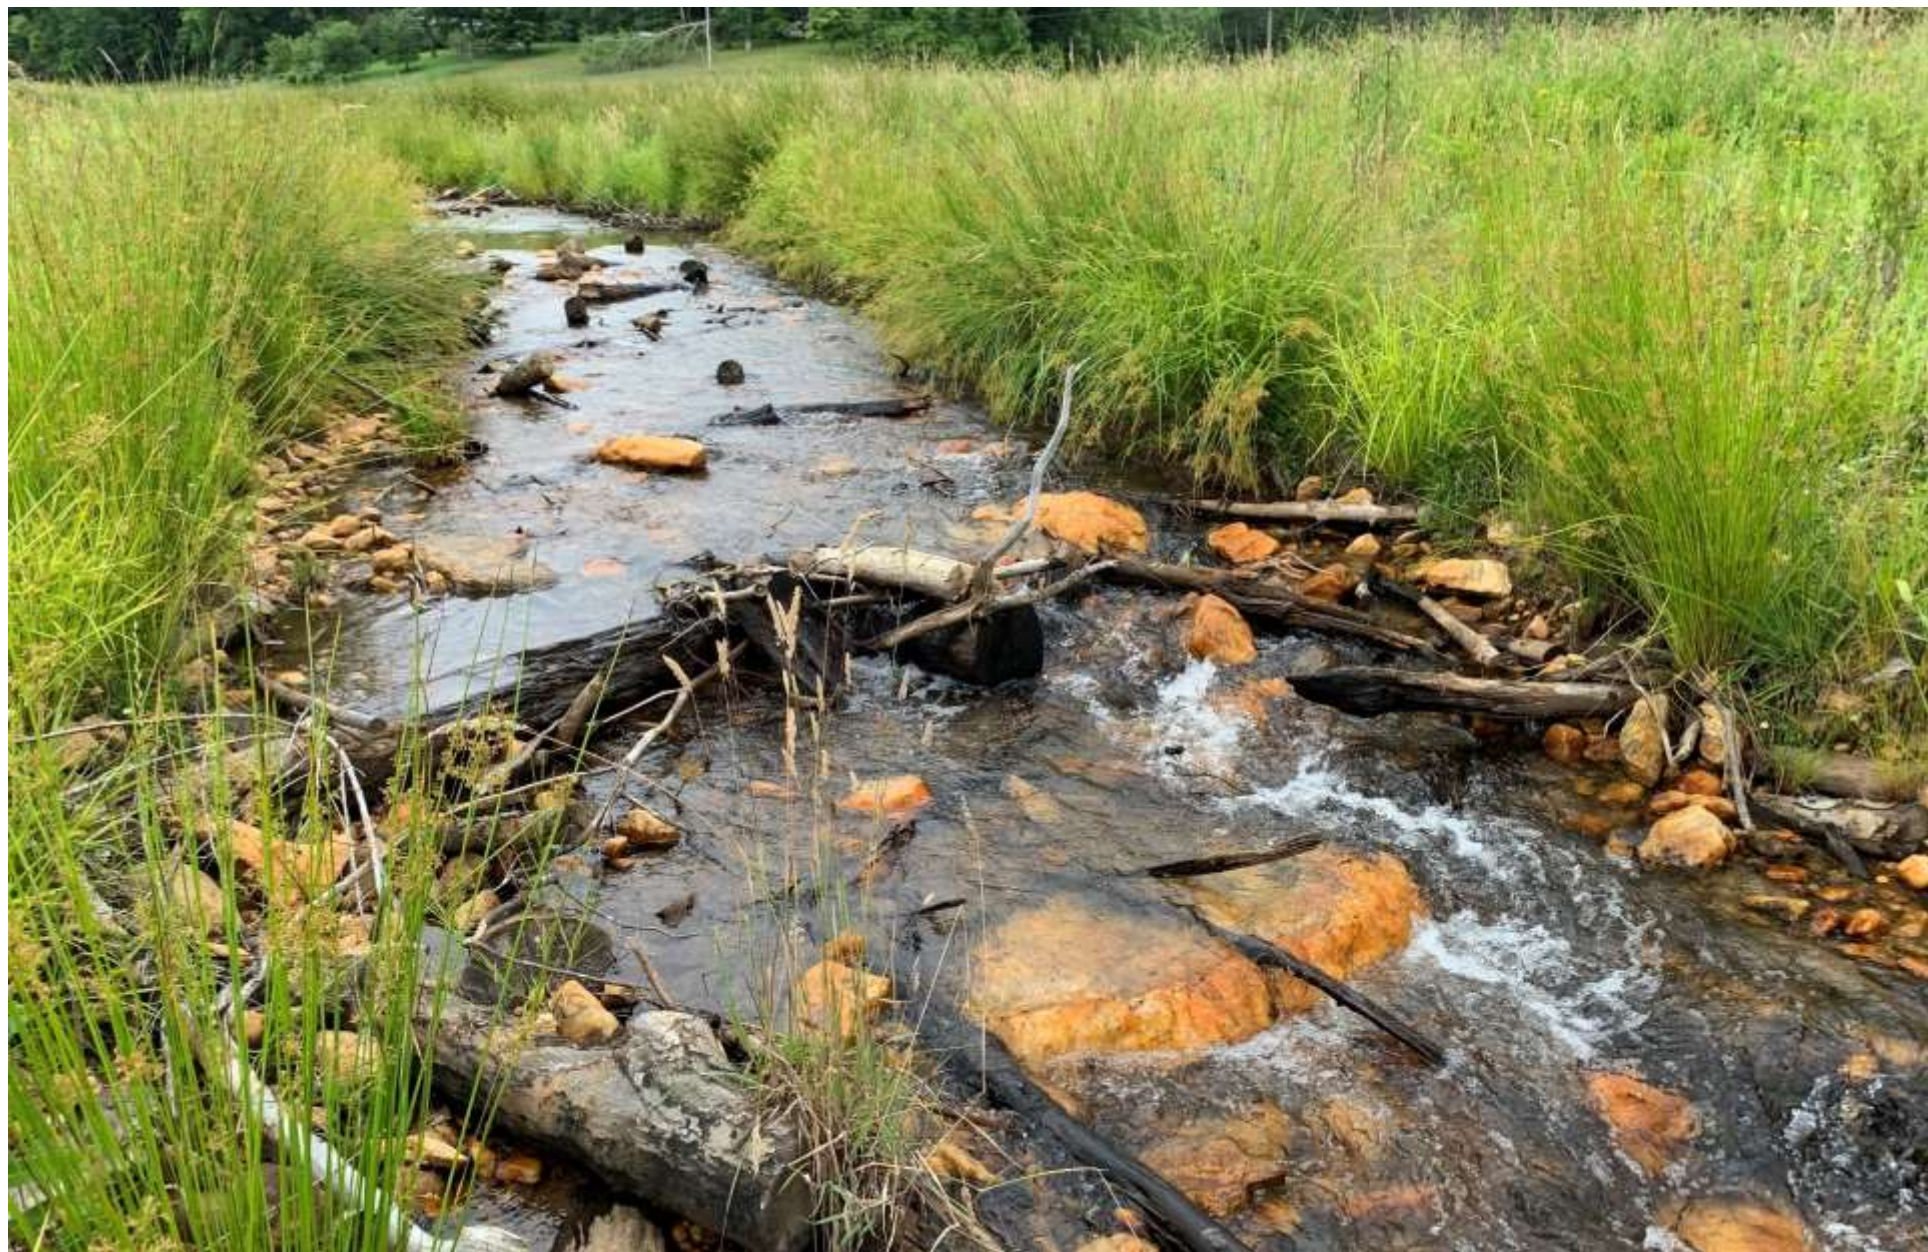
Seniard Creek

- June 2022
- Structure immediately upstream
- No evidence of head-cut propagation
- Failed structure downstream still providing flow resistance

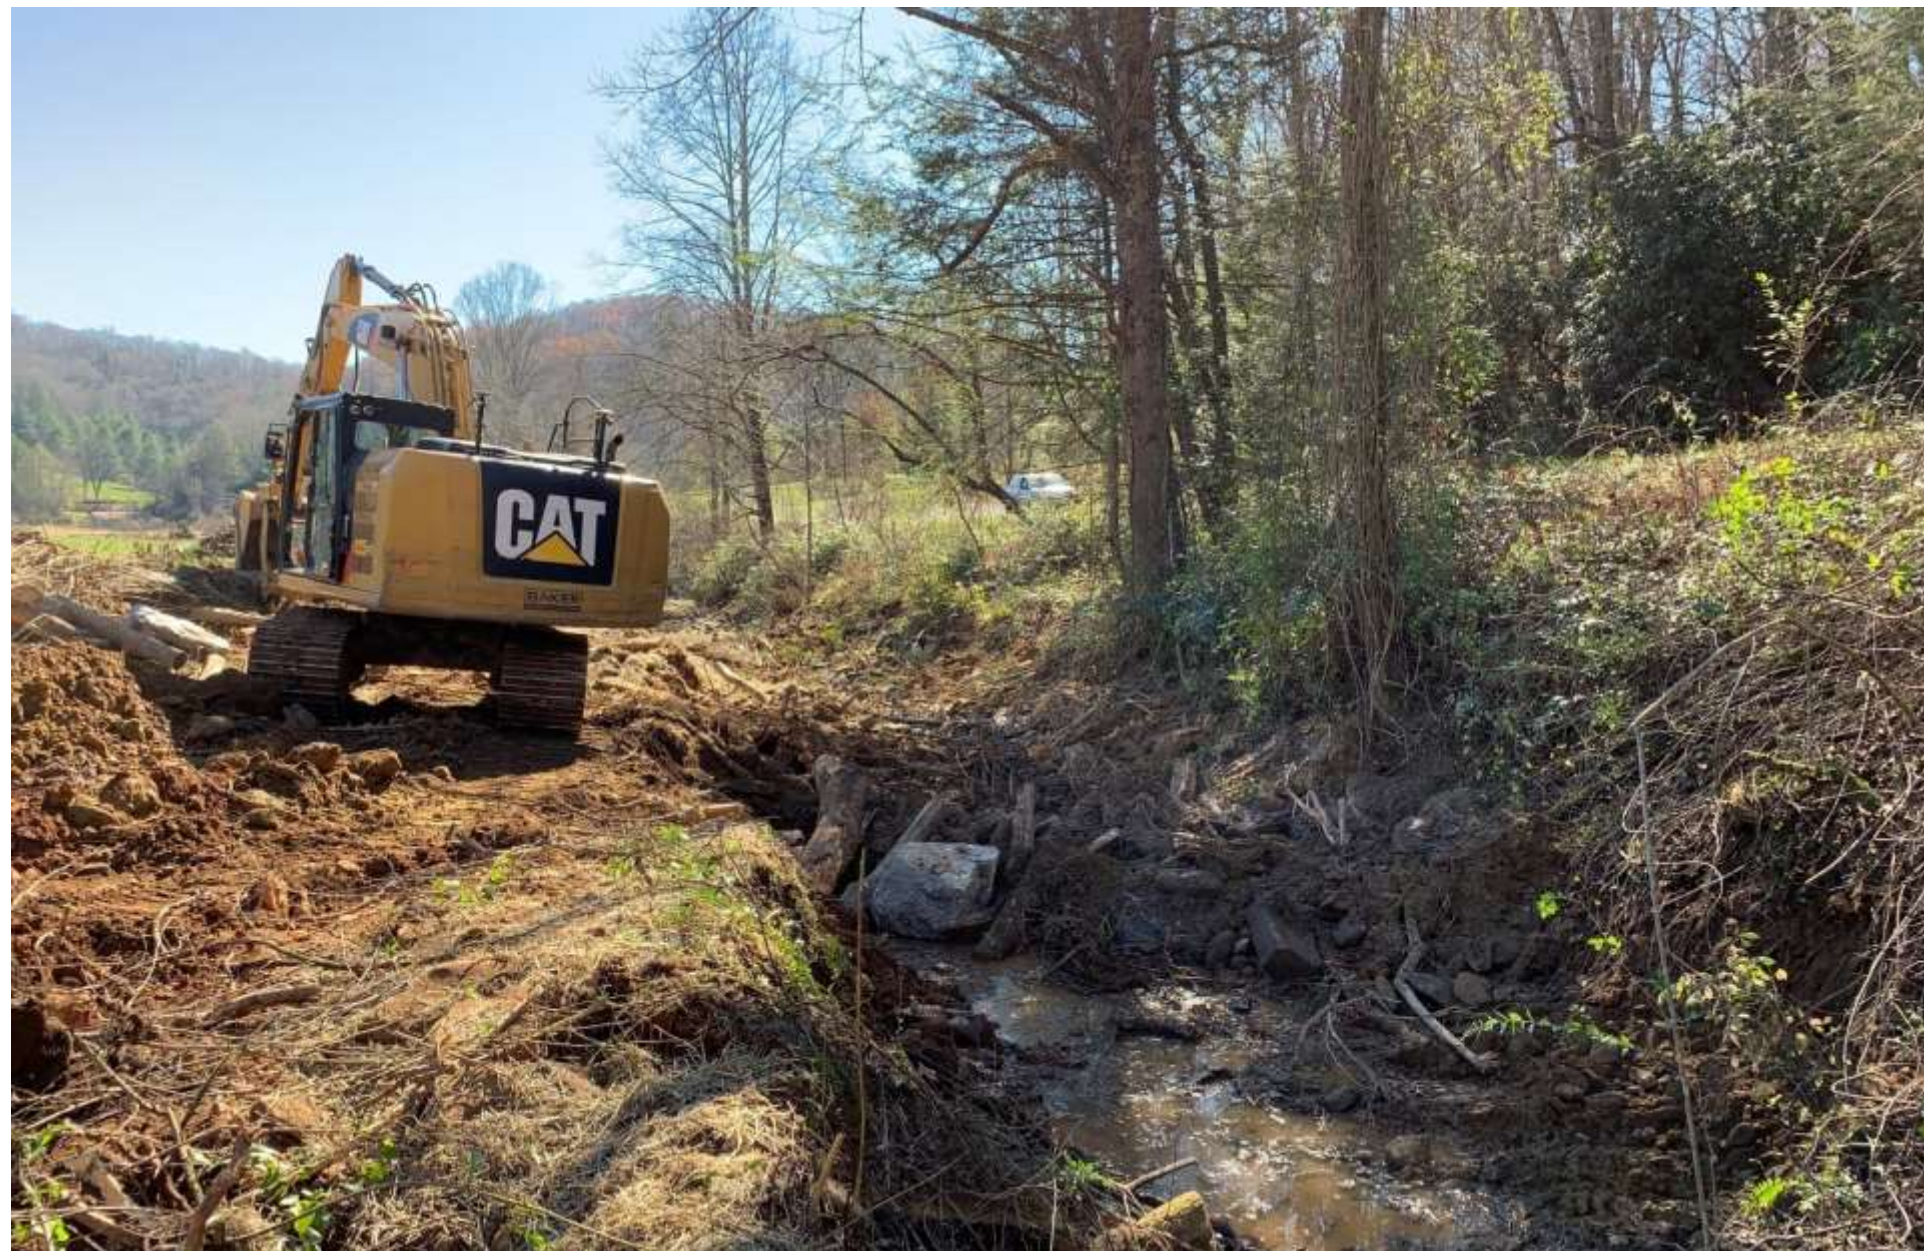
Seniard Creek

- November 2020
- Hanging culvert at upstream end required raising channel grade
- 200-foot-long transition on a 5% grade
- Opted to use same installation technique to construct 200 feet cascade

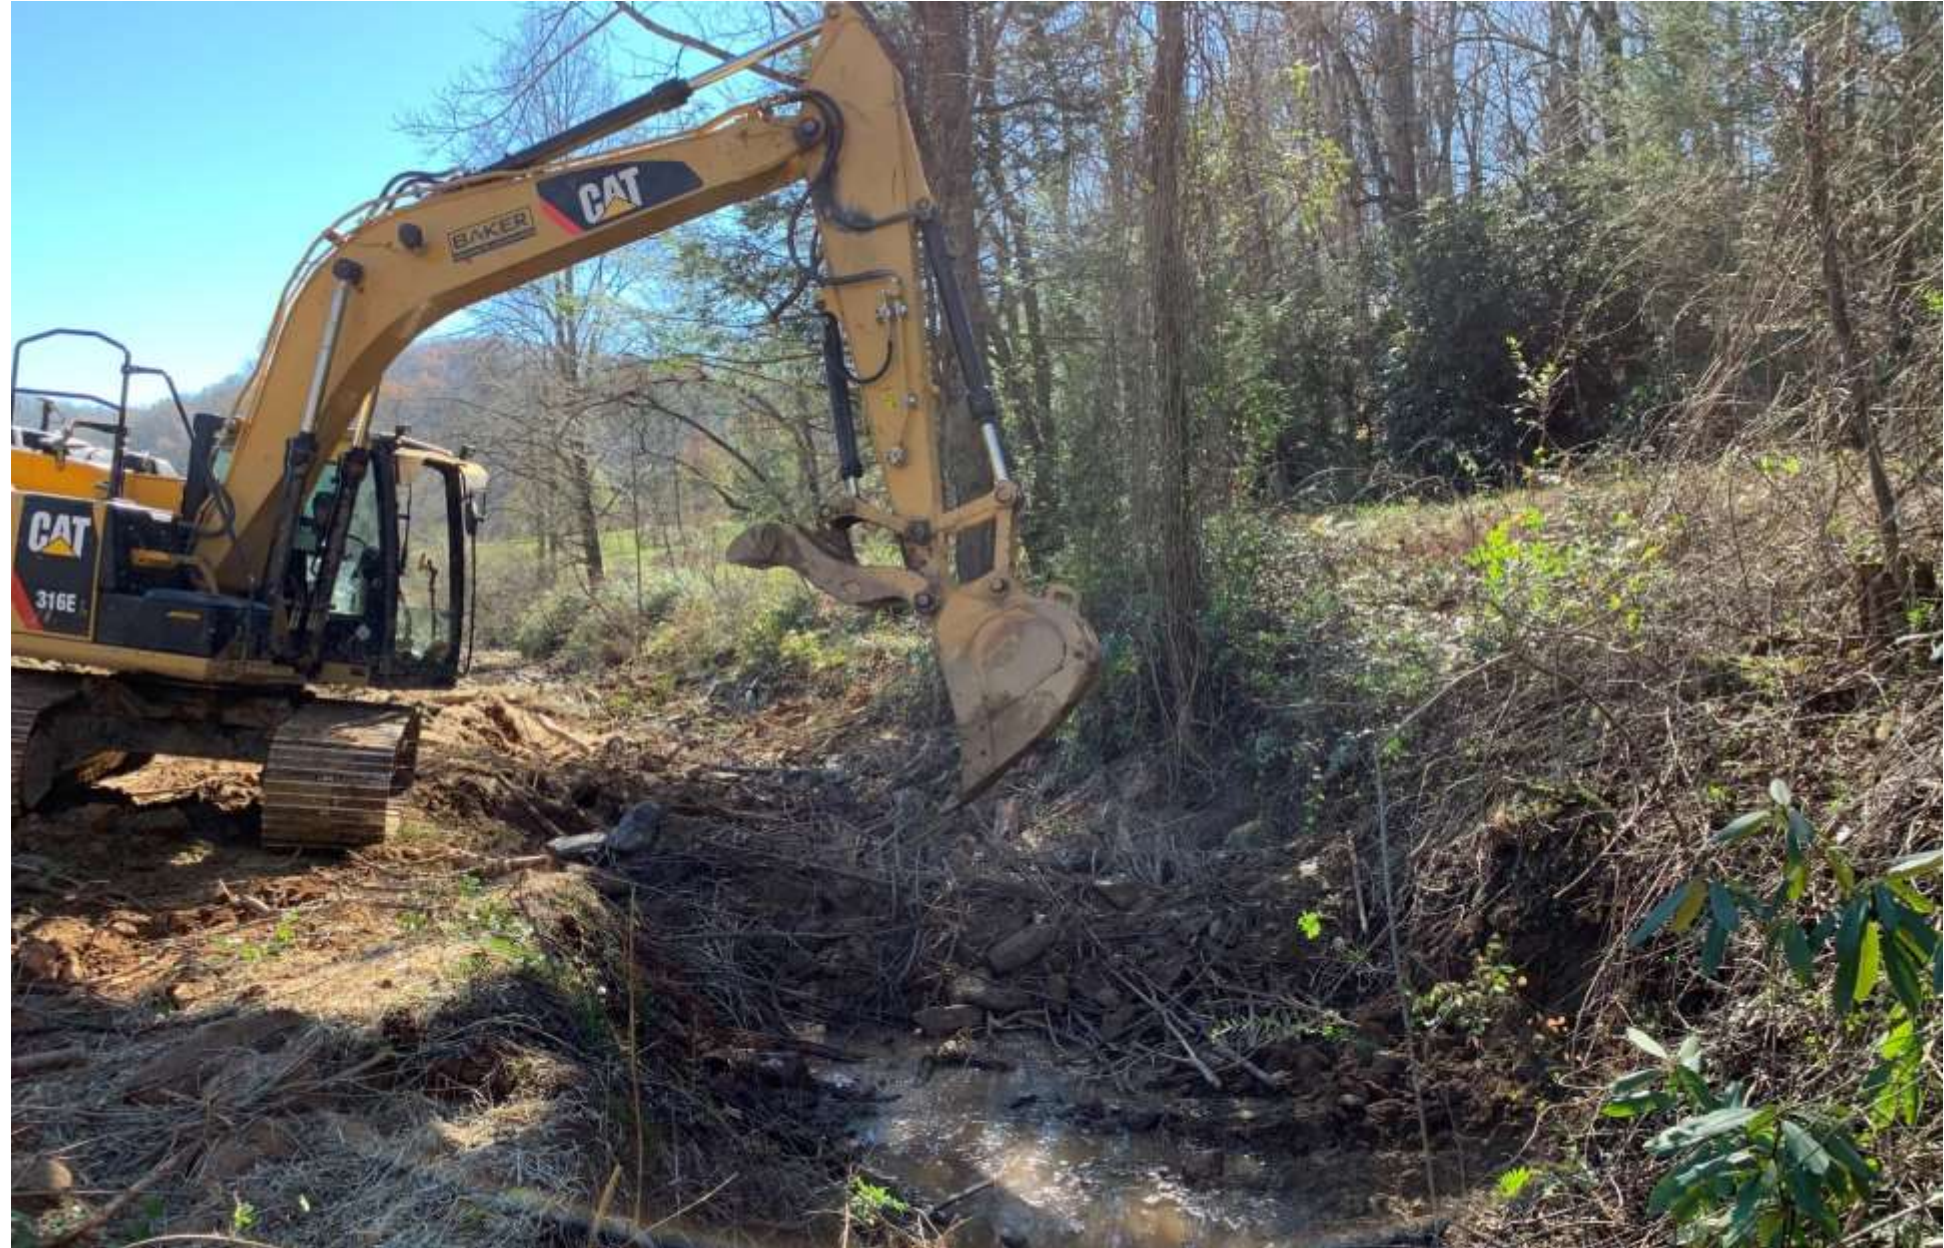
Seniard Creek

- November 2020
- Constructed from downstream up
- Excavated the sub-grade
- Backfilled with alternating courses of logs, limbs, boulders, and cobble

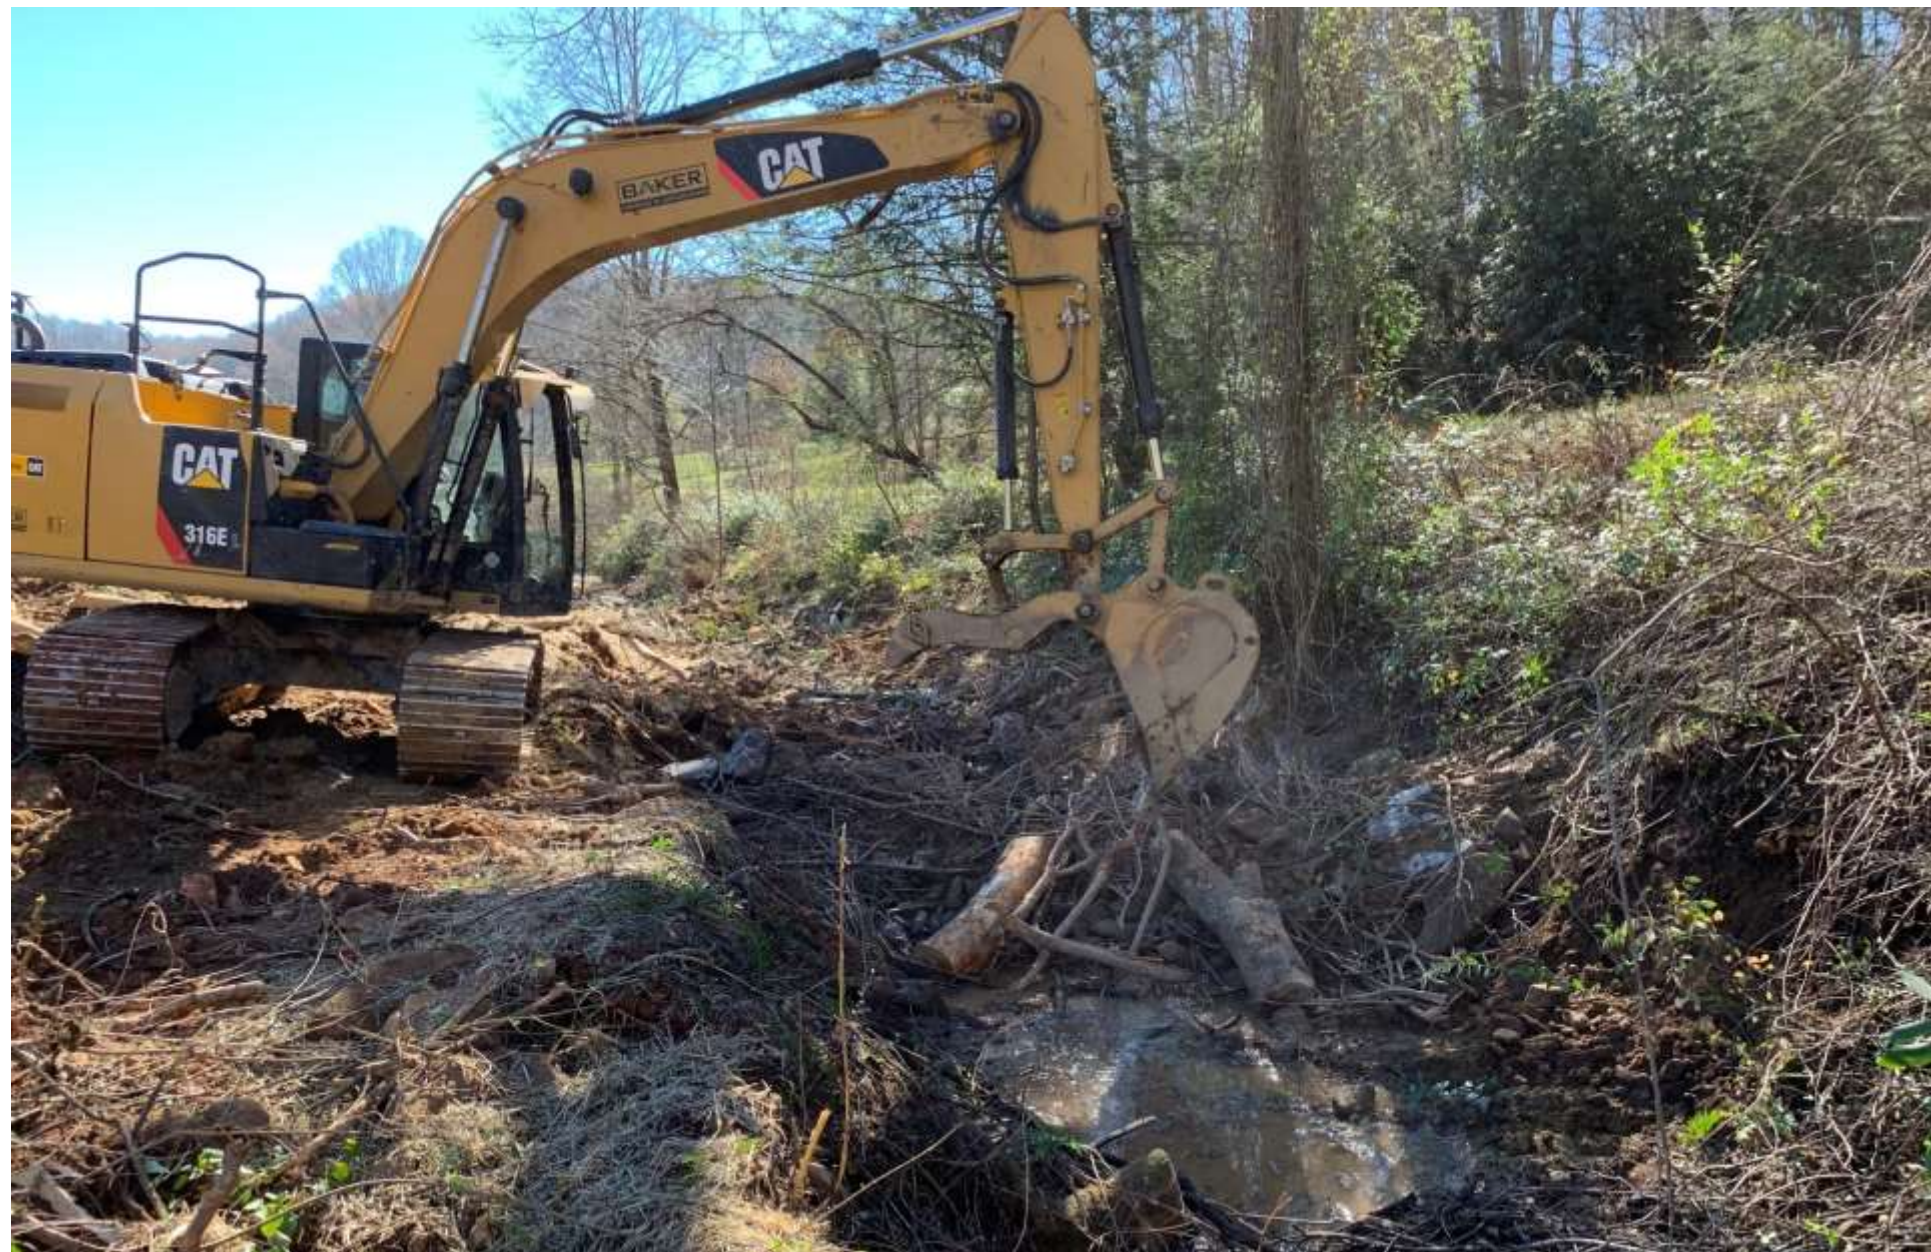
Seniard Creek

- November 2020
- Backfilled with alternating courses of logs, limbs, boulders, and cobble

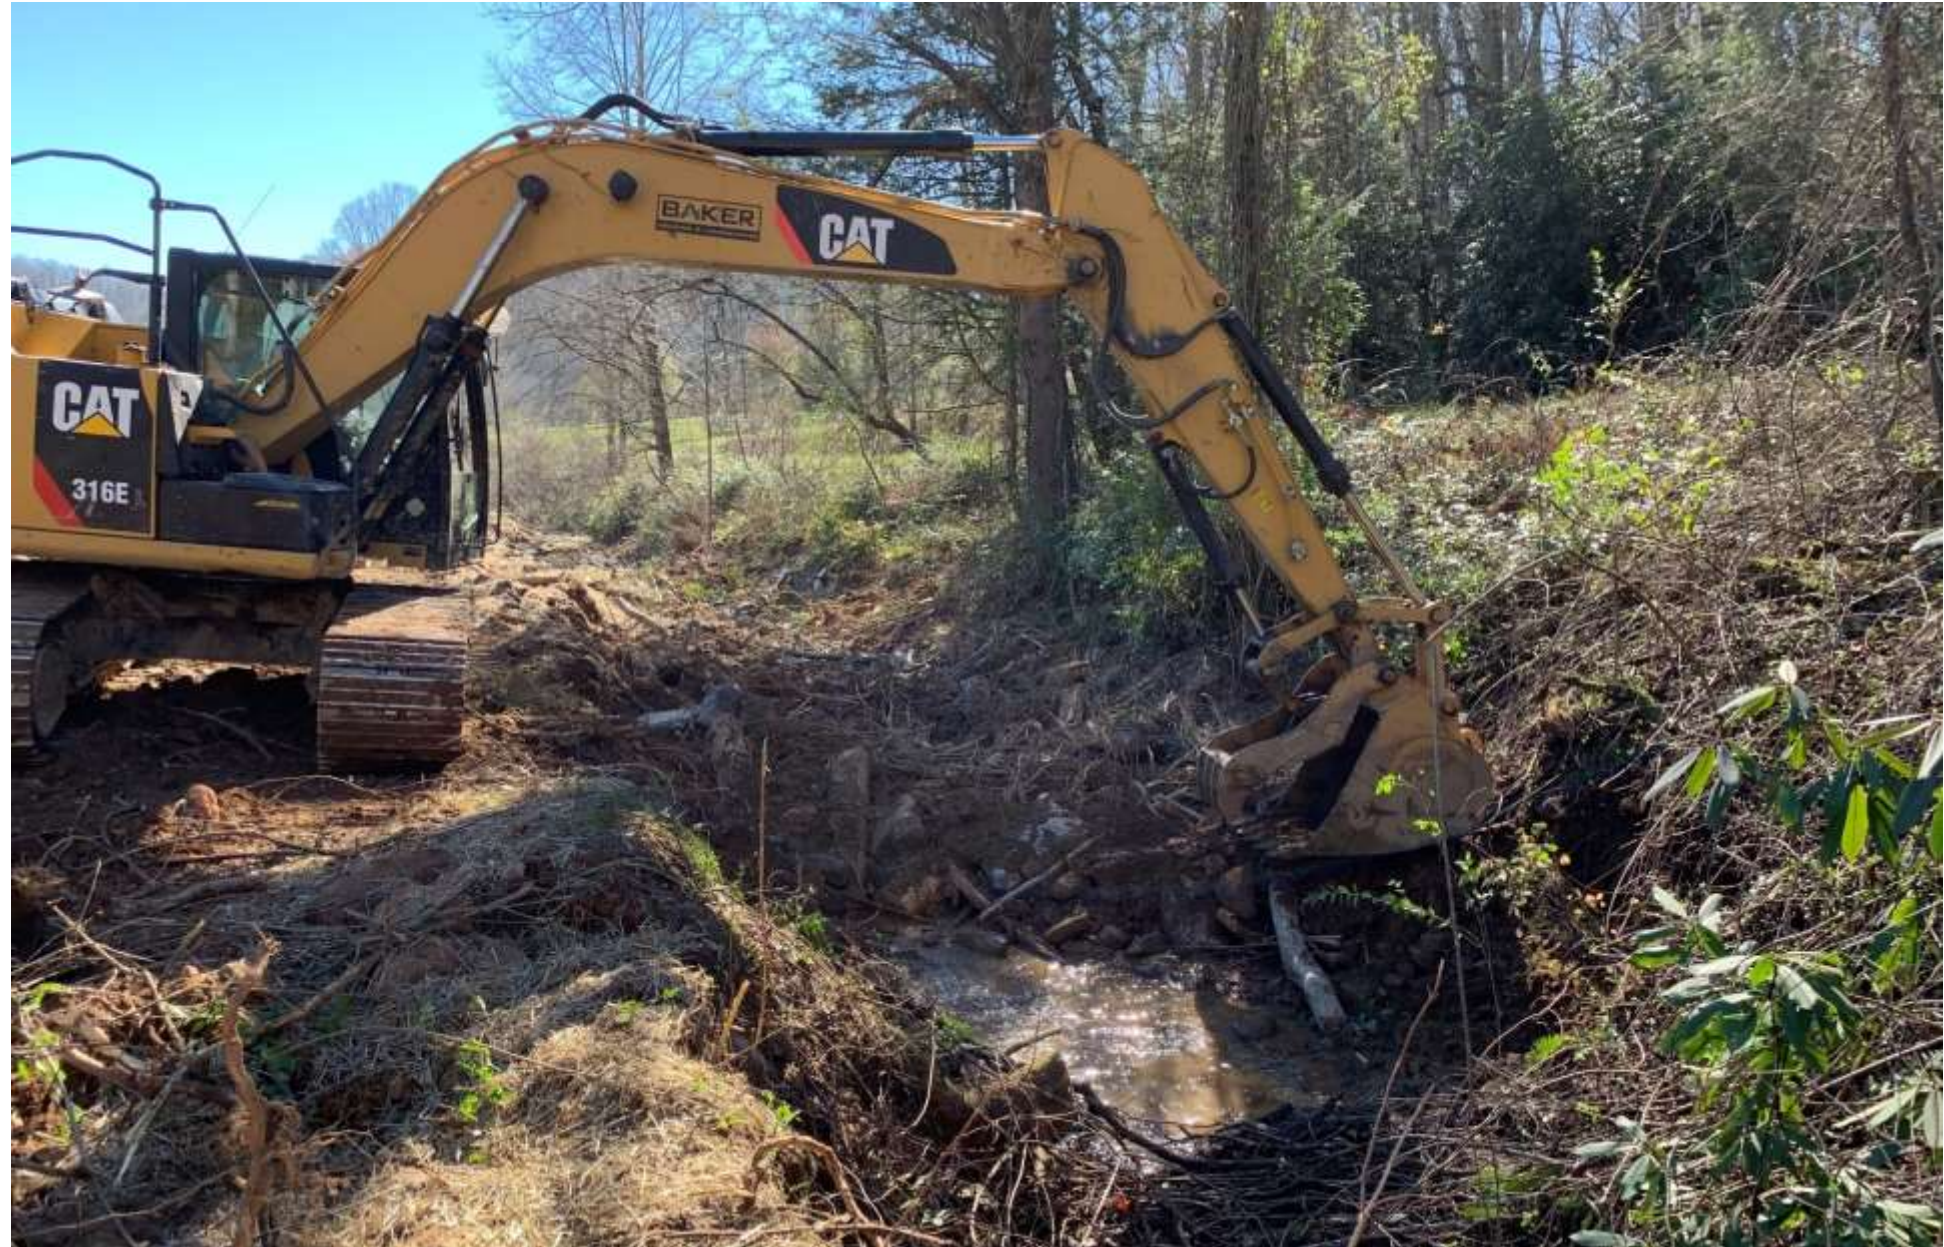
Seniard Creek

- November 2020
- Backfilled with alternating courses of logs, limbs, boulders, and cobble

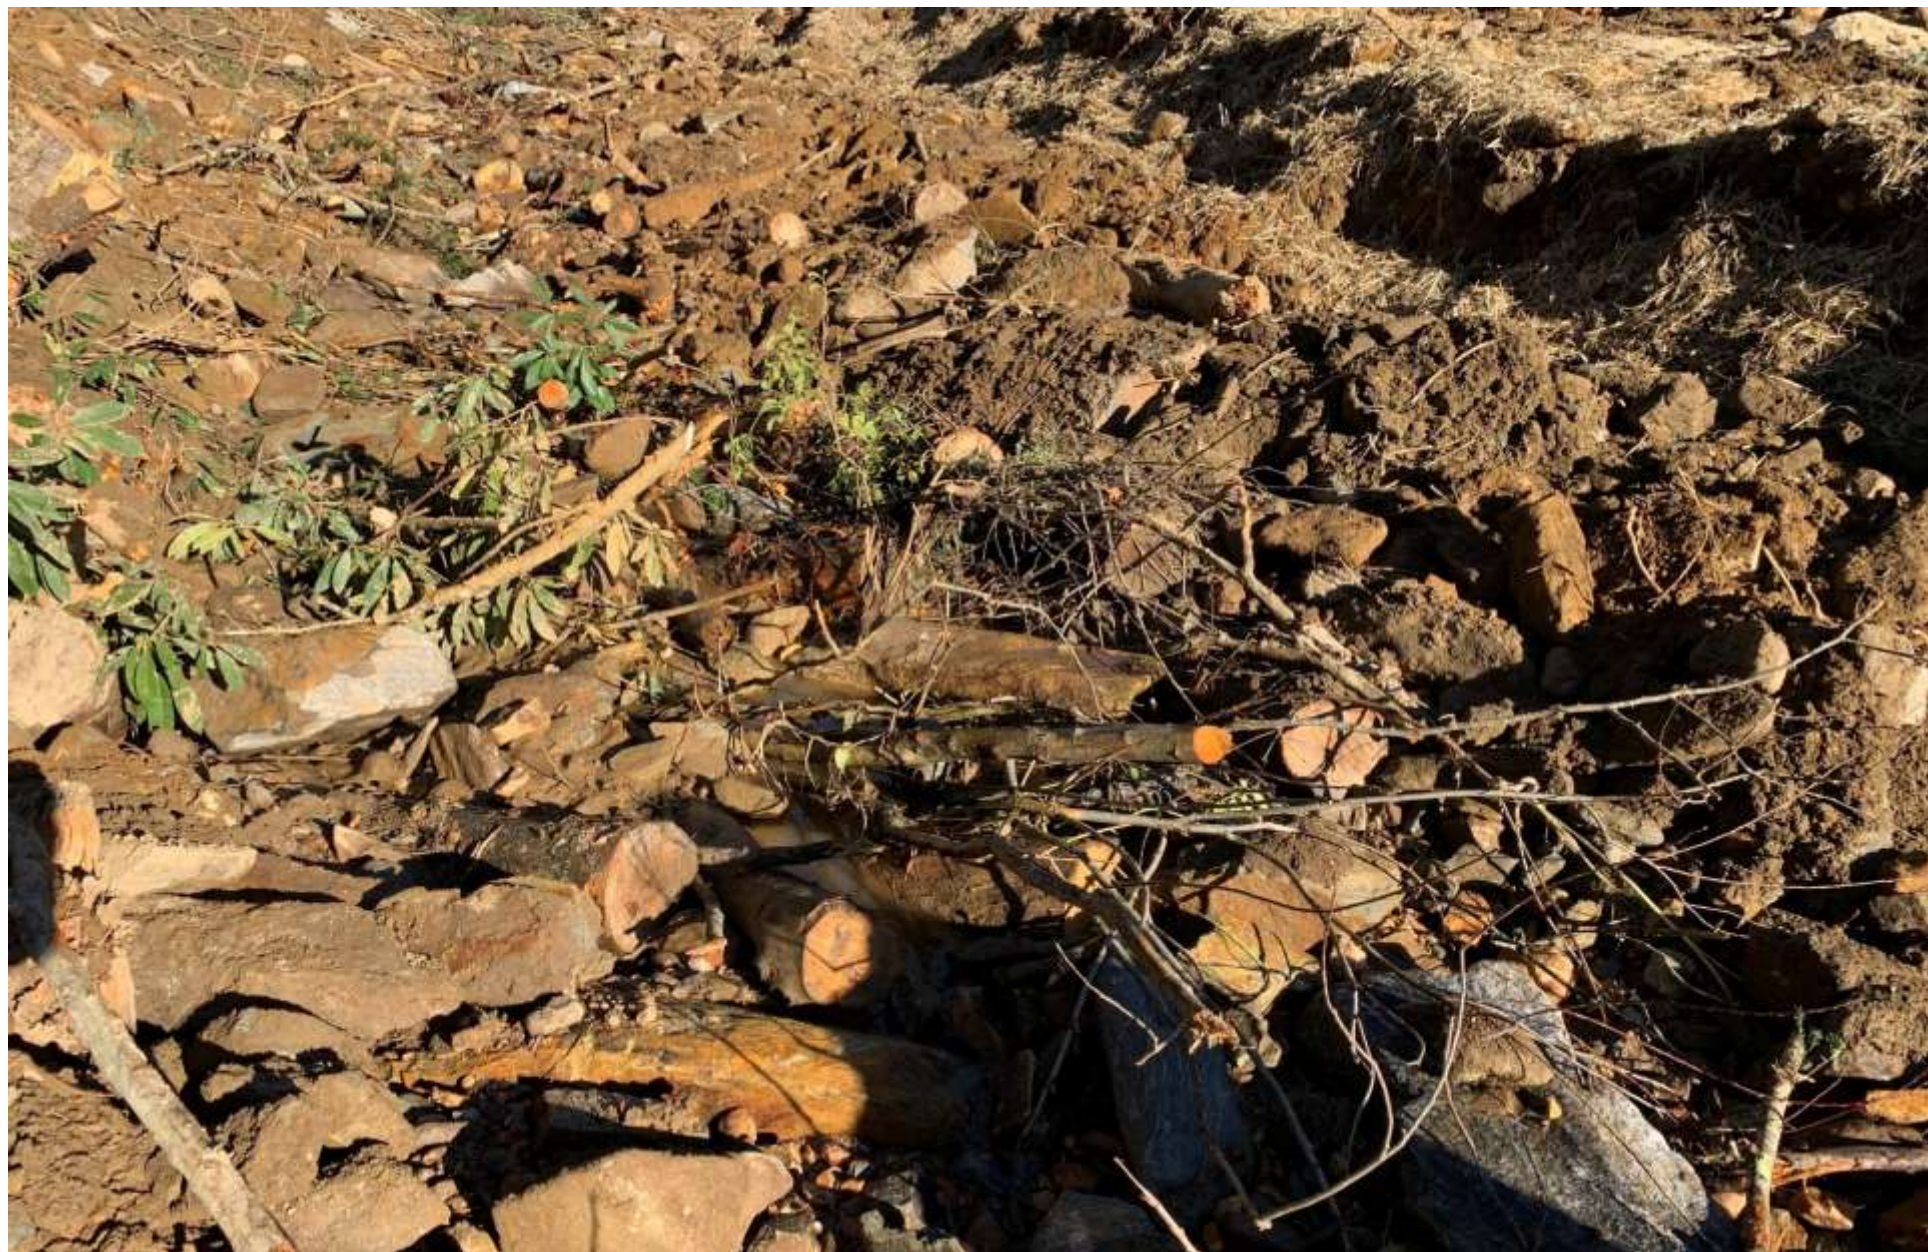
Seniard Creek

- November 2020
- Completed bed without flow

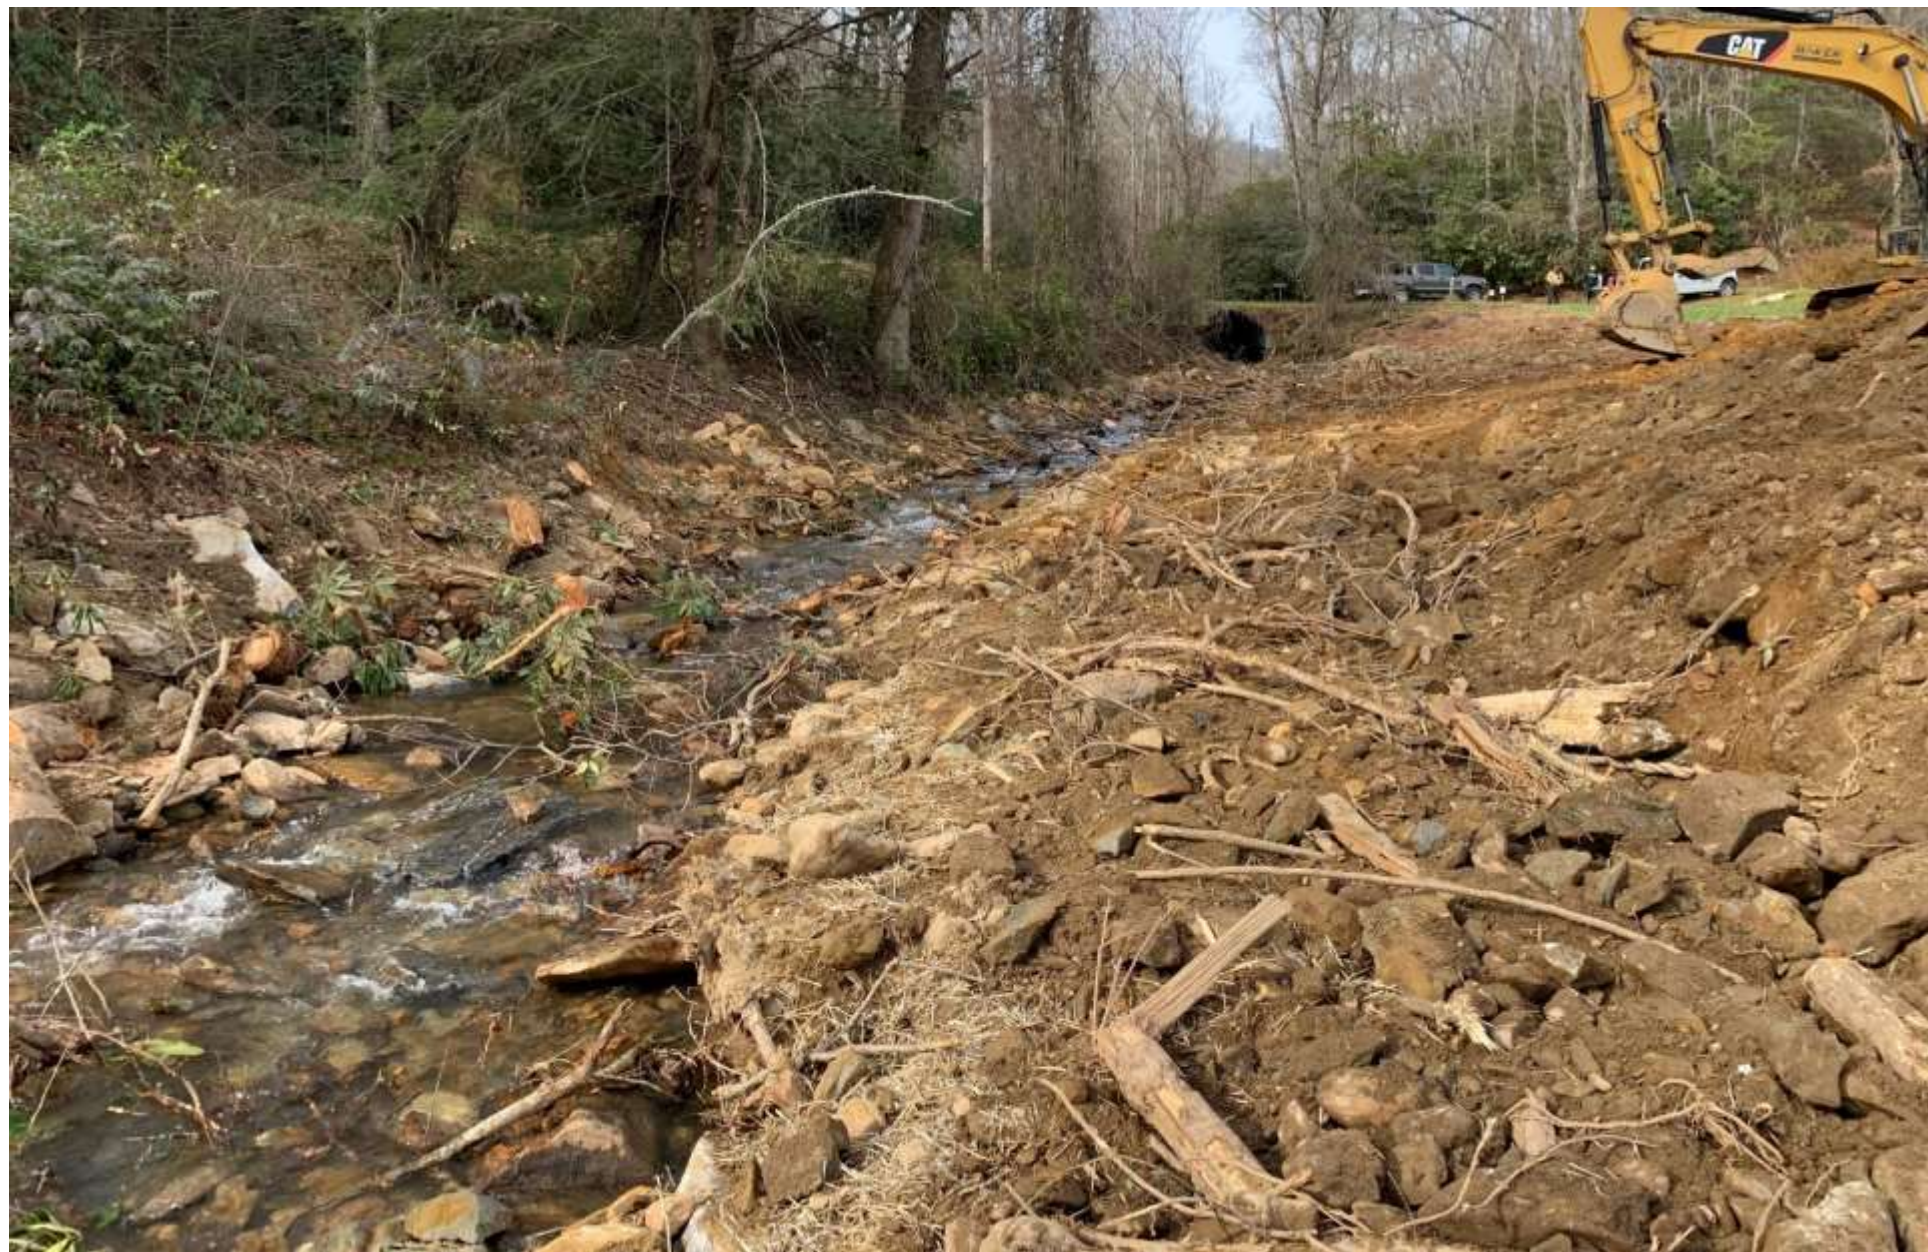
Seniard Creek

- November 2020
- Completed channel
- Material mix carried to back of bench
