Subgrade Structures in Restoration Design

Presented by:
Grant Ginn, PE, Senior Principal/River Engineer

National Stream Restoration Conference 2022
August 2, 2022

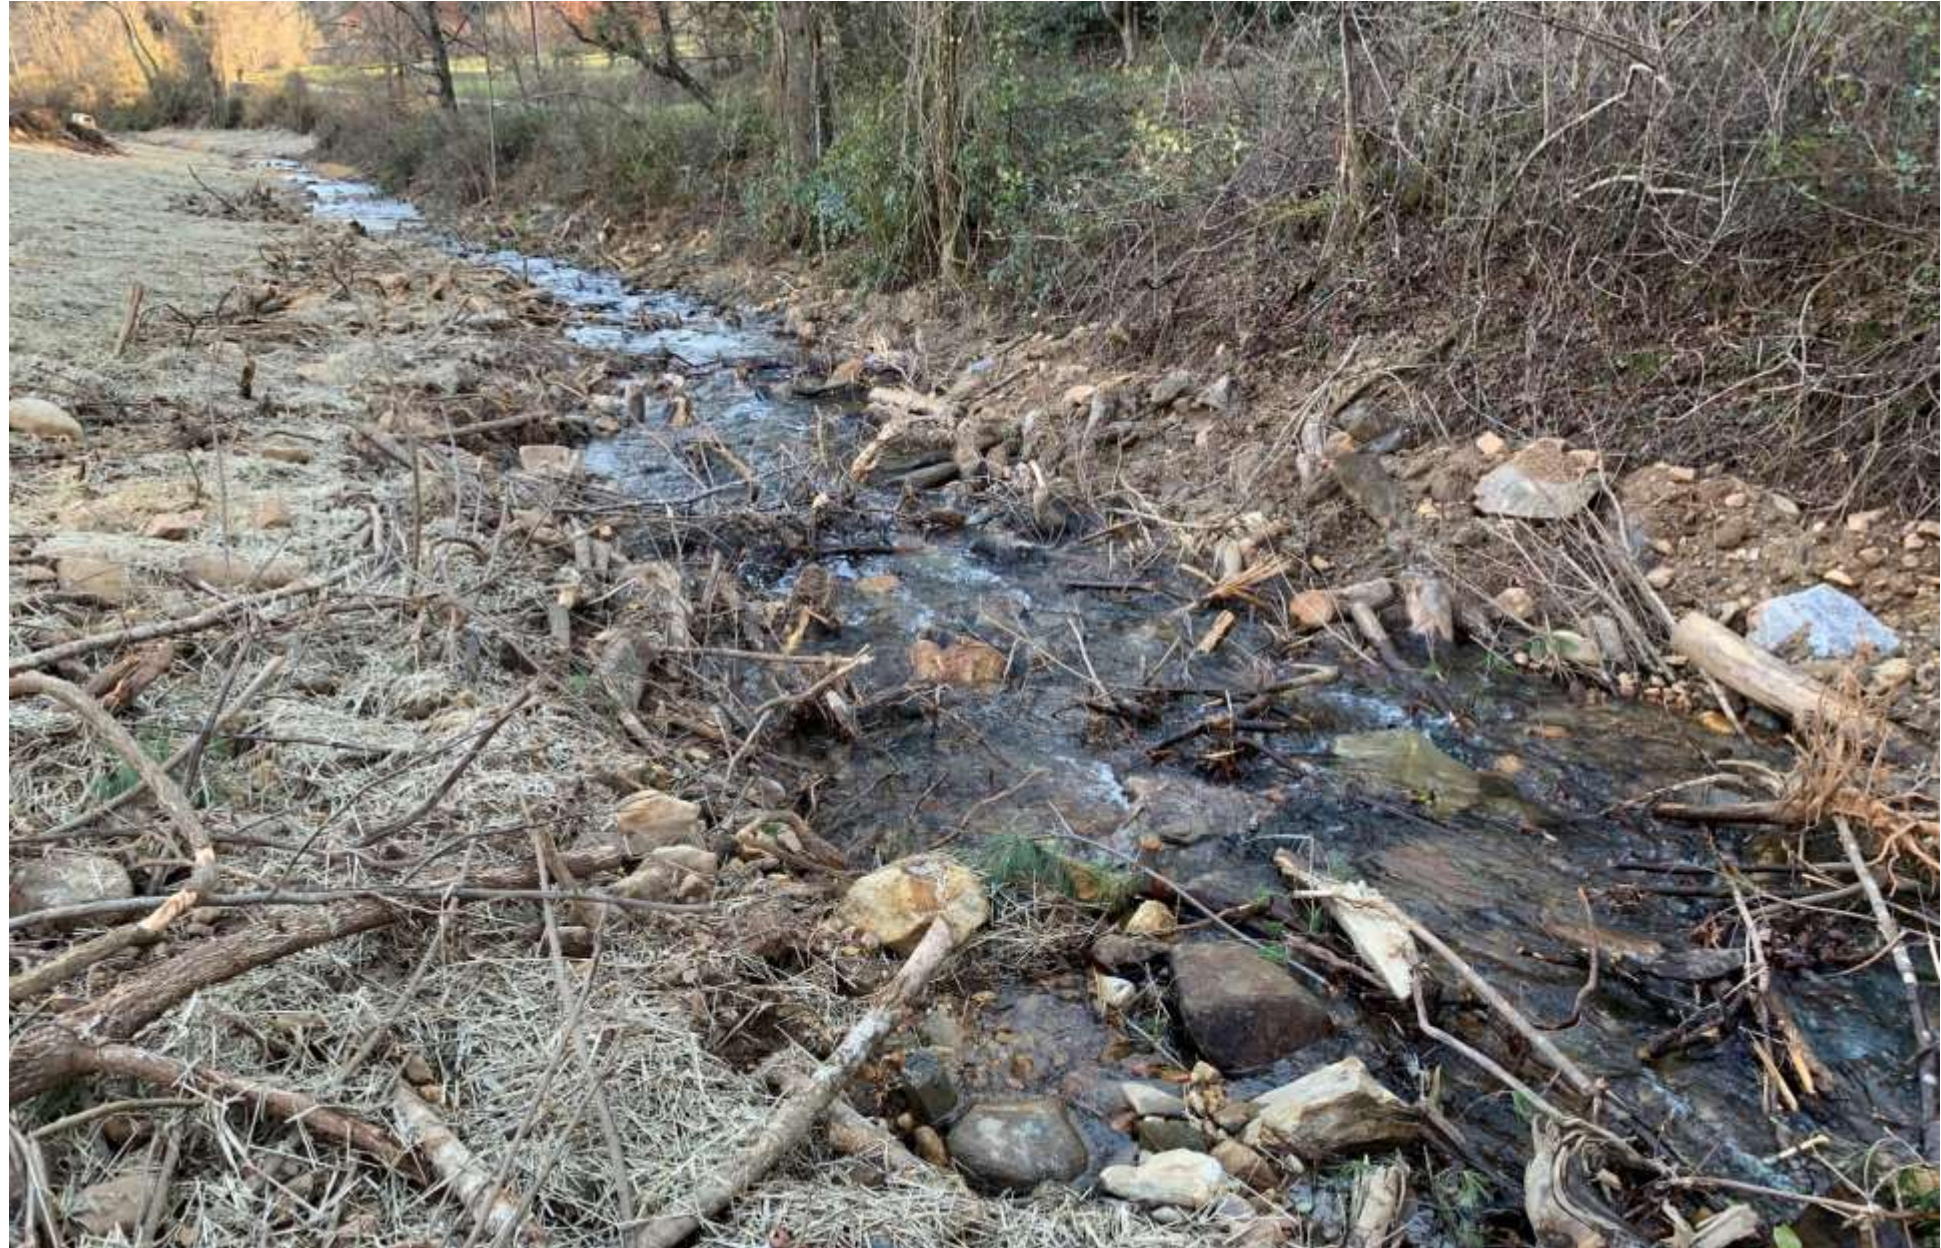
Seniard Creek

- December 2020
- Immediately follow construction
- Facing downstream

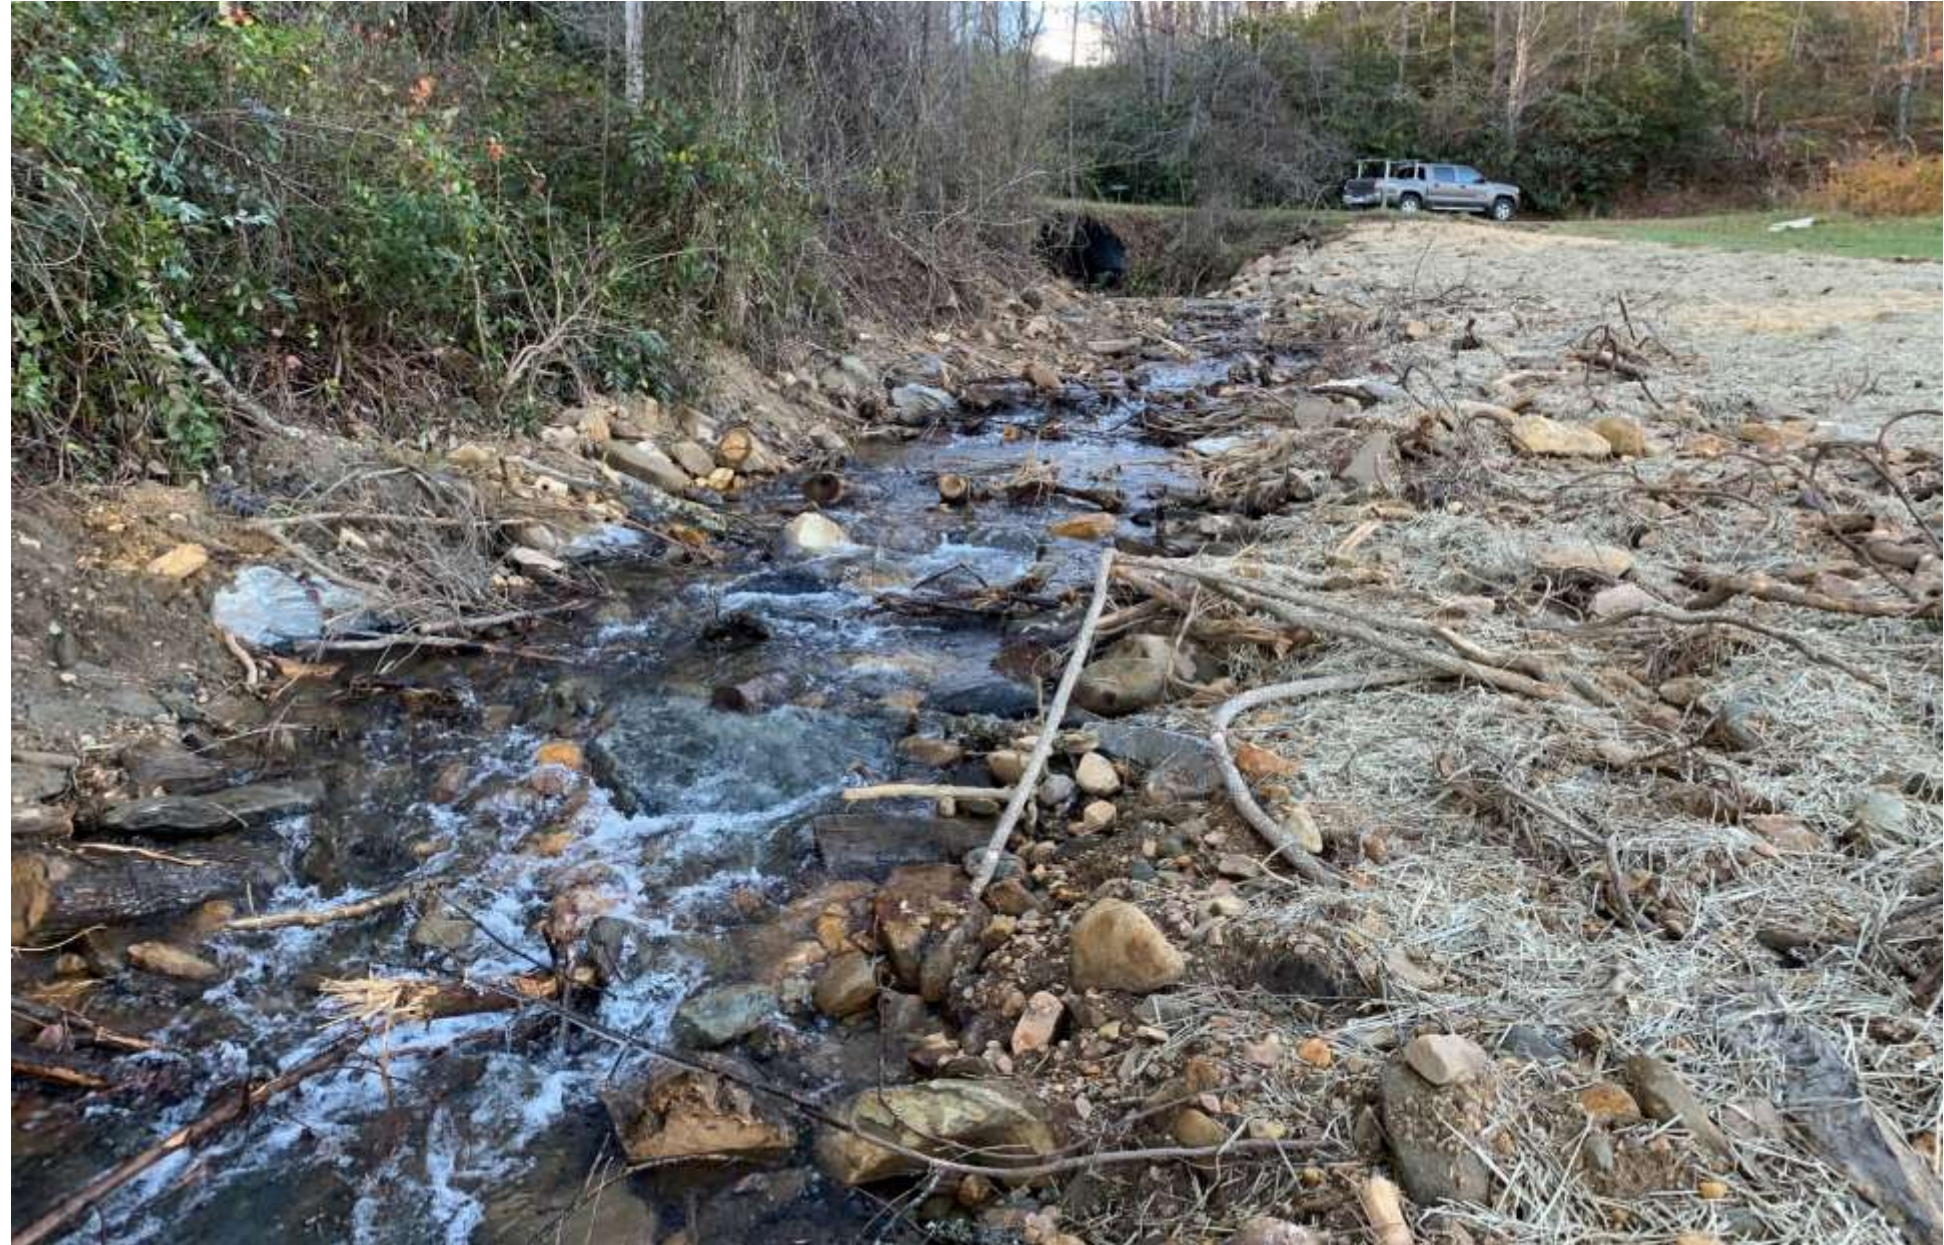
Seniard Creek

- December 2020
- Immediately follow construction
- Facing upstream

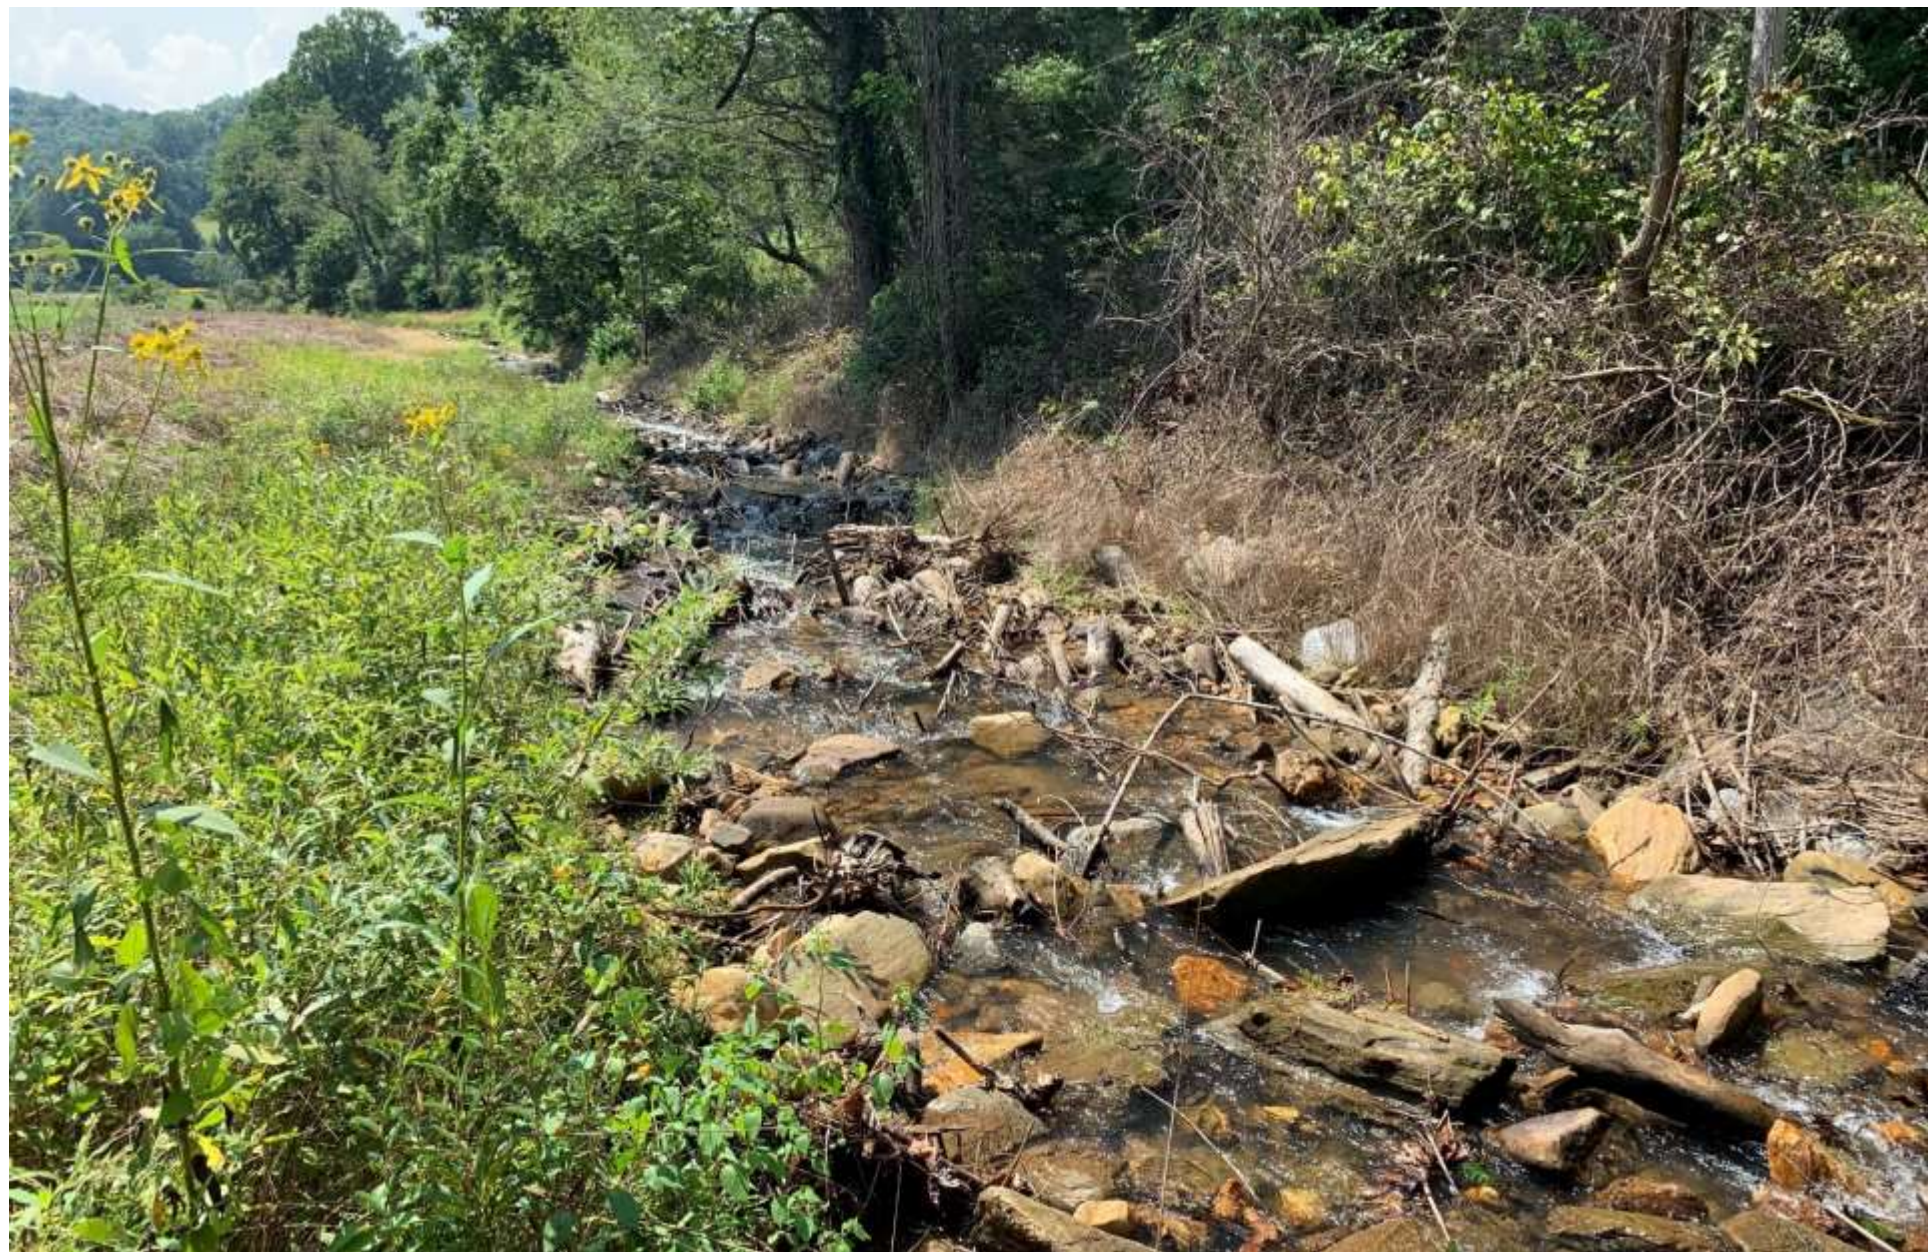
Seniard Creek

- August 2021
- One year later
- After Hurricane Fred

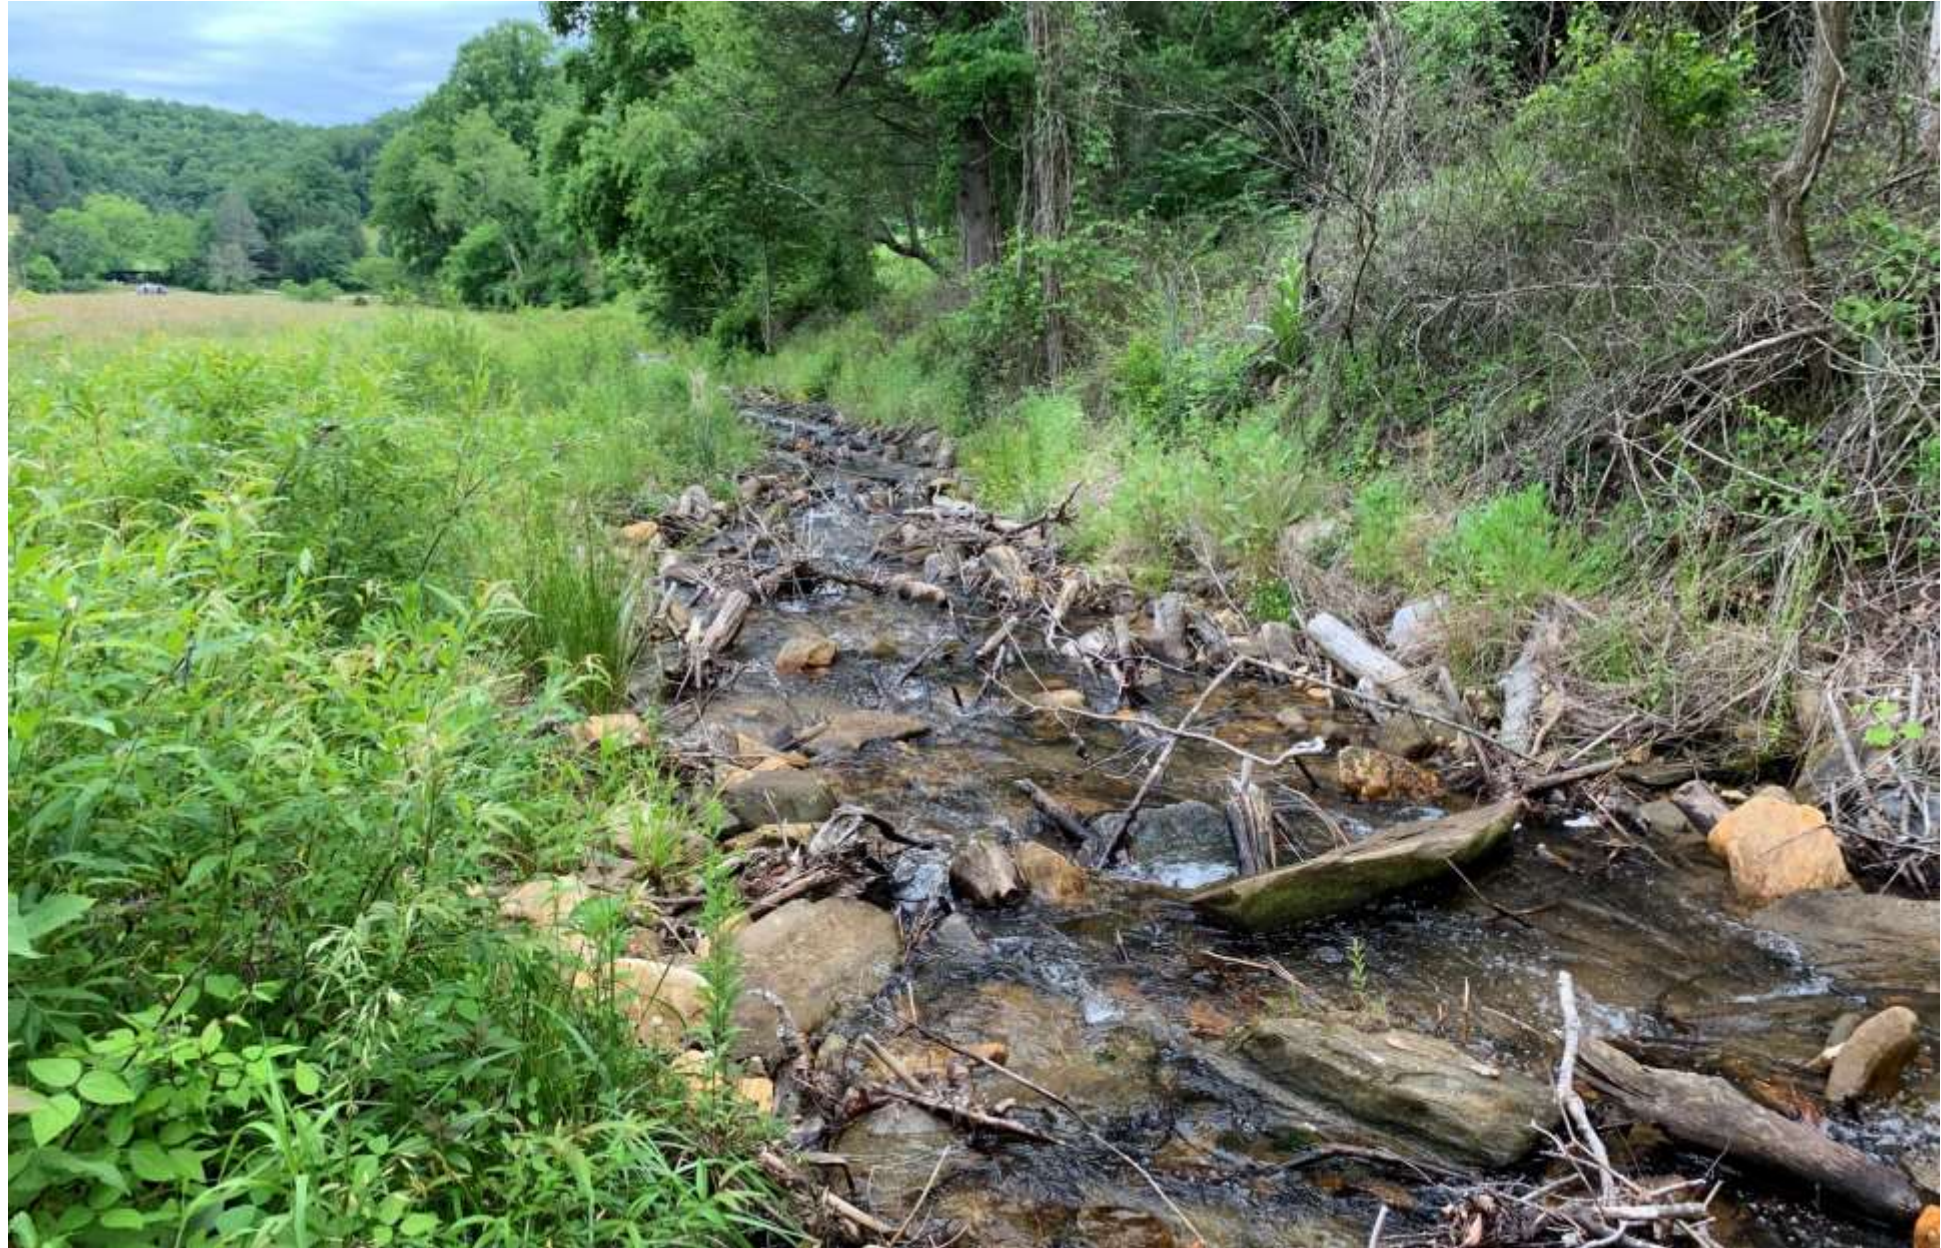
Seniard Creek

- June 2022
- Two years after construction

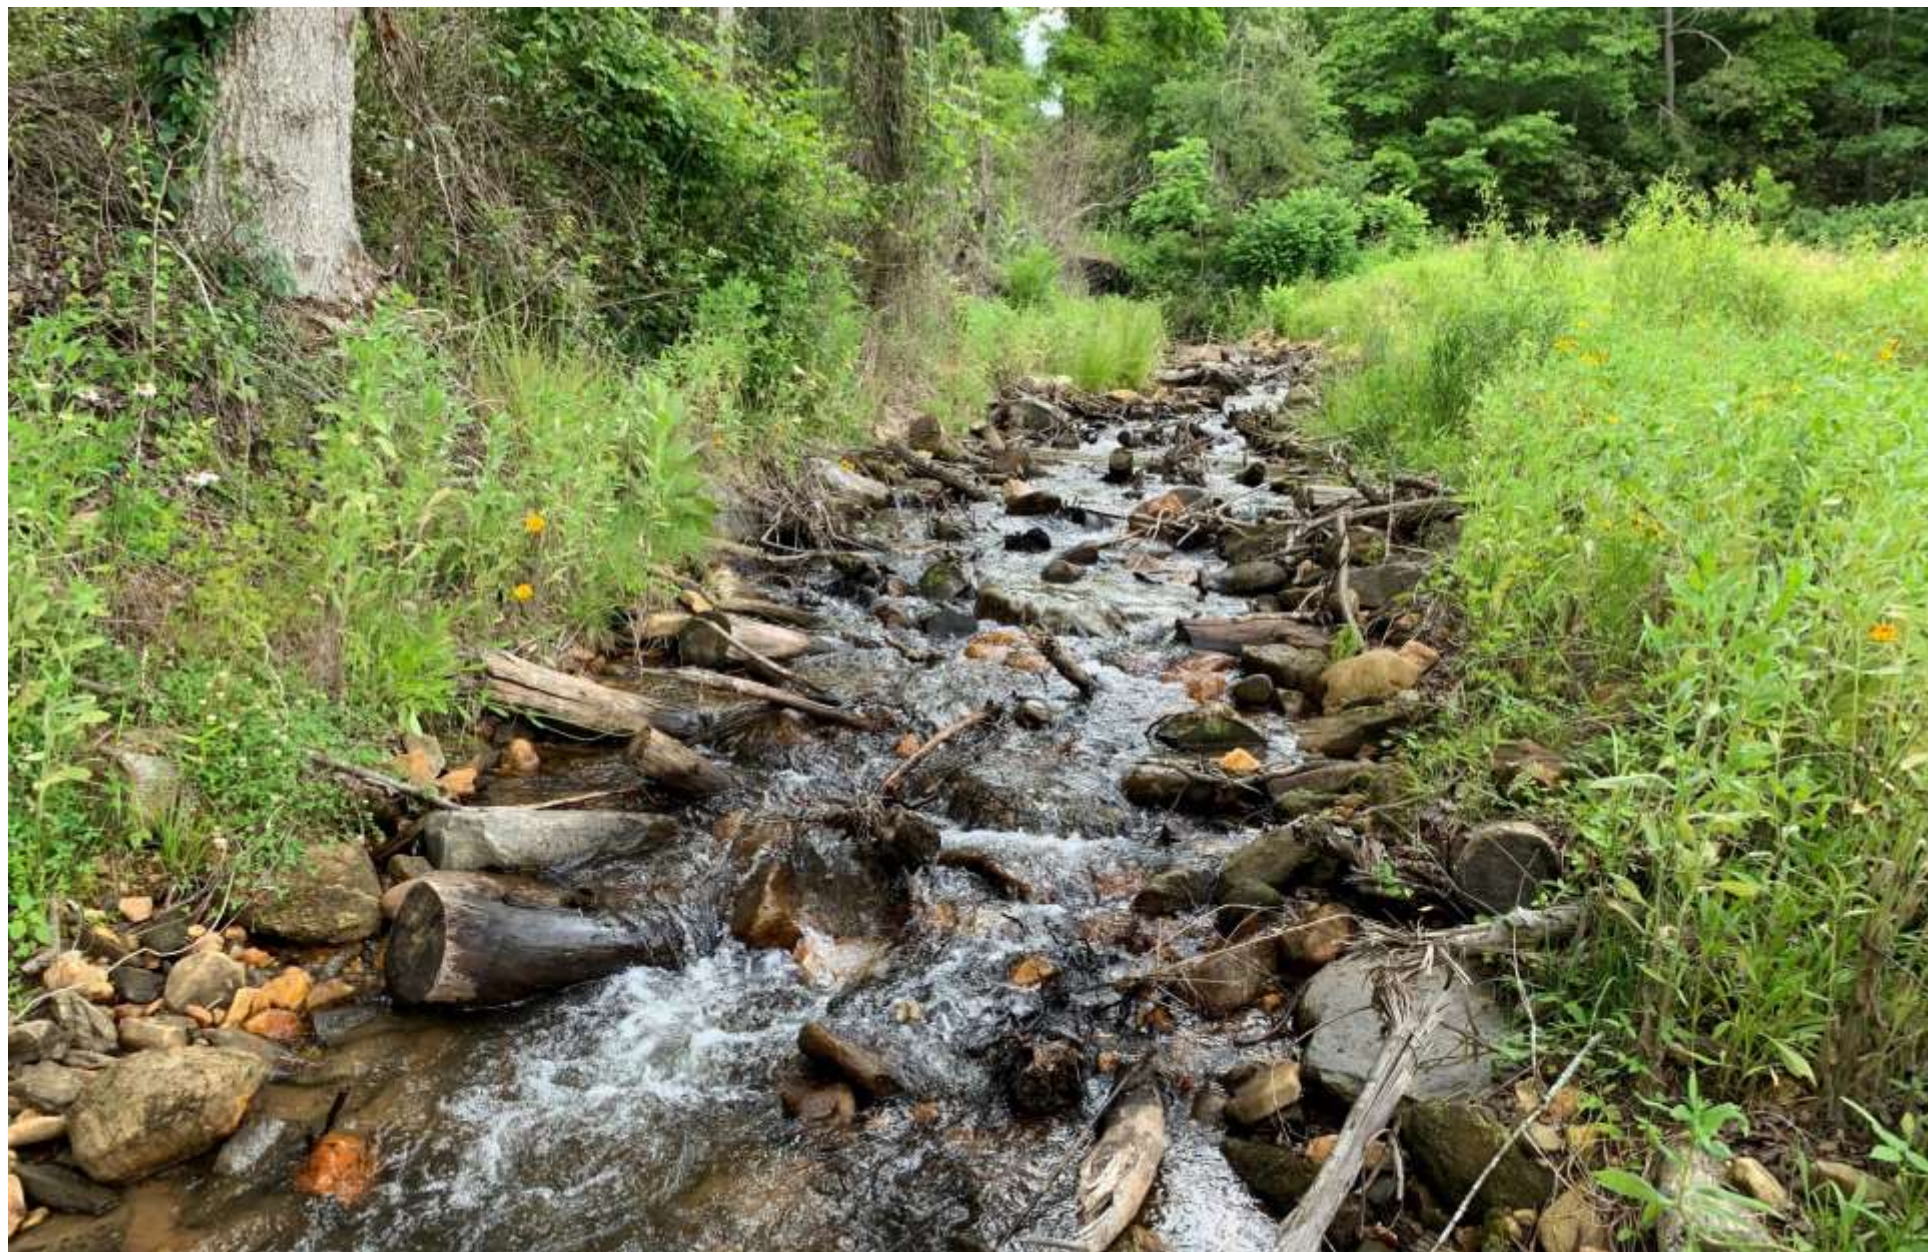
Seniard Creek

- June 2022
- Two years after construction
- Facing upstream

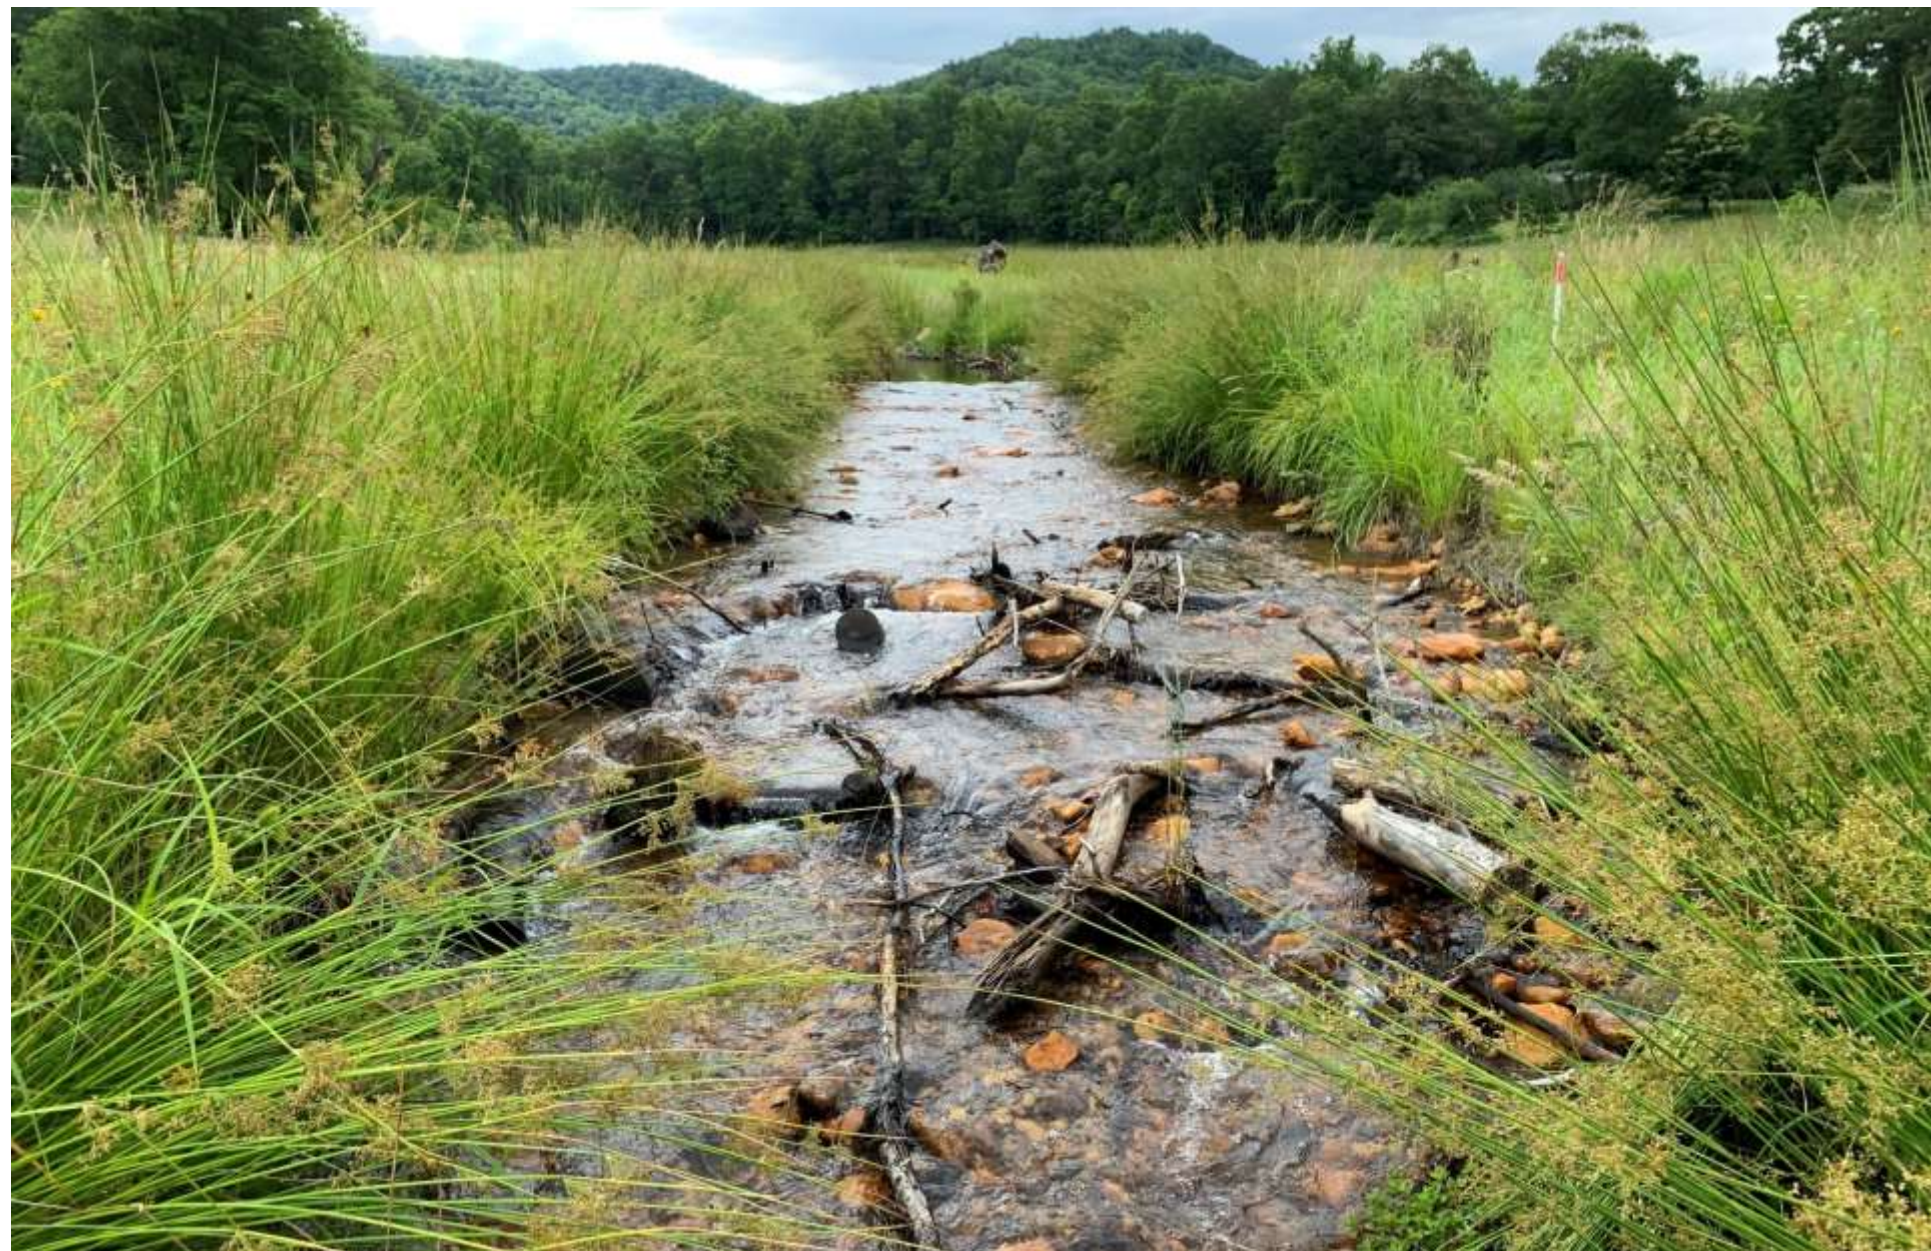
Seniard Creek

- June 2022
- Two years after completion
- Steeper facet at downstream end
- Structure supporting upstream riffle grade

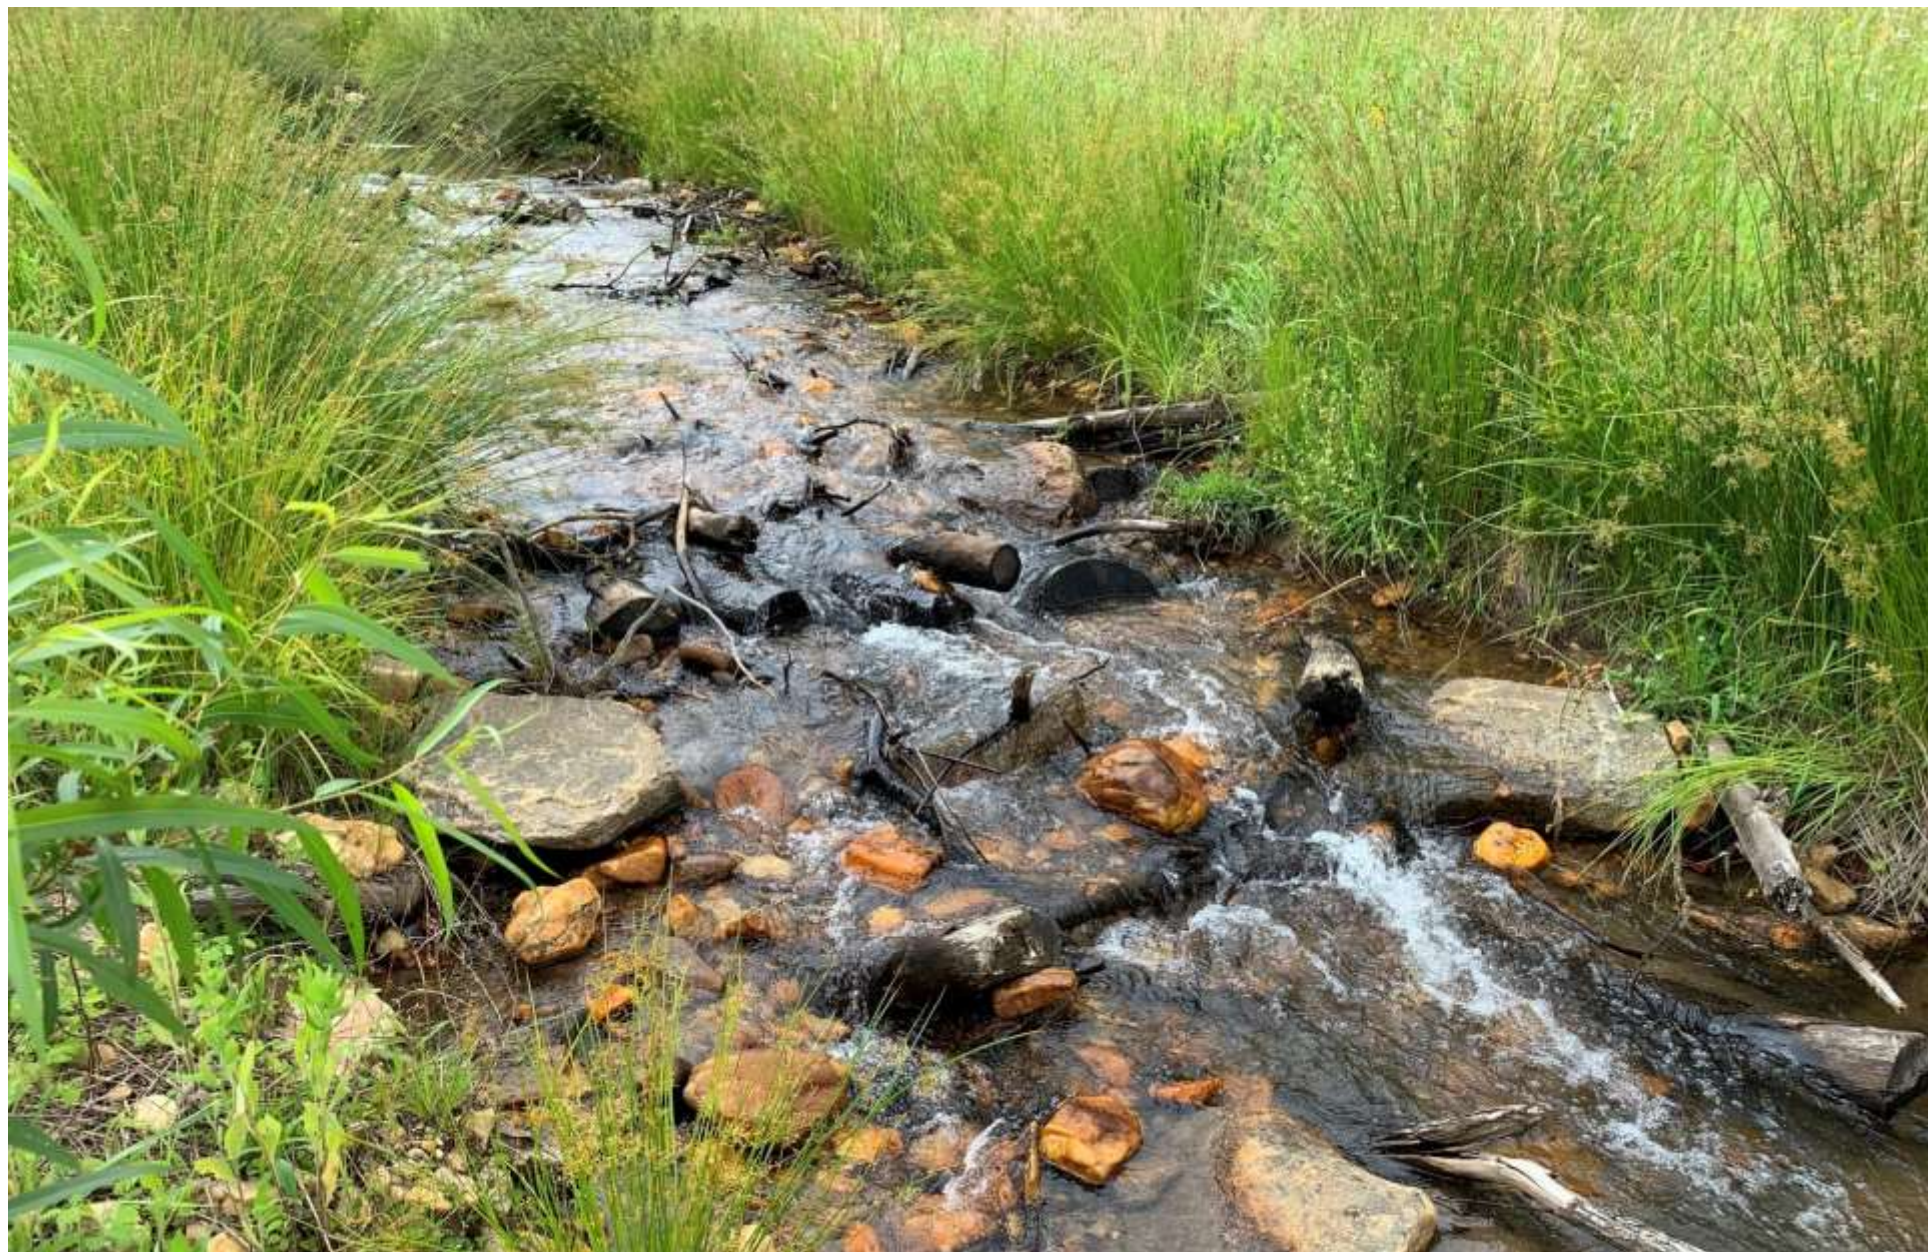
Seniard Creek

- June 2022
- Two years after completion
- Steeper facet at downstream end
- Structure supporting upstream riffle grade

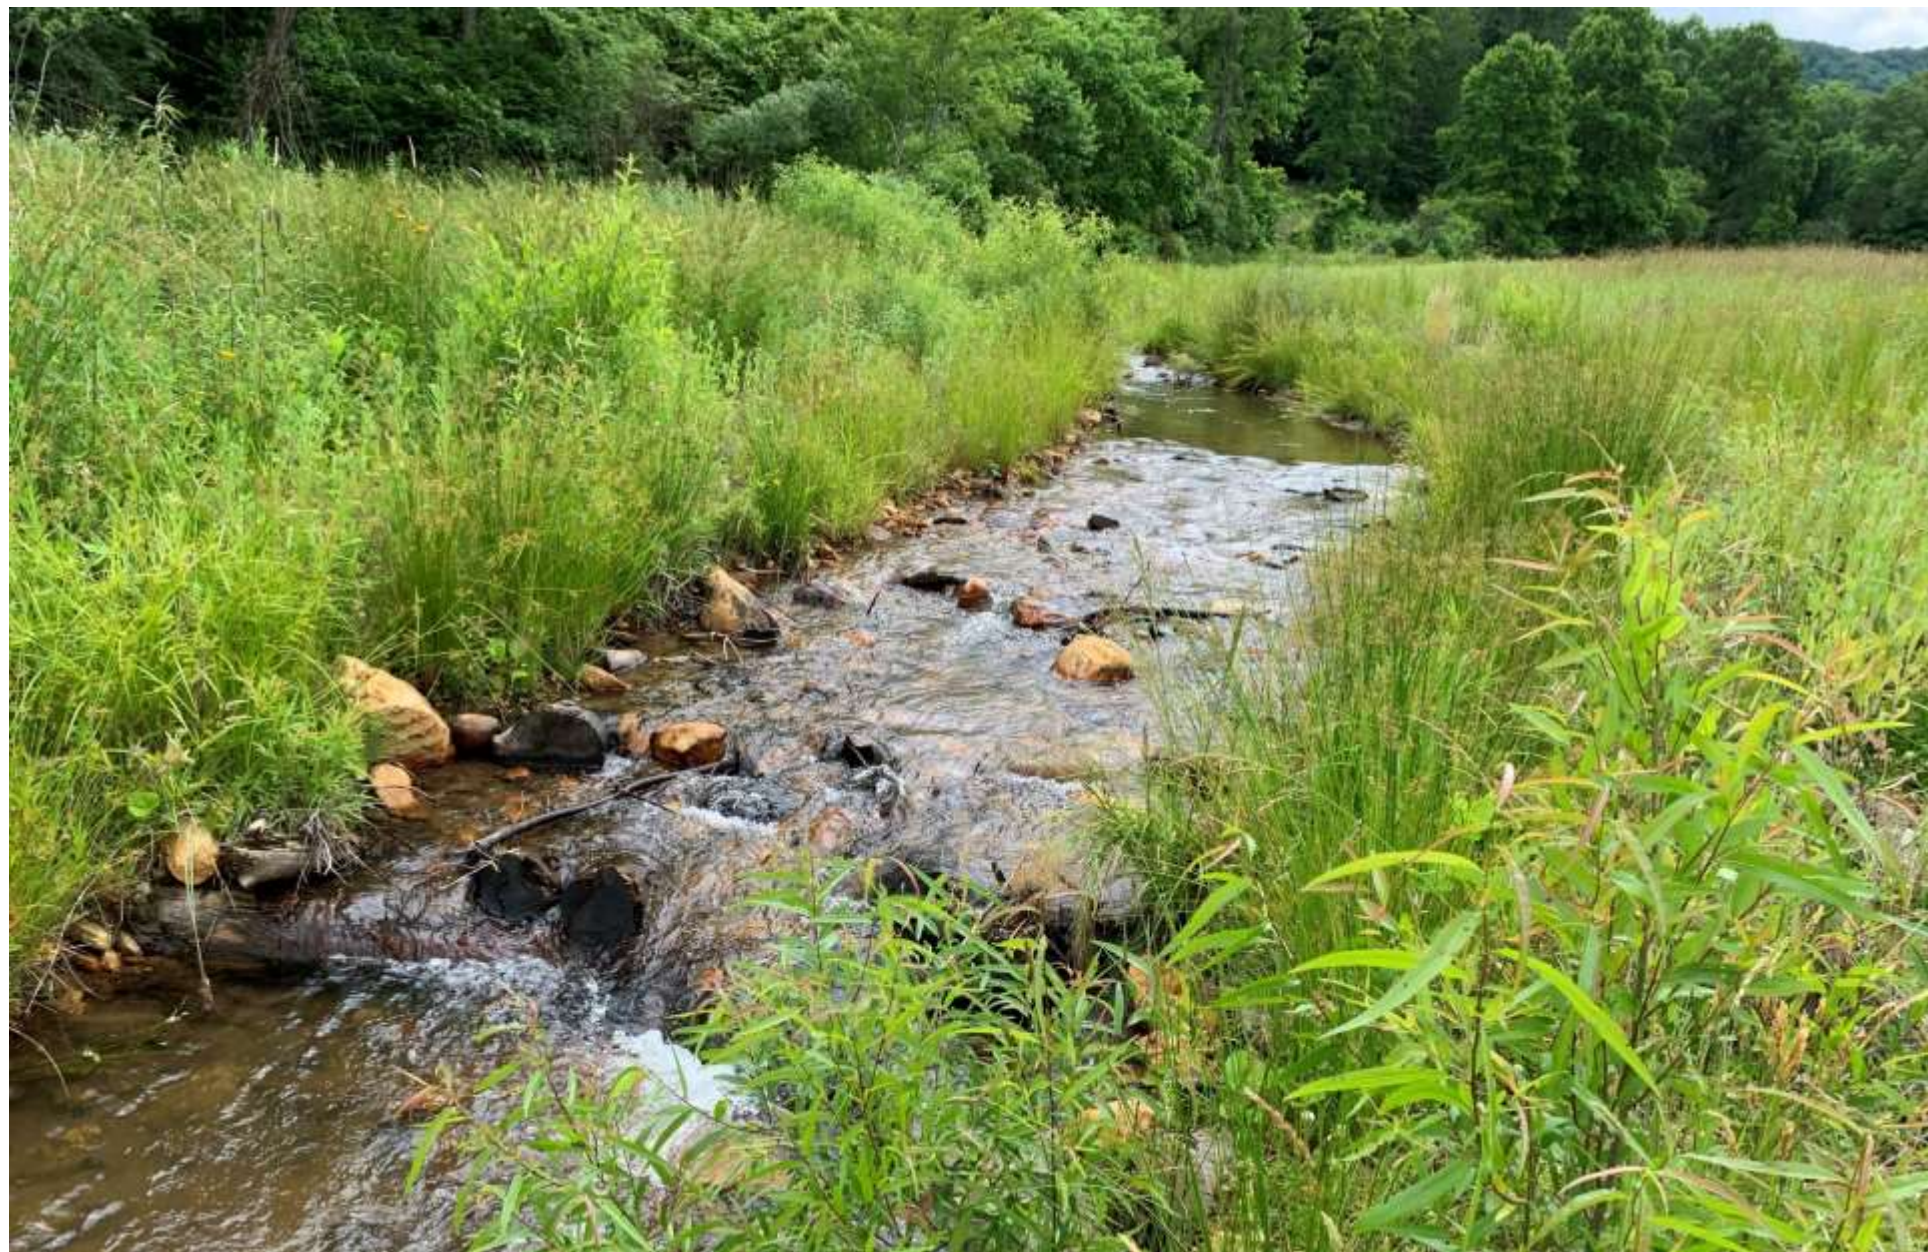
Seniard Creek

- June 2022
- Two years after completion
- Steeper facet at downstream end
- Structure supporting upstream riffle grade

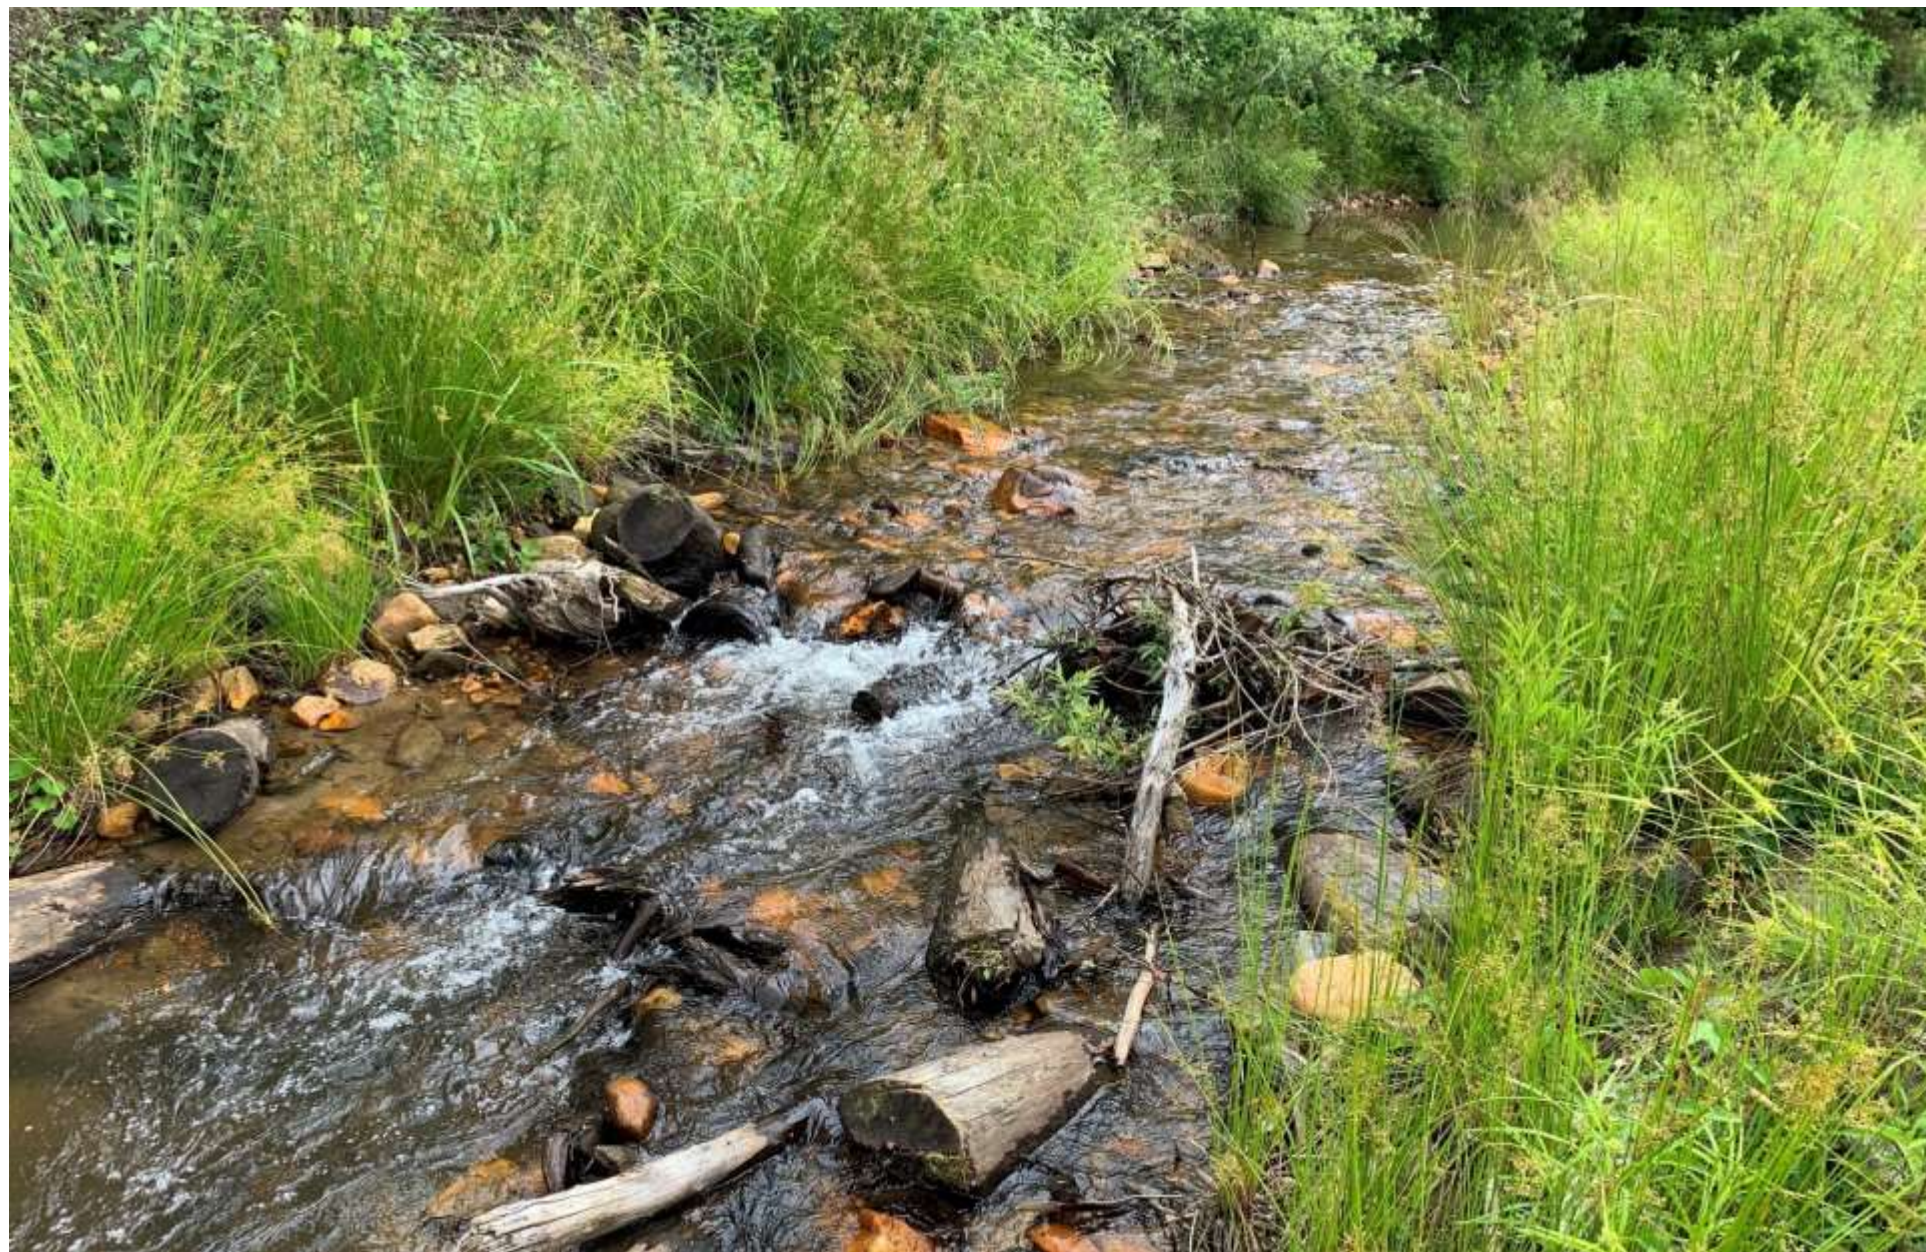
Seniard Creek

- June 2022
- Two years after completion
- Steeper facet at downstream end
- Structure supporting upstream riffle grade
